The Locomotive

THE HARTFORD STEAM BOILER
INSPECTION AND INSURANCE CO.

VOL. XL

1934-1935

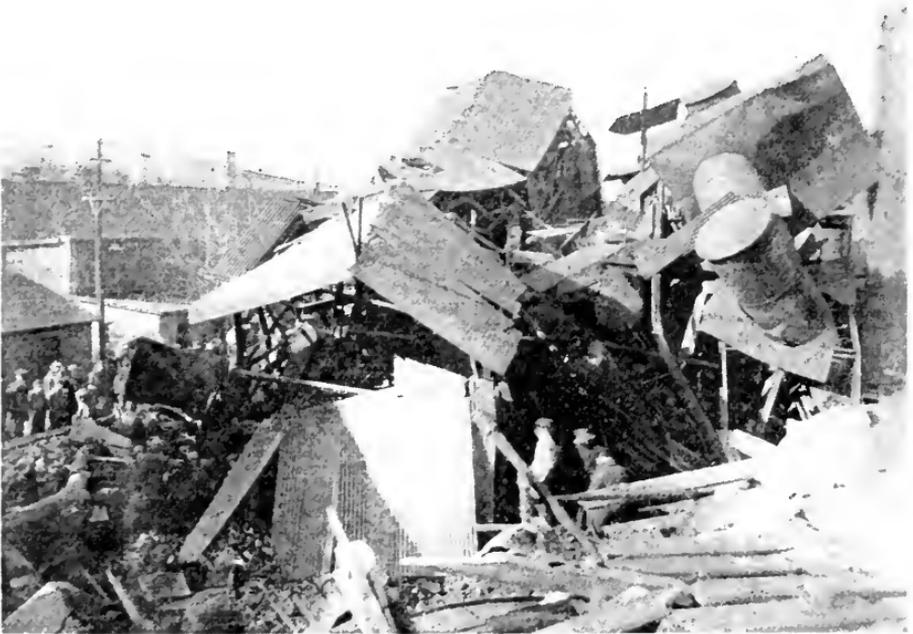
After a corroded mud drum head blew out at an Indiana paper mill.

Investigators were agreed that the boiler had been weakened because of corrosion on the outside of a lower mud drum at the "blind" end of the drum, concealed by the brickwork of the setting, and that this weakening led to the accident. All of the tubes were pulled from the mud drum and the drum itself was thrown a distance of approximately 75 ft, landing on the roof of a paper storage house. Examination of

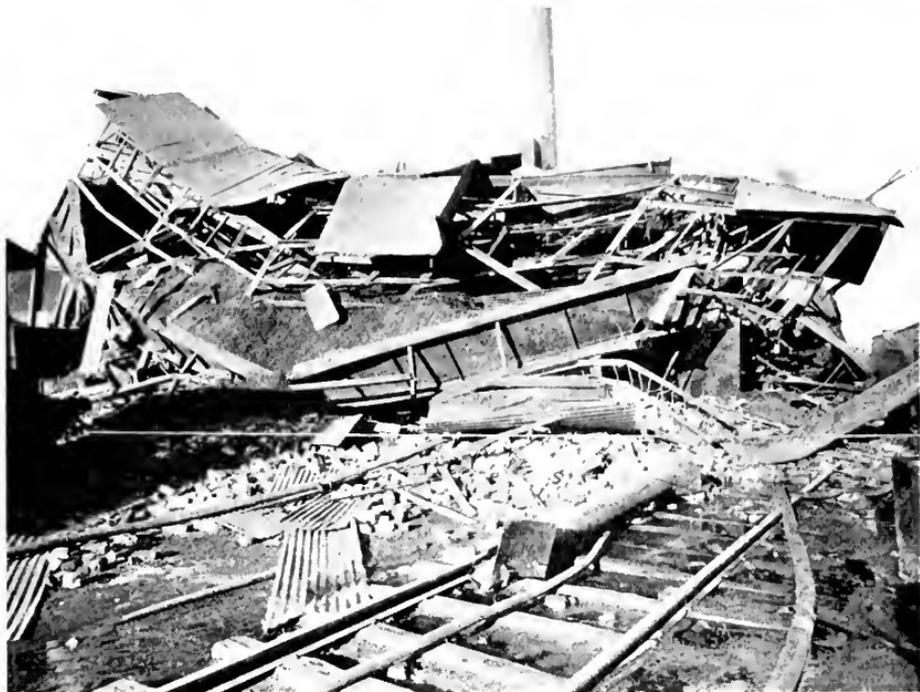
A bunker of coal collapses into the debris to complicate the search for a fireman's body.

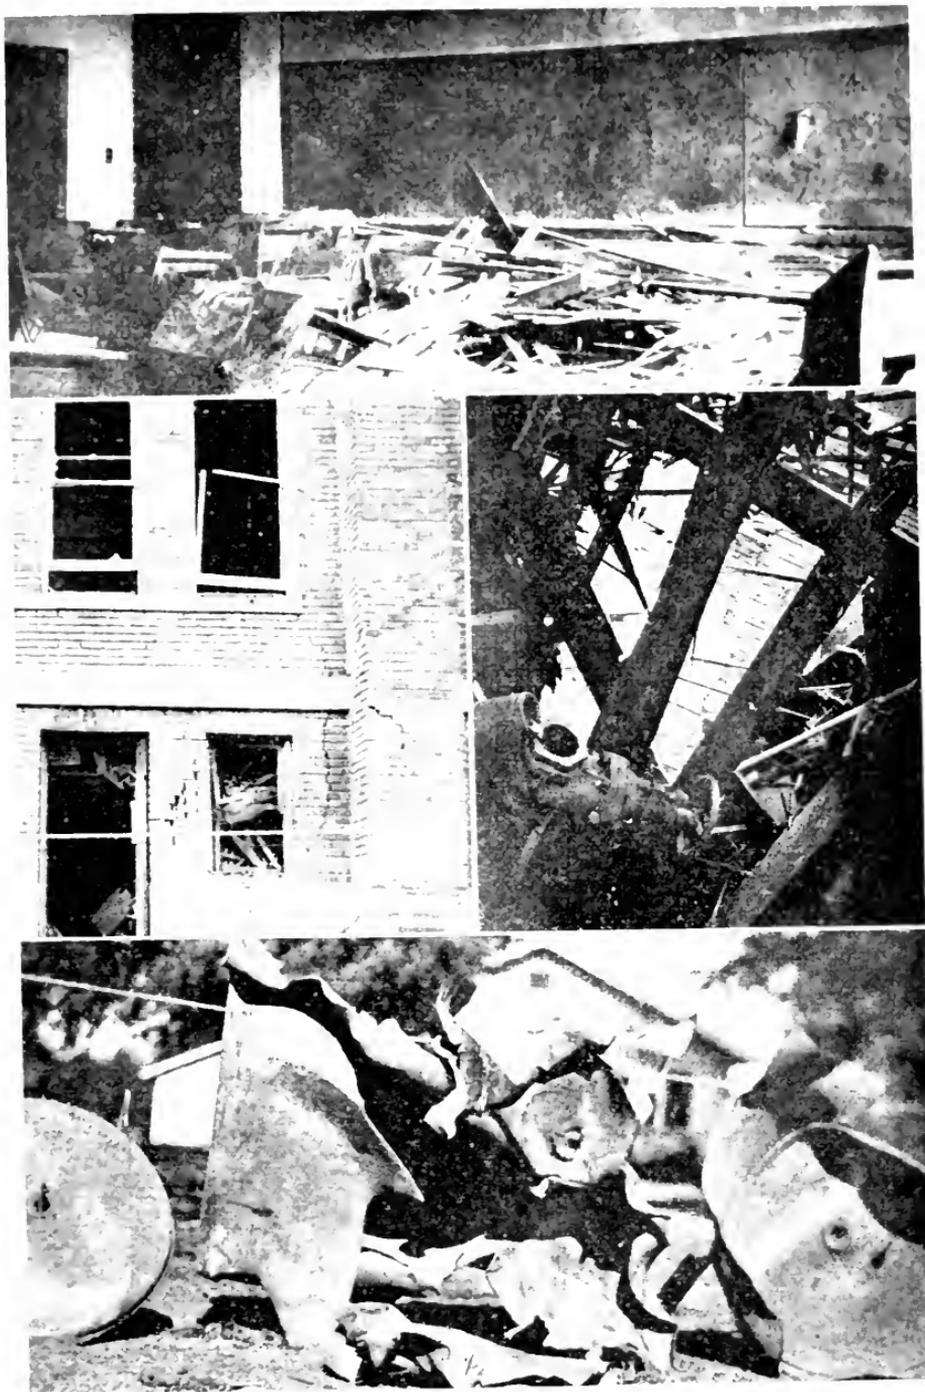
Scenes at Forest, Mississippi. Top and right center—pieces of the school-room floor. Left center—cracks in the building. Bottom—pieces of the tank.

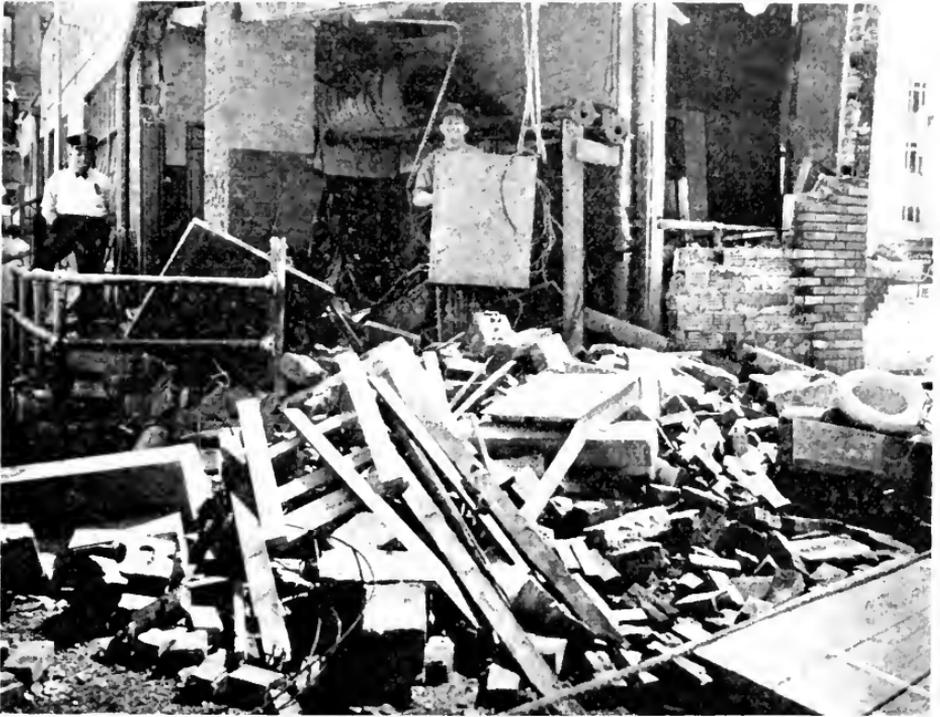
An Indiana automobile service station after a hot water heater burst.

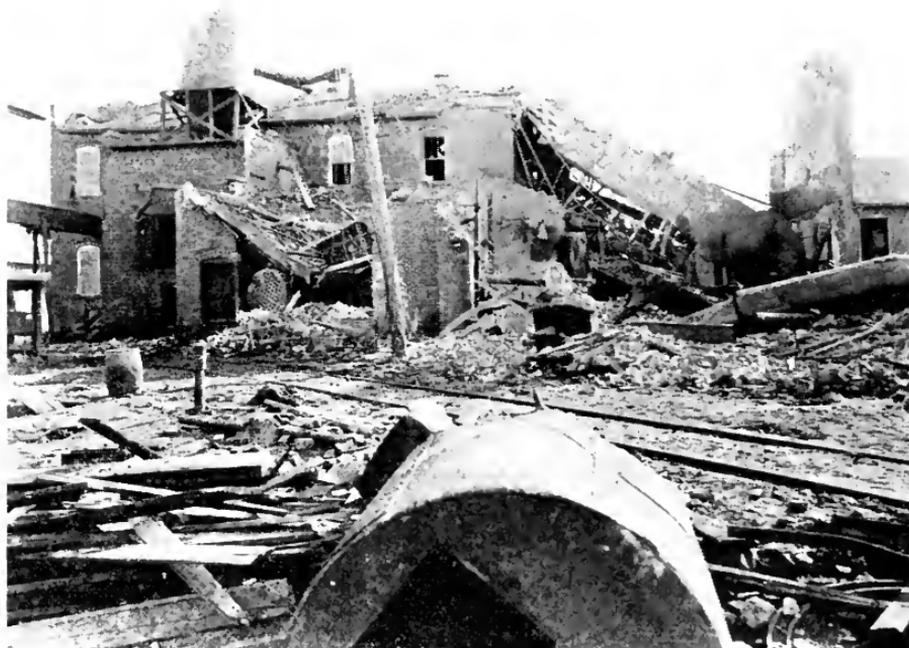
Wreckage at Hertford, North Carolina. A one-story boiler room formerly stood at the right just beyond the tracks at about the spot where the steel smokestack is lying. Near the left center of the mill building is No. 1 boiler beneath which is the engine. On the roof of the mill building at the extreme left is the rear course of the No. 2 boiler which exploded. The breeching is in the foreground.

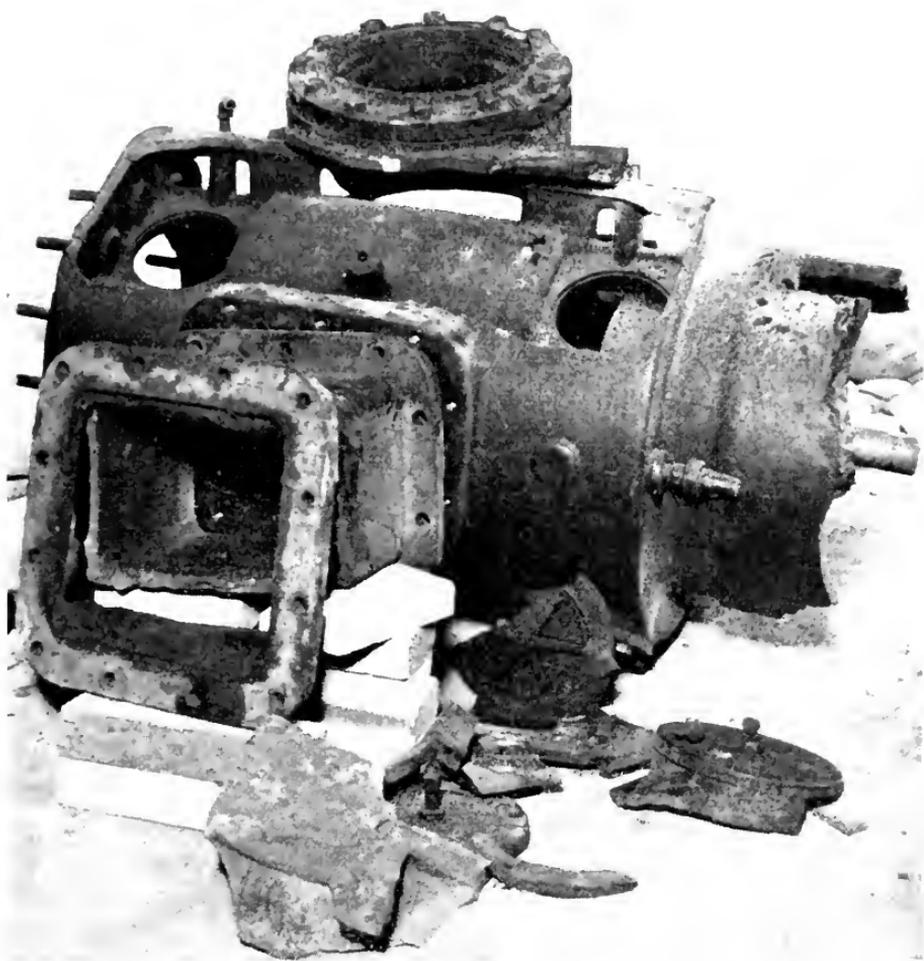
High pressure cylinder of an air compressor demolished by explosion of a mixture of oil vapor and air.

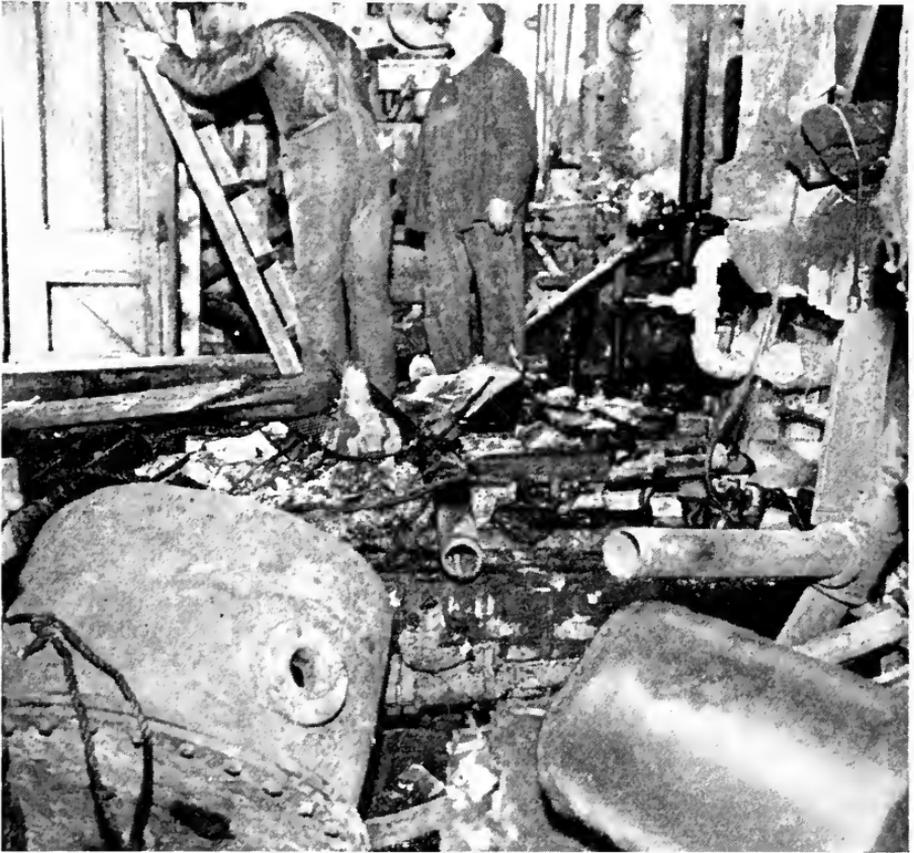
Result of cast iron blow-off tank explosion.

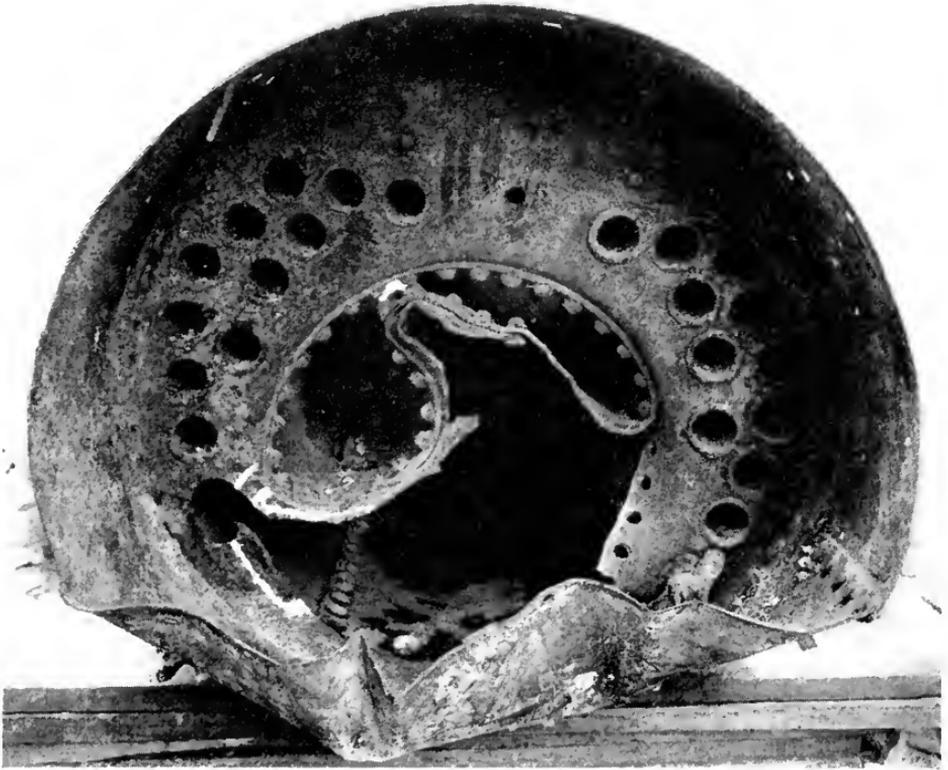
Caused by corrosion and over-pressure.

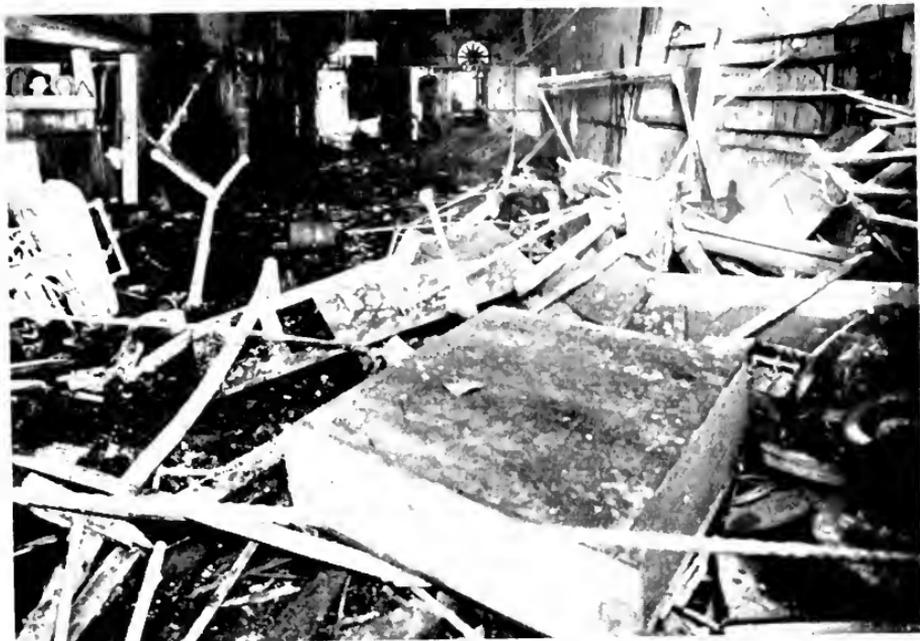
What a boiler did to its owner's dry cleaning establishment.

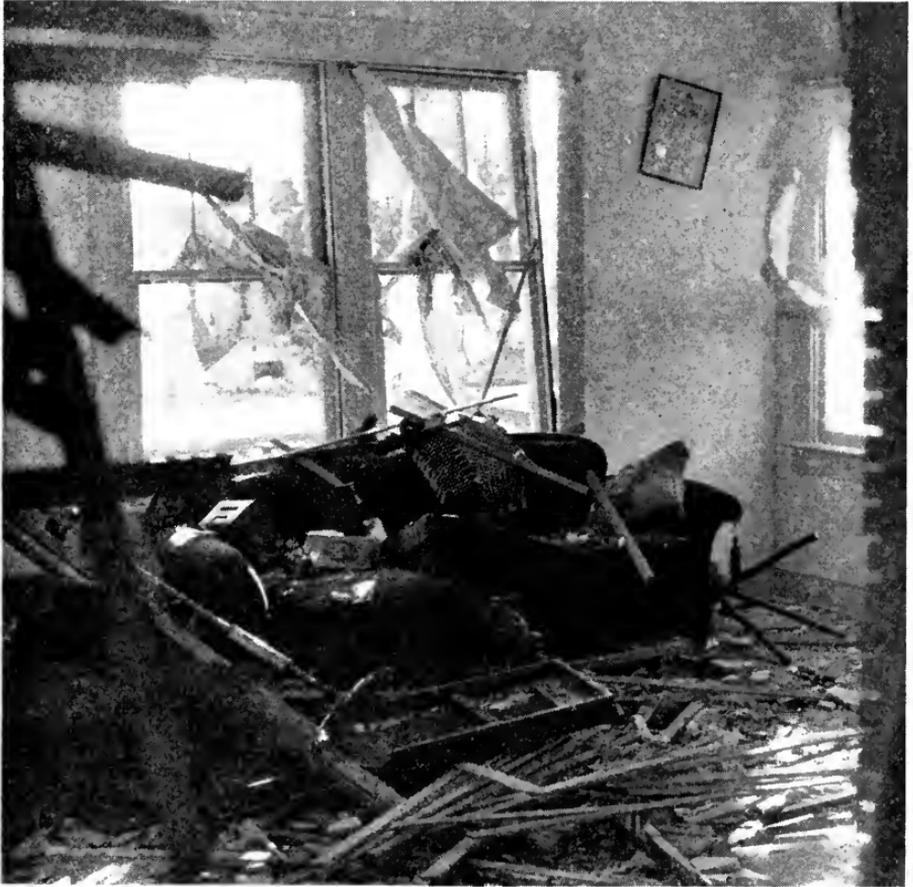
Home wrecked by bursting of hot water tank.

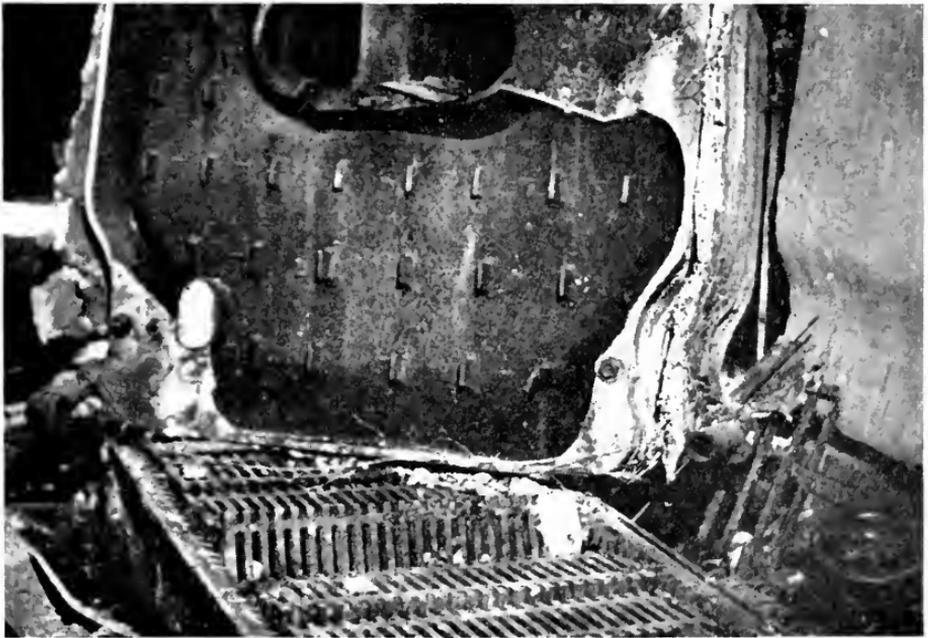
Church's cast iron boiler weakened by broken stays.

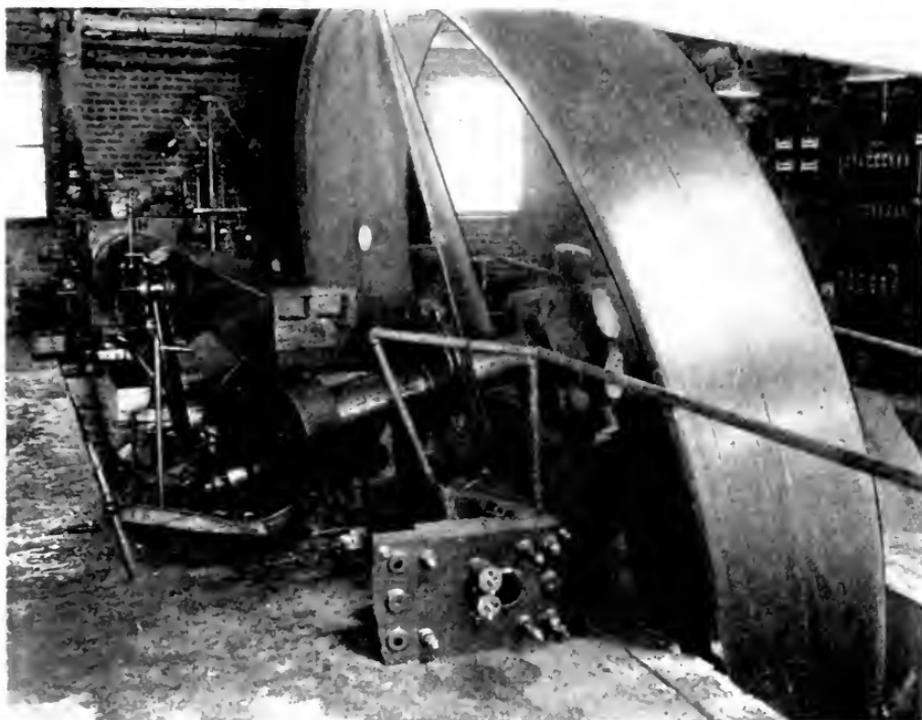
The engineer heard a crash; he returned to this wreck.

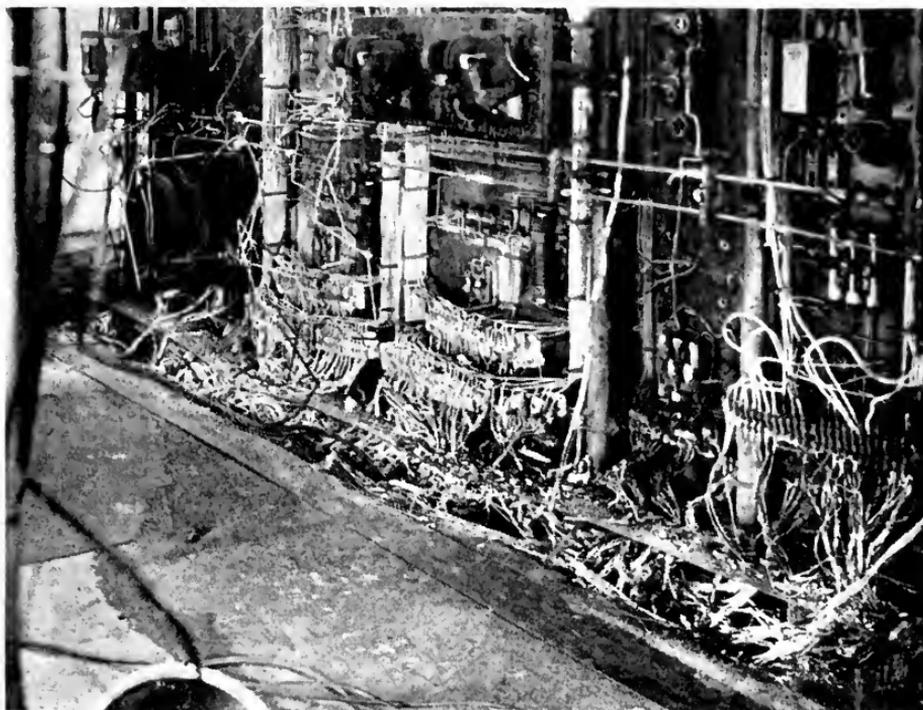
Switchboard wrecked by a short circuit and fire.

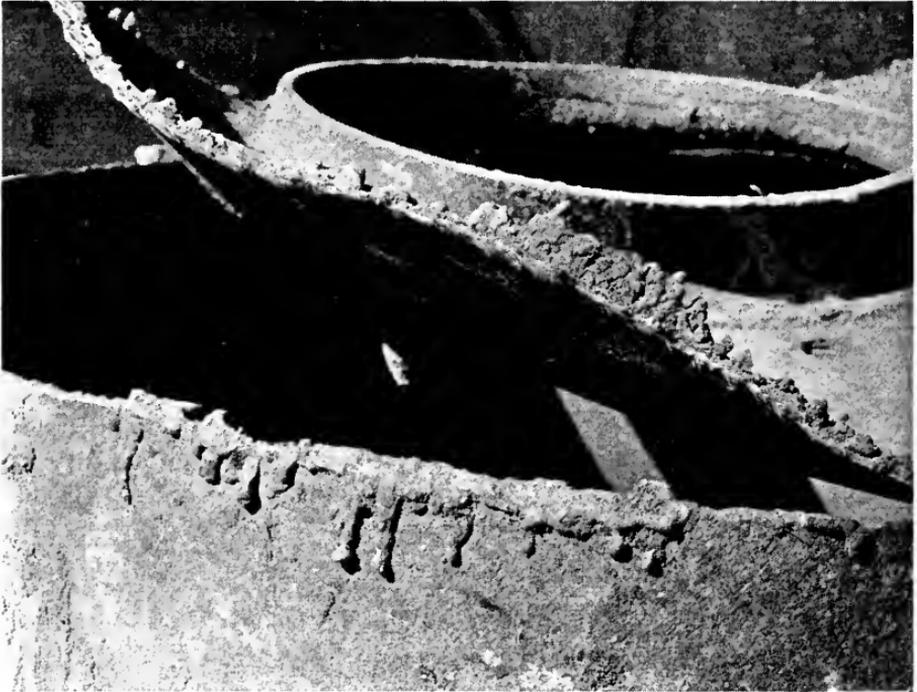
Close-up view of welded seam failure.

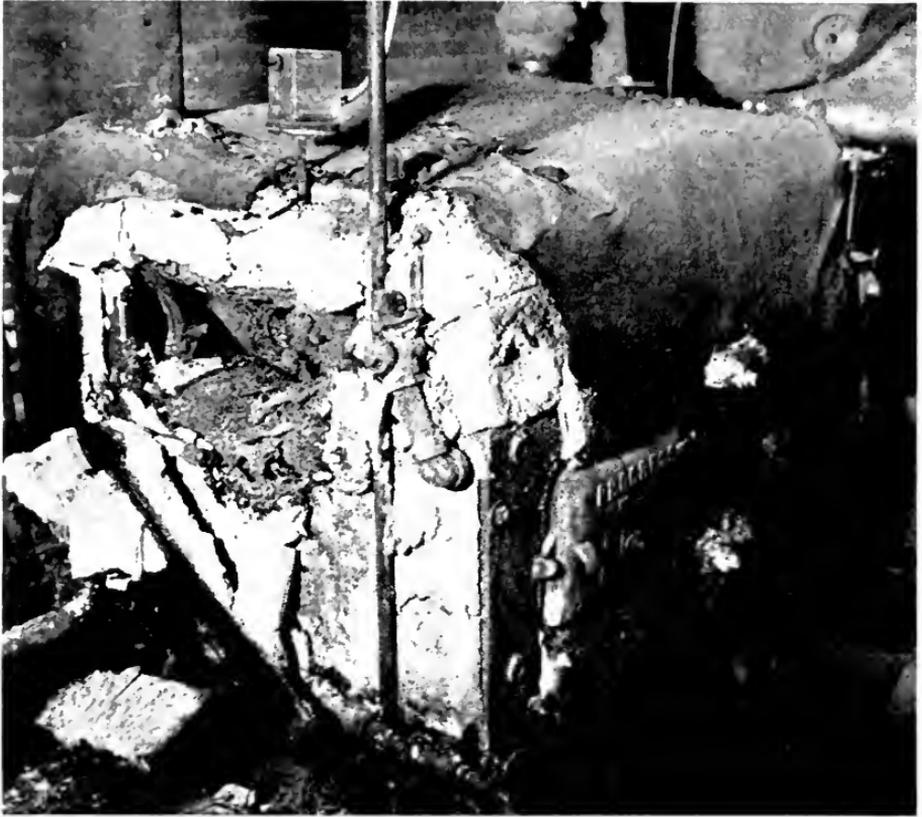
After the boiler drained the oil burner kept on operating. The sections were fused into a shapeless mass.

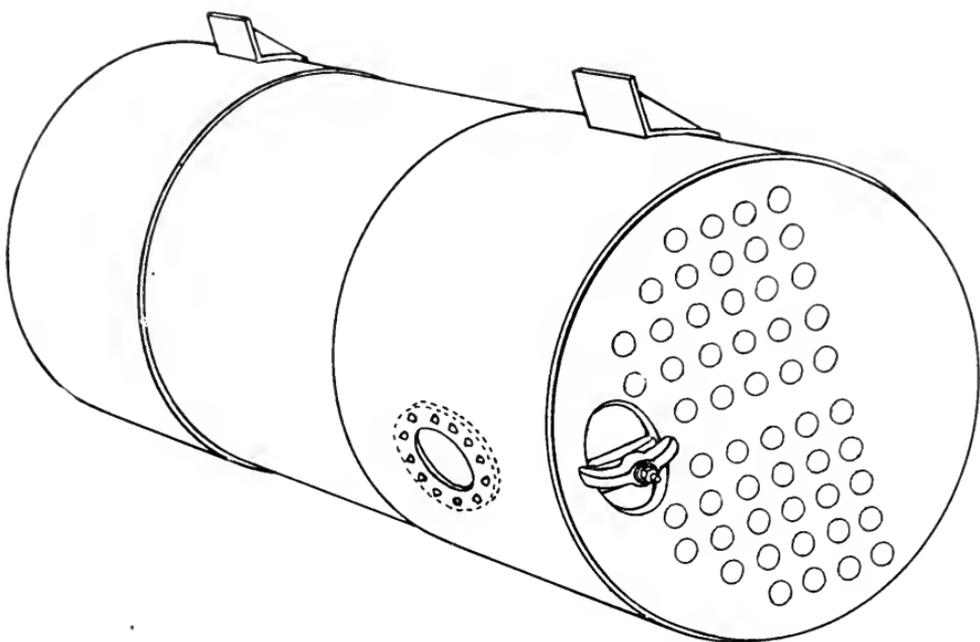
Figure 3—Repair of a bulge caused by overheating because of scale.

If the depth of such a bulge is not more than 25% of its diameter, it may be possible to restore the plate to practically its original shape by proper heating and hammering. Even if there is no rupture at the apex of the bulge it is well to drill a hole of about 1" diameter at that point in order to determine the thickness of the plate and to facilitate the upsetting of the bulged metal. A welding torch, secured to a long

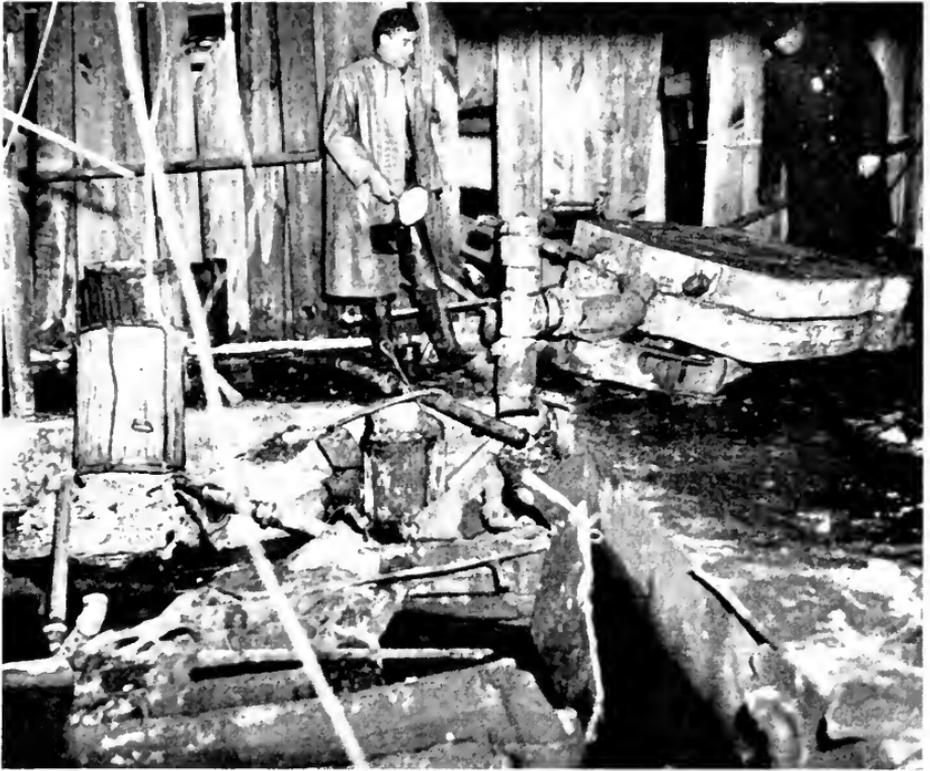
Wreckage following a heating boiler explosion at Clifton, N. J.

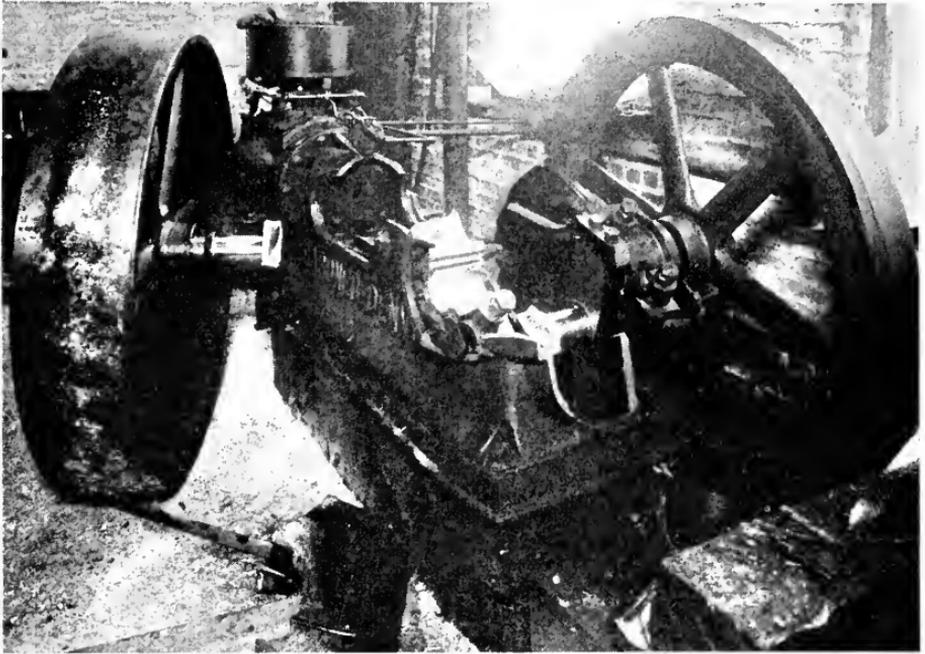
AN old and originally small flaw in the metal gradually extended in the crank of an air compressor at a North Carolina mill until the crank could no longer sustain the load and broke suddenly with the result shown in the accompanying photograph. The break caused a

An air compressor wrecked when the crank broke as shown.

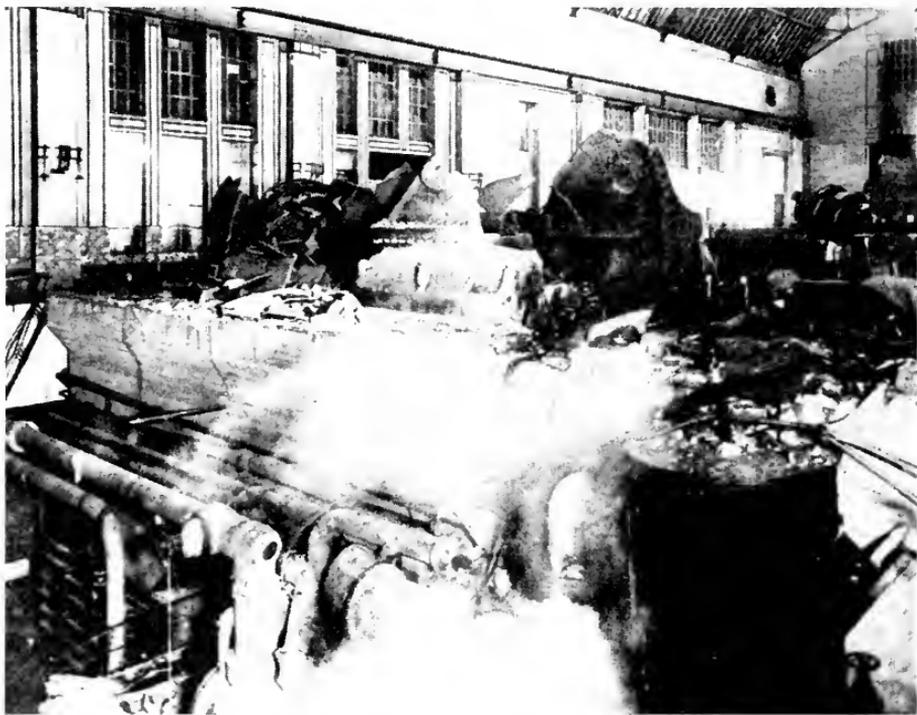
photograph of a turbine that exploded some months ago in a power station at Stettin, Germany. This 23,000 kw unit was undergoing a 10 per cent overspeed trial when it let go, severely injuring two attendants and causing damage estimated at \$200,000.

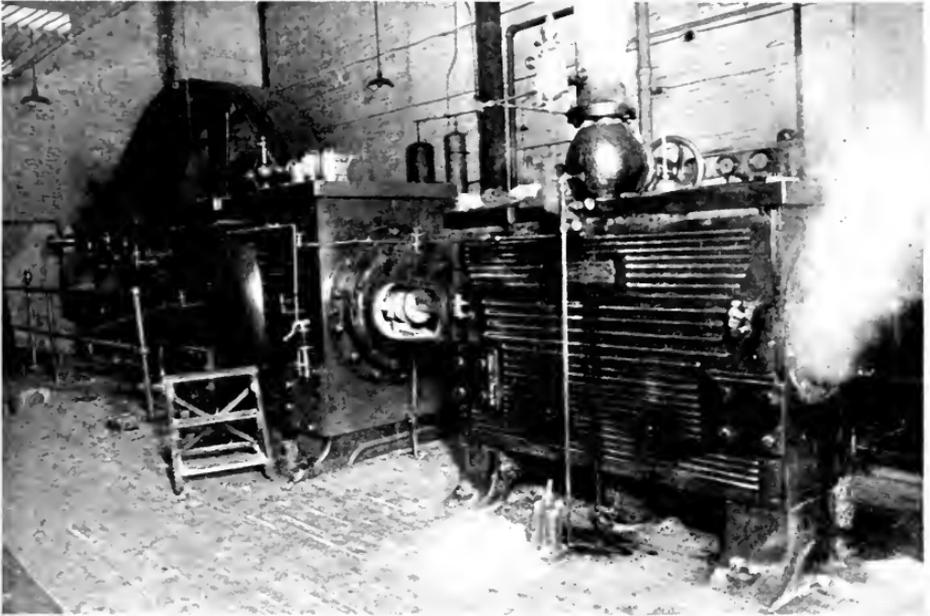
What unharnessed reciprocating parts can do to a steam engine

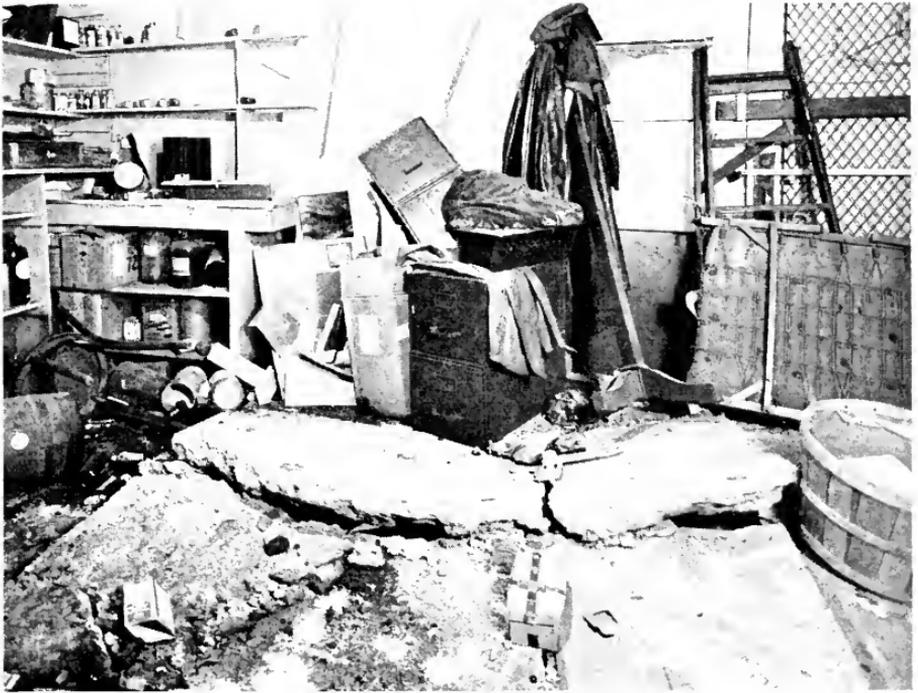
Part of drug store floor damaged by hot water heater blast.

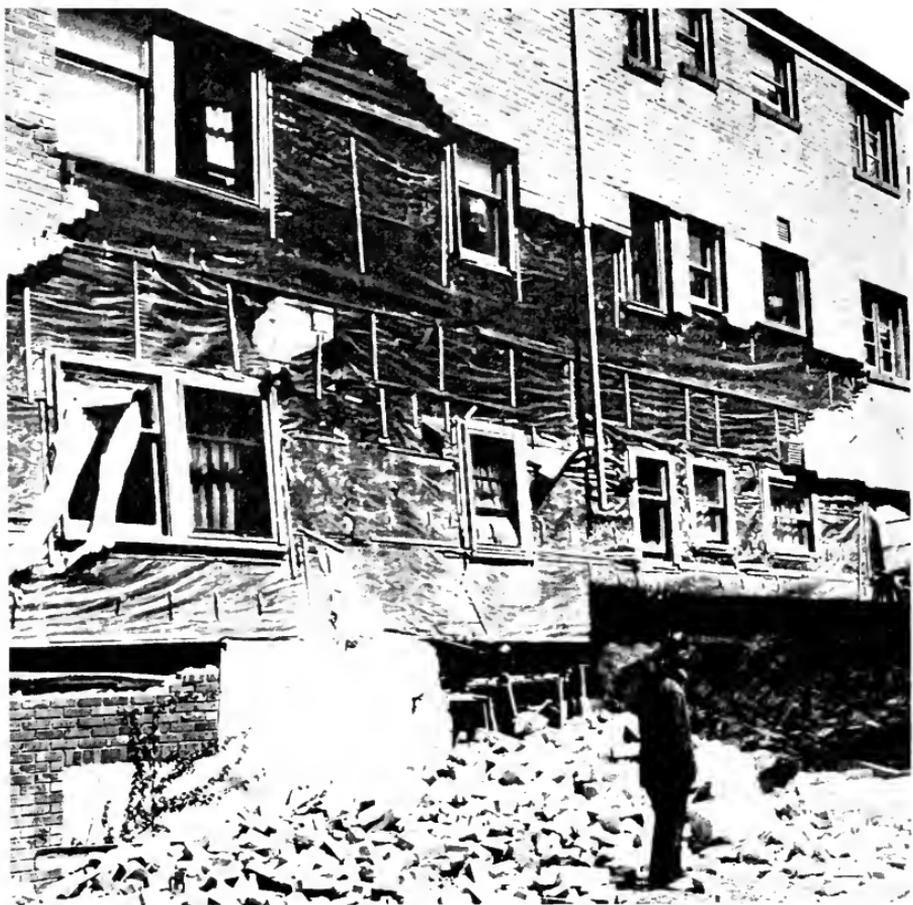
Part of \$30,000 damage after heating boiler exploded in Seattle apartment.

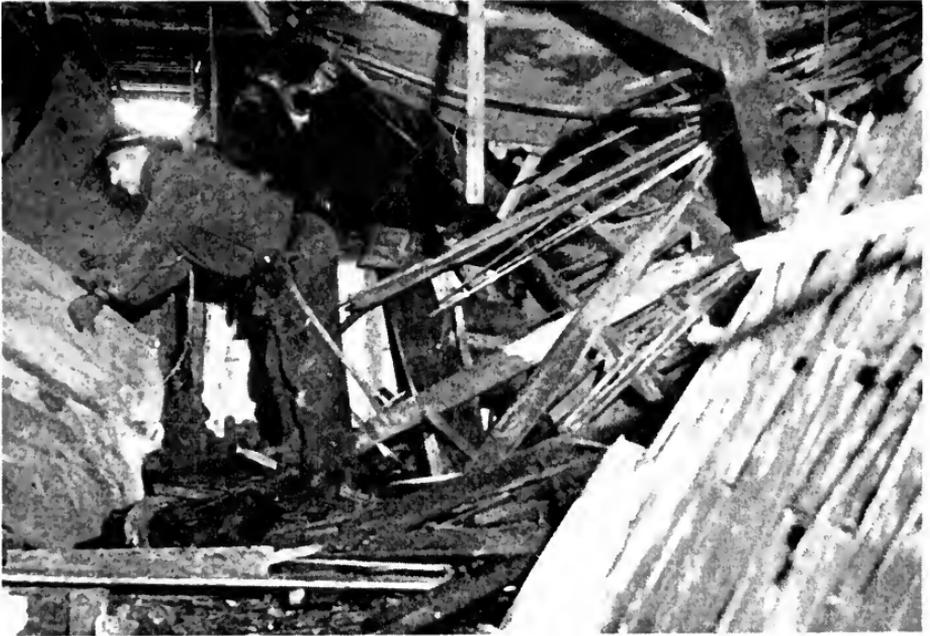
Debris inside apartment following the accident.

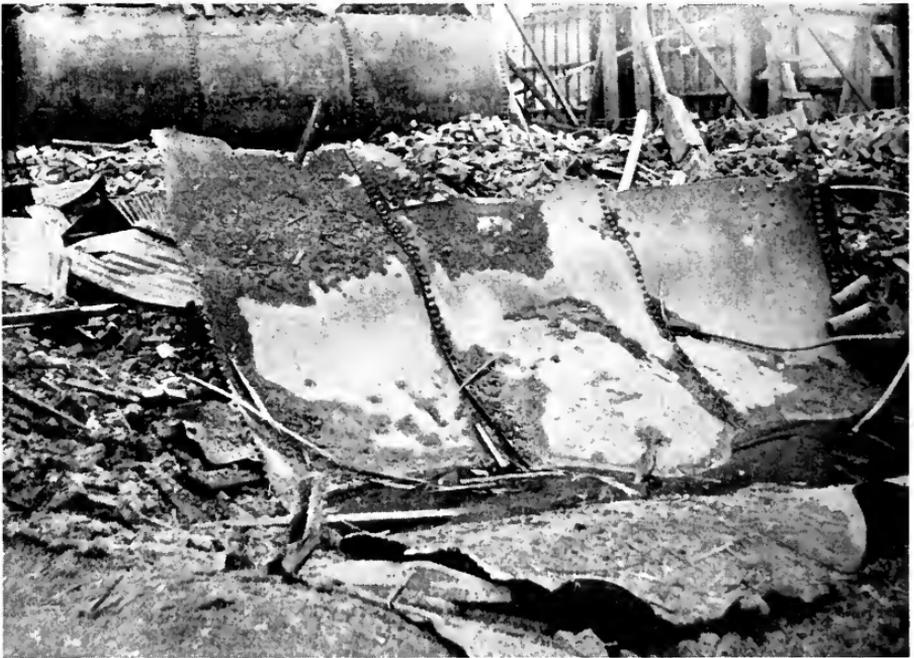
Partial view of wreckage from Georgia boiler blast.

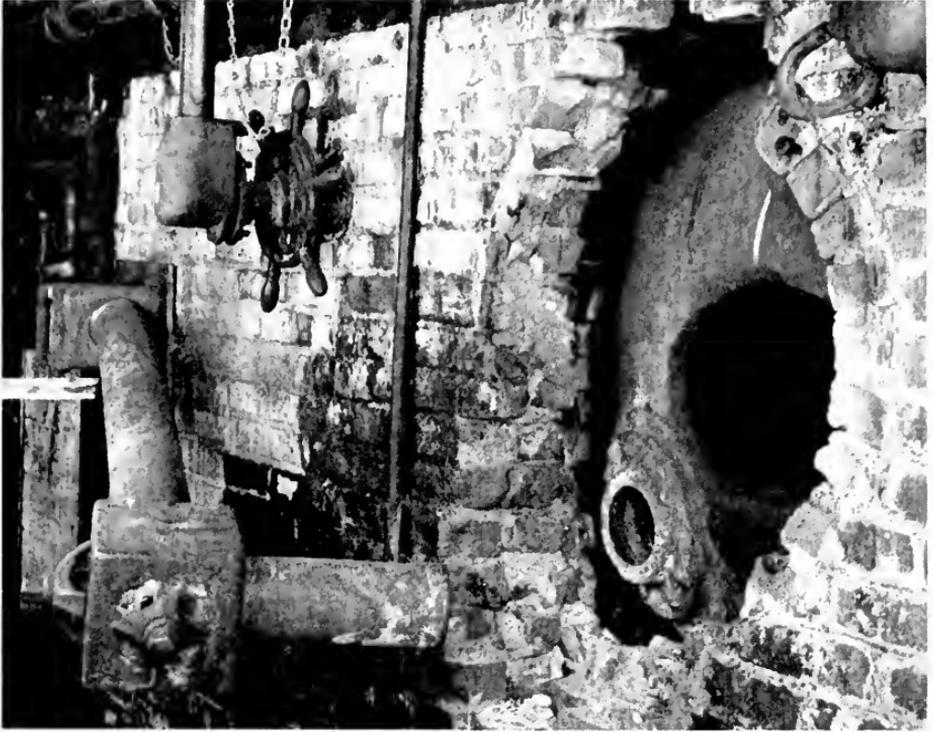
Circulating tube which pulled out of drum. Prompt drawing of the fire prevented serious overheating of the draining boiler.

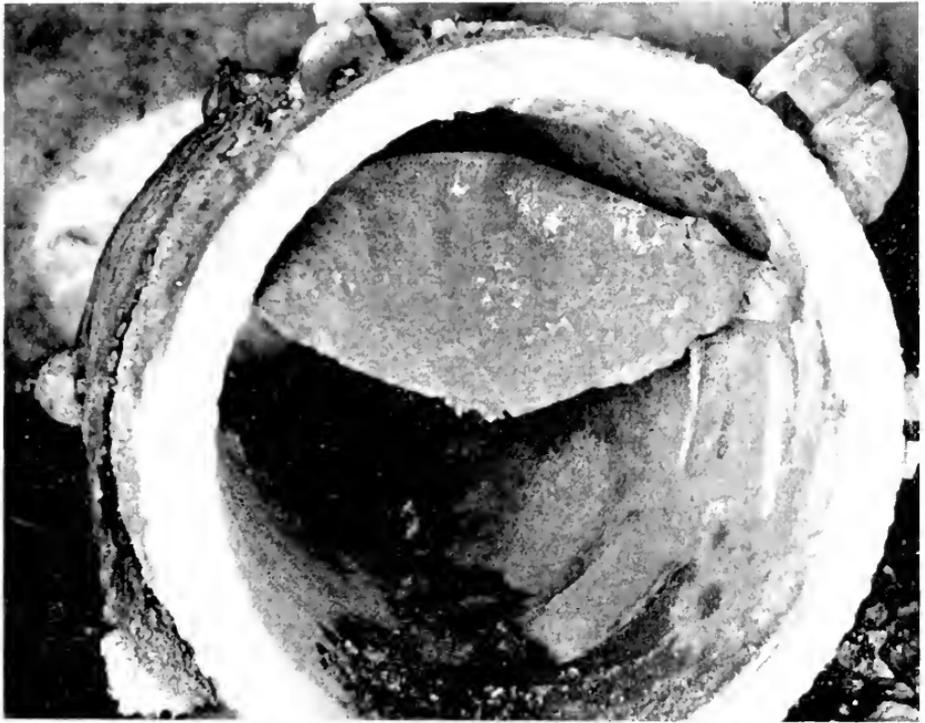
An accident clearly attributable to corrosion.

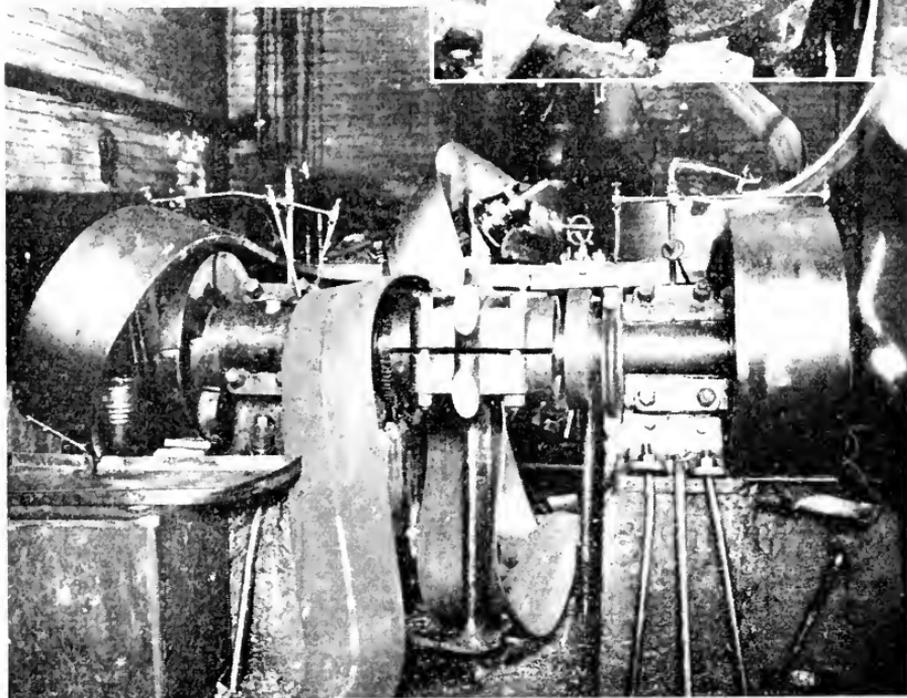
Spoke stumps and a tangle of belts and machinery after the engine stopped suddenly. Above—The cracked crank disc.

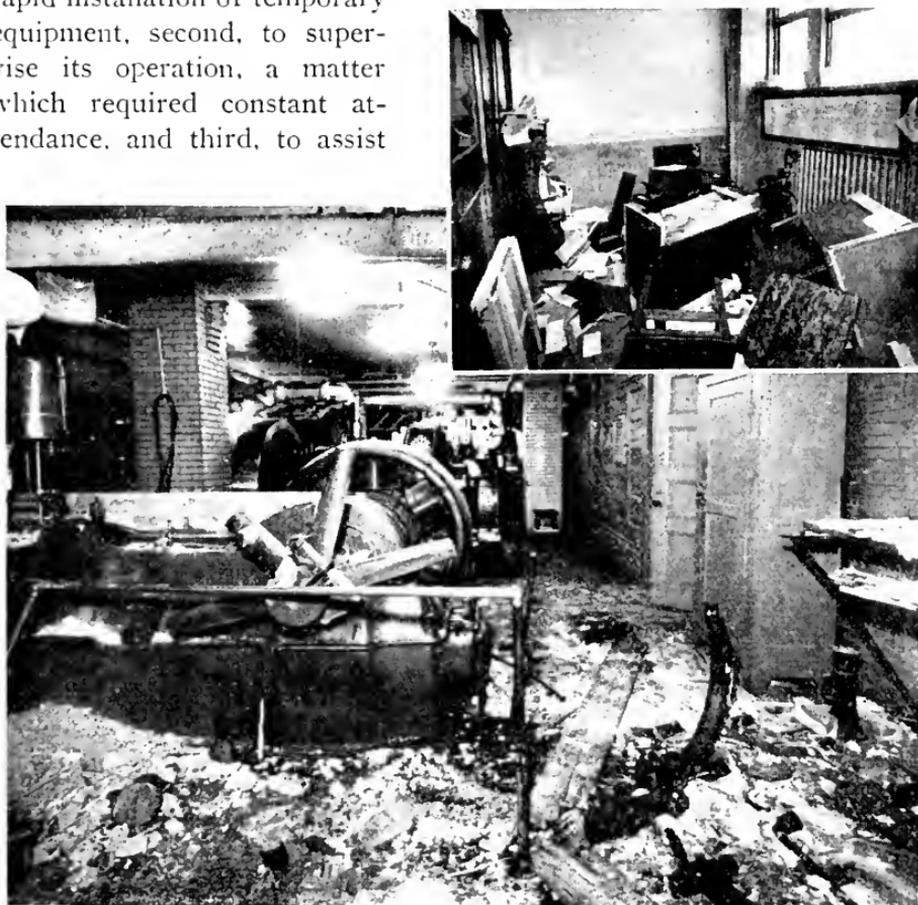
Only the spokes remain. Part of the wheel jarred the room shown above by heaving the concrete floor.

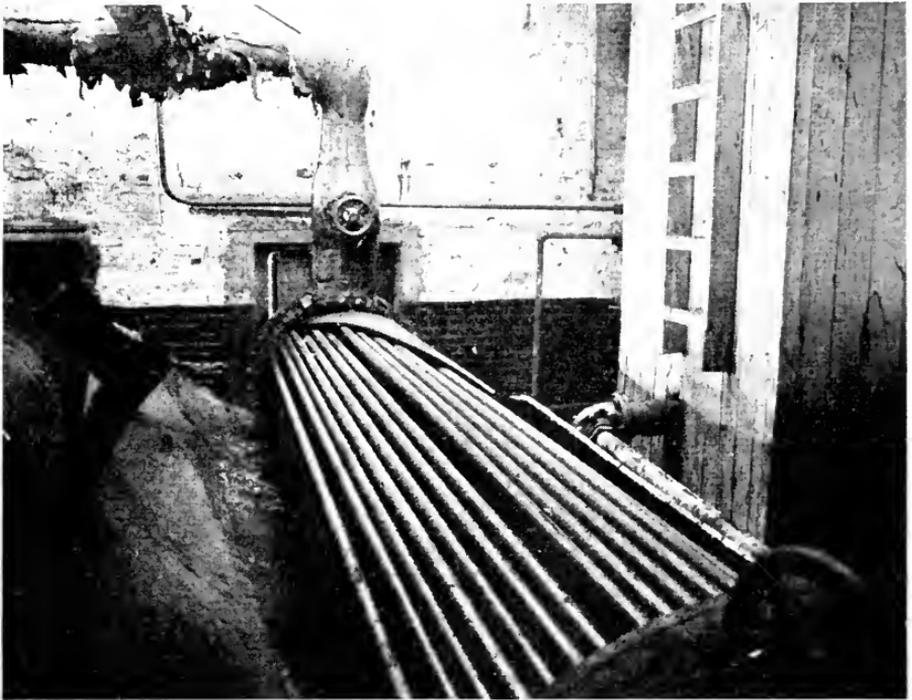
Figure 1—Caused by an unsound weld.

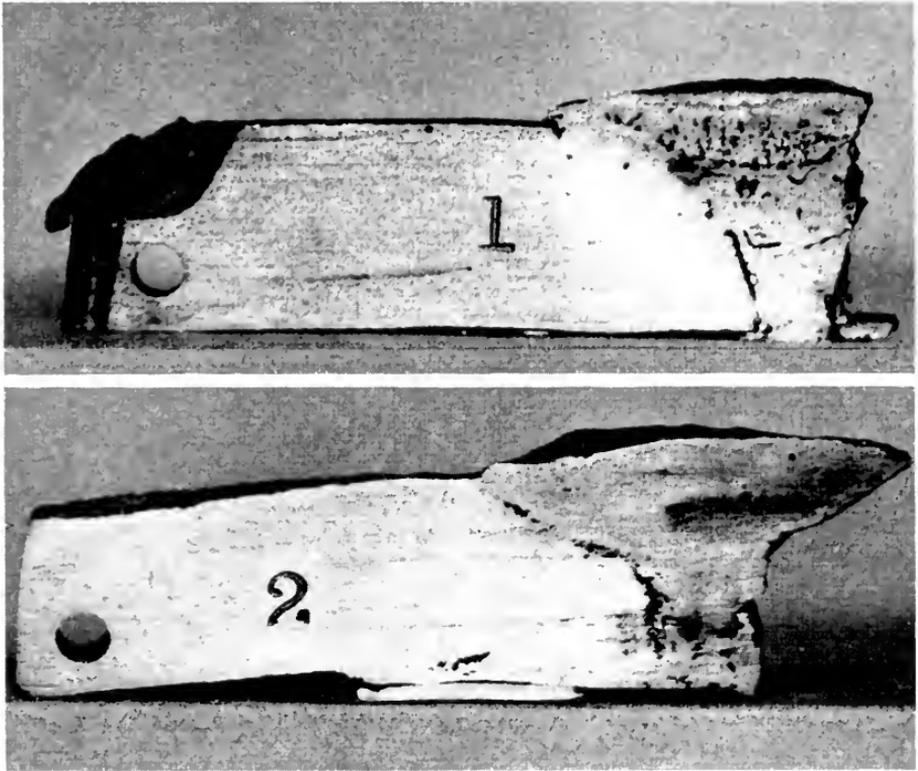
Figure 2—Etched specimens of the seams from the vessel shown in Figure 1.

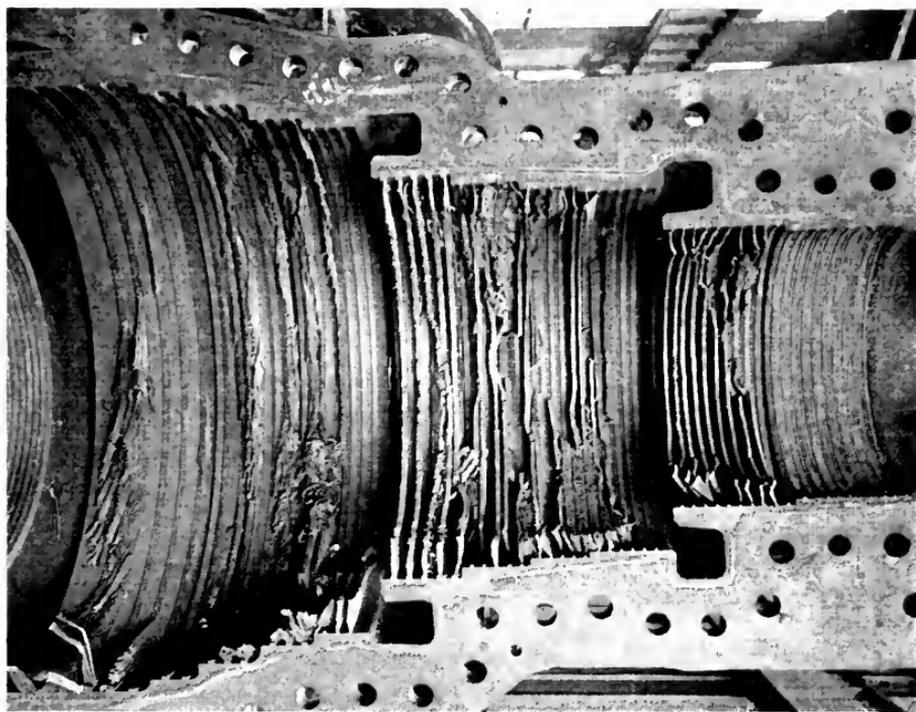
Mashed rows of reaction blading after temperature strains had contracted the casing and rotor unevenly.

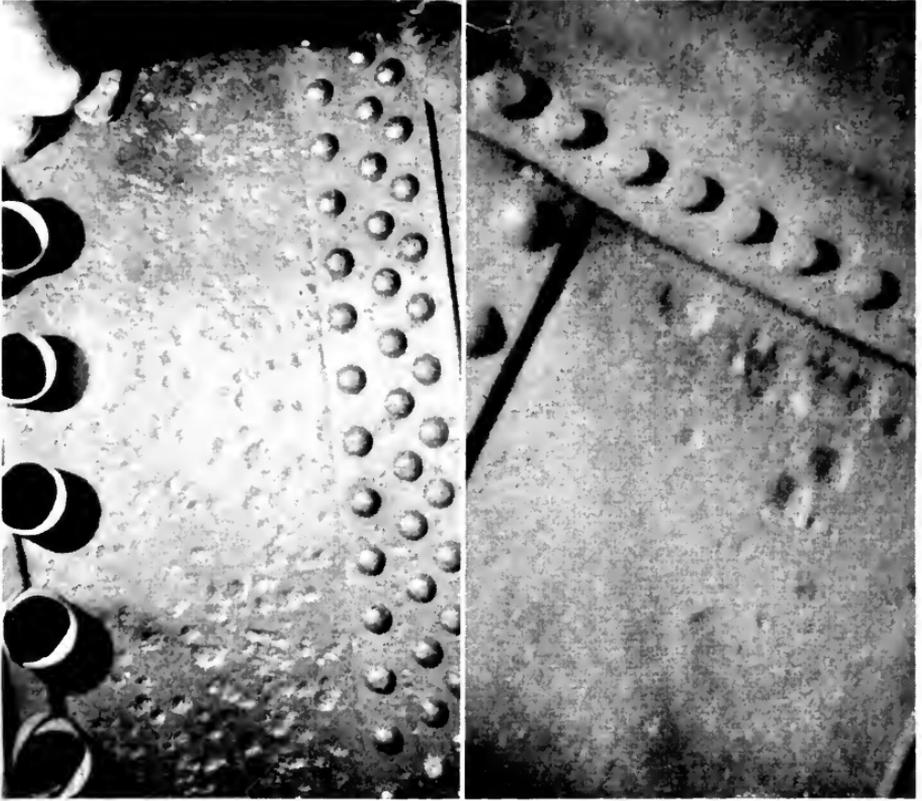
Characteristic pitting in boilers operated intermittently.
