The Locomotive

THE HARTFORD STEAM BOILER
INSPECTION AND INSURANCE CO.

VOL. XL

1934-1935

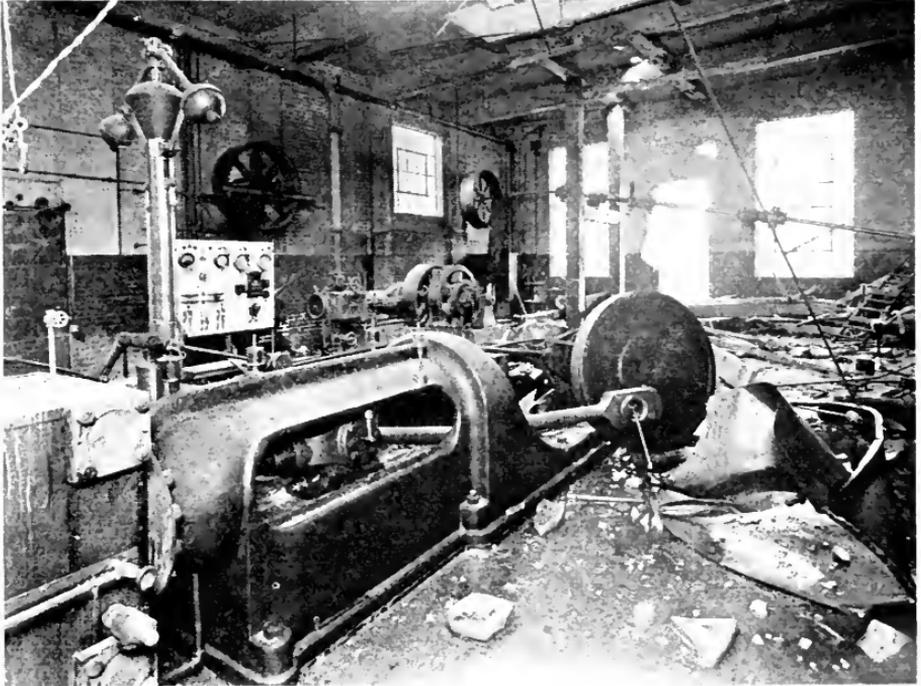
Engine room after the flywheel exploded and wrecked the engine.

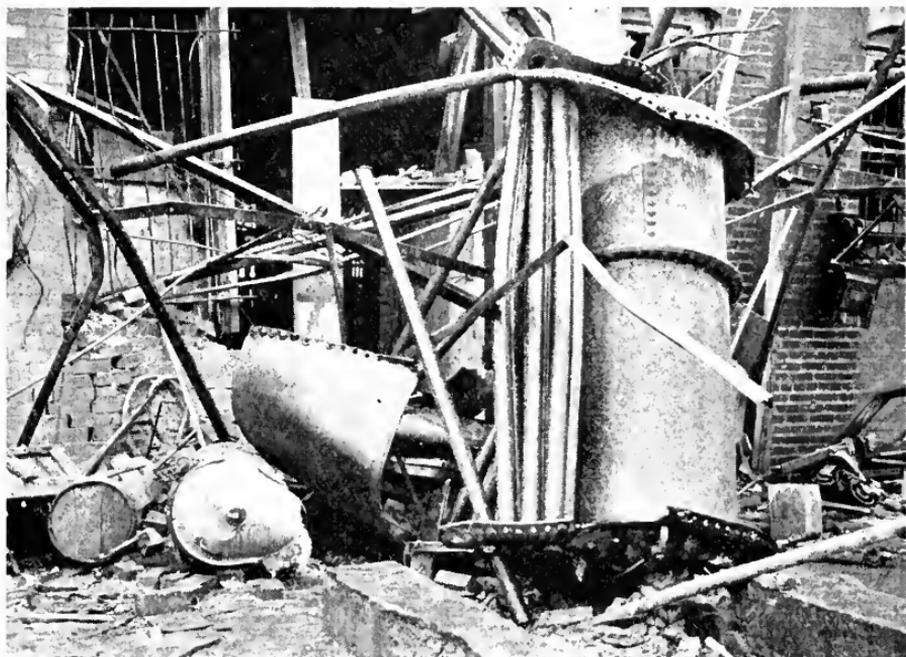
A check-up of the welding in a patch that failed might have prevented this \$25,000 boiler accident.

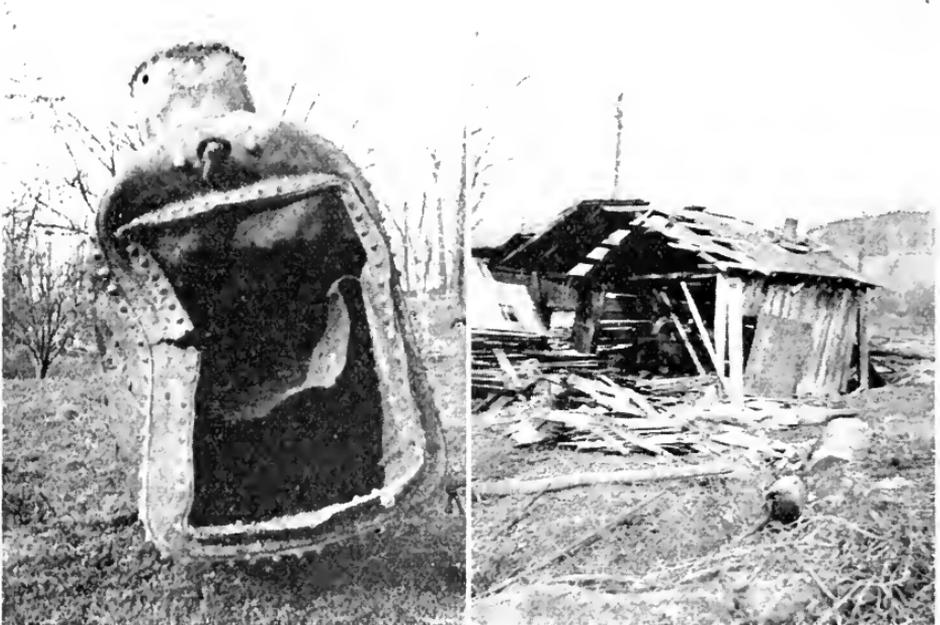
Left:—Boiler after 300 ft. journey. Right:—The shattered engine house where the eight persons who were killed or injured had gathered.

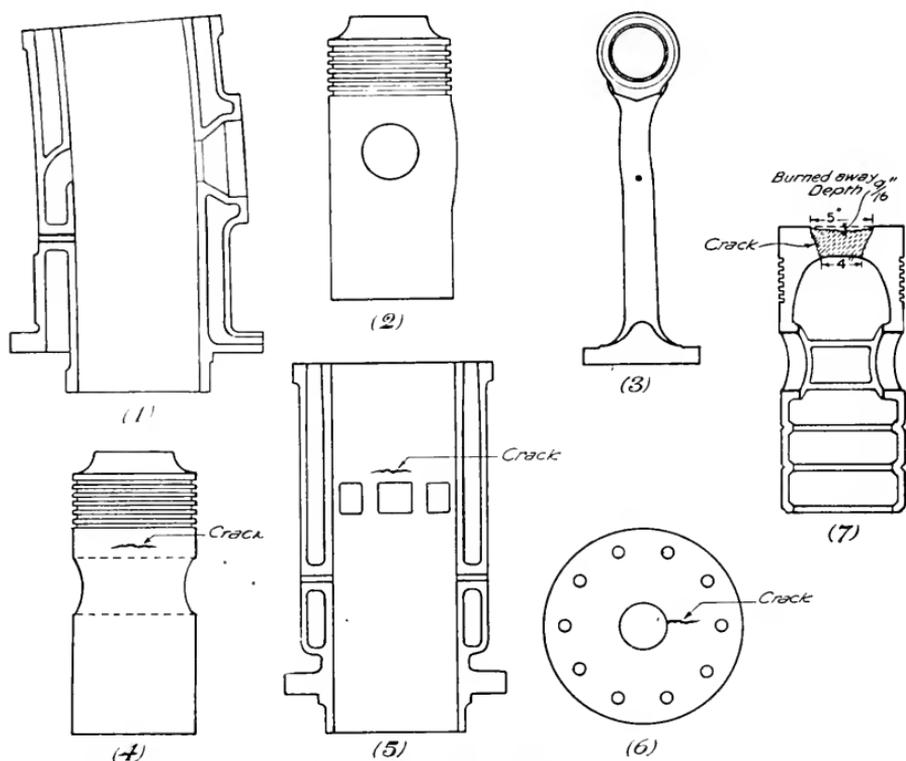
Six evidences of over-heating in a single Diesel cylinder—(1) Distortion of the cylinder because of "growth"; (2) "Growth" of piston; (3) Bend in connecting rod; (4) Crack in piston; (5) Crack in cylinder; (6) Crack in cylinder head; (7) Another evidence of over-heating in another piston. The head was burned to a depth of 9/16" and a crack had extended through the top of the piston.

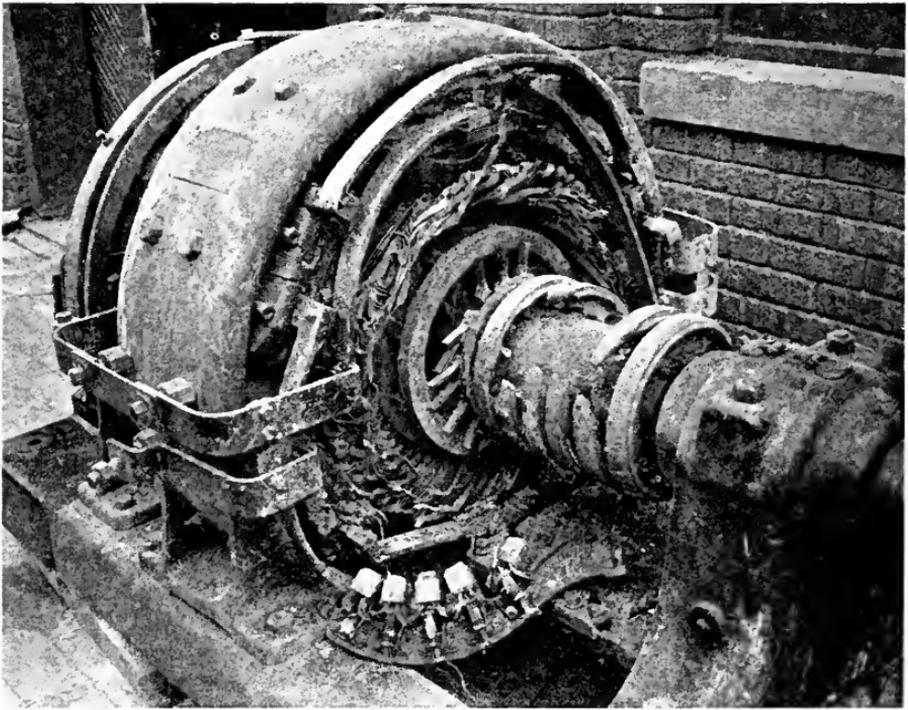
Rotary converter damaged by short circuit and fire.

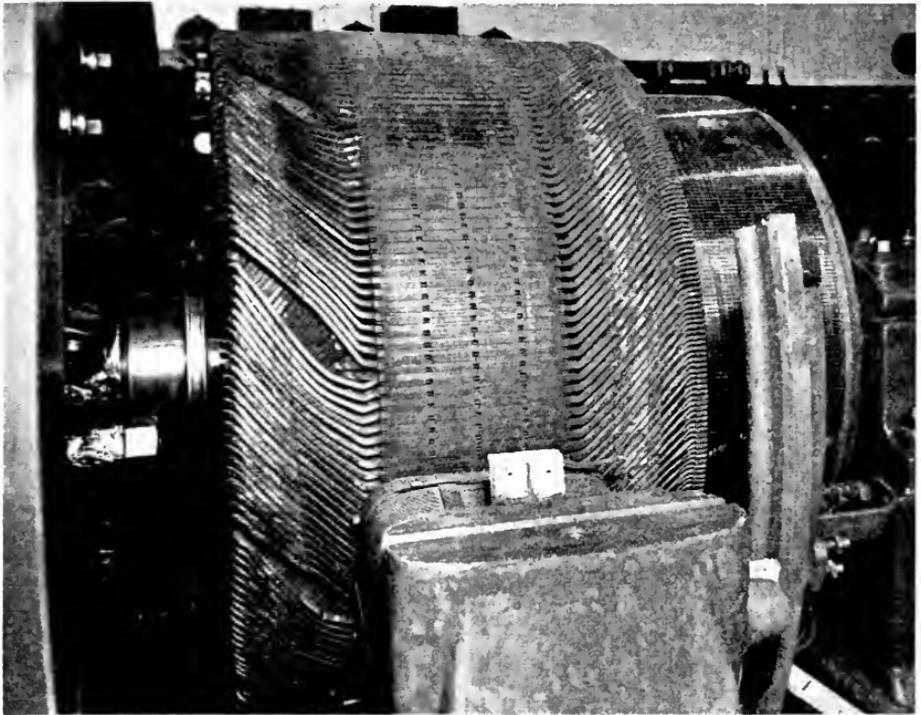
Distortion of coils on a 500 kw direct current generator caused by a surge when the operator threw the wrong switch connecting the idle machine to the station bus.

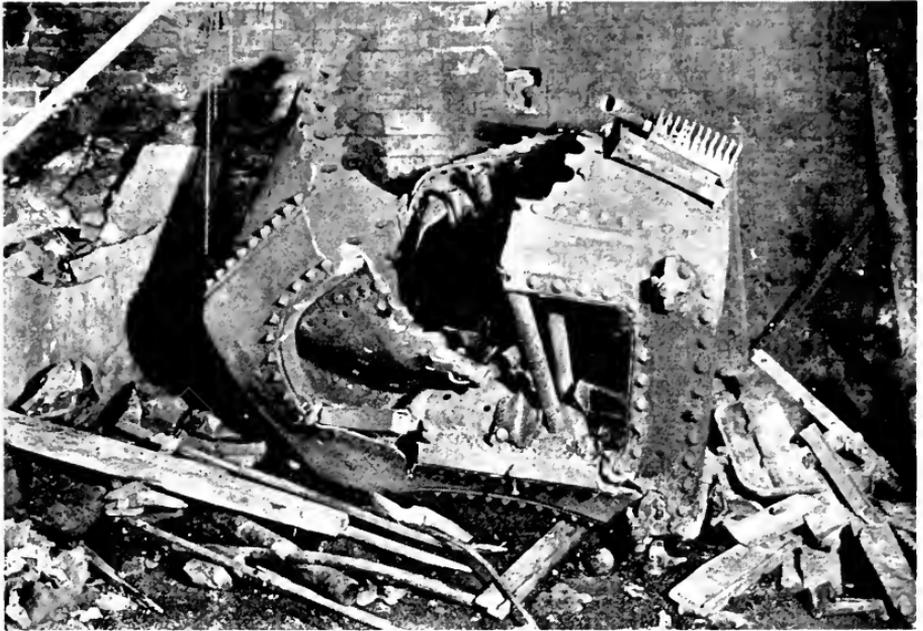
Wreckage of garbage burner—An accident which illustrates the need for a relief valve in operative condition and of care in the manipulation of valves in the pipe connections.

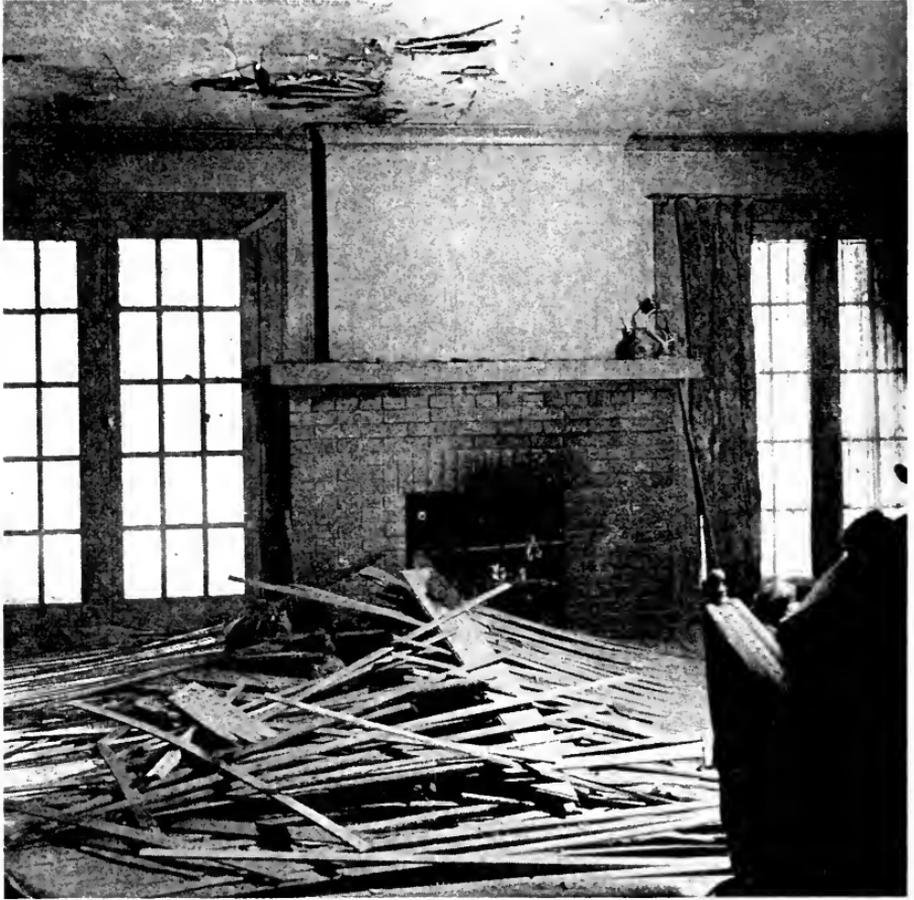
Above is pictured a wrecked living room, part of the damage caused by the explosion last spring of a small round type cast iron hot water heating boiler in a Buffalo residence. Its explosion led to the injury of three women who were knocked to the floor by the blast or were struck by flying glass or other objects. Damage to the house, which was a two-story frame dwelling, included that shown in the living room, the breaking of all the windows, and the demolition of the heating plant. The property damage was estimated at about \$2,000.

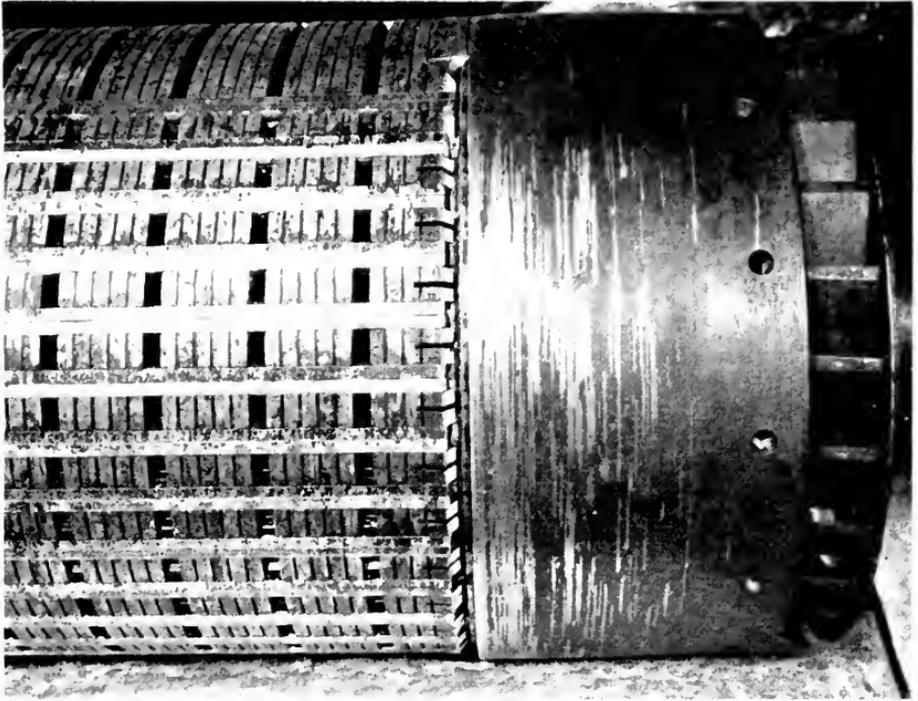
Damaged rotating field after over-speed. The core is a solid steel forging so machined that the forged steel end rings are fitted into a rabbet-joint on the ends of the rotor forging. The centrifugal forces exerted against this rabbet were sufficient to break off sections of the steel rotor forging, which immediately jammed between the field and stator where they were rolled into small balls or were embedded in the stator laminations.

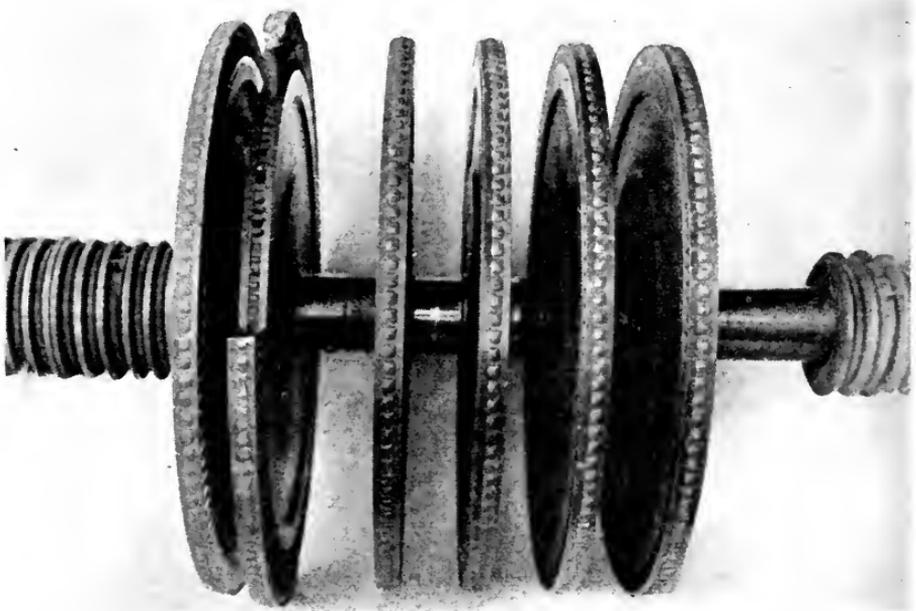
Wheel from which 24 blades were broken when water forced it out of line and permitted it to rub.

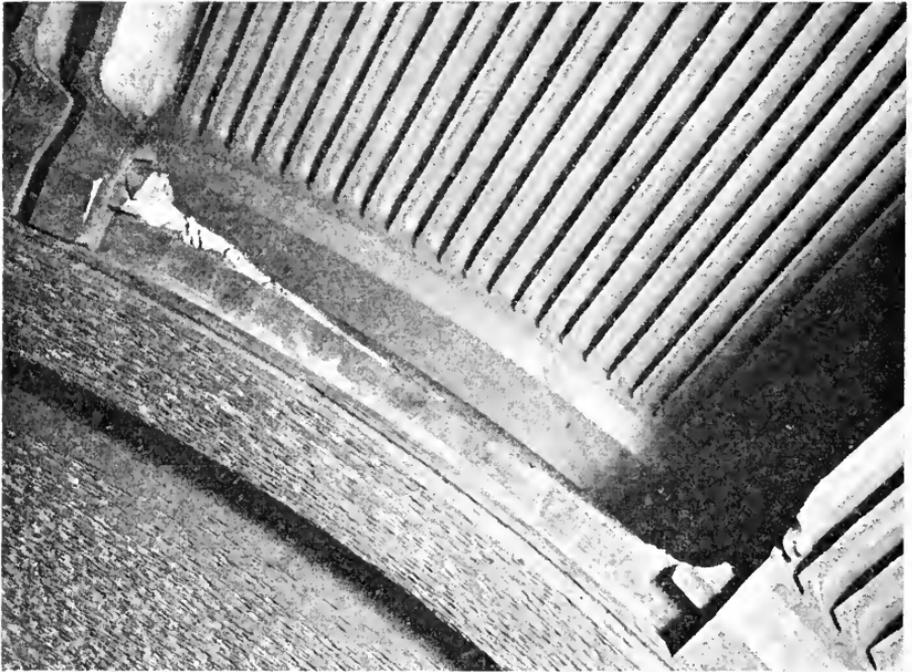
Figure 1—The broken disc. The dovetail arrangement of fastening the blades is clearly visible at the left.

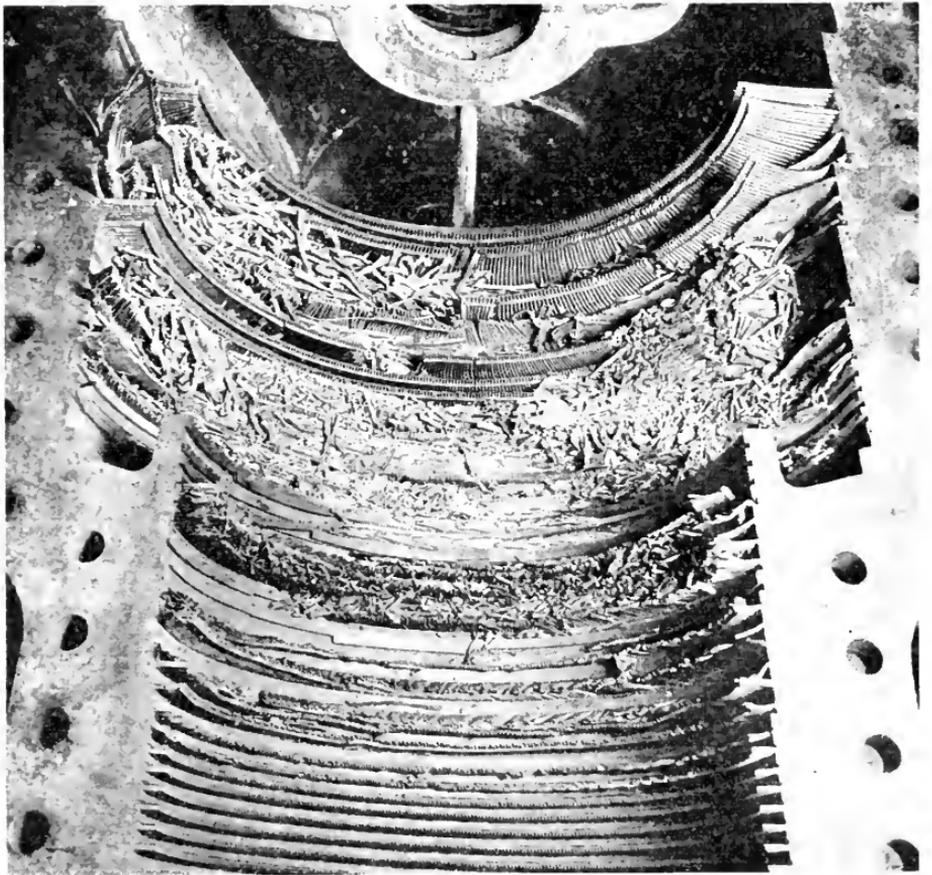
Figure 3—Casing of 1875 kva turbine after several blades broke out. The rotor was stripped of practically all of its blading.

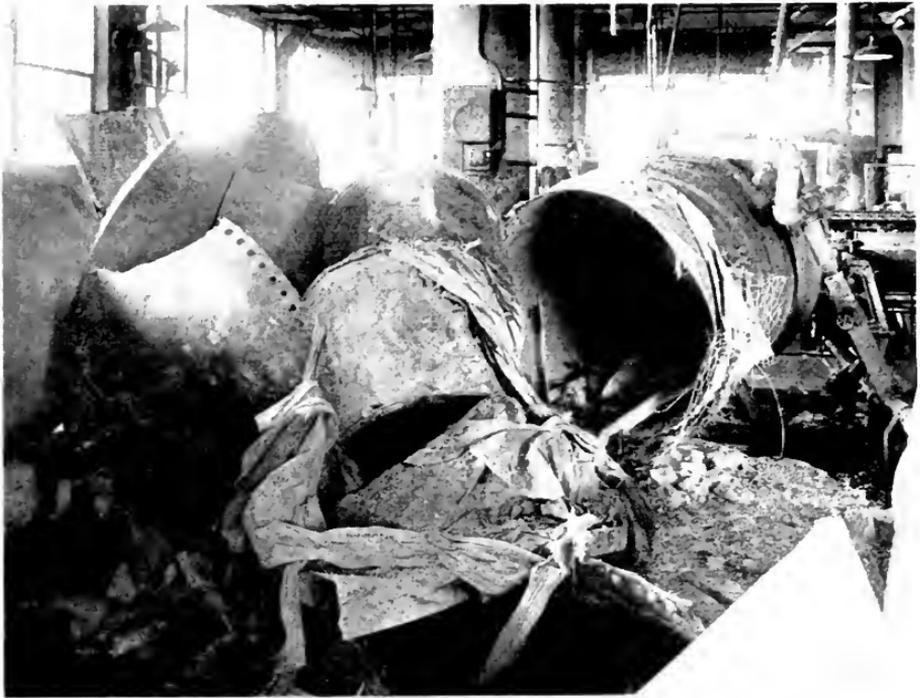
Figure 1. Remains of the vulcanizer after its explosion.

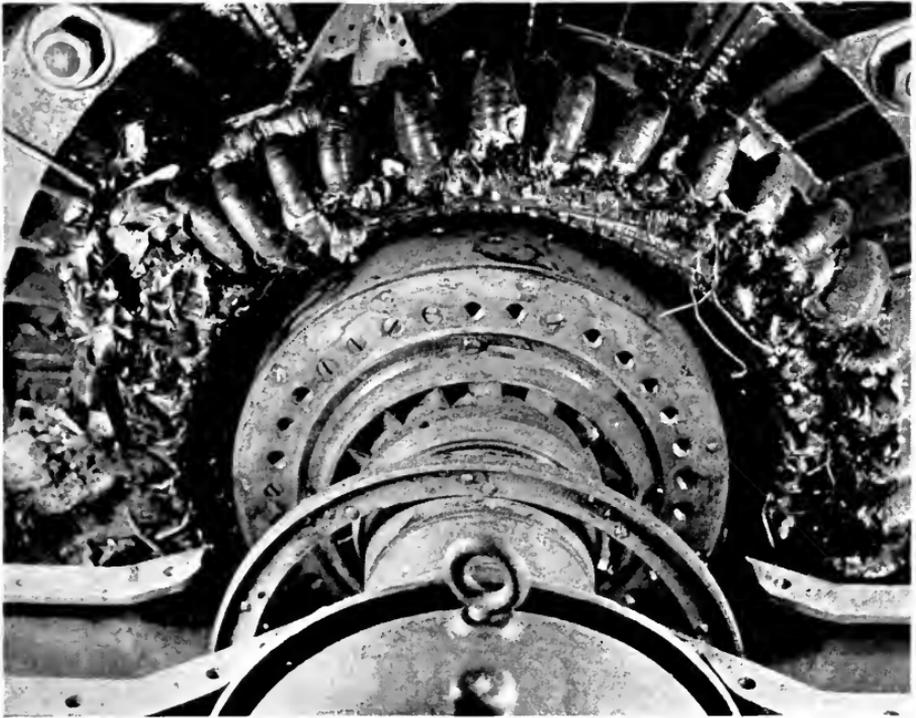
After the cooling fan cut into the windings. A piece of the broken fan may be seen at the top of the stator.

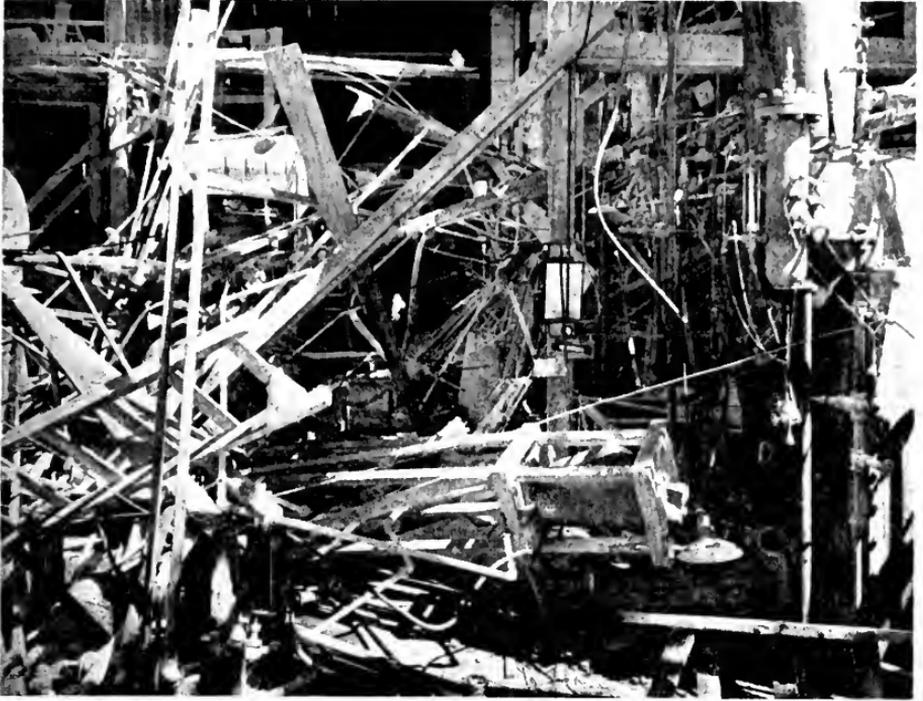
Figure 2. Wreckage caused by the explosion and the subsequent collapse of the building.

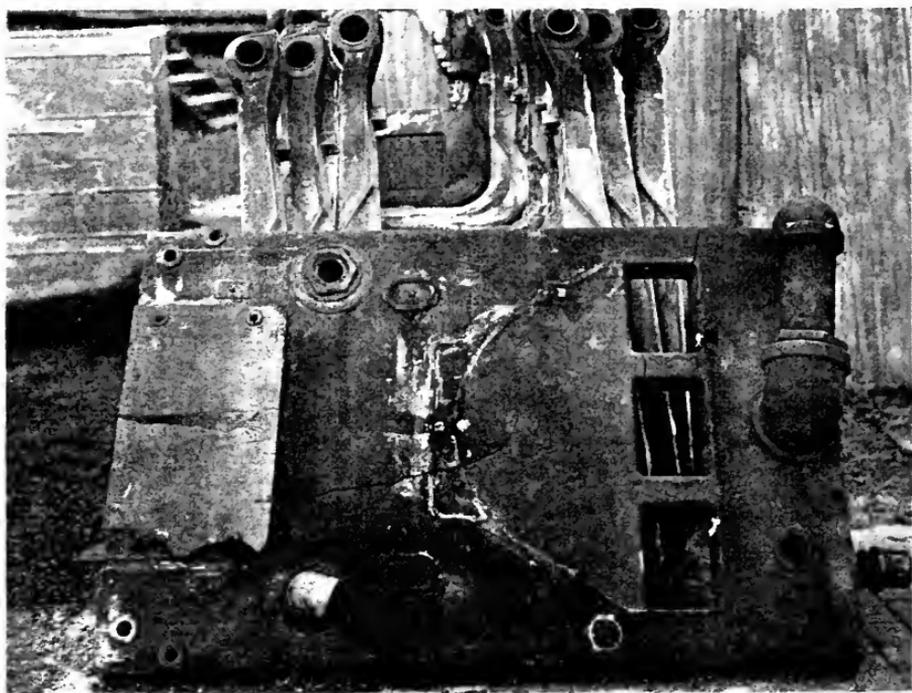
Figure 1. Cracks in a cast iron section—never a spectacular accident but the most frequent of all failures of heating boilers.

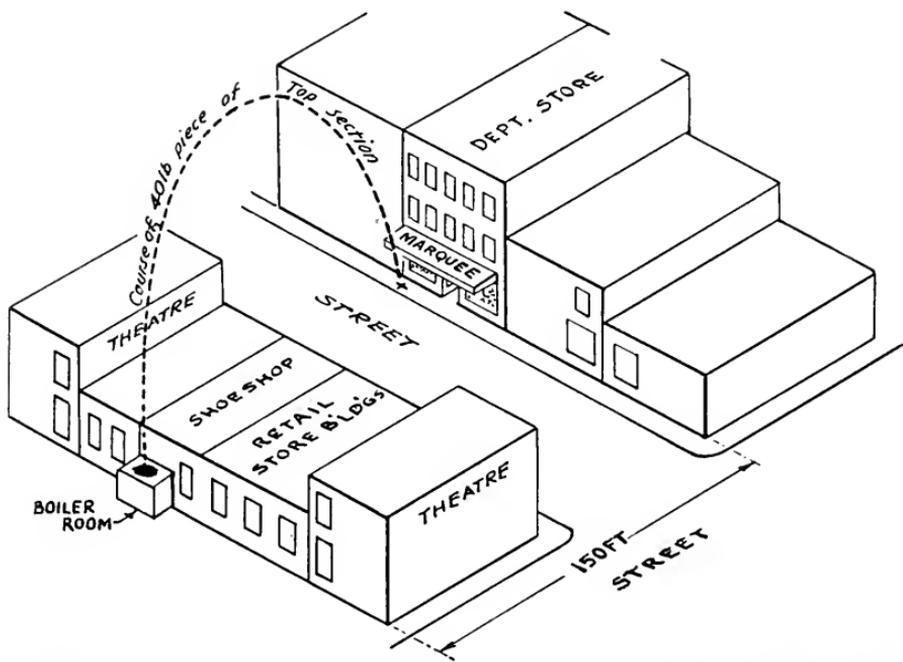
Figure 3. Course of travel of the top of a hot water heating boiler that exploded because of over-pressure.

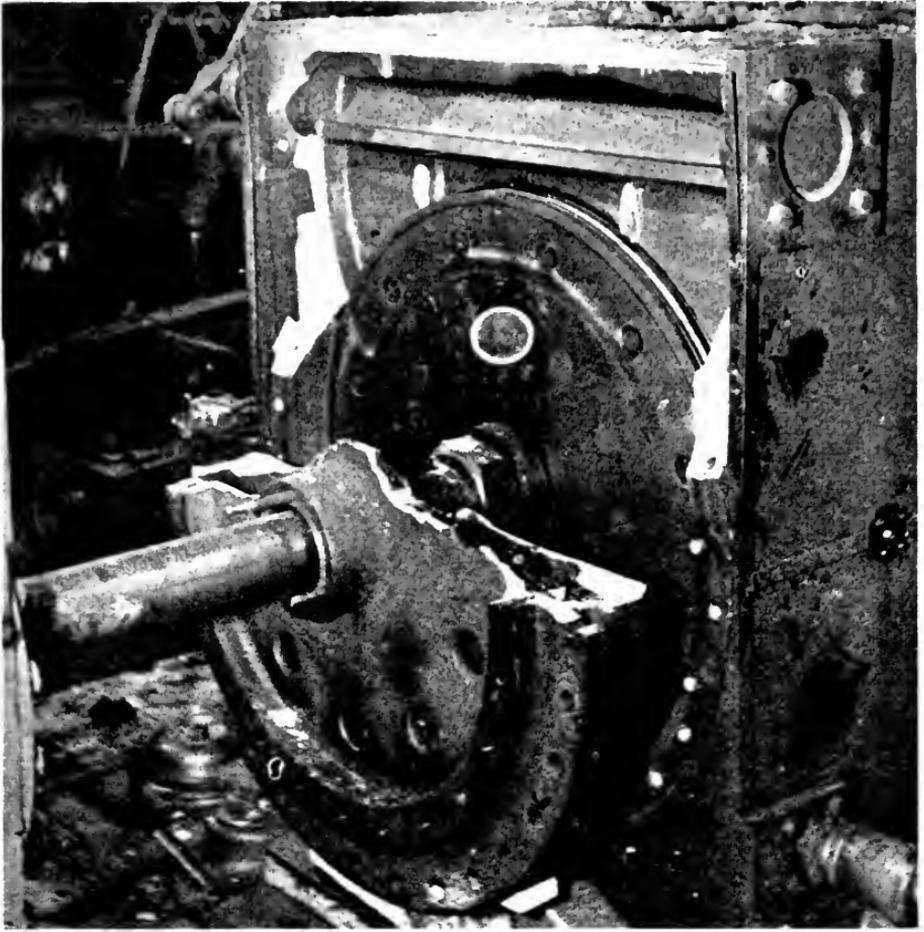
Figure 1—Cylinder wrecked because of connecting rod failure. The damage is typical of accidents from this cause.

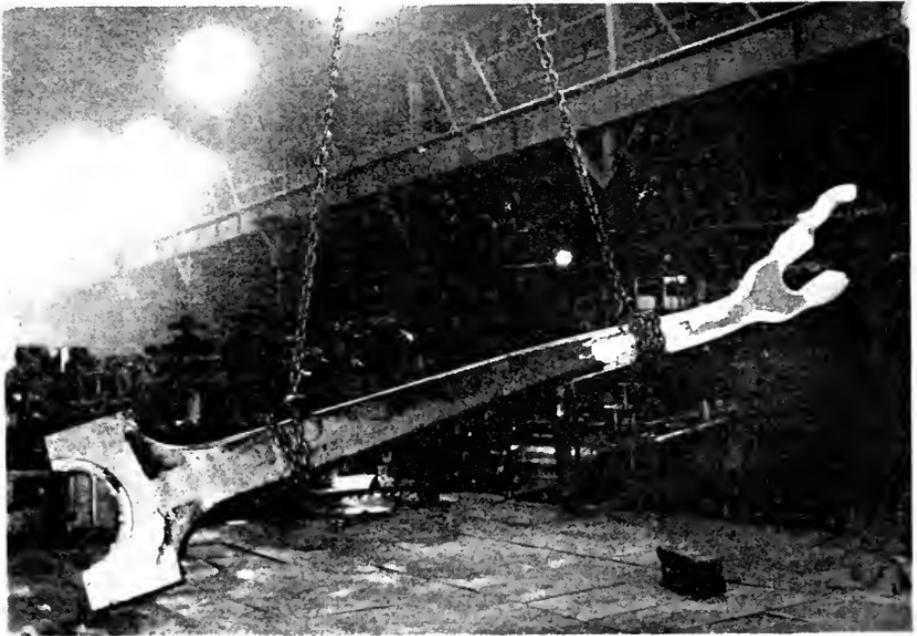
Figure 4—Typical break of the rod-end in a large Corliss engine.
