The Locomotive

THE HARTFORD STEAM BOILER
INSPECTION AND INSURANCE CO.

INDEX
to
VOL. 42 - 43

INDEX TO VOL. 42—1938-1939

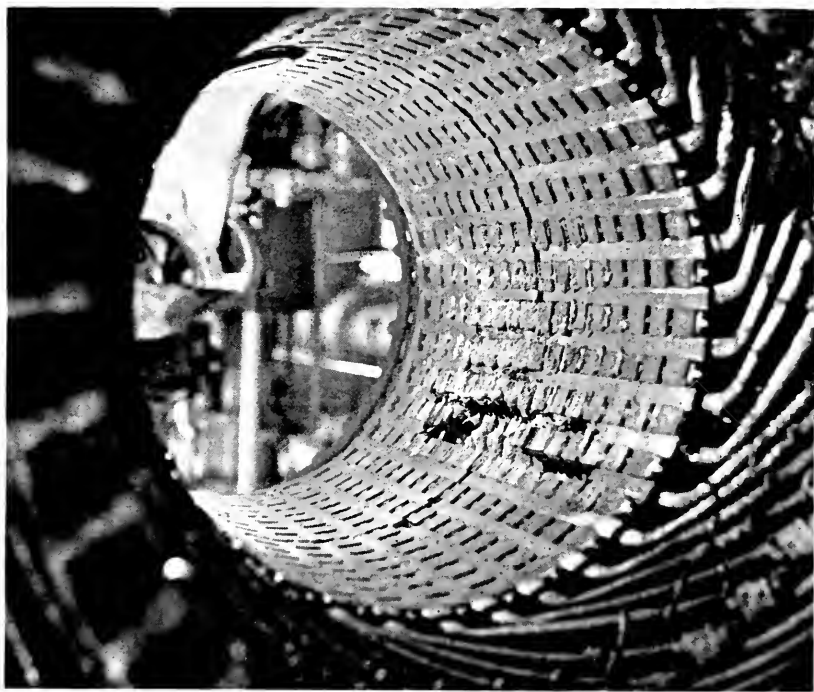
Stator burnout caused by short circuit in a cable.

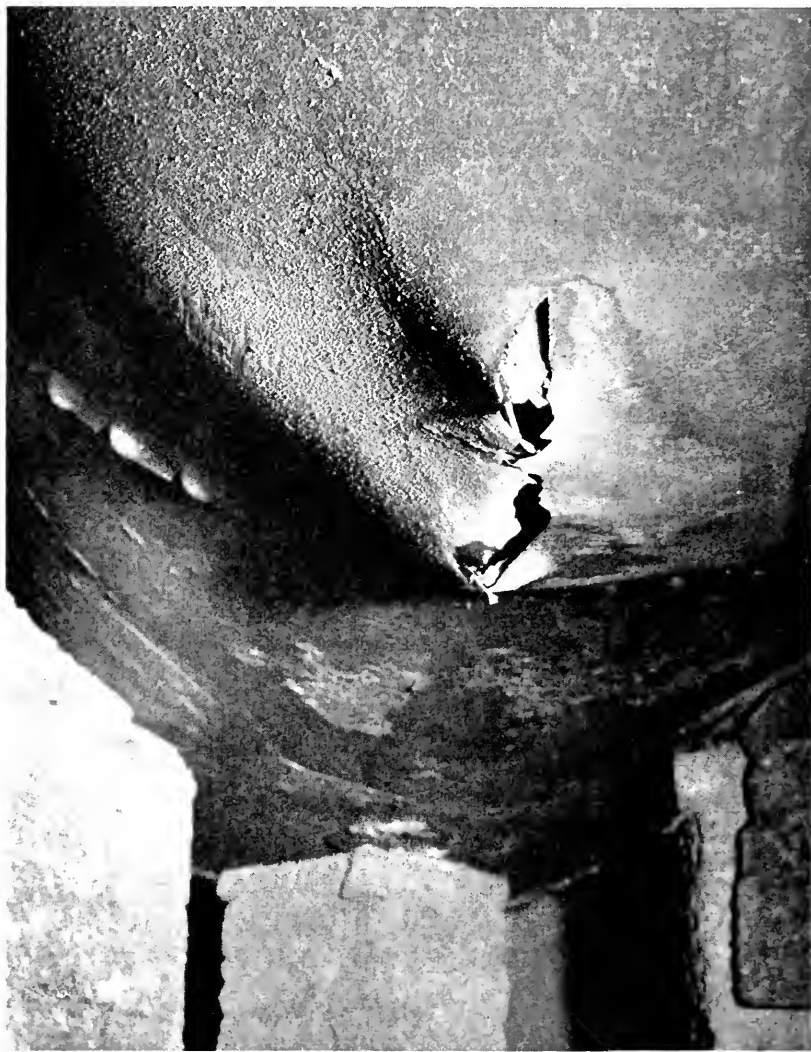
Figure 1. A serious rupture caused by over-heating.

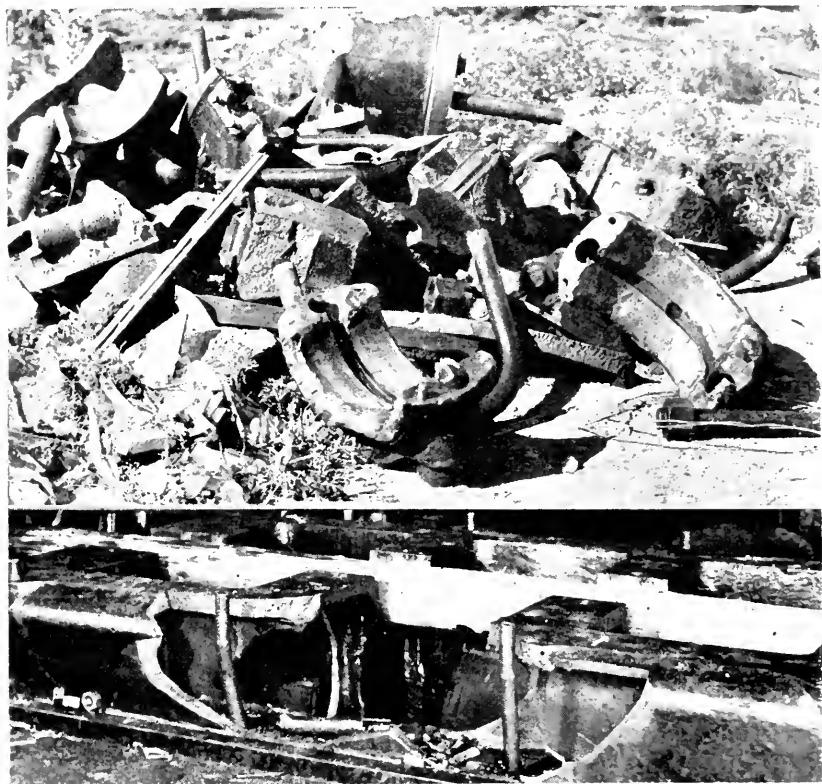
Figure 1—Above—This pile of metal contains parts of a 600 hp Diesel engine which was destroyed in a second or two when it over-speeded. Below—One side of the engine base after the broken engine parts passed through it.

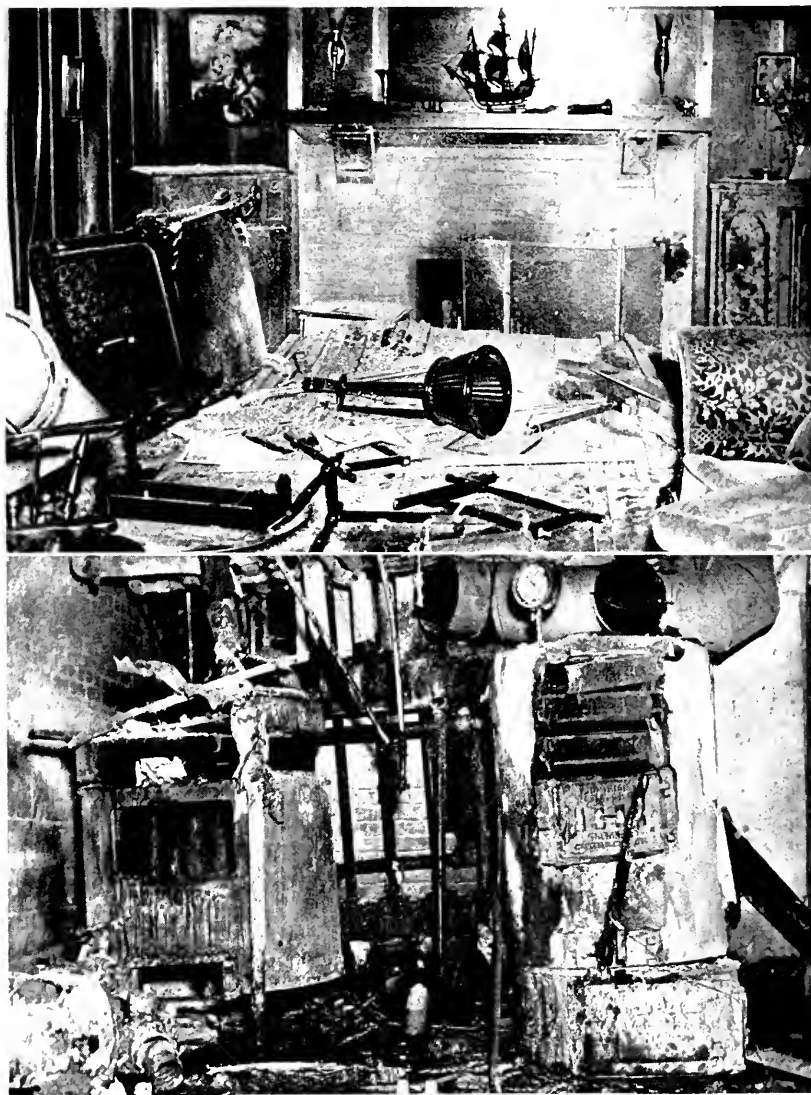
The above views show part of the damage caused by the recent explosion of an oil-fired hot water heating boiler in a residence. Occurring in the boiler at the left, the explosion blew the top section into the floor above, damaging the living room as shown. The foundation of the

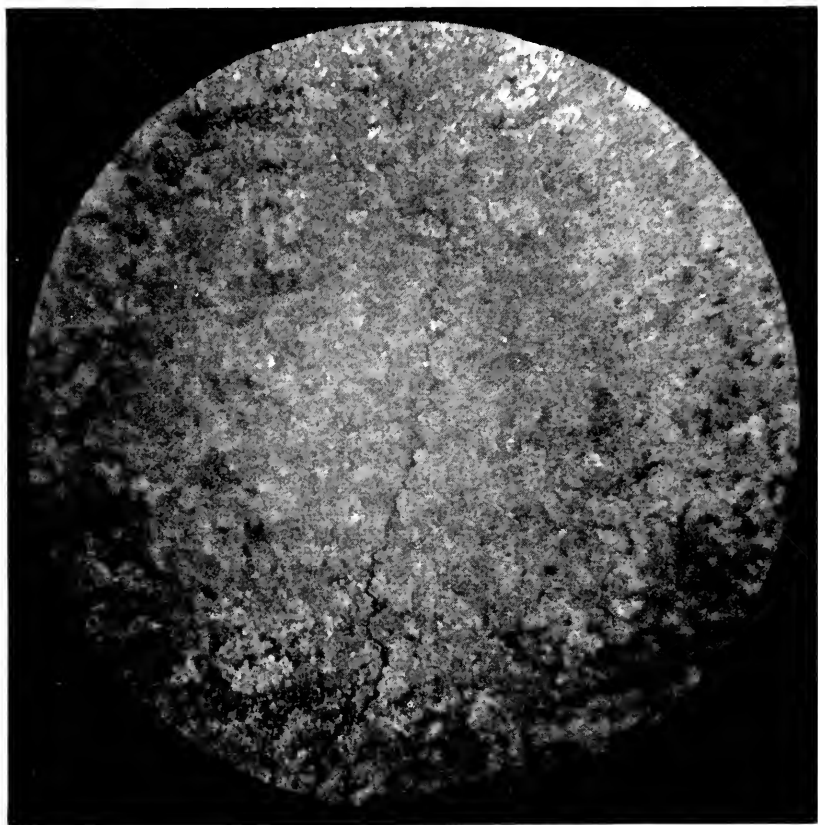
Figure 1—An embrittlement defect at about 100 magnifications. This is what the eye sees when using the regular Hartford Steam Boiler magniscope on a highly polished wall surface of a rivet hole.

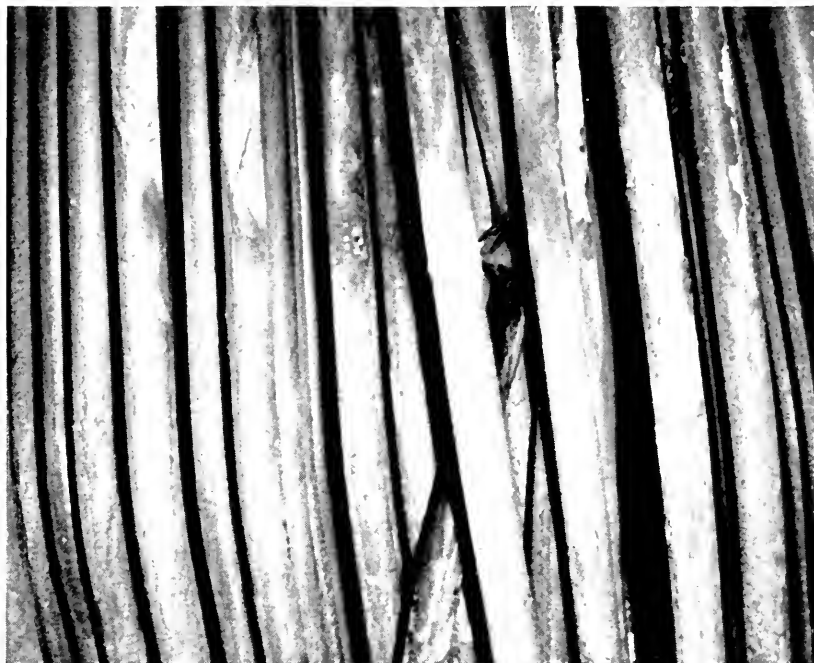
Figure 3—A bank of tubes in which magnetic oxide formed due to excessively high temperatures.

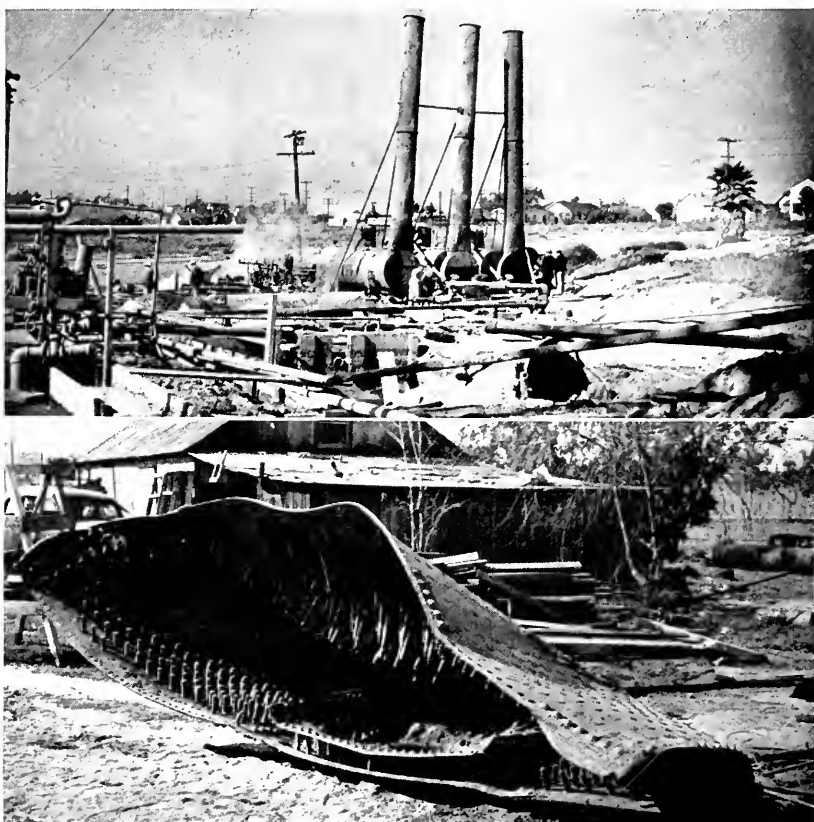
Figure 2—Above—An oil field drilling scene. Below—Outside wrapper sheet of the fourth boiler after it had traveled 900 feet.

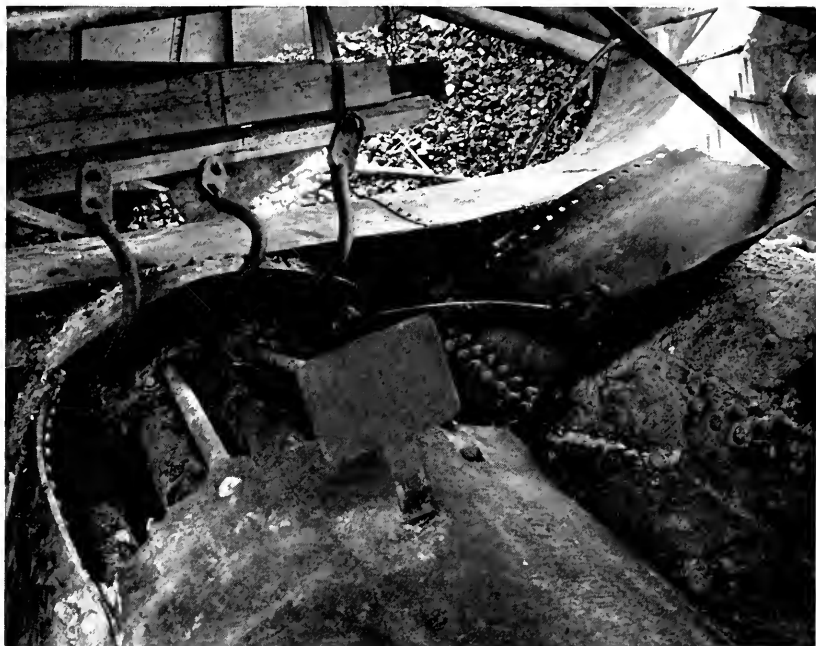
Figure 1—The failure in Boiler No. 2. The break along the rivet holes near the caulking edge of the seam at the left is clearly evident.

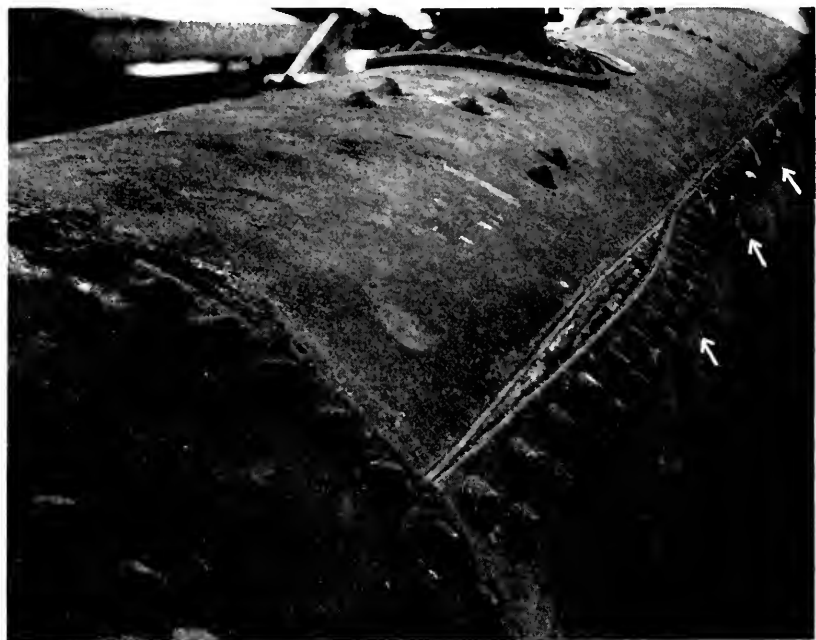
Figure 3—Failure in the longitudinal seam of No. 1 boiler during the hydrostatic test. A few of the paths of embrittlement defects are exposed and clearly show the progress from rivet hole to rivet hole. This boiler has been slotted as a means of detecting a lap seam crack. The slots are indicated by the arrows. See also Figure 4.

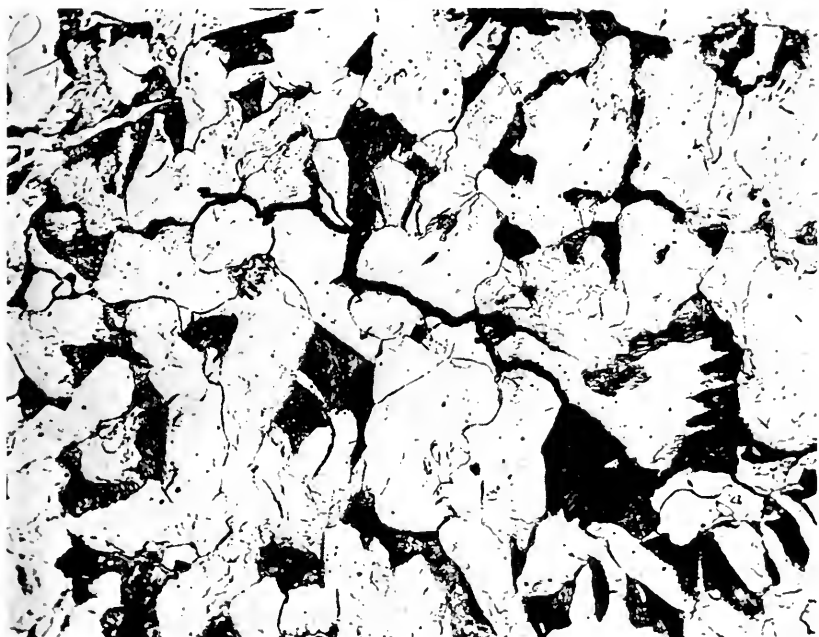
Figure 8—Embrittlement at 500 magnifications in a section of plate from Bolier No. 1.

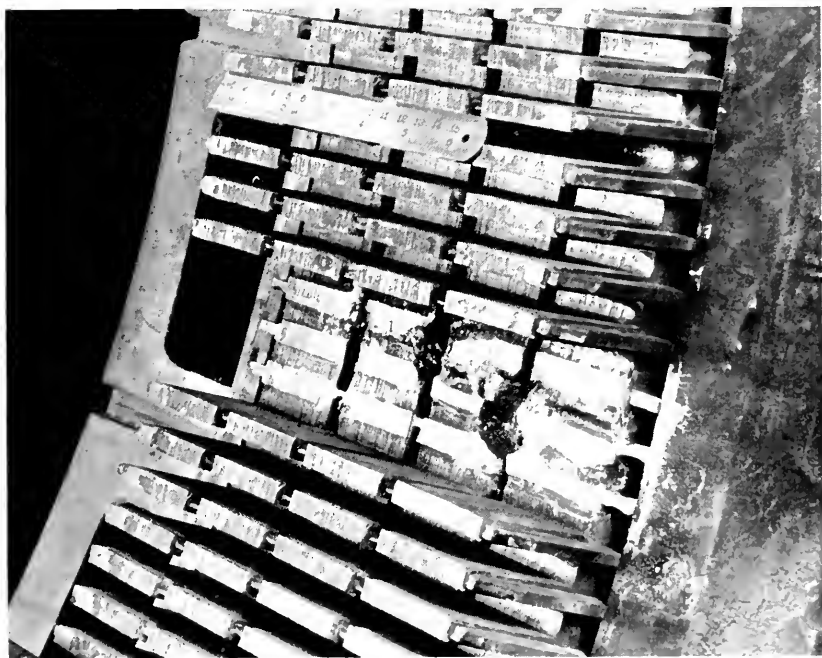
Figure 1—Failure of 450 hp hoist motor showing the iron burns after three laminated teeth had been cut away.

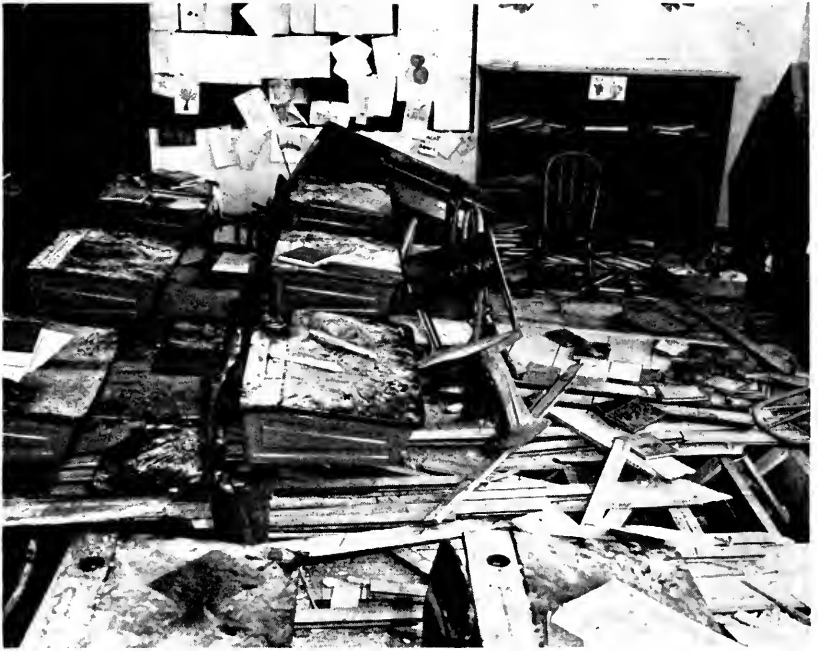
Figure 1—School room after air lift water system tank exploded.

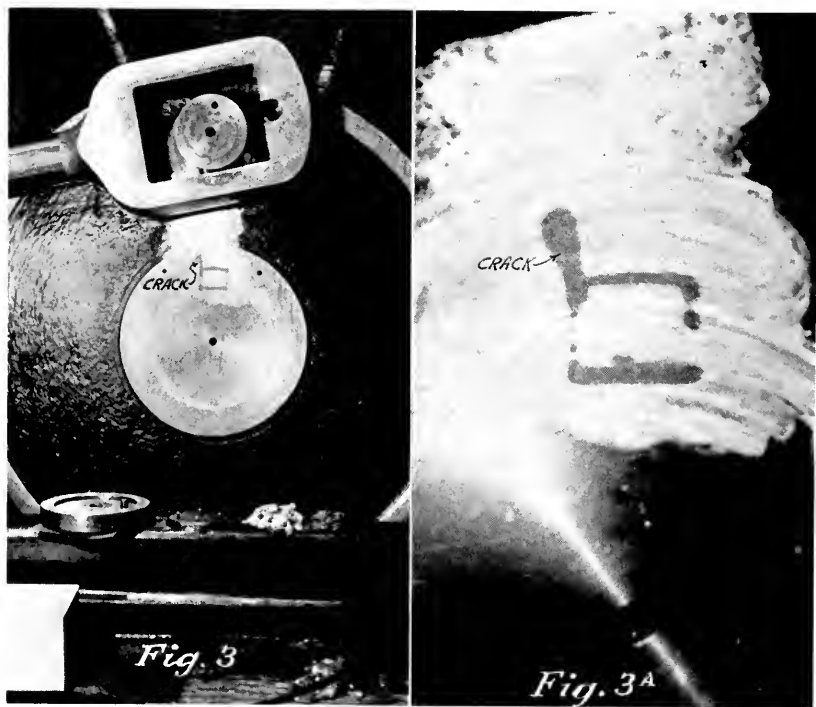
Figures 3 and 3A—A fine crack in the keyway of a steam engine crank. Figure 3A is a magnification of the defect.

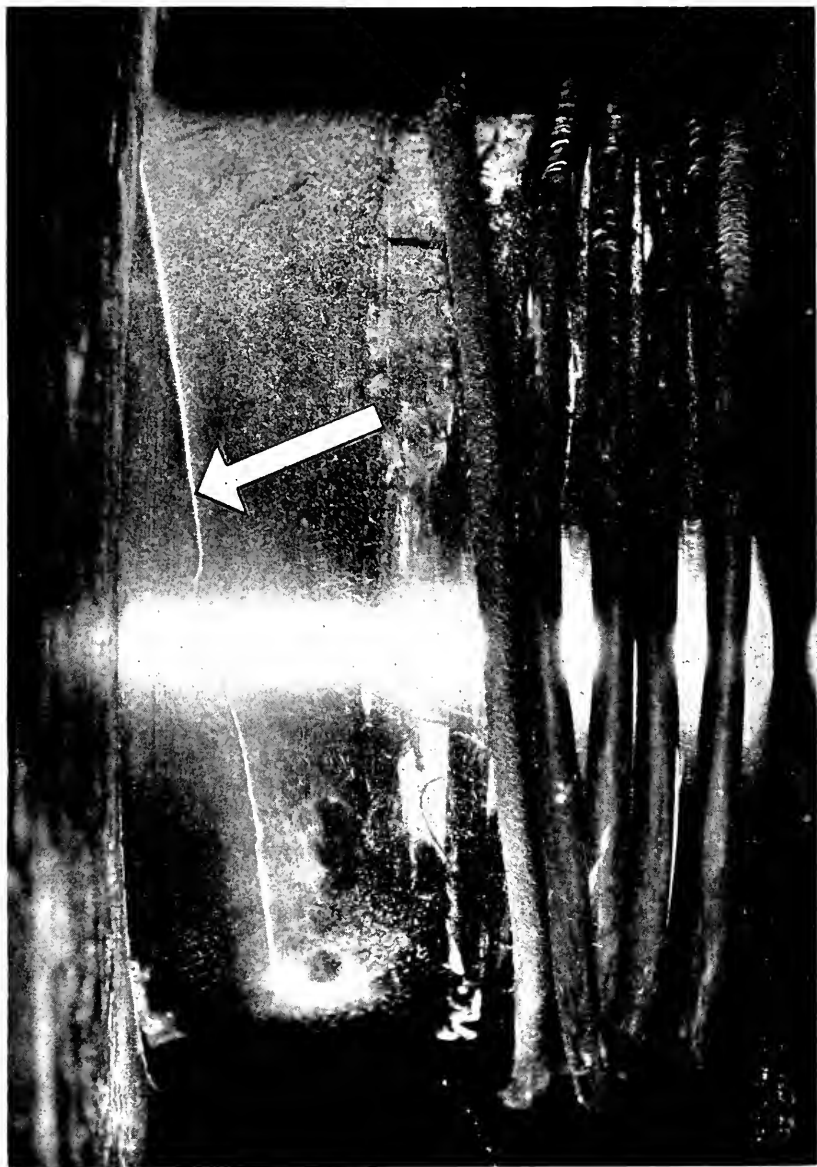
Figure 5—Magnaflux method applied to a shaft to determine the extent of a crack which had been detected by means of the unaided eye. The magnetizing coils are shown at the right.

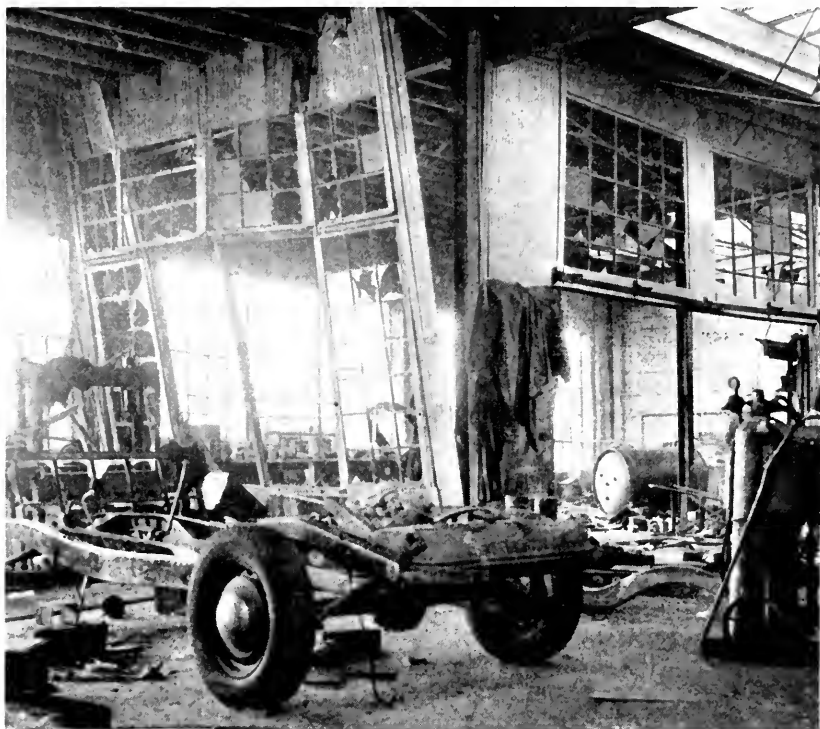
Figure 1—Typical damage as the result of an air tank explosion. This accident occurred in a paint spray room. A workman was injured.

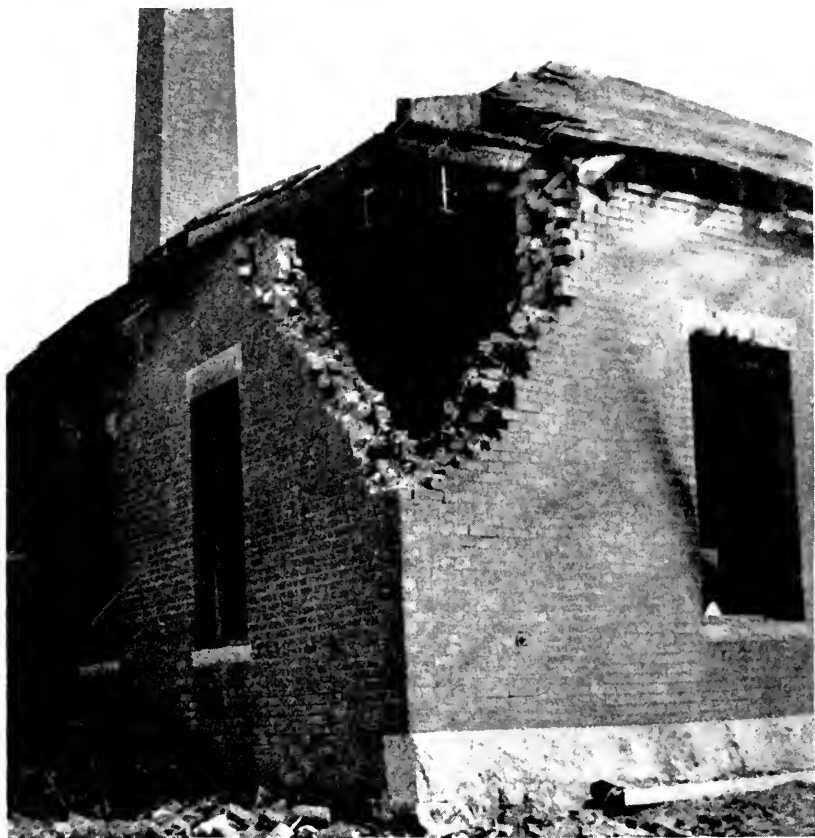
Figure 4—Where an air tank head passed after an explosion. The photograph gives an idea of the force of compressed air suddenly released.

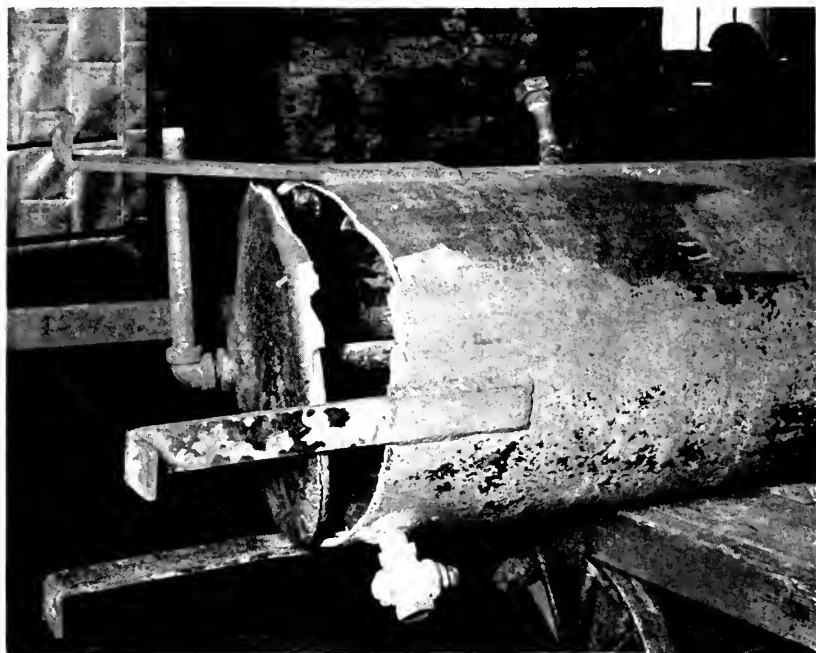
Figure 5—Broken shell of a hydro-pneumatic tank in which the shell had been crimped around the head and welded.

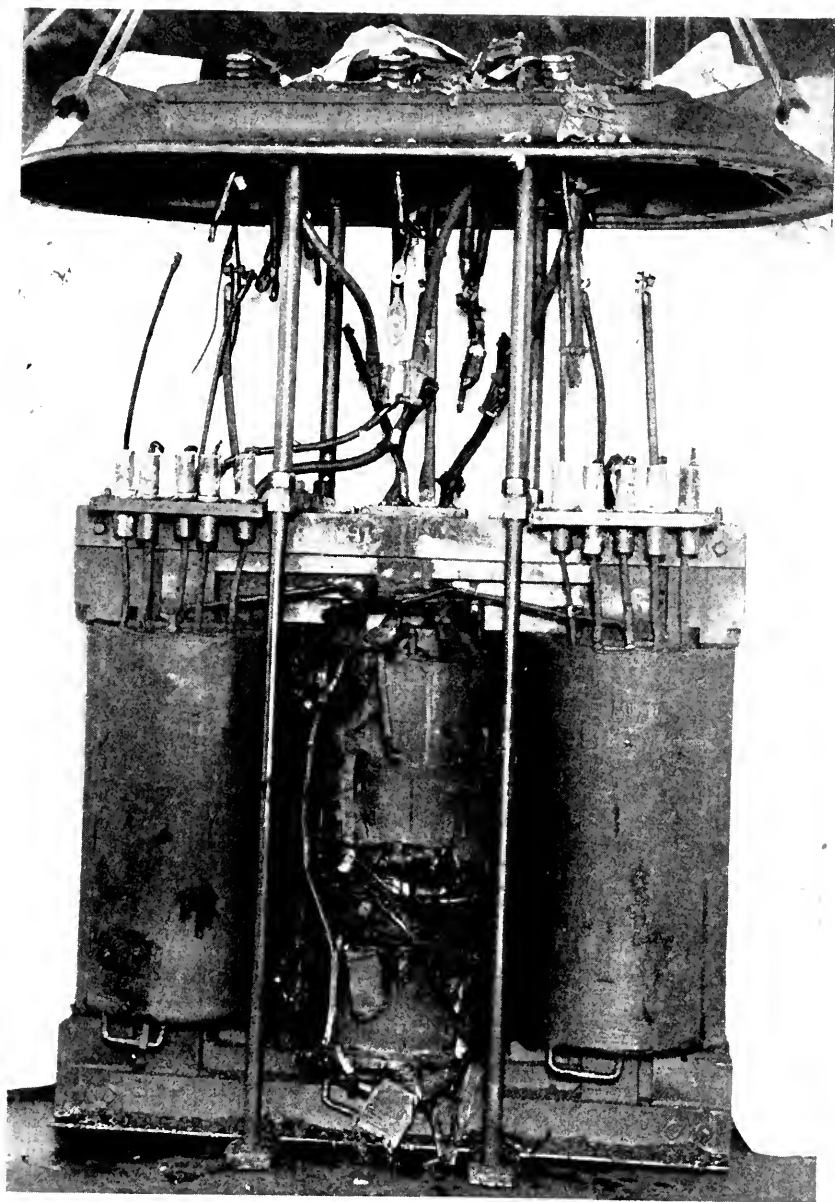
Figure 1—Coils of a 500 kva transformer after a short circuit in the primary windings. The photograph shows the high voltage terminal side of the transformer.

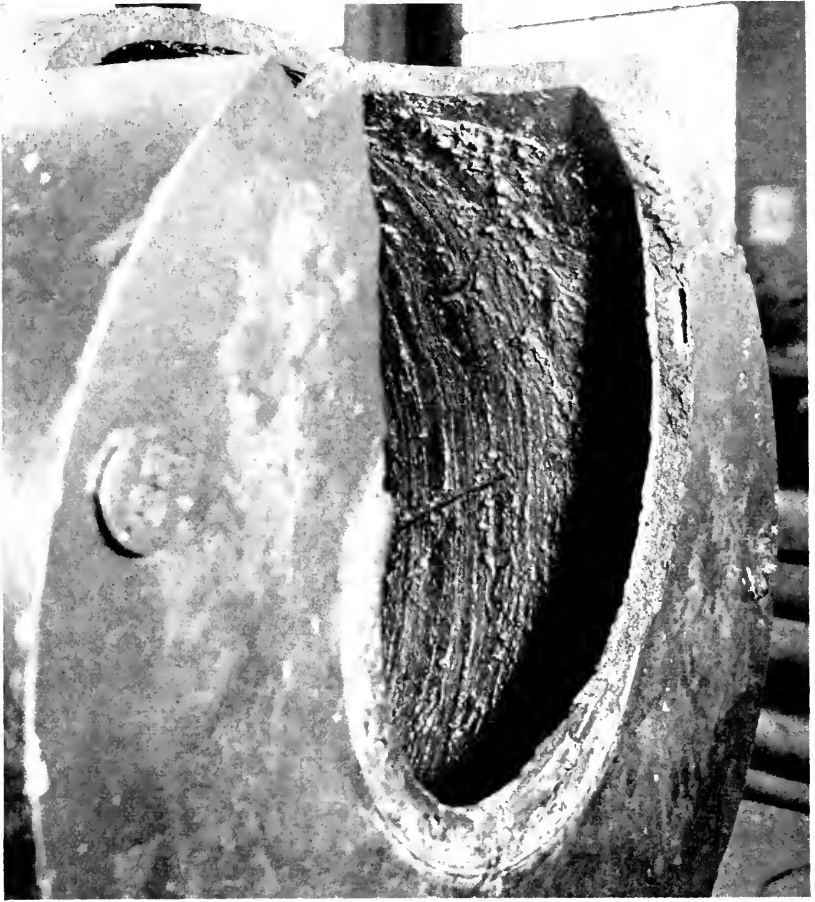
Figure 3—Lard cooler which exploded under normal use because of the failure of a defective casting.

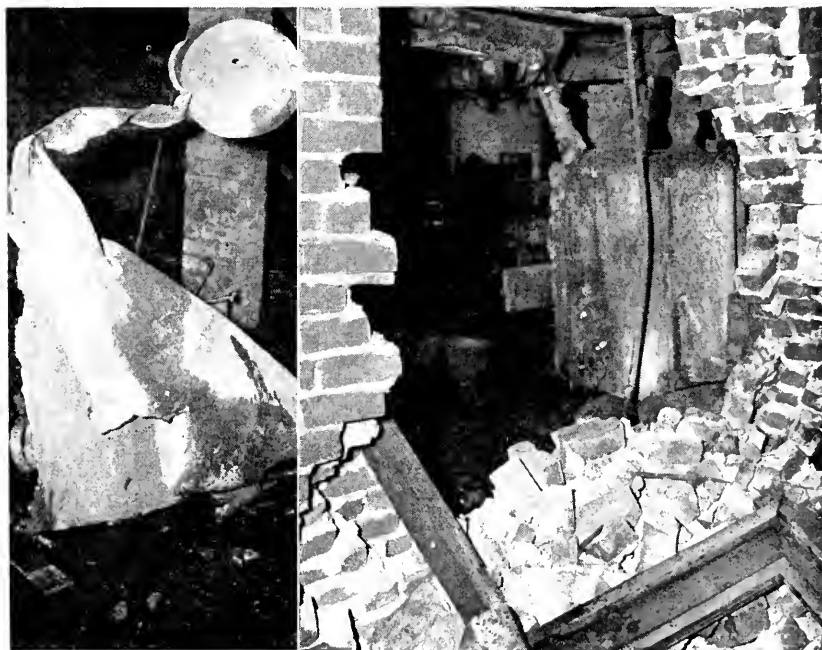
Figure 5—Left—Hot water tank after its explosion. Right—Hole in brick wall made by the exploding tank.

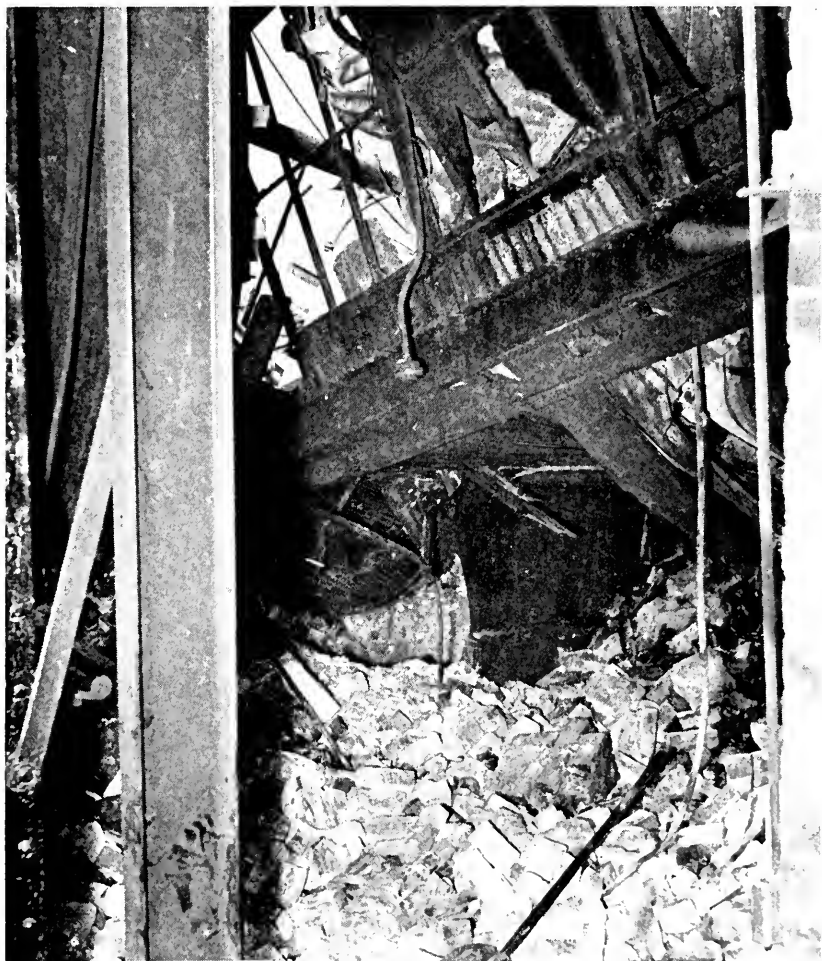
Figure 1—Top page 226—Damage after the explosions of a creosote tank and a water tube boiler at a southern plant.

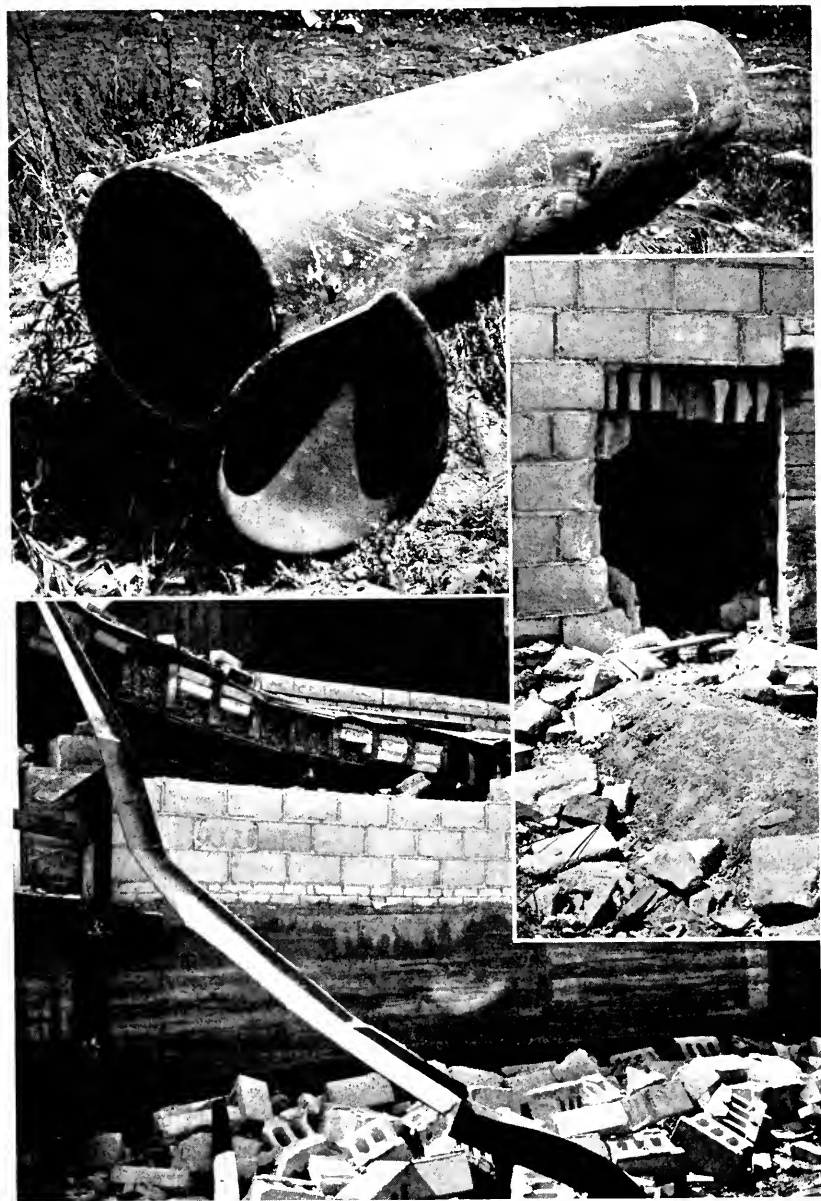
Damage following the explosion of an ammonia receiver after the city water supply was reduced and hot refrigerant gas was pumped through the condenser into the receiver. This accident occurred some months ago in Toronto. The pictures recently became available.

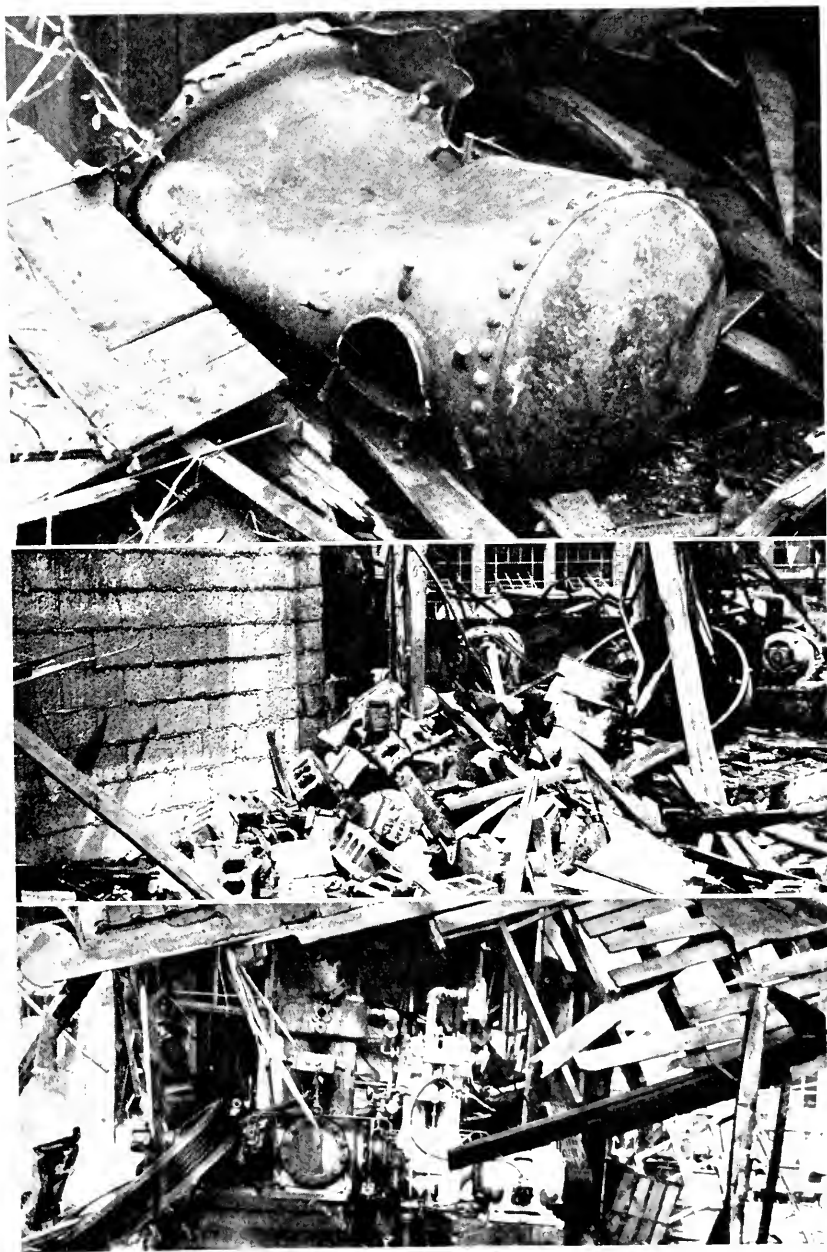
Three views of wreckage following the explosion of a 12" x 8' vertical tubular boiler at an ice cream plant on August 2.

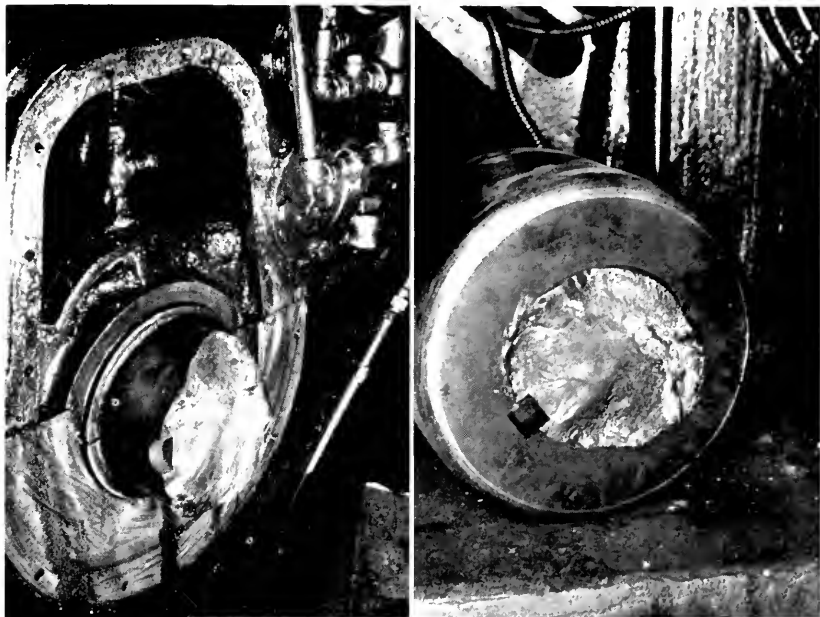
A GOOD example of a shaft break because of torsional vibration is illustrated by the two photographs on this page showing the faces of the break, which started at the keyway and progressed about 40 per cent of the way through the shaft before the final separation occurred. The picture at the left shows the engine end of the shaft and that at the right the coupling end.

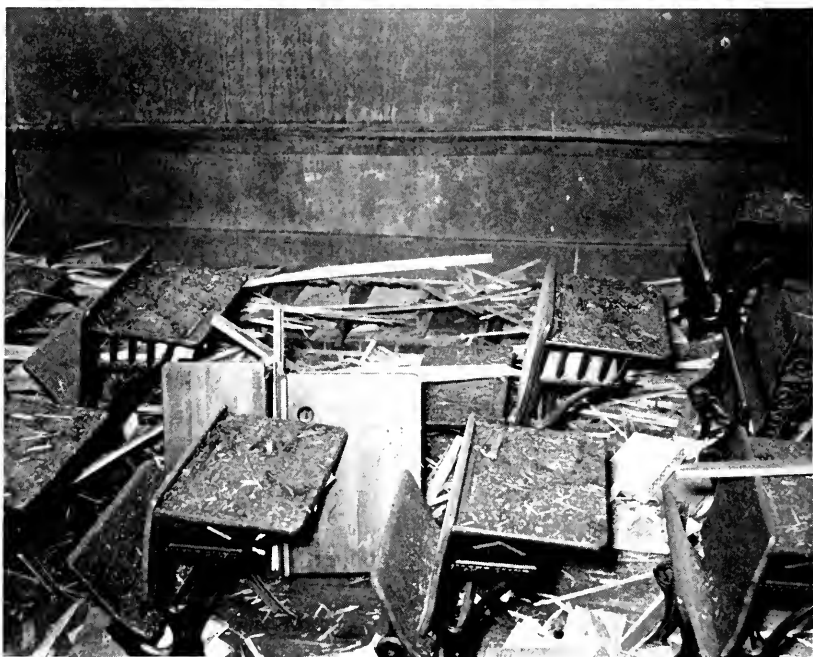
Above is a room at an Alabama school after the bursting of a hydro-pneumatic tank. Air pressure higher than the tank could withstand caused the explosion after the automatic control of the compressor failed to work. The tank went through the floor, ceiling and roof and fell to the ground outside the building. Fortunately the accident occurred at 8:00 P.M. when the room was empty. During school hours it accommodated 37 sixth grade pupils.

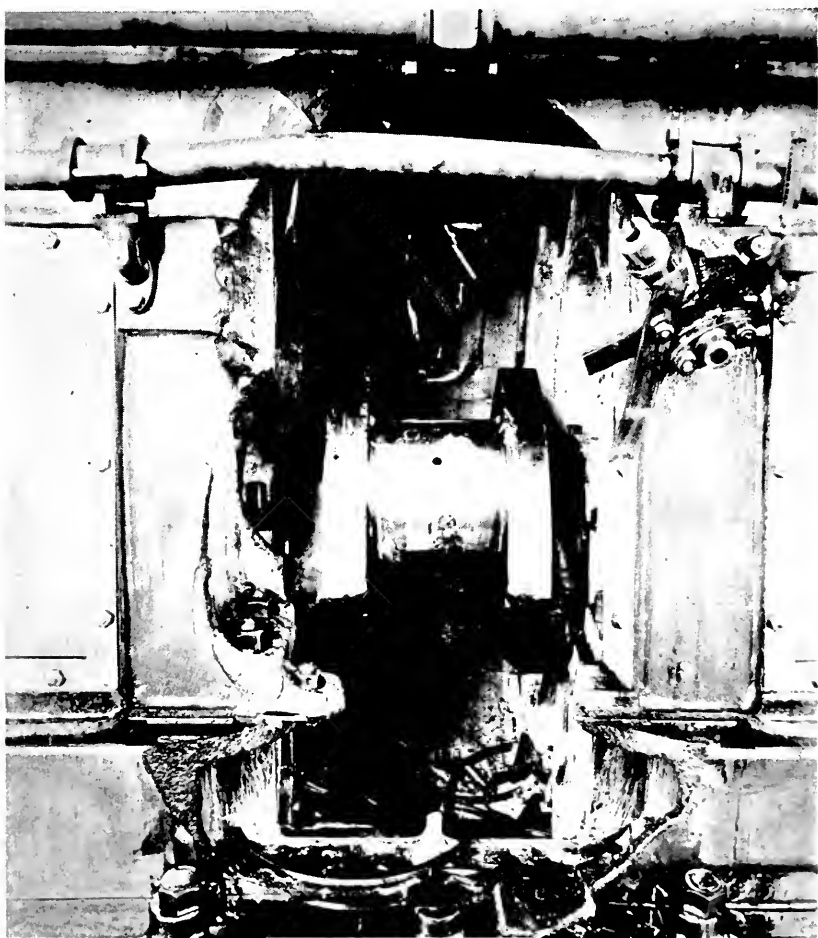
Figure 3—A wreck brought about by a crankbolt failure in a 2,000 hp engine. This accident resulted in a lost estimated at \$15,000. Vertically the picture shows about 5 feet of the engine.

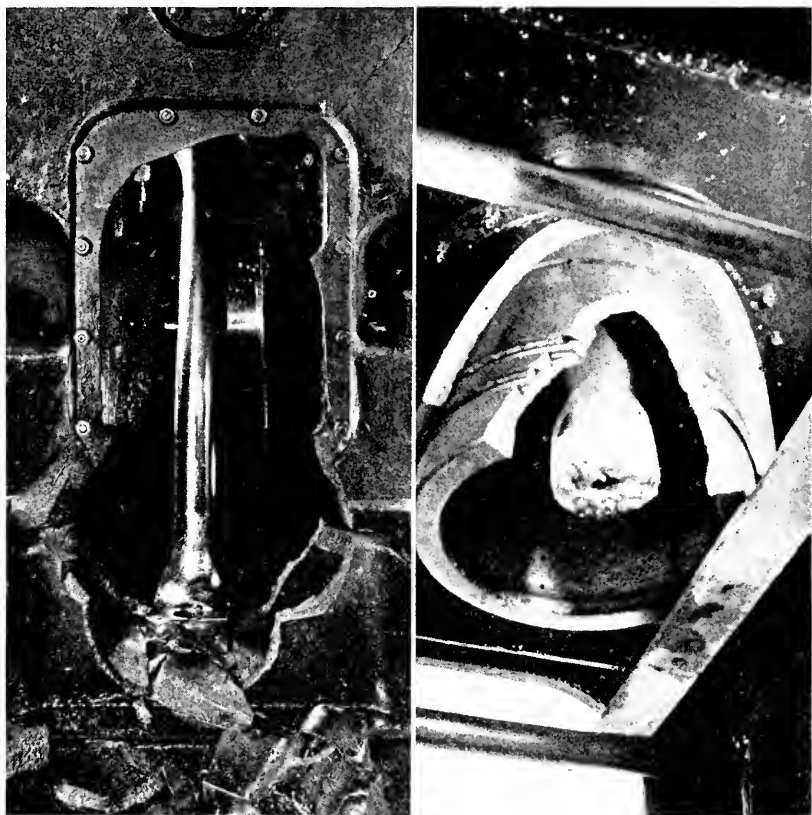
Figure 4—Left—Crankbolt breakage in a 260 hp Diesel engine. Figure 5—Right—Broken connecting rod and other damage on a 600 hp engine. This accident was caused by failure of a crankbolt, which had been in use for approximately 30,000 operating hours.

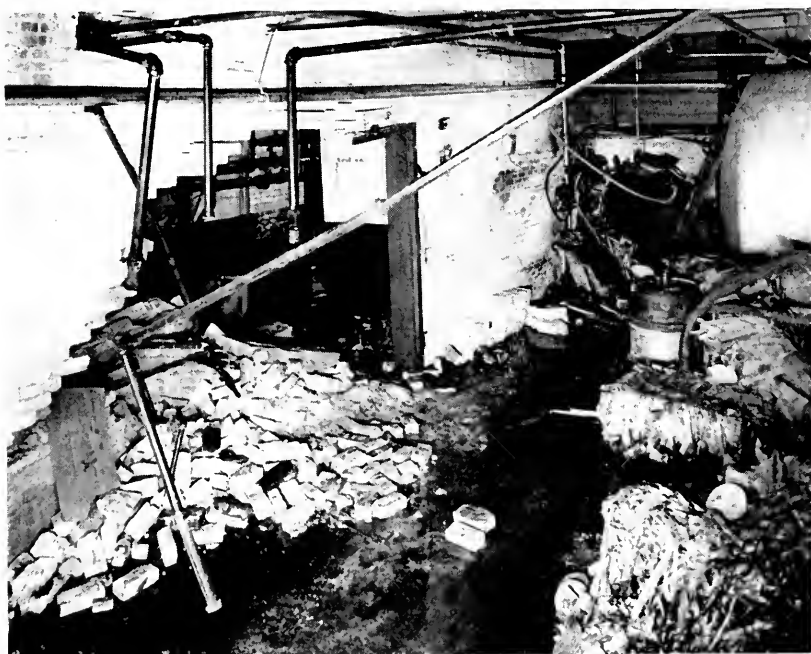
Part of the damage caused by the recent explosion of a condensate receiving tank.

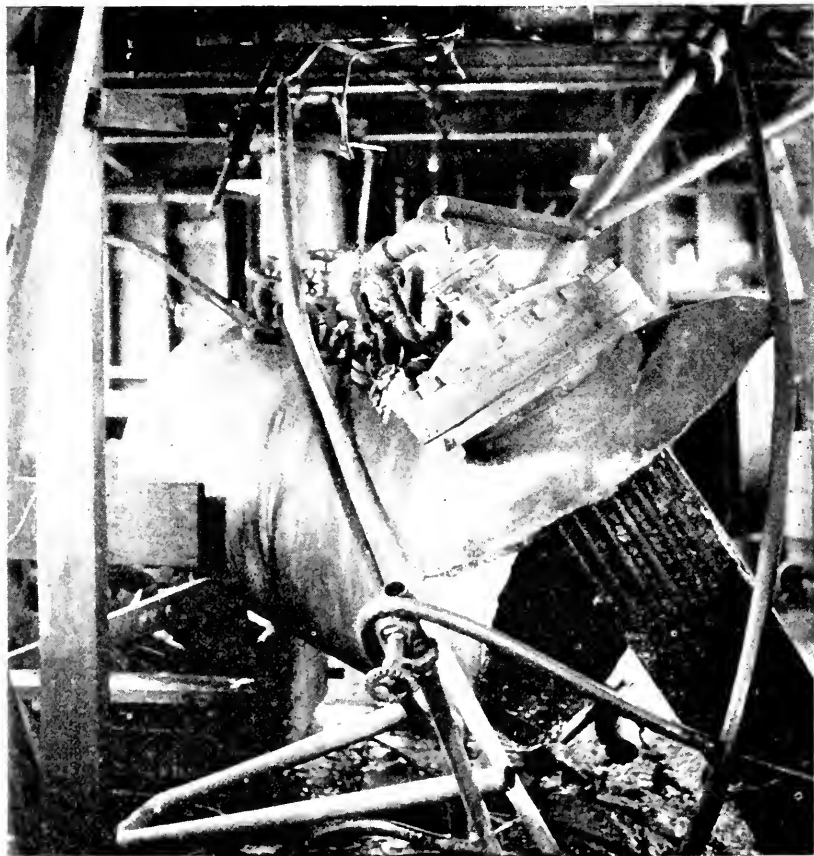
Damage after a combustion explosion in a chemical process tank.

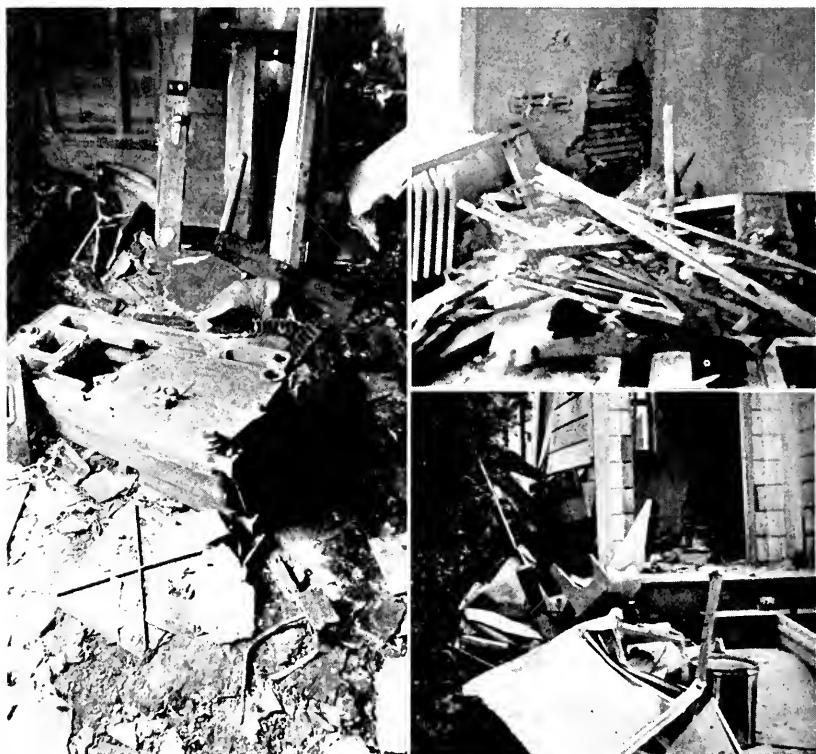
Left—Damage caused by the bursting of a hot water heating boiler from excess pressure. An investigation brought the conclusion that the system had been expected to operate with no expansion tank outlet and no relief valve. This accident occurred in Detroit.

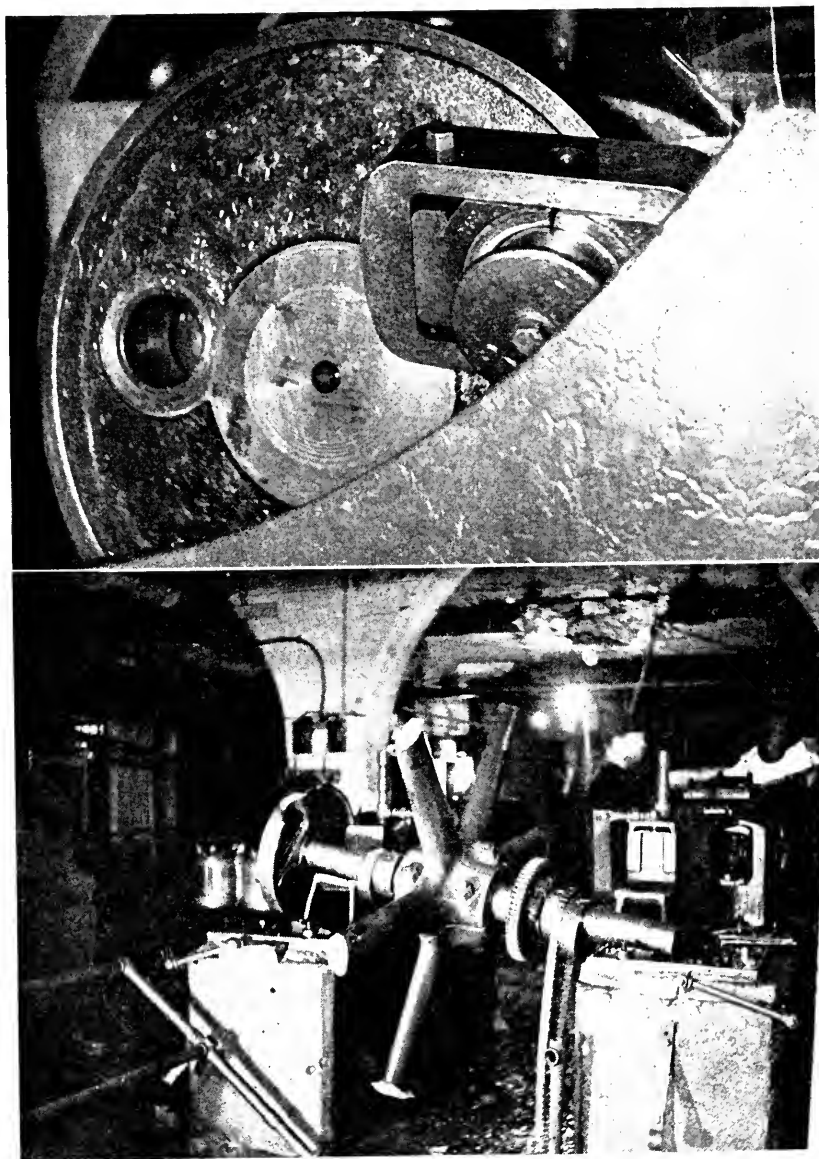
Figure 1 (above)—View of Engine No. 1 showing the loosened crank-pin and the connecting rod jammed between the disc and the frame.

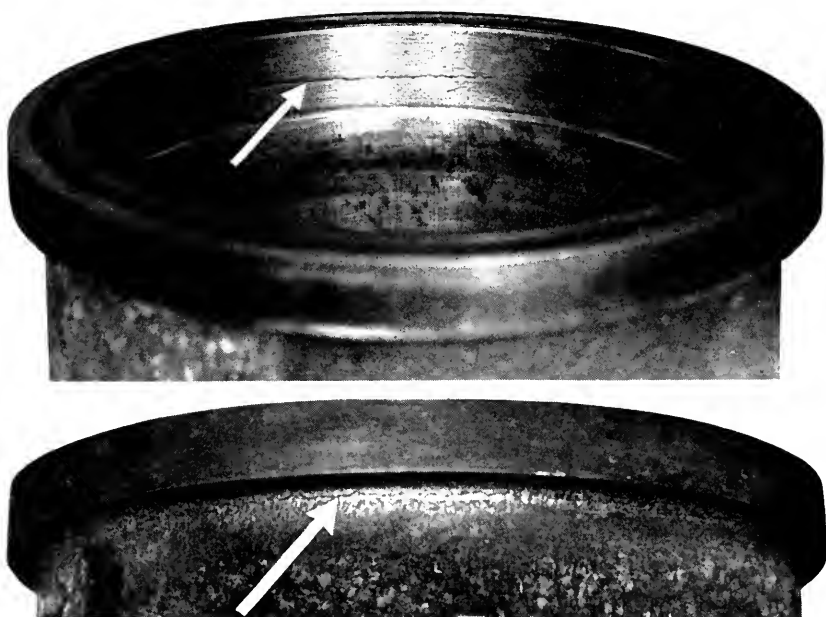
Figure 2 and 2A—Views showing a circumferential crack near the top of a 15" cylinder liner. This crack permitted leakage of water into the cylinder.
