The Locomotive

THE HARTFORD STEAM BOILER
INSPECTION AND INSURANCE CO.

INDEX
to
VOL. 42 - 43

INDEX TO VOL. 42—1938-1939

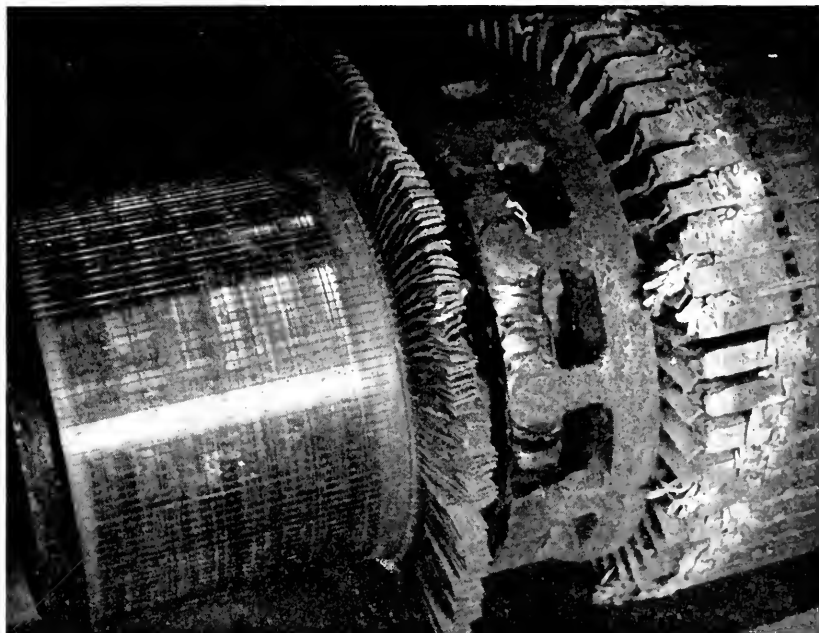
Breaking of the band wires on the commutator end was found to have caused the damage to this exciter armature of a 30,000 kw turbo-generator set. The winding between the armature core and the commutator risers was completely destroyed. The resultant arcing burned the iron and laminations of the core and also set fire to the insulation. Estimated cost of repairs, which consisted of rewinding the armature and the field, rebuilding of the commutator and replacing the burned iron and laminations in the core, was \$3,000.

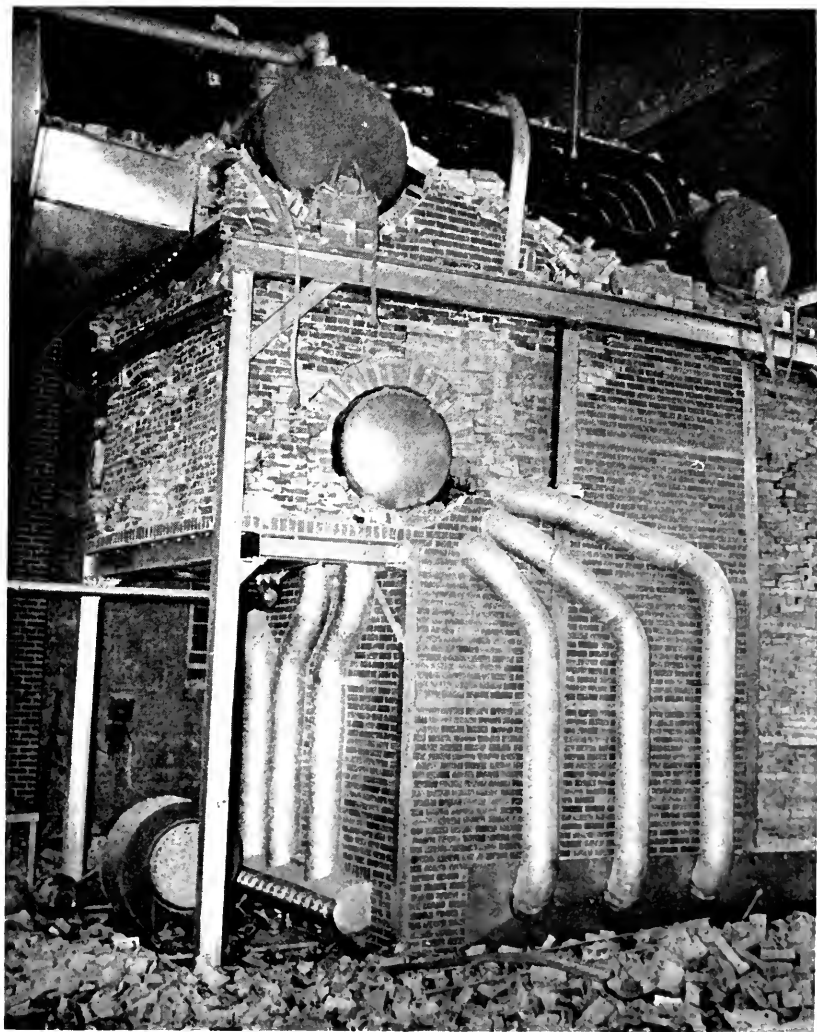
The damage to this large water tube boiler fired with natural gas was caused by a furnace explosion.

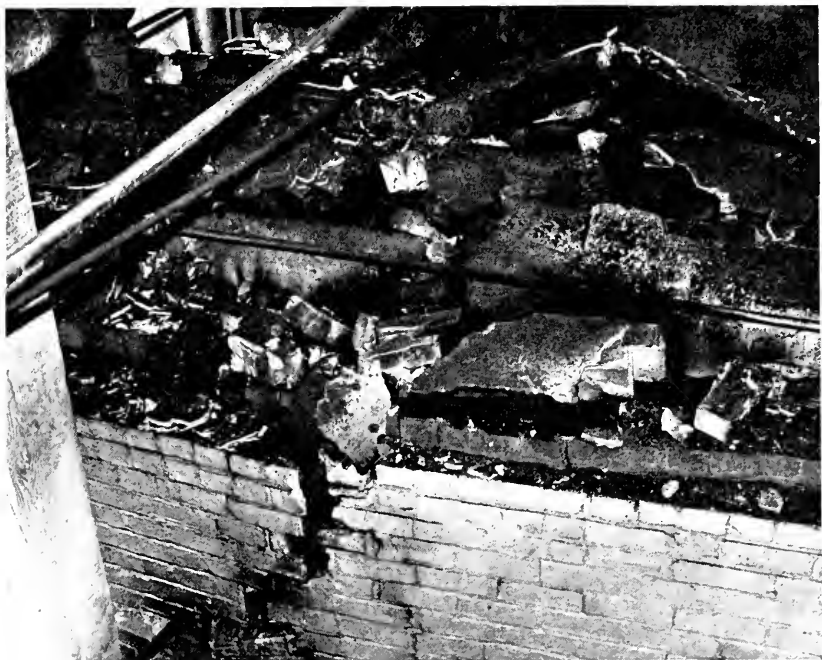
View of another watertube boiler—oil fired—showing damage from a furnace explosion.

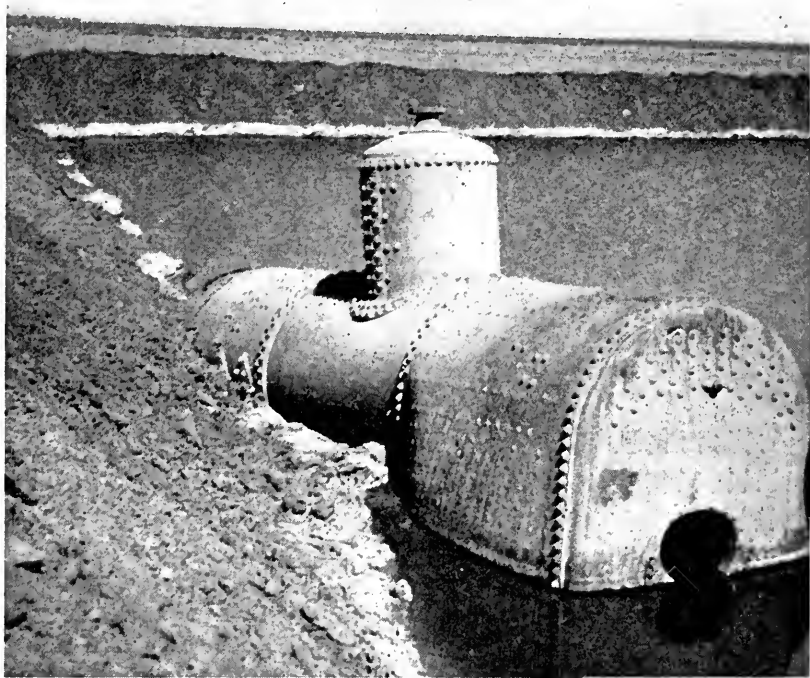
This locomotive fire box type boiler soared to the above location 250 feet from its setting in a California oil field when the crown sheet dropped because of low water and over-heating. A boiler attendant was scalded.

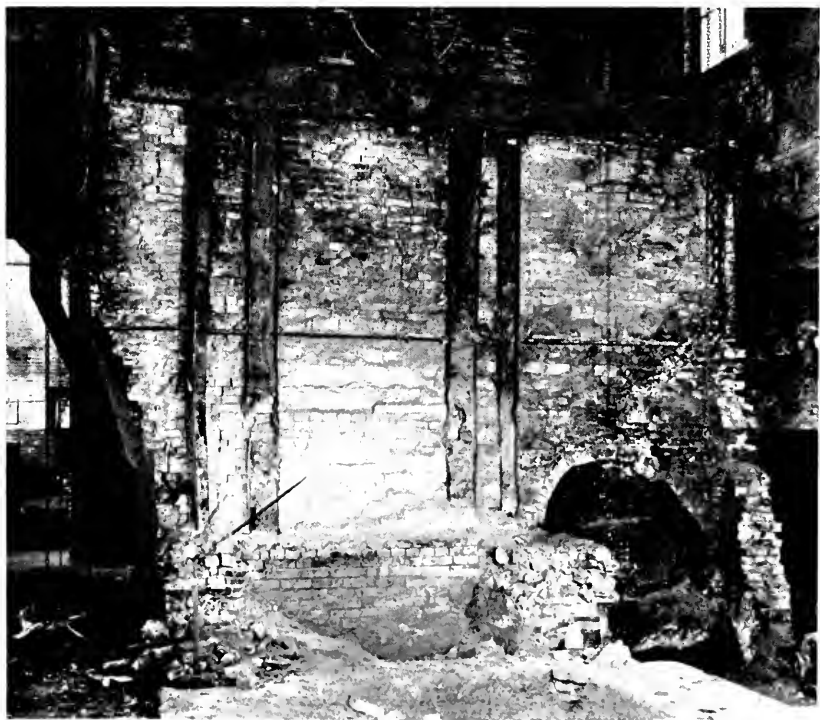
Figure 1—Boiler supporting column, encased in intermediate brickwalls of a battery of boilers, almost entirely wasted away by oxidation from the high temperatures in the combustion chambers.

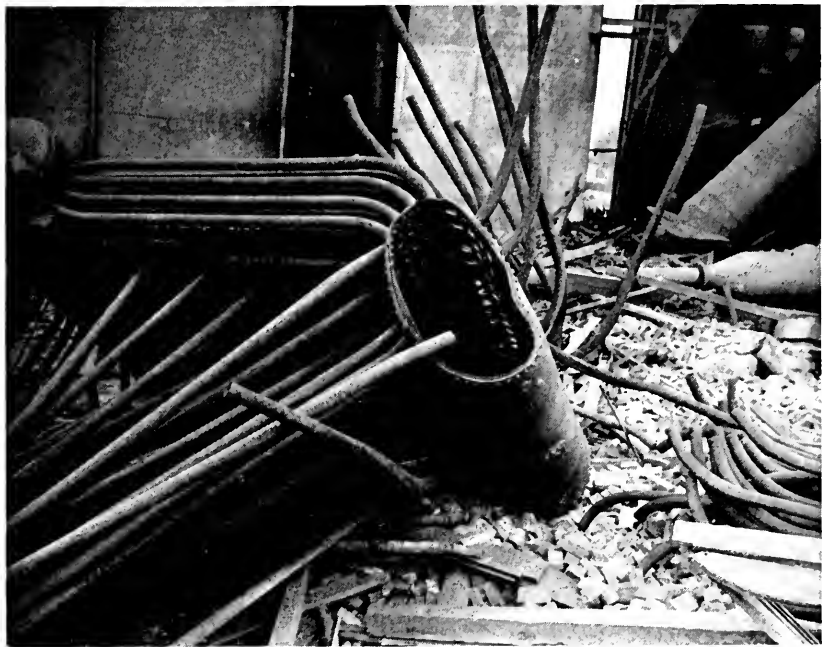
Figure 2—Weakened by corrosion, the blind head in the mud drum of this water tube boiler in a utility plant tore loose and caused the death of four people, injuries to six others and \$100,000 property loss.

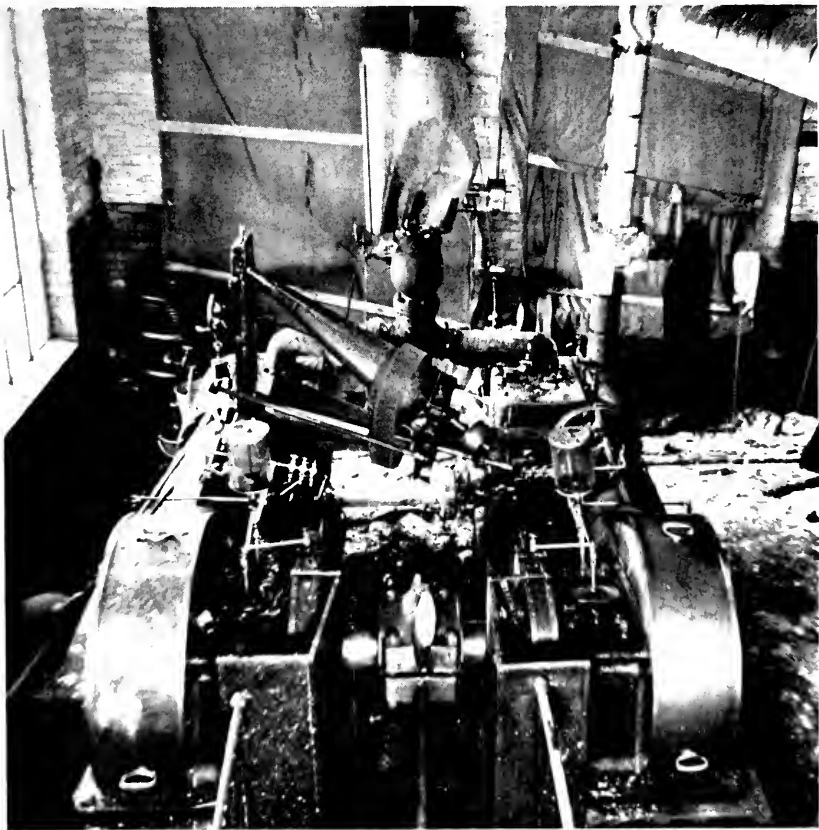
View of the steam engine showing the wreckage following the explosion.

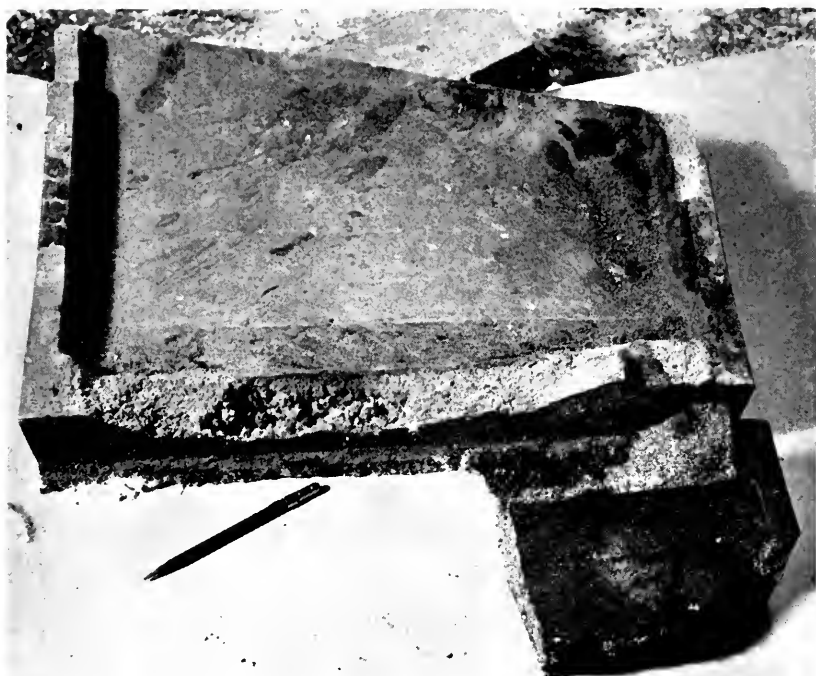
These two broken parts of the wheel, placed together as they were located in the rim, show slag and gas pockets in the casting.

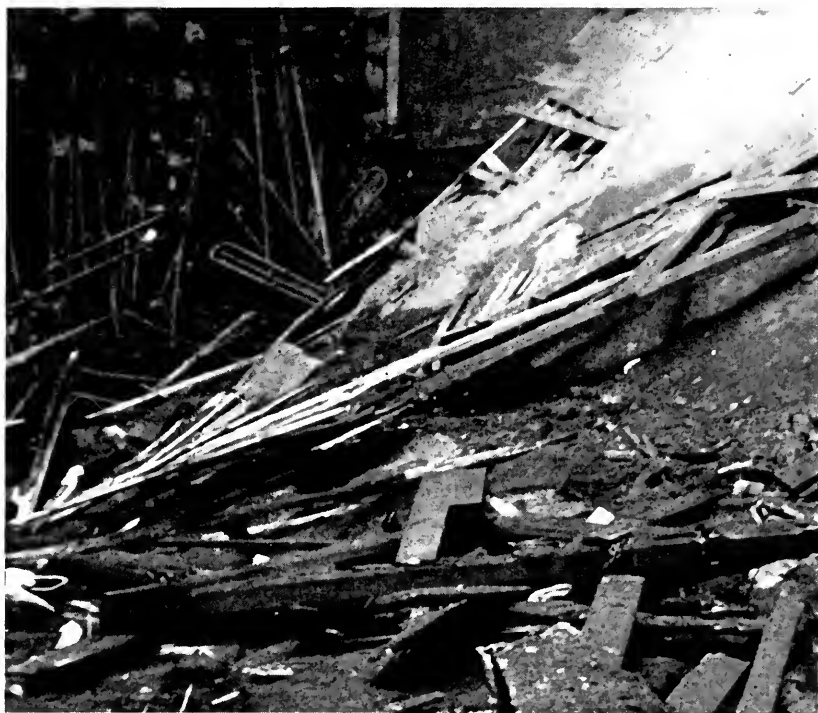
Figure 2—Some of the broken ammonia cooling coils and a section of the collapsed roof following an accident to a refrigerating system in an ice storage building.

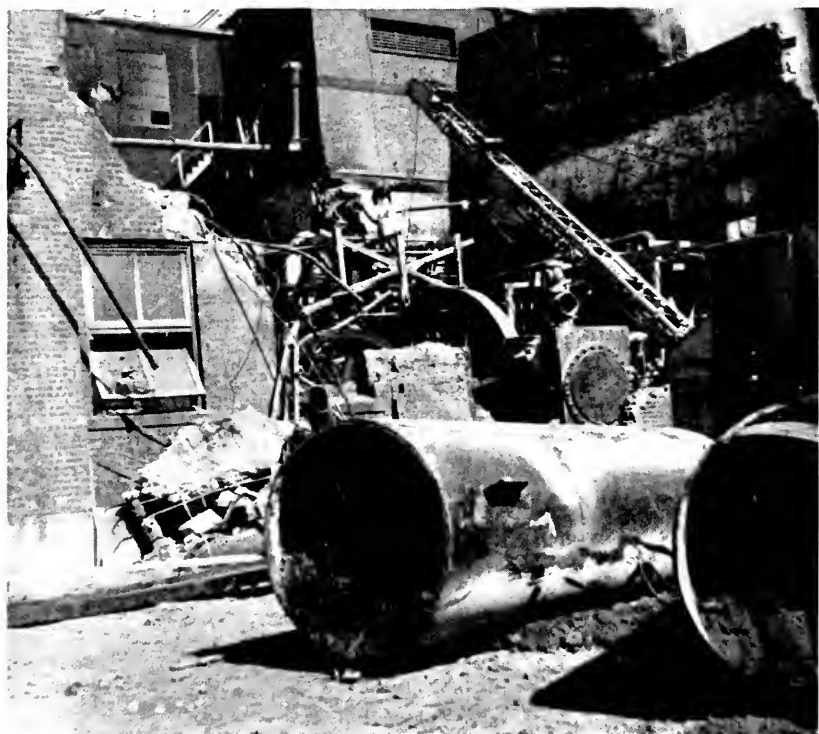
Figure 3—Power plant for a packing company wrecked by an explosion and fire after a fitting ruptured in an ammonia discharge line of a large refrigerating system.

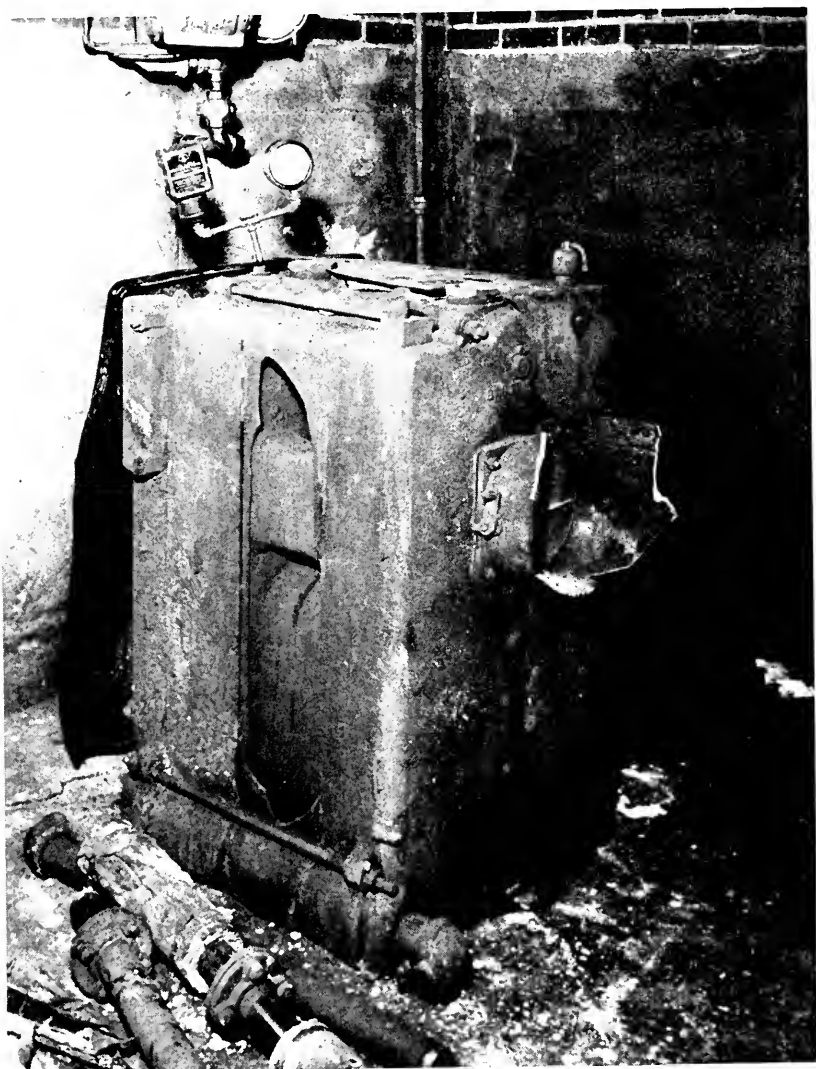
Figure 4—Failure of a pressure control device plus an inoperative safety valve caused the explosion of this cast iron steam heating boiler in a Kansas residence.

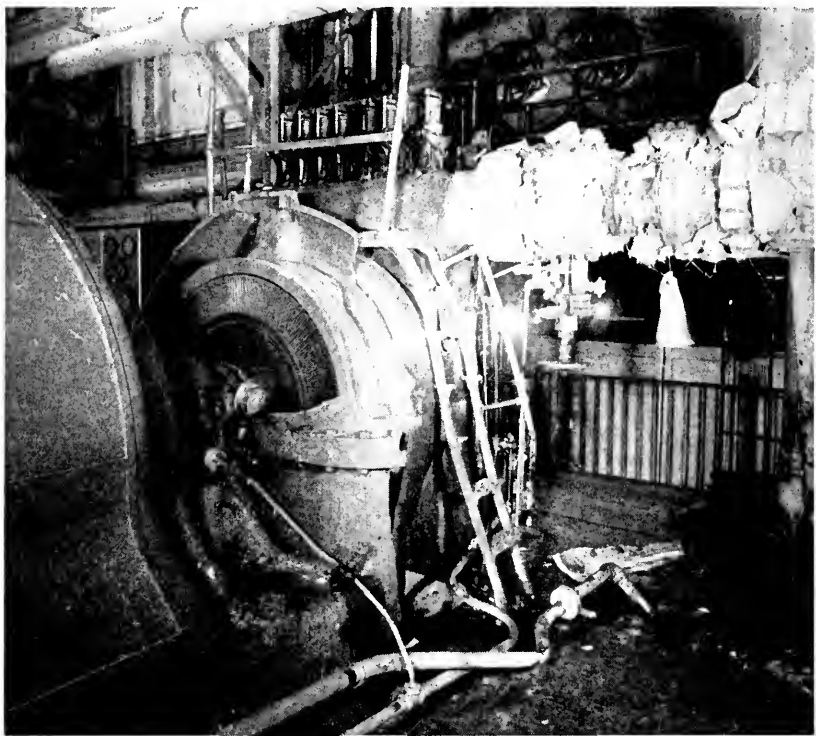
Steam turbine wrecked by an explosion when its exhaust casing burst from excessive steam pressure.

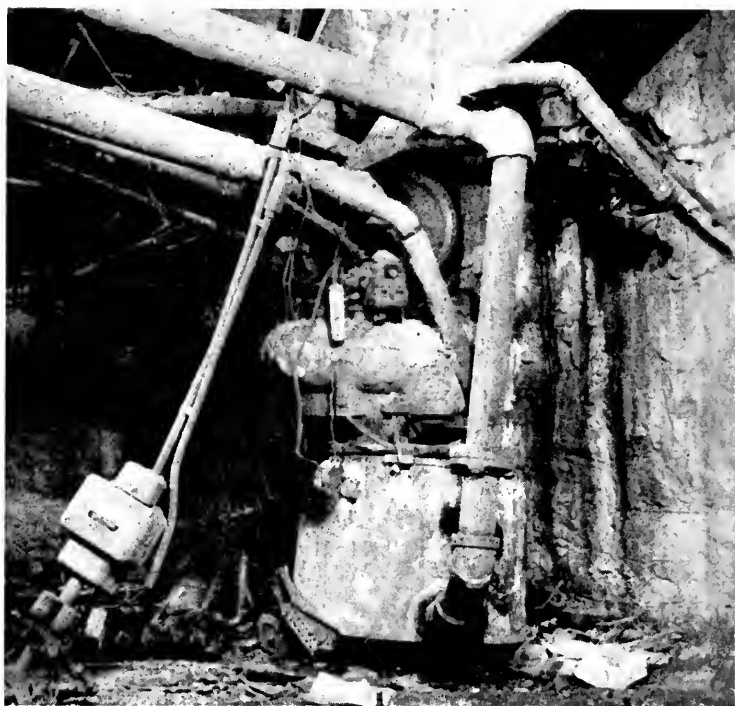
THIS cast iron boiler—uninsured—exploded from overpressure. Connected to a closed type hot water heating system, the boiler was not equipped with a dependable means to provide for expansion of the water. Electric wiring for an aquastat short circuited, the oil burner continued in operation, and as the water expanded the pressure increased. A closed valve between the boiler and a safety valve prevented release of excessive pressure.

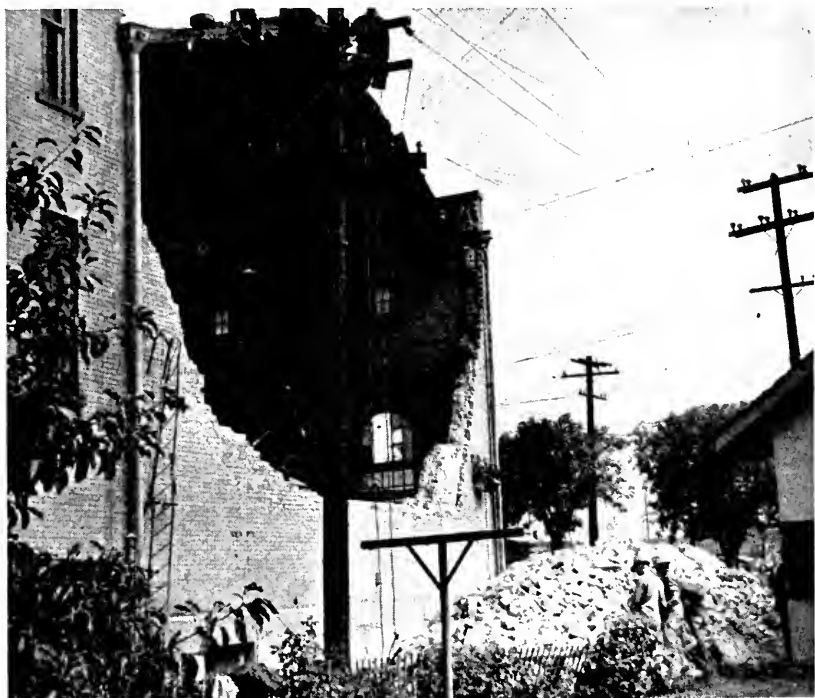
Two views of a utility sub-station after an explosion, caused by a direct stroke of lightning, blew out the end-walls.

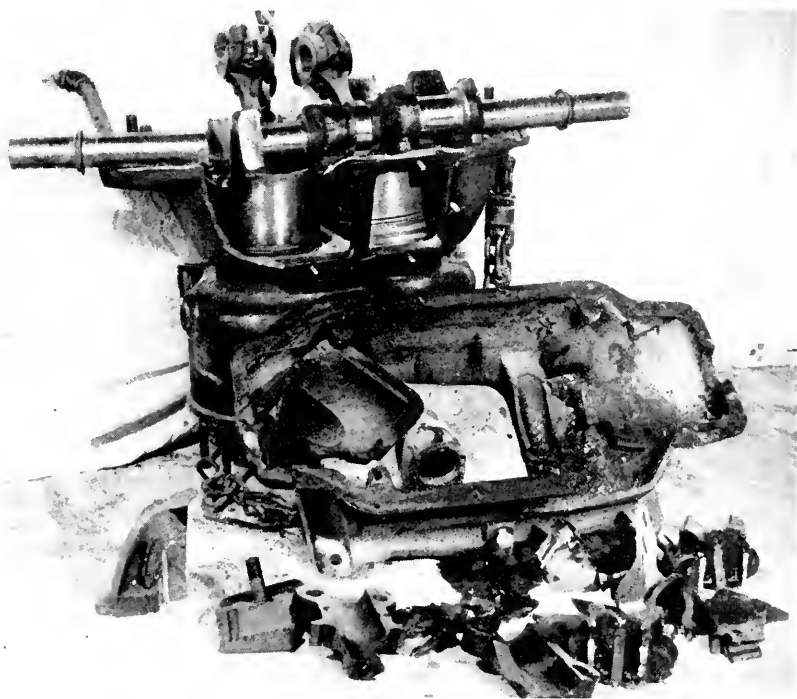
Figure 2—Vertical two-cylinder air compressor so completely wrecked when the crankshaft broke that repairs were impracticable.

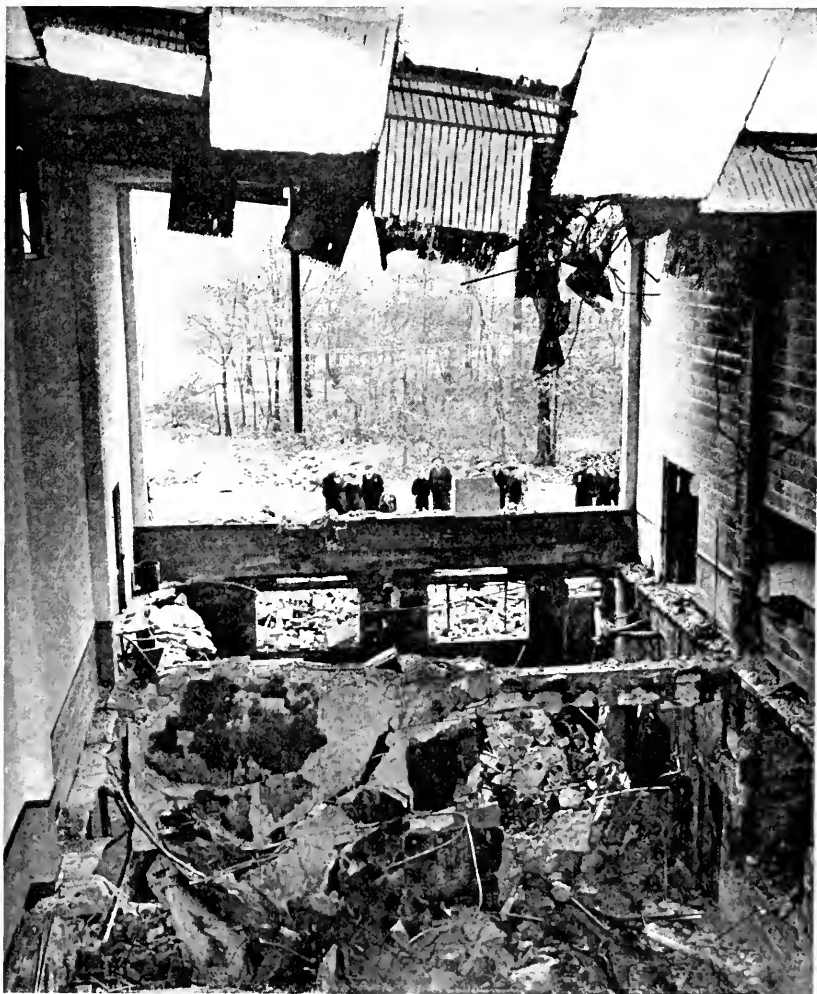
Pictured above are the ruins of a high-school study hall. An explosion of a hot water heating boiler caused this damage.

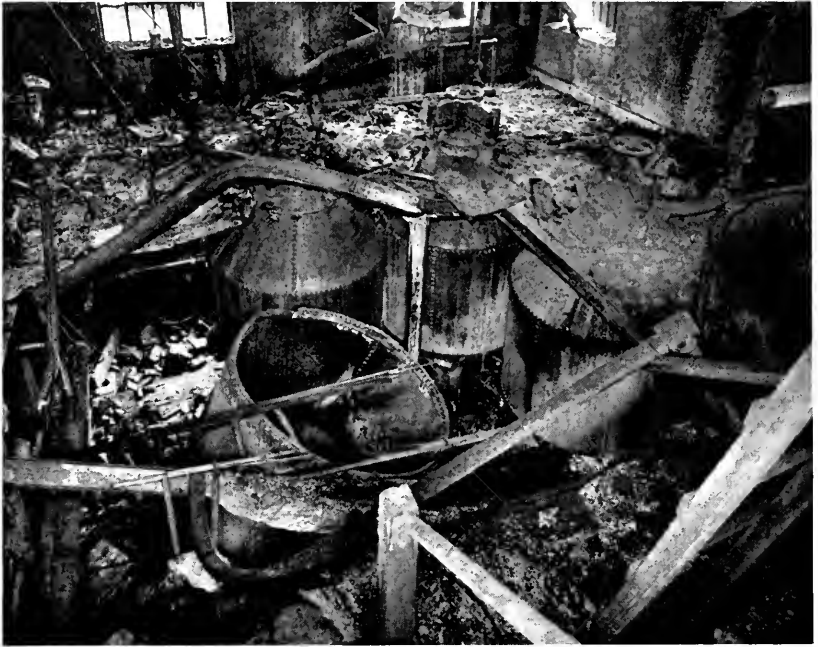
Scene in a soda recovery room at a paper pulp manufacturing plant after an explosion of a soda leaching tank.

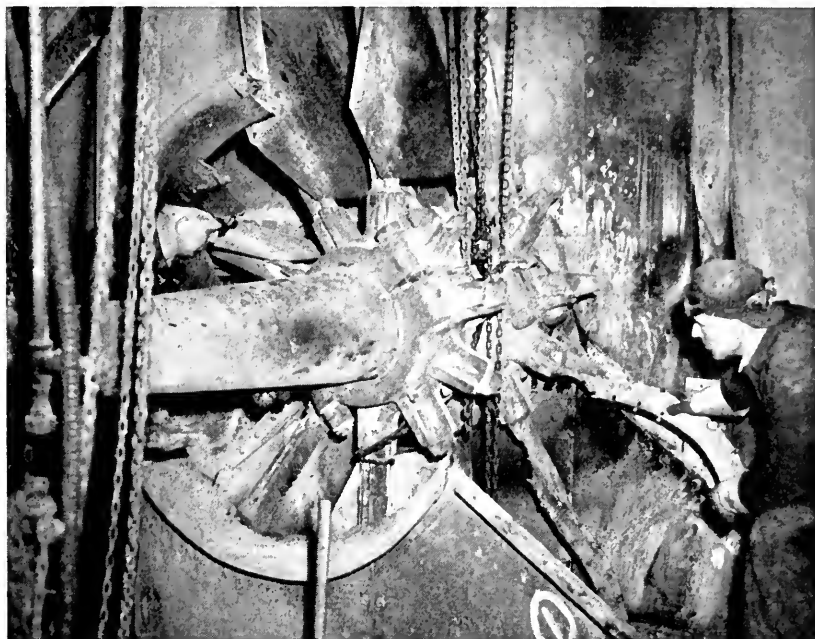
Figure 1—Part of the damage to one-half of a duplex-type induced draft fan, 450 hp capacity. Erosion of the shrouding and excessive temperature of the stack gases caused the accident.

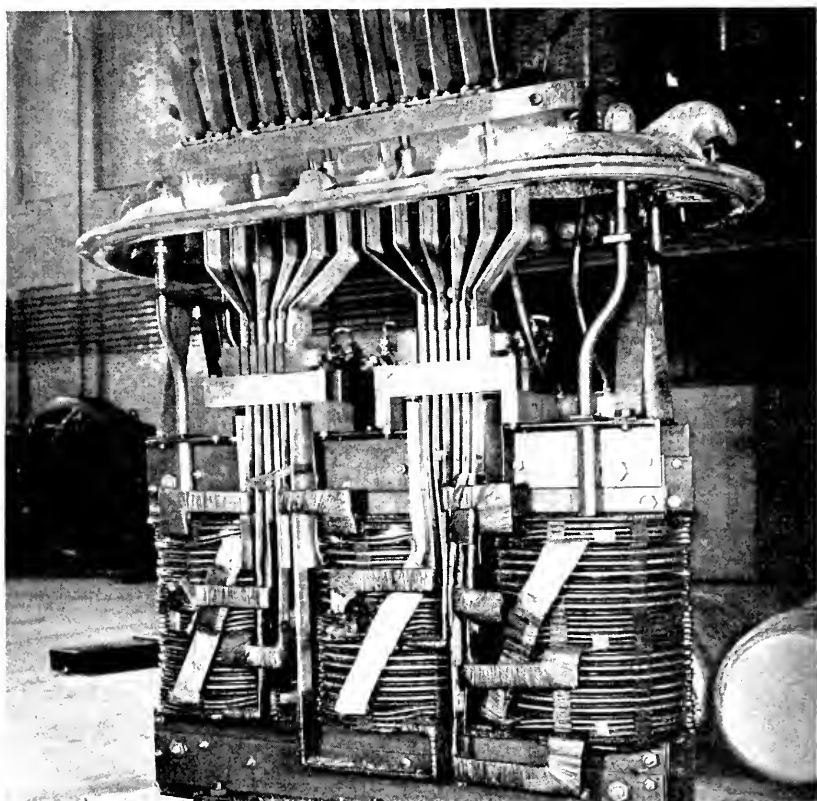
View of a three-phase, 800 kv-a transformer, removed from its casing for an examination after it had failed to operate. The source of trouble was readily determined, for as shown in the photograph the short-circuited coils in the center phase were plainly visible. Further investigation revealed that several high-tension windings had burned through completely and a number of secondary coils had been damaged as well. Intermittent excessive overloads which produced both severe mechanical stresses between the windings and excessive heating were believed to have been the cause. The cost of repairs to the transformer was about \$1,000 although production loss and extra expense incurred for a temporary transformer while repairs were being made exceeded \$12,000.

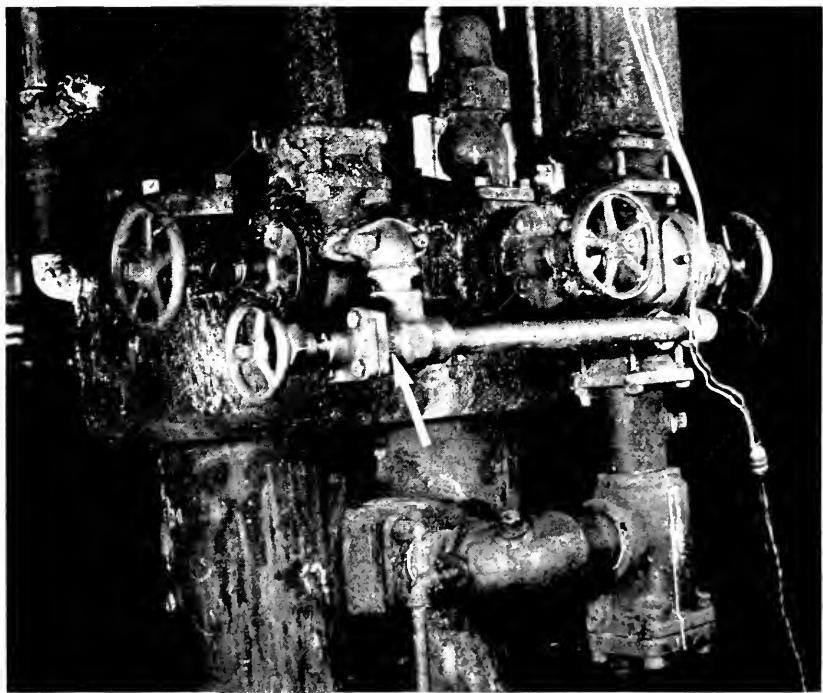
Figure 1—Four people were injured and a \$37,000 property damage loss was caused by the breaking of a by-pass valve on this ammonia compressor. Arrow indicates the point where the break occurred although a new valve had been installed when this picture was taken.

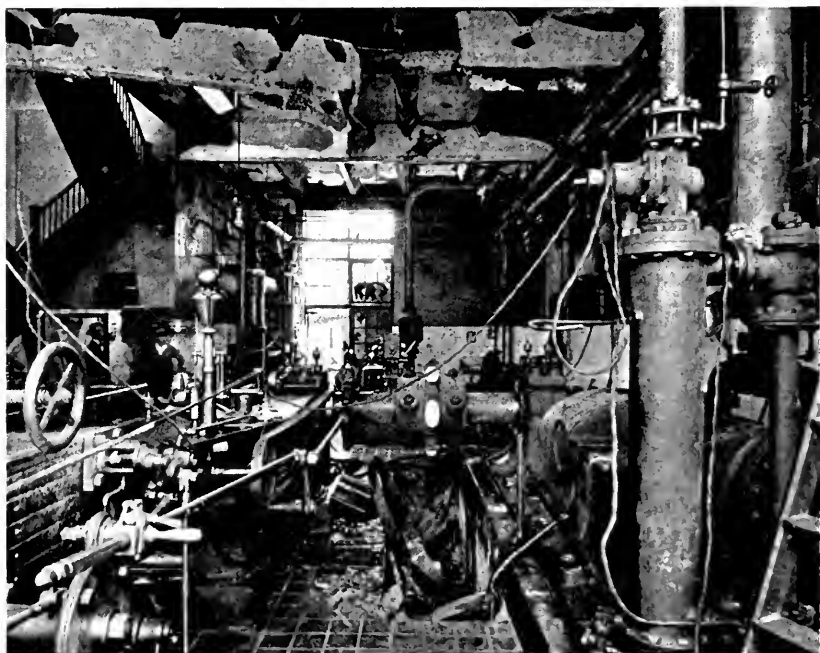
Figure 3—When a 12' flywheel on this steam-driven ammonia compressor ran away, the resultant property damage amounted to more than \$10,000.

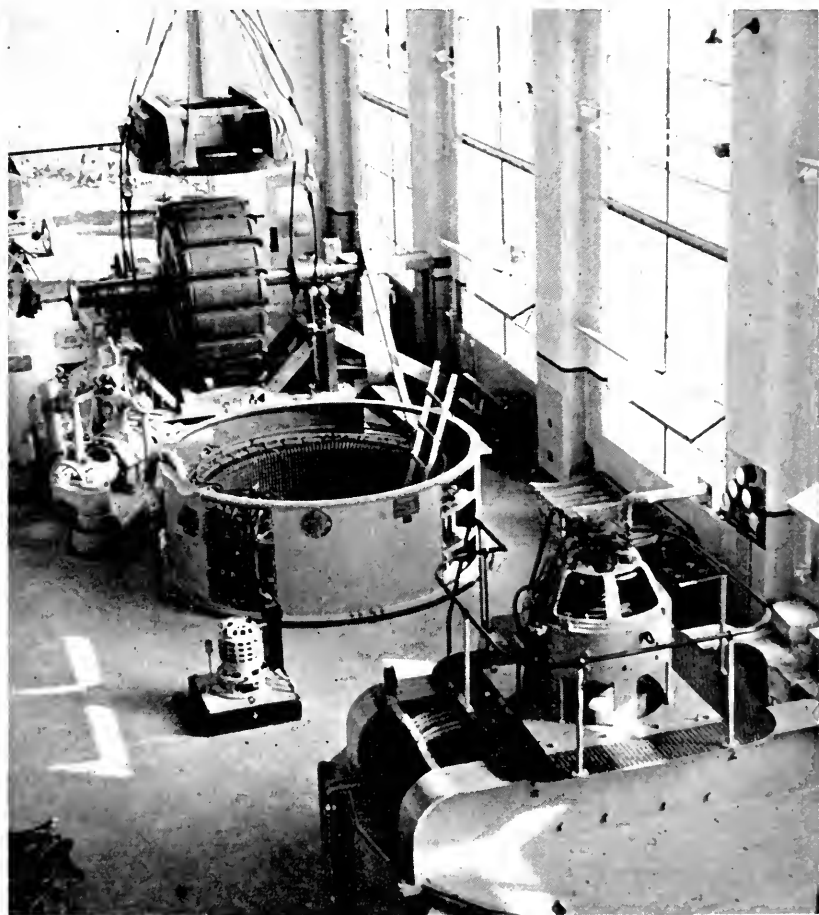
Scene in a California power plant showing the generator ends of two vertical water turbine-generator units, each of 7,500 kw capacity. One generator has been dismantled for complete rewinding of its stator, necessitated by failure during a severe electrical storm. The total loss, direct and indirect, was \$37,000.

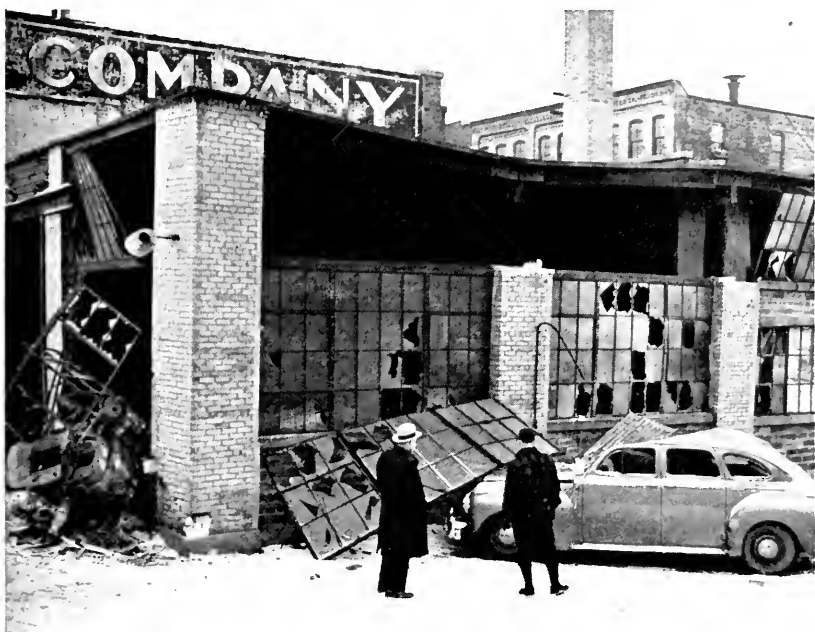
Figure 3—A check valve between a hot water heating boiler and its relief valve was reported as the cause of the explosion which wrecked this building.

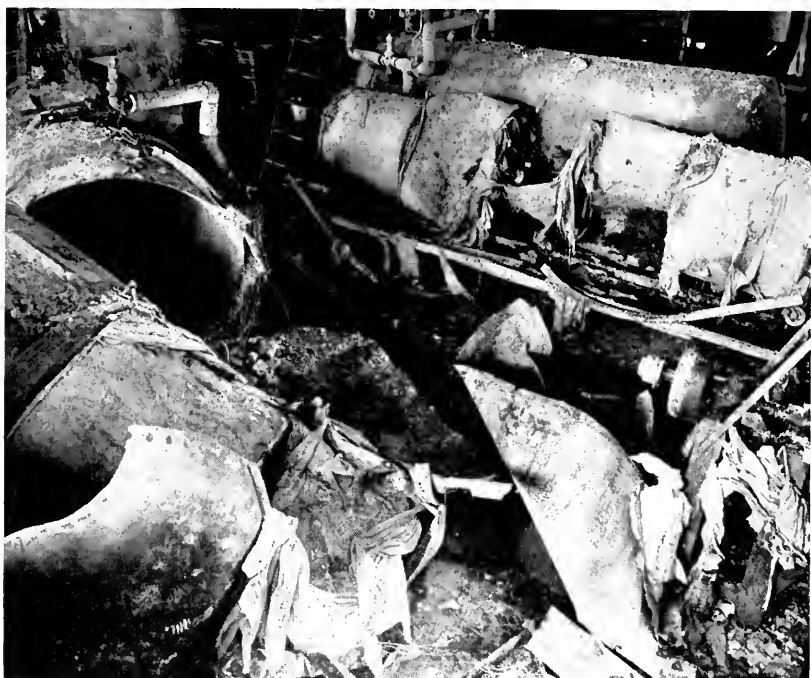
Figure 4—When a badly corroded vulcanizer exploded in a Pennsylvania plant, two persons were injured and the property damage amounted to \$6,000. This shows parts of the exploded vessel.

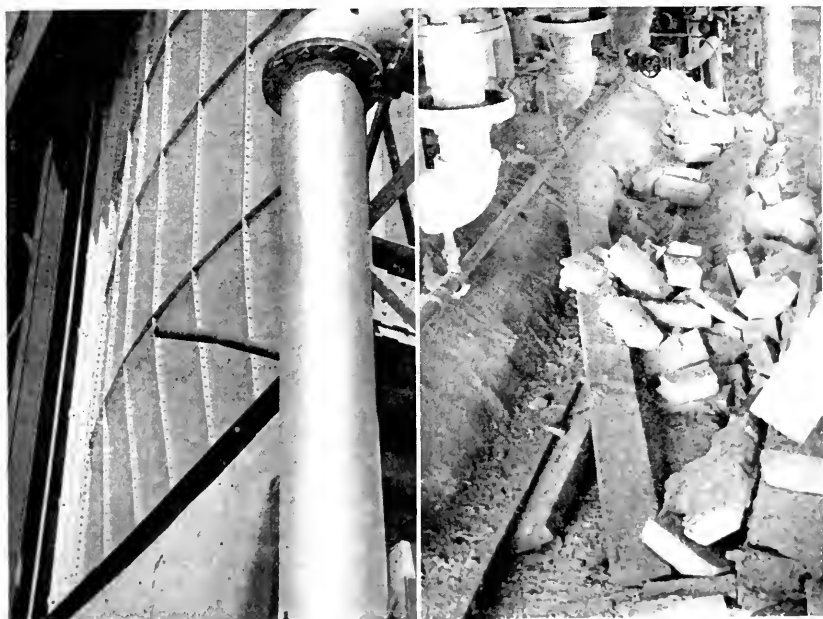
Figure 5—(Left) and 5A (Right)—Two pictures showing some of the damage caused by a furnace explosion to a large water-tube boiler in an Arizona utility power house. The one at the left shows one wall of the boiler's economizer bulged out several inches, while the other gives a view of damaged brickwork in the top of the setting.
