# The Locomotive

THE HARTFORD STEAM BOILER
INSPECTION AND INSURANCE CO.

VOL. XXXIV.

VOL. XXXIV. HARTFORD, CONN., JANUARY, 1922. No. 1.

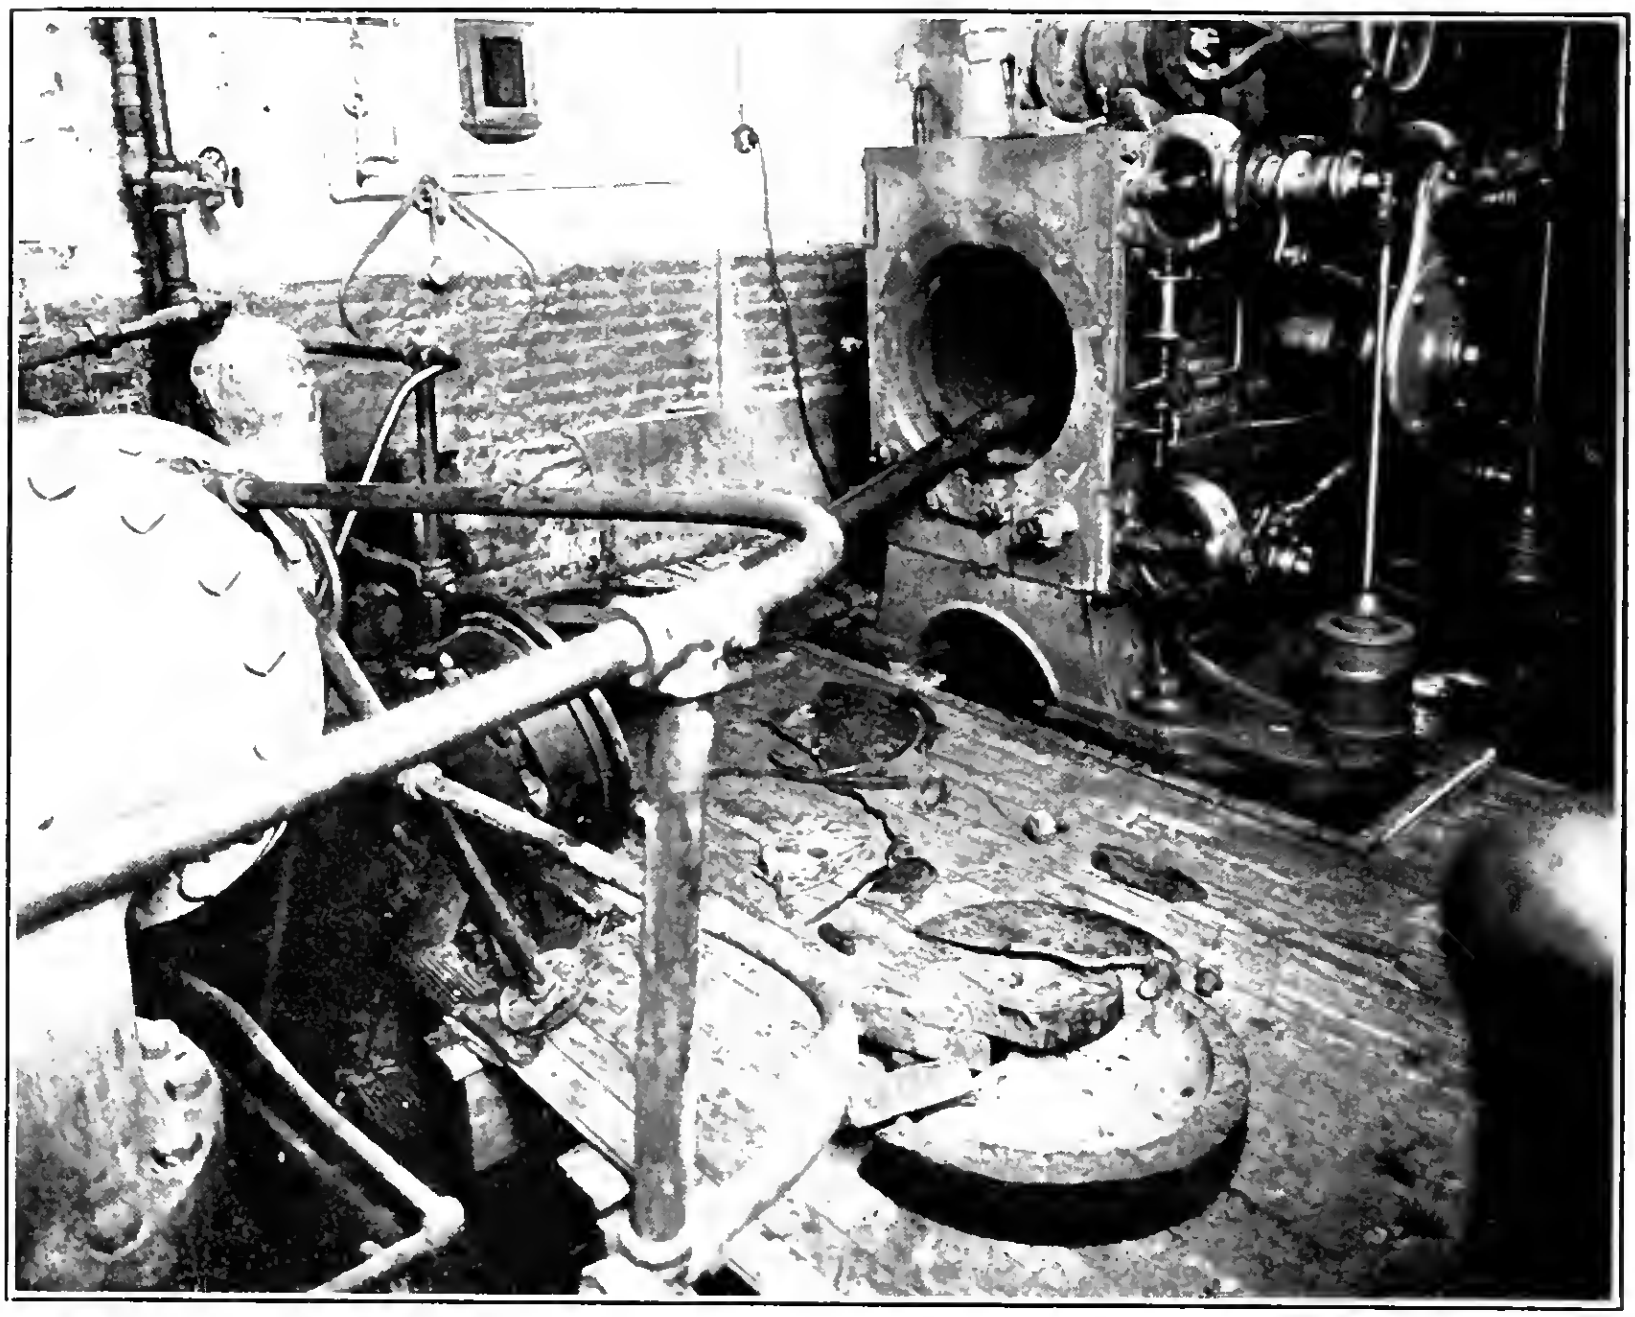
View of Wreck From Head End of Engine.

An investigation was made to determine the cause of the accident and it was found that the gib which, with a cotter key, held the piston-rod in the cross head, had broken and, as this permitted the cotter or key to drop out, the piston-rod and the crosshead had become separated. Apparently this occurred shortly after the engine had passed the crank-end center so that the steam admitted to the cylinder at that time carried the piston and rod with terrific force toward the opposite end of the cylinder, breaking out the cylinder-head and causing the other damage that has been mentioned. What caused the gib to break has not been fully determined. The accident serves to illustrate however, the danger that is attendant upon the use of an engine however satisfactory its operation may appear.

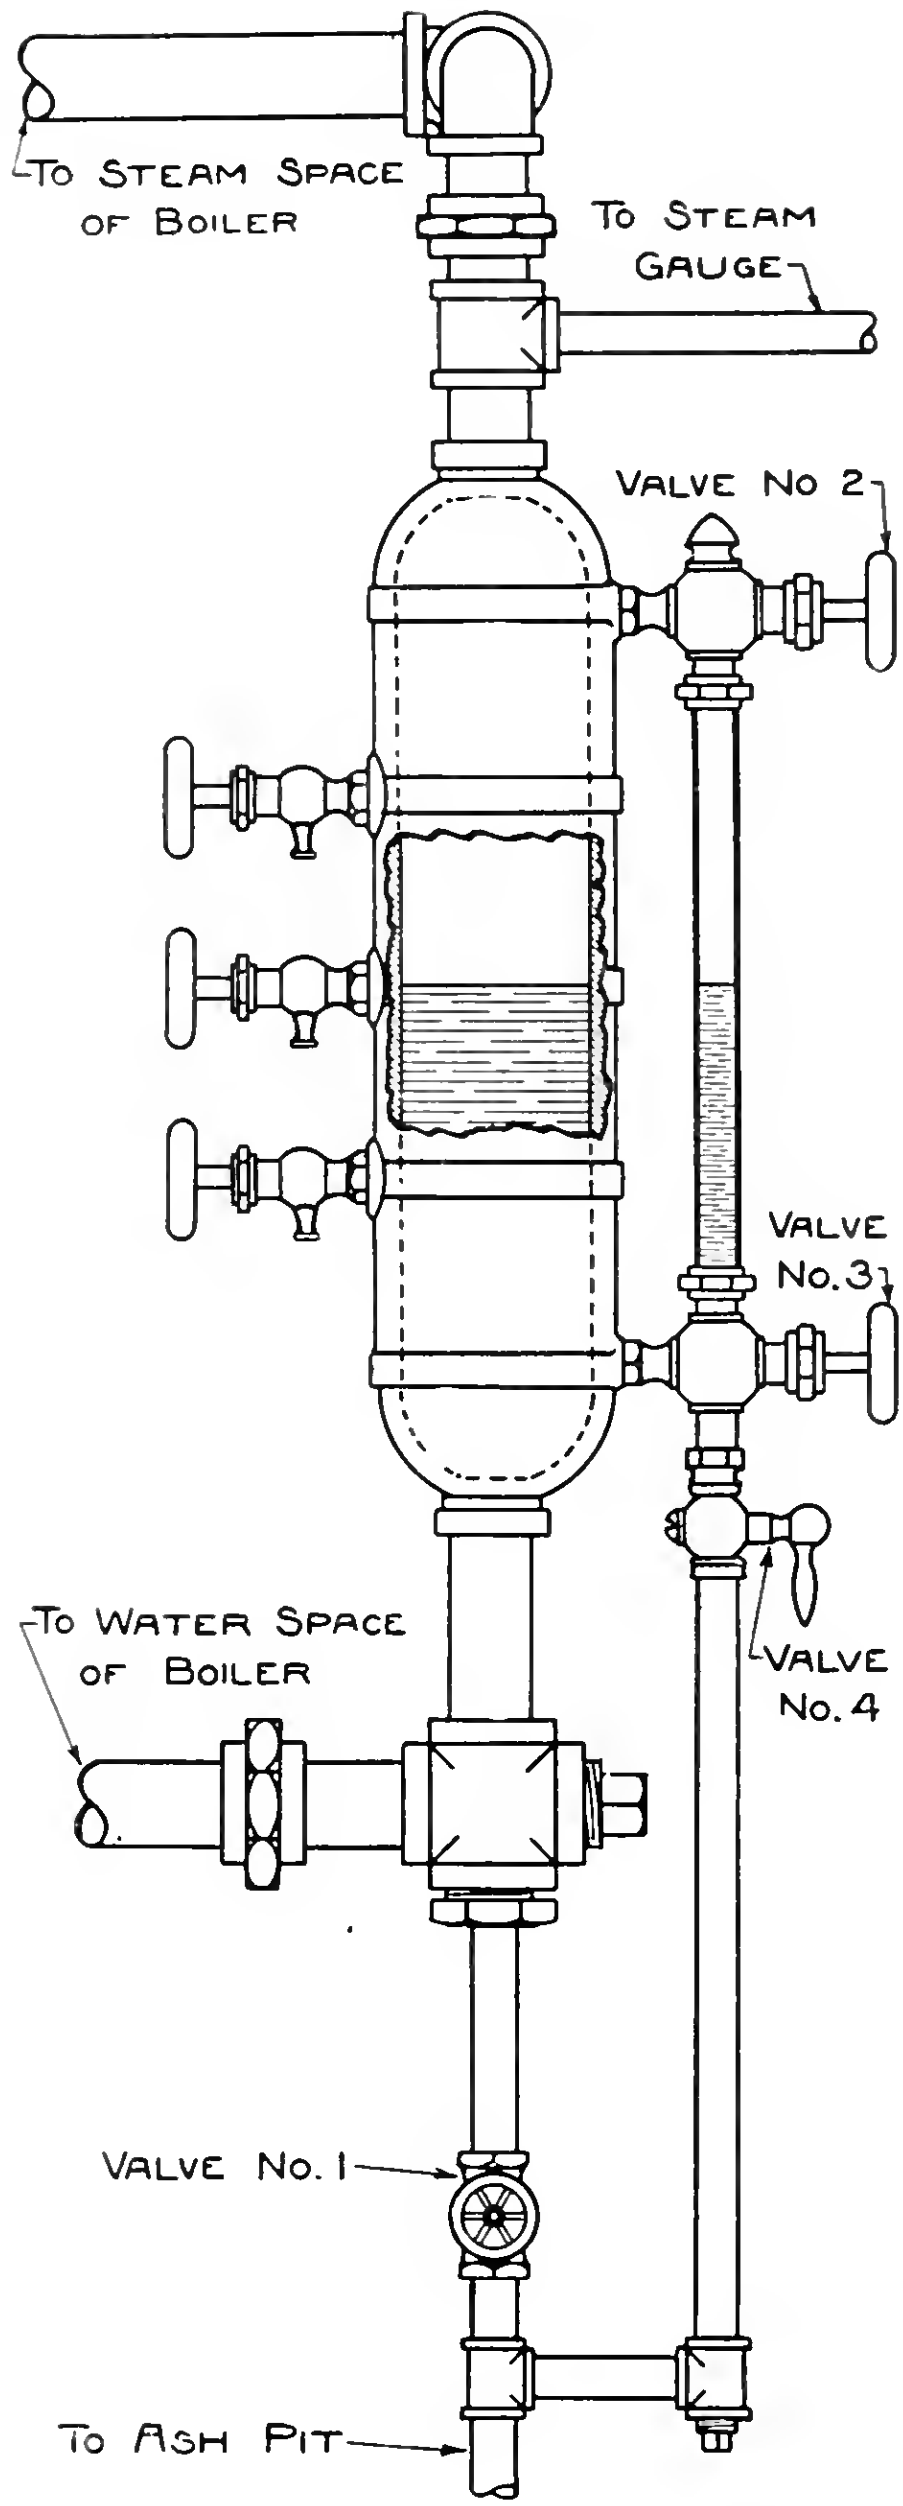
The method of piping the water column, gauge glass and try cocks to a boiler, as approved by this company, is illustrated in Fig. 1.

The connections between the boiler and the water gauge should at all times be kept free and open. Upon coming on duty and several times while on duty the fireman should blow down the water gauge piping to preclude any possibility of a stoppage in the pipe such as might be caused by scale entering it from the boiler. To do this the cocks or valves at the top (No. 2) and the bottom (No. 3) of the gauge glass are closed and the mud valve (No. 1) in the water column drain is opened and permitted to blow steam and water for a minute or two so as to thoroughly flush out the water column and the pipe connections to the boiler. After this has been done and valves 2 and 3 have again been opened, attention should be turned to the gauge glass itself. The pet cock (No. 4) should first be opened and steam and water allowed to blow through it freely for a short time. Then the top valve, No. 2, is closed to let water only pass out through the pet cock, thereby showing a clear pas-

sage to the bottom of the gauge. By closing valve 3 and opening valve 2 the passage of steam only will indicate that the top connection is clear. When this manipulation of the valves has been accomplished, the pet cock is closed and the top and bottom gauge cocks opened. If the connections are clear, the water will rise at once to the proper level where it will have a gentle up and down motion in the gauge glass. On the other hand, if the bottom connection were obstructed in any way the water would not return quickly to its proper level. If, at the same time, the top connection were open, steam would enter through it and by condensing in the glass would give a slowly rising water level. A faulty reading would also be given if the top valve were left closed after the procedure of blowing down. The vapor left in the glass would slowly condense, thereby forming a vacuum and the water, entering through the lower connection and forced by the pressure in the boiler, would rise until the glass was completely filled.

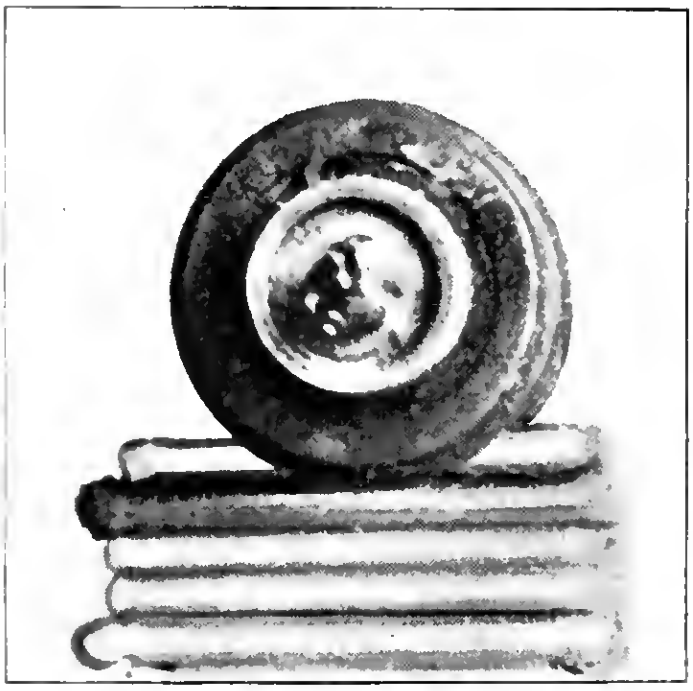
Fig. 3.

"In the selection of a glass, one should be used that will freely enter the valve receptacle and leave a little space around it when in position, and the nuts or glands for compressing the gaskets should be large enough not to touch the glass when screwed up. Only fresh, pure rubber gaskets or washers cut by machine, uniform in size, and prepared for such purpose should be used. After inserting the glass in the valves, it should be shifted so the washers will be at an equal distance from its ends. This is very important, for the writer in his investigations of boiler explosions has found two instances where a washer softened by the heat, under pressure of the gland, has squeezed out under the glass and closed the opening, thus permitting a false indication of the water level. [*Editor's Note — Fig. 3 illustrates such an obstruction which recently came to the attention of the Bureau of Locomotive Inspection of the Interstate Commerce Commission.*] The glands should first be screwed by hand, each a little in turn until they can no longer be moved by the fingers. Then a small wrench may be used on them alternately, until the glass is firm in the packing. Care should be taken that the glass does not shift in its vertical position, during this operation.

"It may be needless to say that in renewing a glass with pressure on the boiler, the valves should be closed tight and the drip opened to release the pressure before attempting the removal. When a new glass has been put in, if the valves are not provided with means for opening at a distance, a board or sheet-iron shield large enough to protect one's head should be held between the face and the glass, and the valves then opened very easily and slowly to their full extent. When they are open, it is advisable to retire with the shield in front of the face to observe at a distance whether there are any leaks, and if any appear, to return to the glass with the face still protected, shut off the valves, release the pressure through the drip, and then tighten the nuts. Never under any circumstances attempt to tighten them with pressure on the glass.

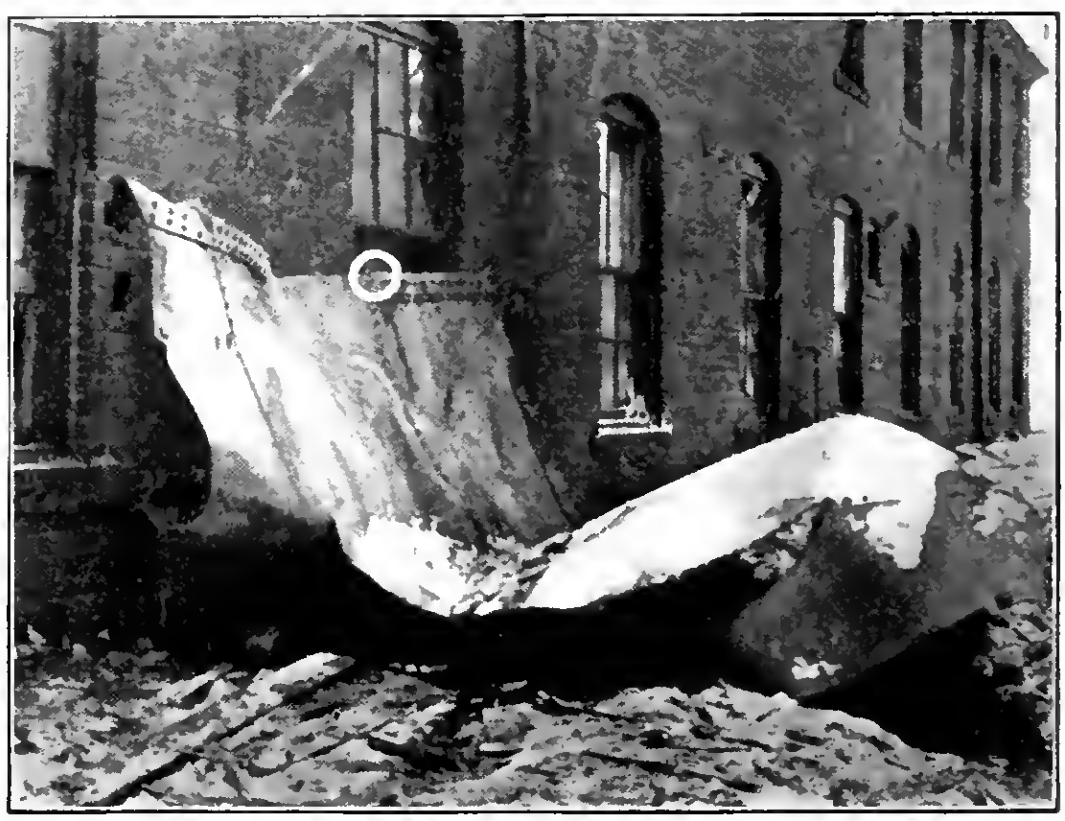
FIG. 1.

The boiler was an old one — we do not know just how old, but we believe that the age was at least twenty years — of the locomotive type and of lap seam construction. The metal was severely corroded and, worst of all, repairs had been made by autogenous welding. The owners had bought the boiler, apparently with the best of intentions, from a second hand dealer and probably this dealer sold the boiler with the belief that it was in reasonably good condition. It was said also that an inspector had passed the vessel as being acceptable for a pressure of 100 lbs. and with this belief the owners thought they had secured a bargain. Two months after the boiler was installed, however, the explosion occurred and property damage to the extent of about $8,000. was done.

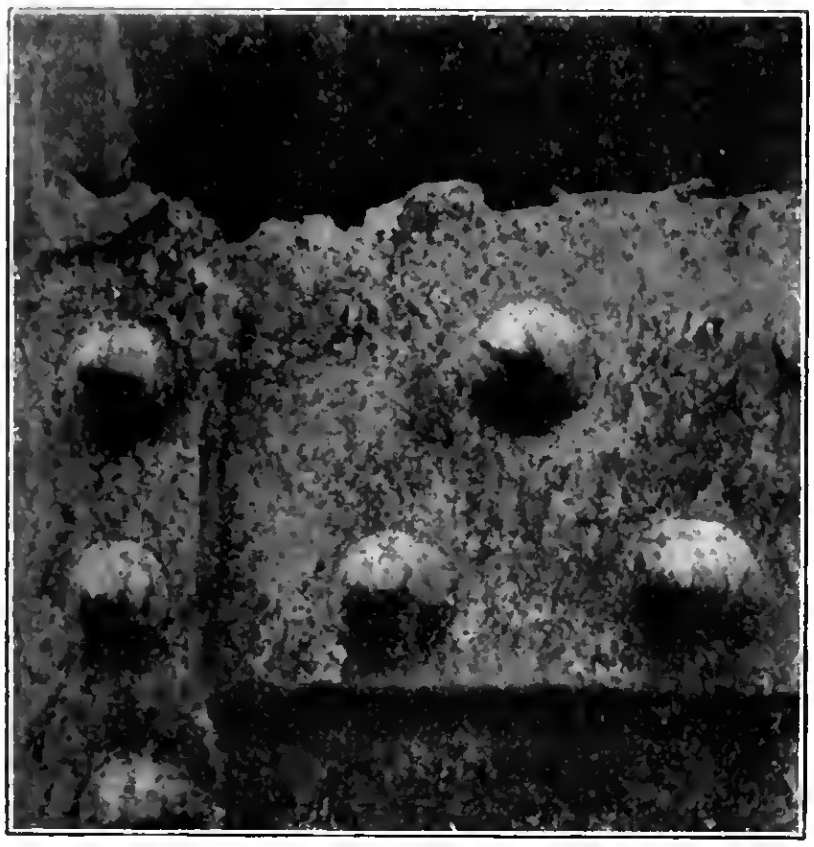
FIG. 2.

There were two boilers at the plant and these were placed side by side in a basement over which there was a one story shed. When the explosion occurred, the barrel-sheet of the boiler was torn off and the remainder — by far the larger part — was hurled up and against the brick wall of an adjoining building, tearing a hole in it and coming to rest in the position shown in the picture above. The barrel-sheet itself was blown up and over the remaining part of the shed and landed in an alley-way between the shed and the next building, as shown in the picture on the opposite page. Just above the third window from the left of the picture the scar may be seen where the plate first struck the brick wall.

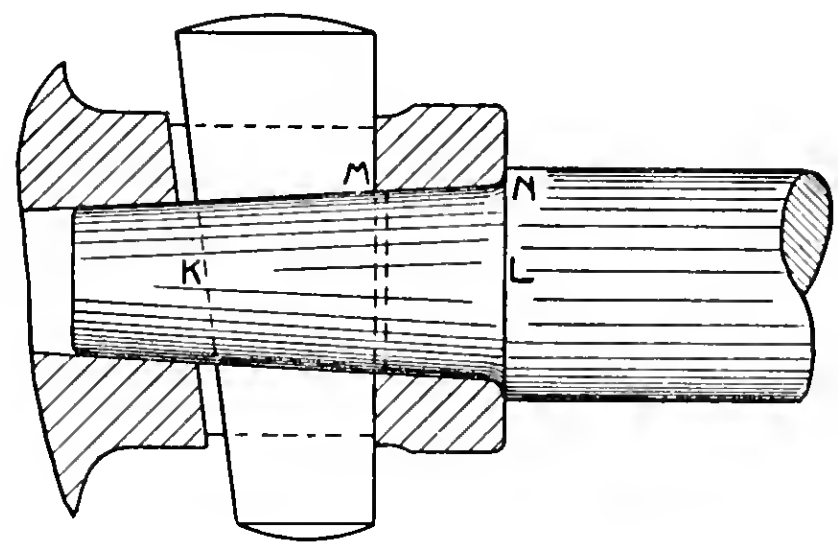
Fig. 1.

A CHAIN is no stronger than its weakest link and in an engine there are so many " links " upon which the safety of the whole structure depends that considerable care must be exercised to see that all parts are in as good condition as circumstances will permit. Engines should be overhauled from time to time and this, very often, calls for a disconnecting of several parts. At times it may be necessary to replace old and worn parts with new. In such replacement a great deal of attention must be paid to securing correct fits or mating of the new parts with the old. In particular, we have in mind the fitting of the piston rod into the crosshead which, when these two are keyed or gibbed together, is a job calling for no small degree of skill.

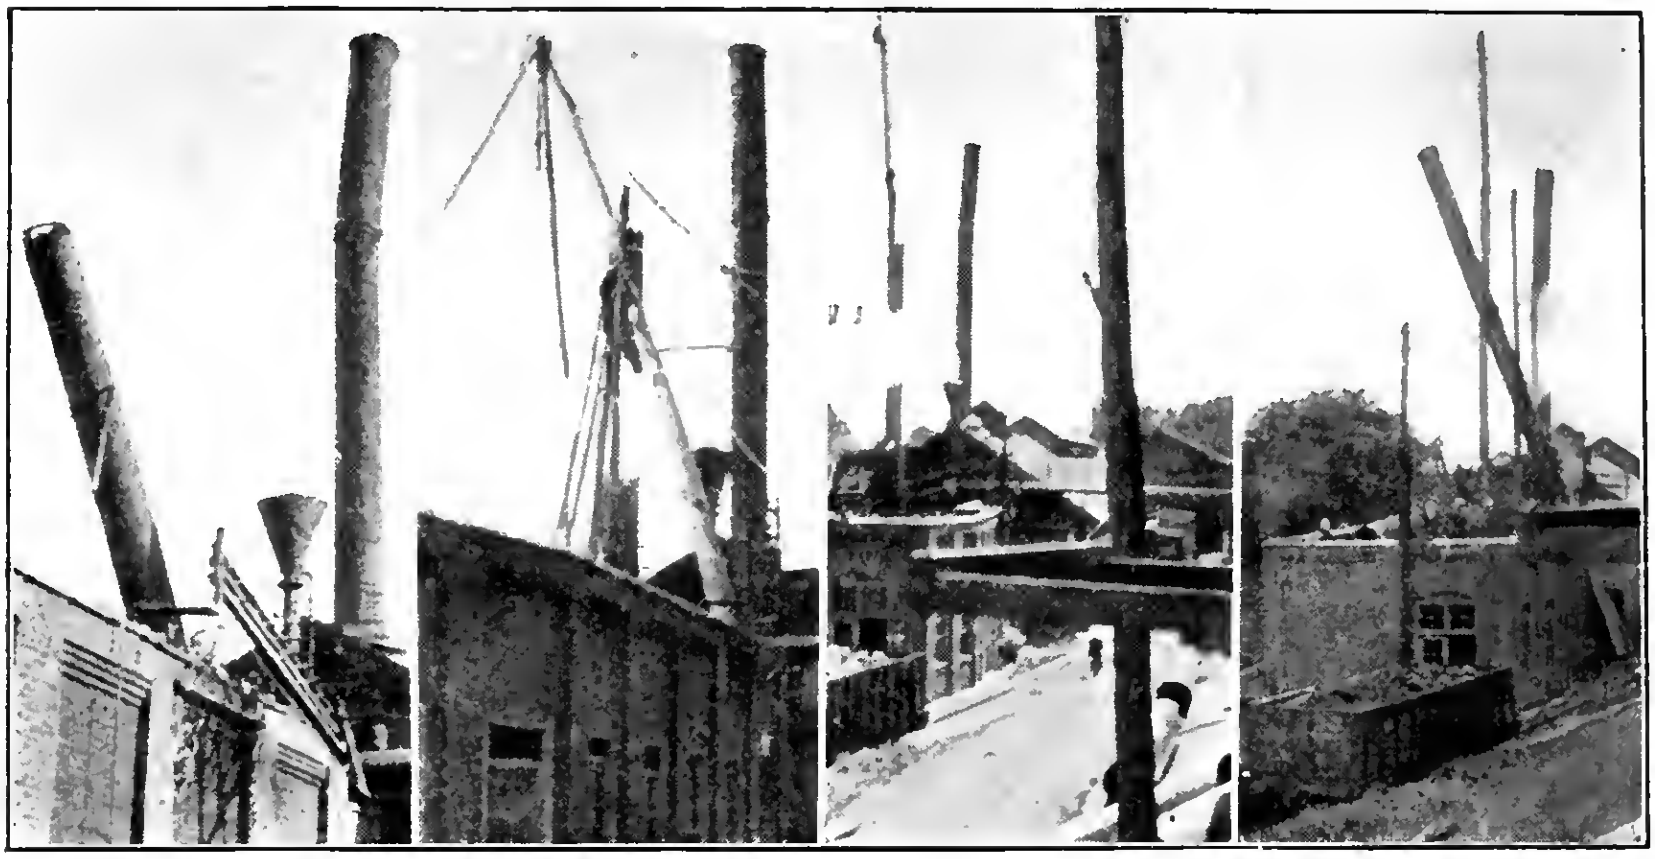
a. b. c. d.

a. STACKS WRECKED BY WIND.
b. GIN POLE BEING ERECTED.
c. GIN POLE IN PLACE.
d. NEW STACK GOING UP.

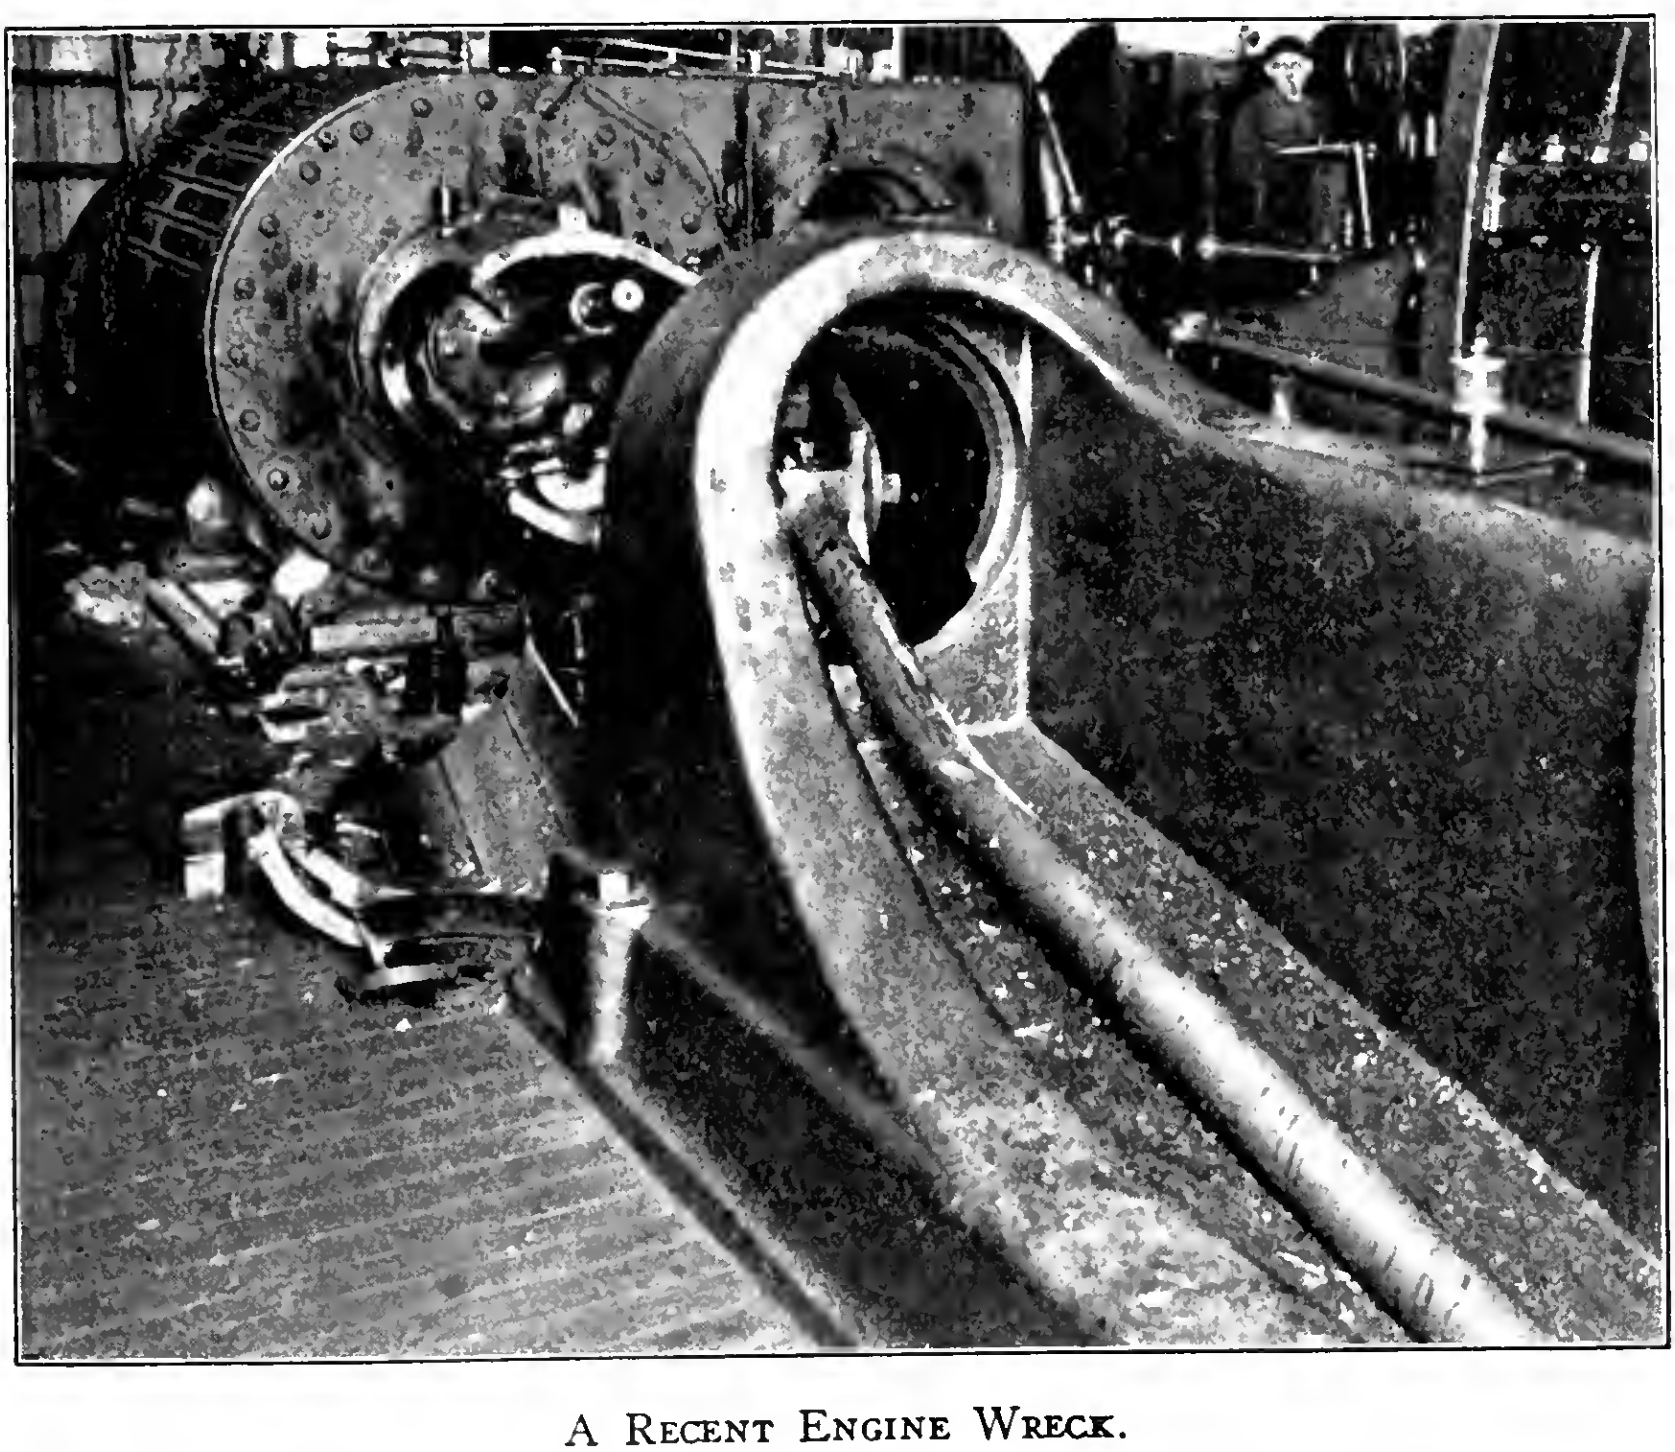
A RECENT ENGINE WRECK.

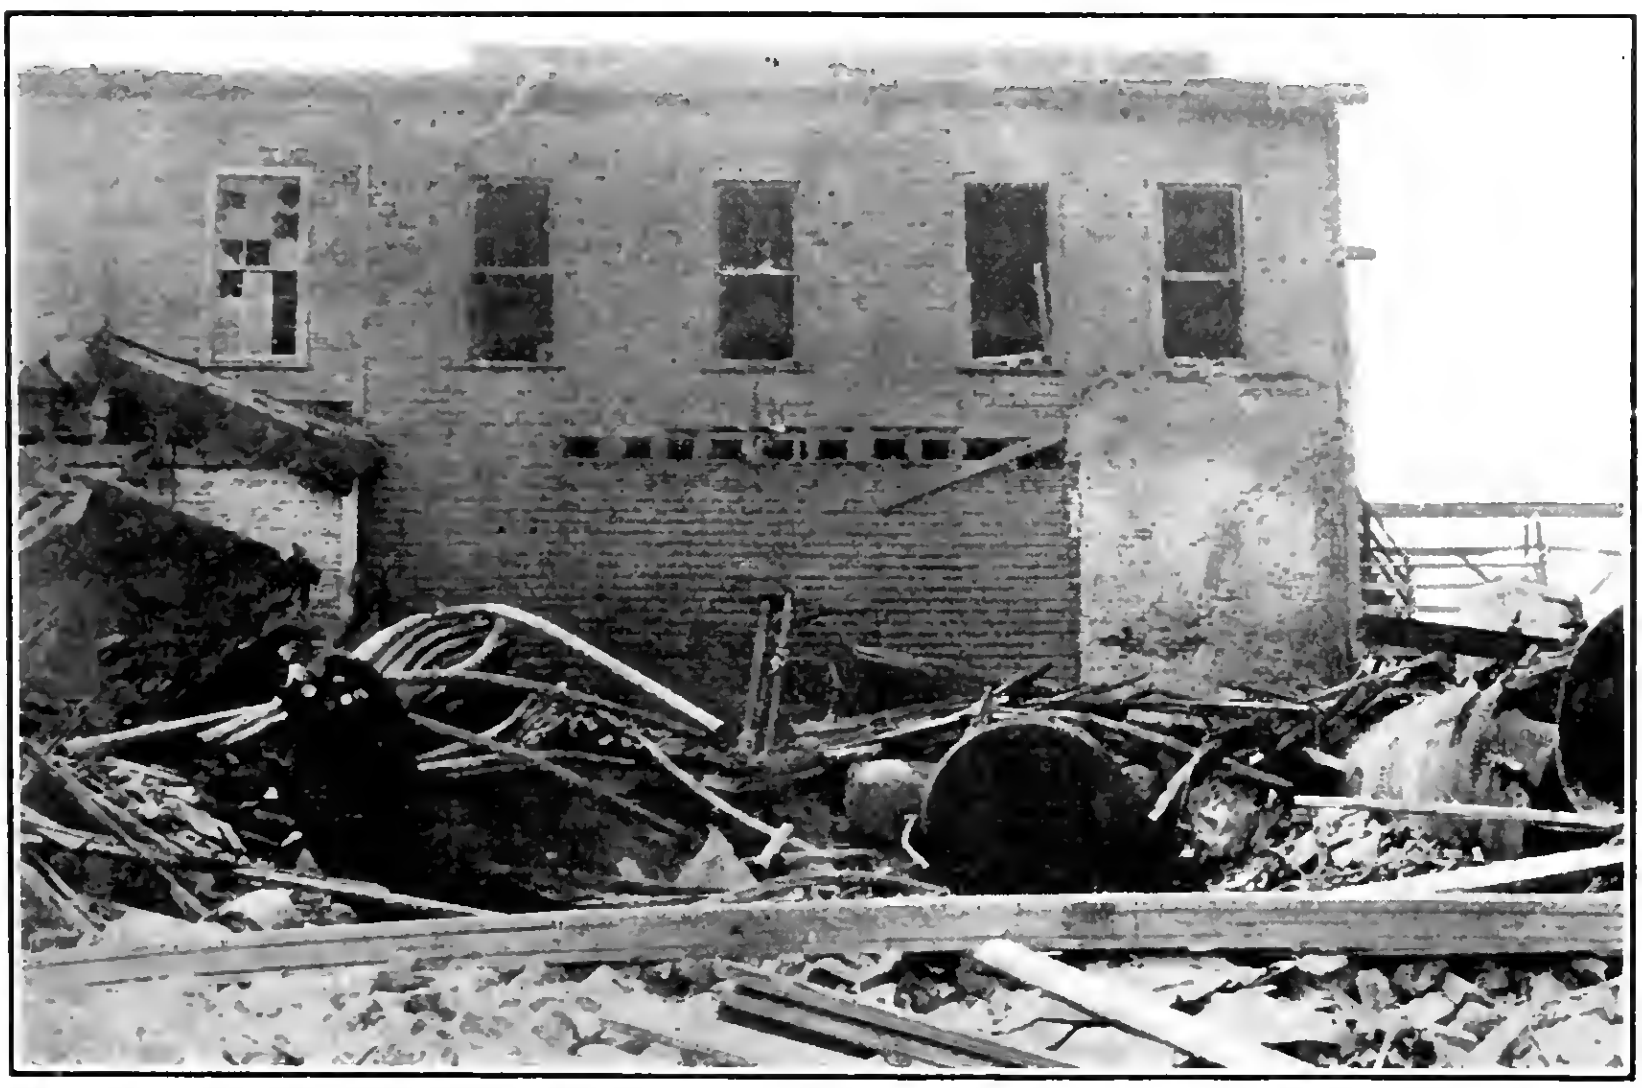
BOILER EXPLOSION AT A LOUISIANA COTTON OIL MILL.

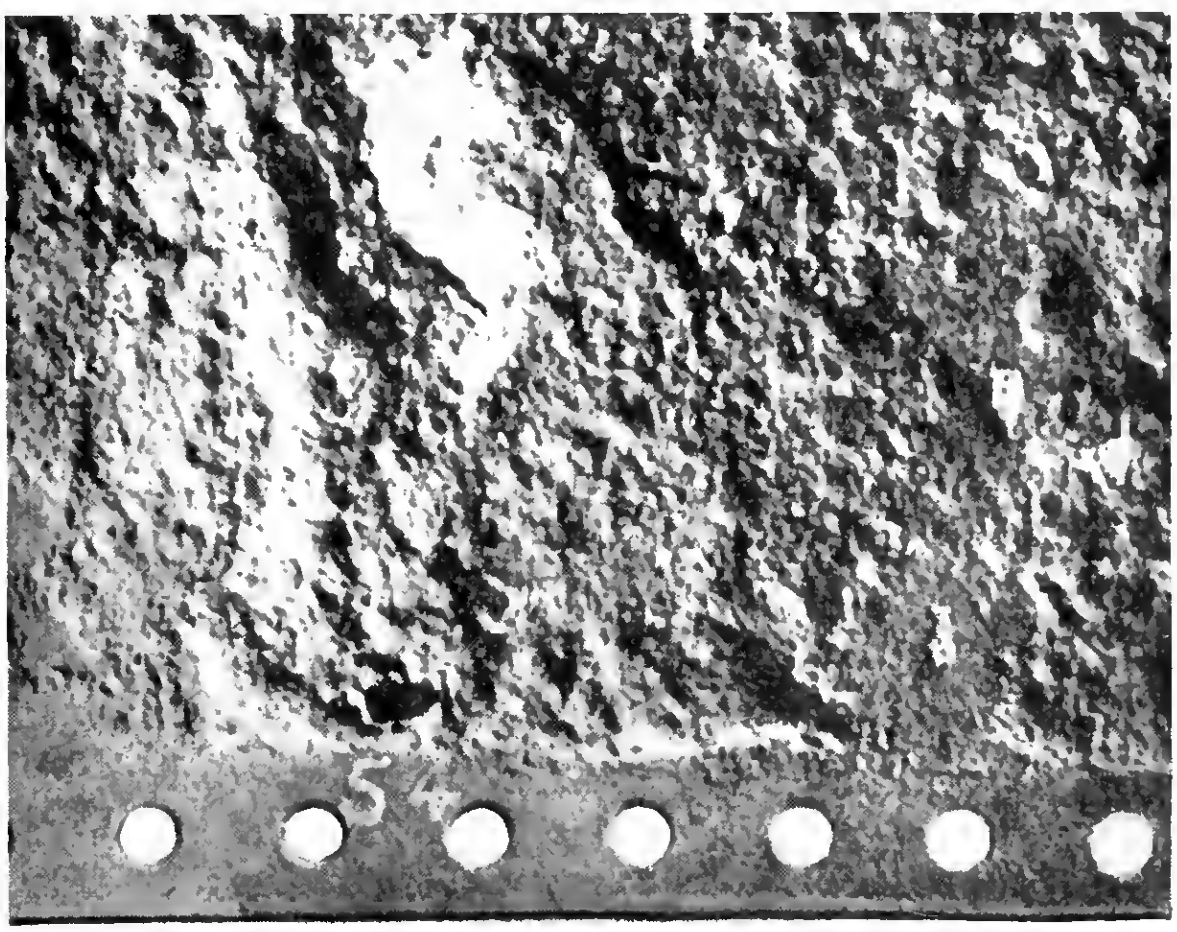
A Corroded Boiler Plate.

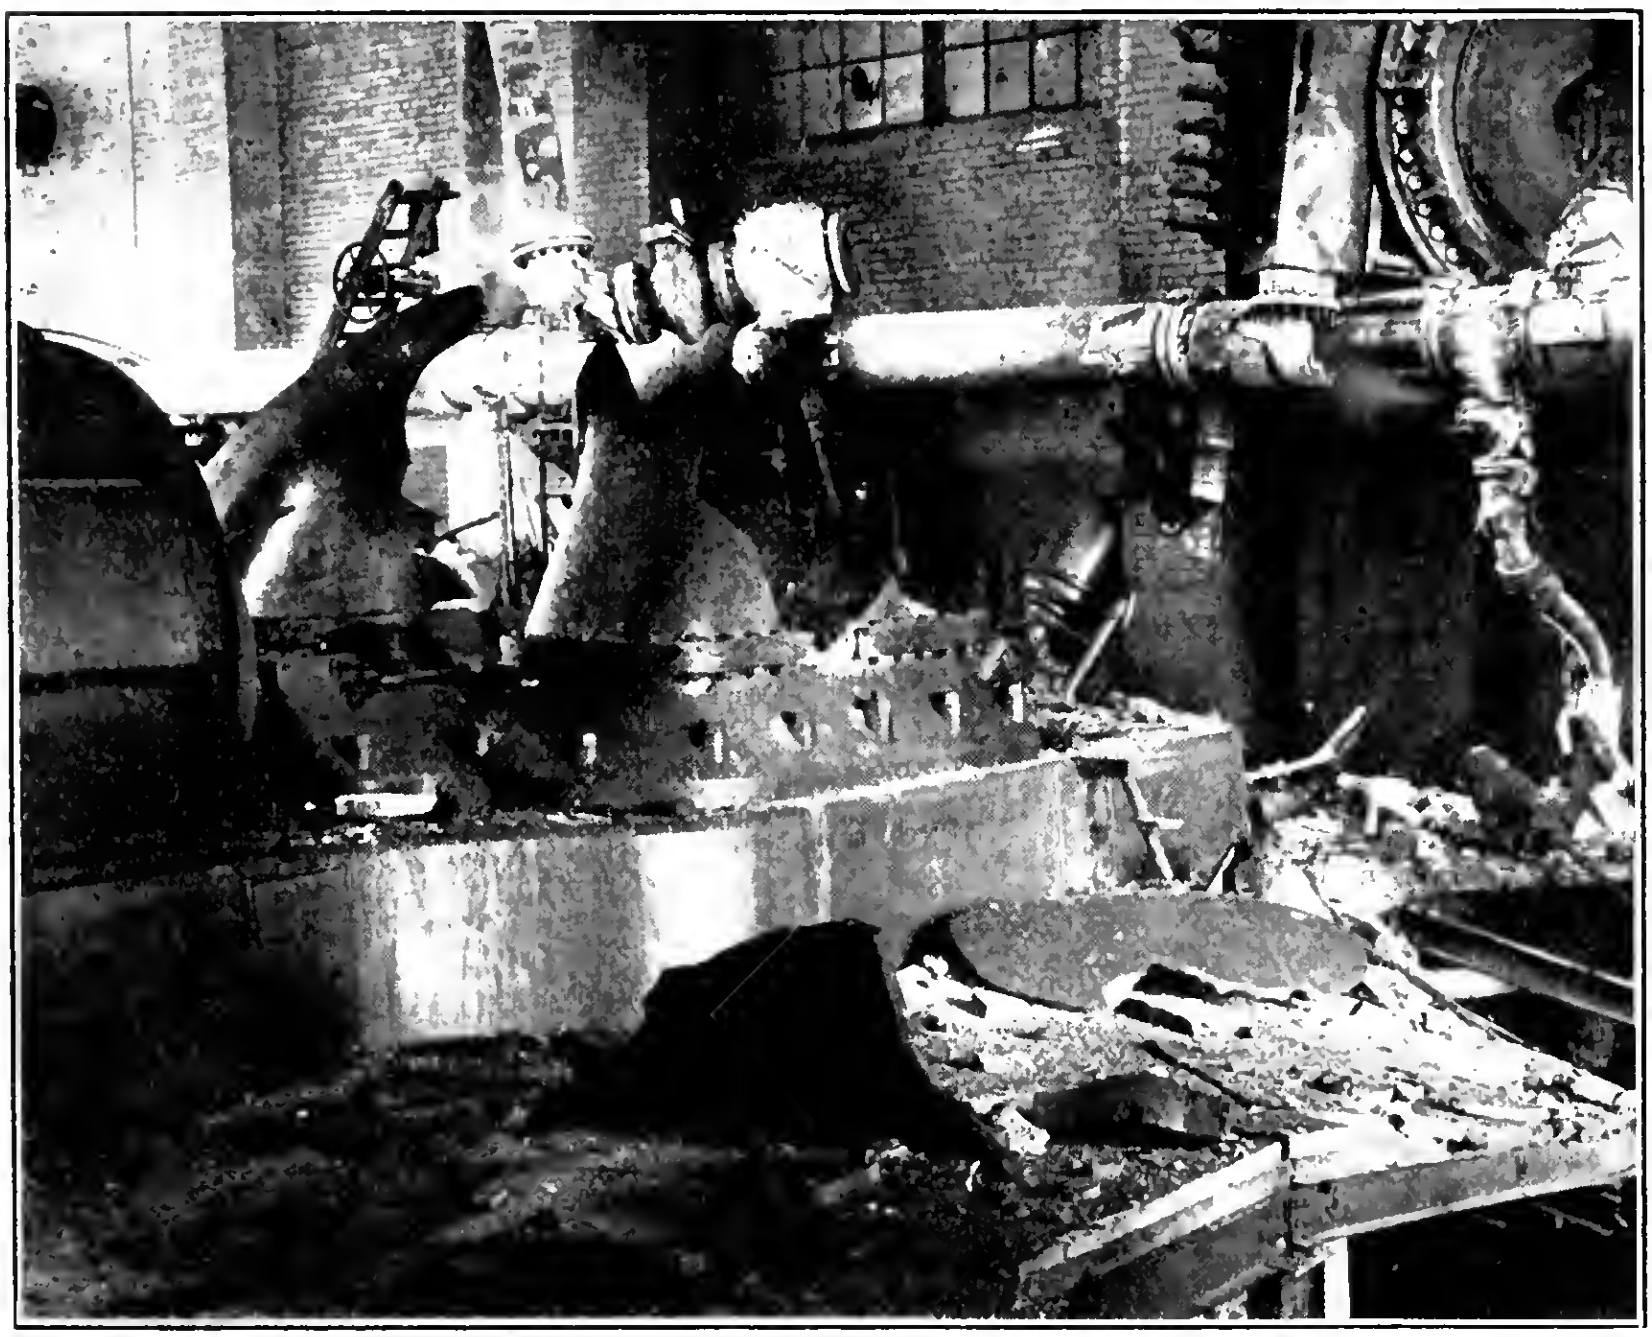
STEAM TURBINE EXPLOSION AT INDIANAPOLIS, IND.

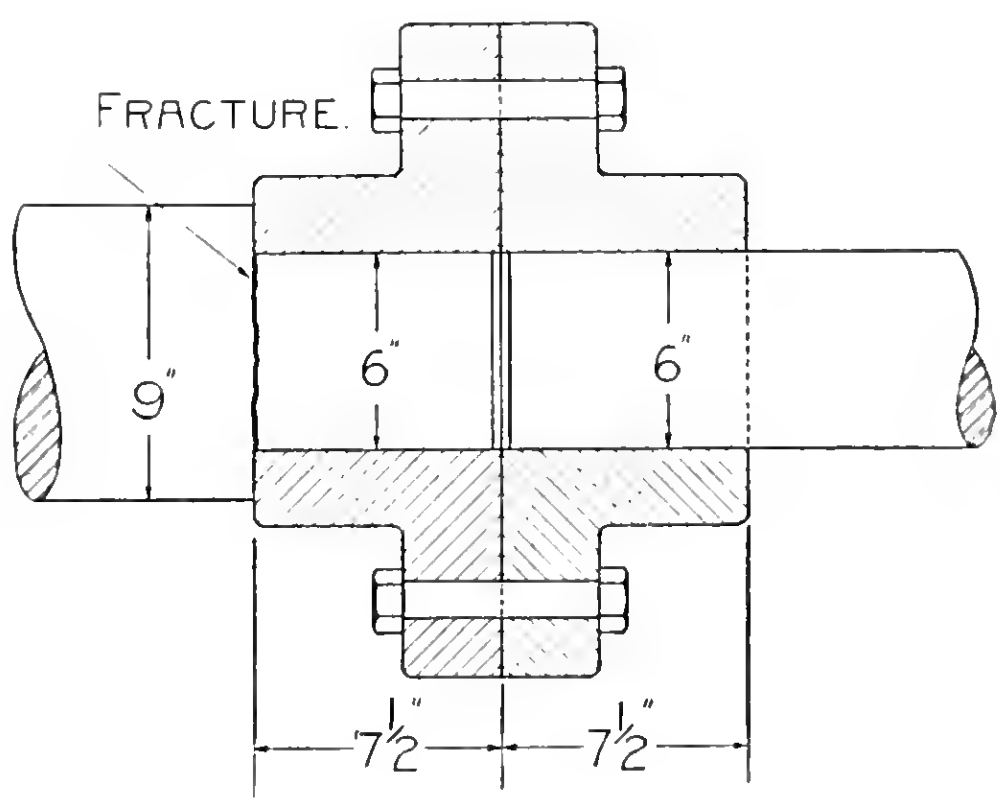
Fig. 1.

A case recently investigated by the writer was that of a broken shaft 9 inches in diameter in bearings and turned down to 6 inches diameter at one end for a length of 7½ inches. On this reduced section there was keyed a cast iron coupling to which was secured, by a number of bolts, a companion coupling which was keyed onto a 6 inch shaft of considerable length, used for transmitting power by means of a number of belt pulleys. The engine referred to is rated at 250 h. p. and was said to be developing 275 h. p. at the time the shaft broke. To illustrate the point of weakness where the fracture took place you are referred to Fig. 1 in which you will note that the 9 inch section of the shaft terminates with a sharp shoulder where it meets the part reduced to 6 inches in diameter. The distance between the surface of the 9 inch section and the surface of the

6 inch section was $1\frac{1}{2}$ inches and the stresses which occurred in the cross sectional area of the 9 inch part are much less per unit of area than in that of the 6 inch diameter part because the energy transmitted is the same at all sections. In other words, we have an increase in torsional stresses at the point under discussion, which may result in the breaking down of the crystals in the material if its elastic limit is exceeded by a repetition of alternate stresses, bringing about what is known as a progressive failure.

There are three other engines at the plant where this accident took place, the shafts of which are similar to the one that broke, and it will be seen by referring to Fig. 1 that the point where the rupture took place is inaccessible for examination. Consequently a means of determining the serviceability of the shafts of the other engines at the point under suspicion had to be devised. Before doing this it had to be taken into consideration that if a flaw was found necessitating repairs similar to those outlined, no part of the limited length of the shaft from the outer side of the outboard bearing to the point where the diameters change could be sacrificed, and after considerable thought it was determined to shorten up the over-all length of the couplings by turning off the faces of the hubs 1¼ inches and forming a fillet having a radius of ⅝ inches by undercutting the 9 inch diameter section of shaft as shown in Fig. 3. This work was done with the shaft in place, an attachment for holding properly shaped tools being bolted onto the engine bed and the engine shaft allowed to revolve under its own power the required number of turns per minute to give a proper machine finish to the surfaces operated on. After this work was done a careful examination was made by means of a powerful glass and to the satisfaction of all parties interested no indication of fracture was in evidence. A further test was made by thoroughly saturating the part examined with gasolene, then drying the surfaces and coating them with a light covering of whitewash. After this had dried the engine was placed in service for a time, then shut down and careful examination of the whitened surfaces made to detect any discoloration, for had there been any fracture, which could not be seen, the gasolene having great searching properties would have entered the crack and remained therein while the shaft was in a static condition, but would have been driven to the whitened surfaces when the shaft was in rotation, thus indicating the crack. The absence of any such discoloration proved conclusively that the shafts were serviceable.

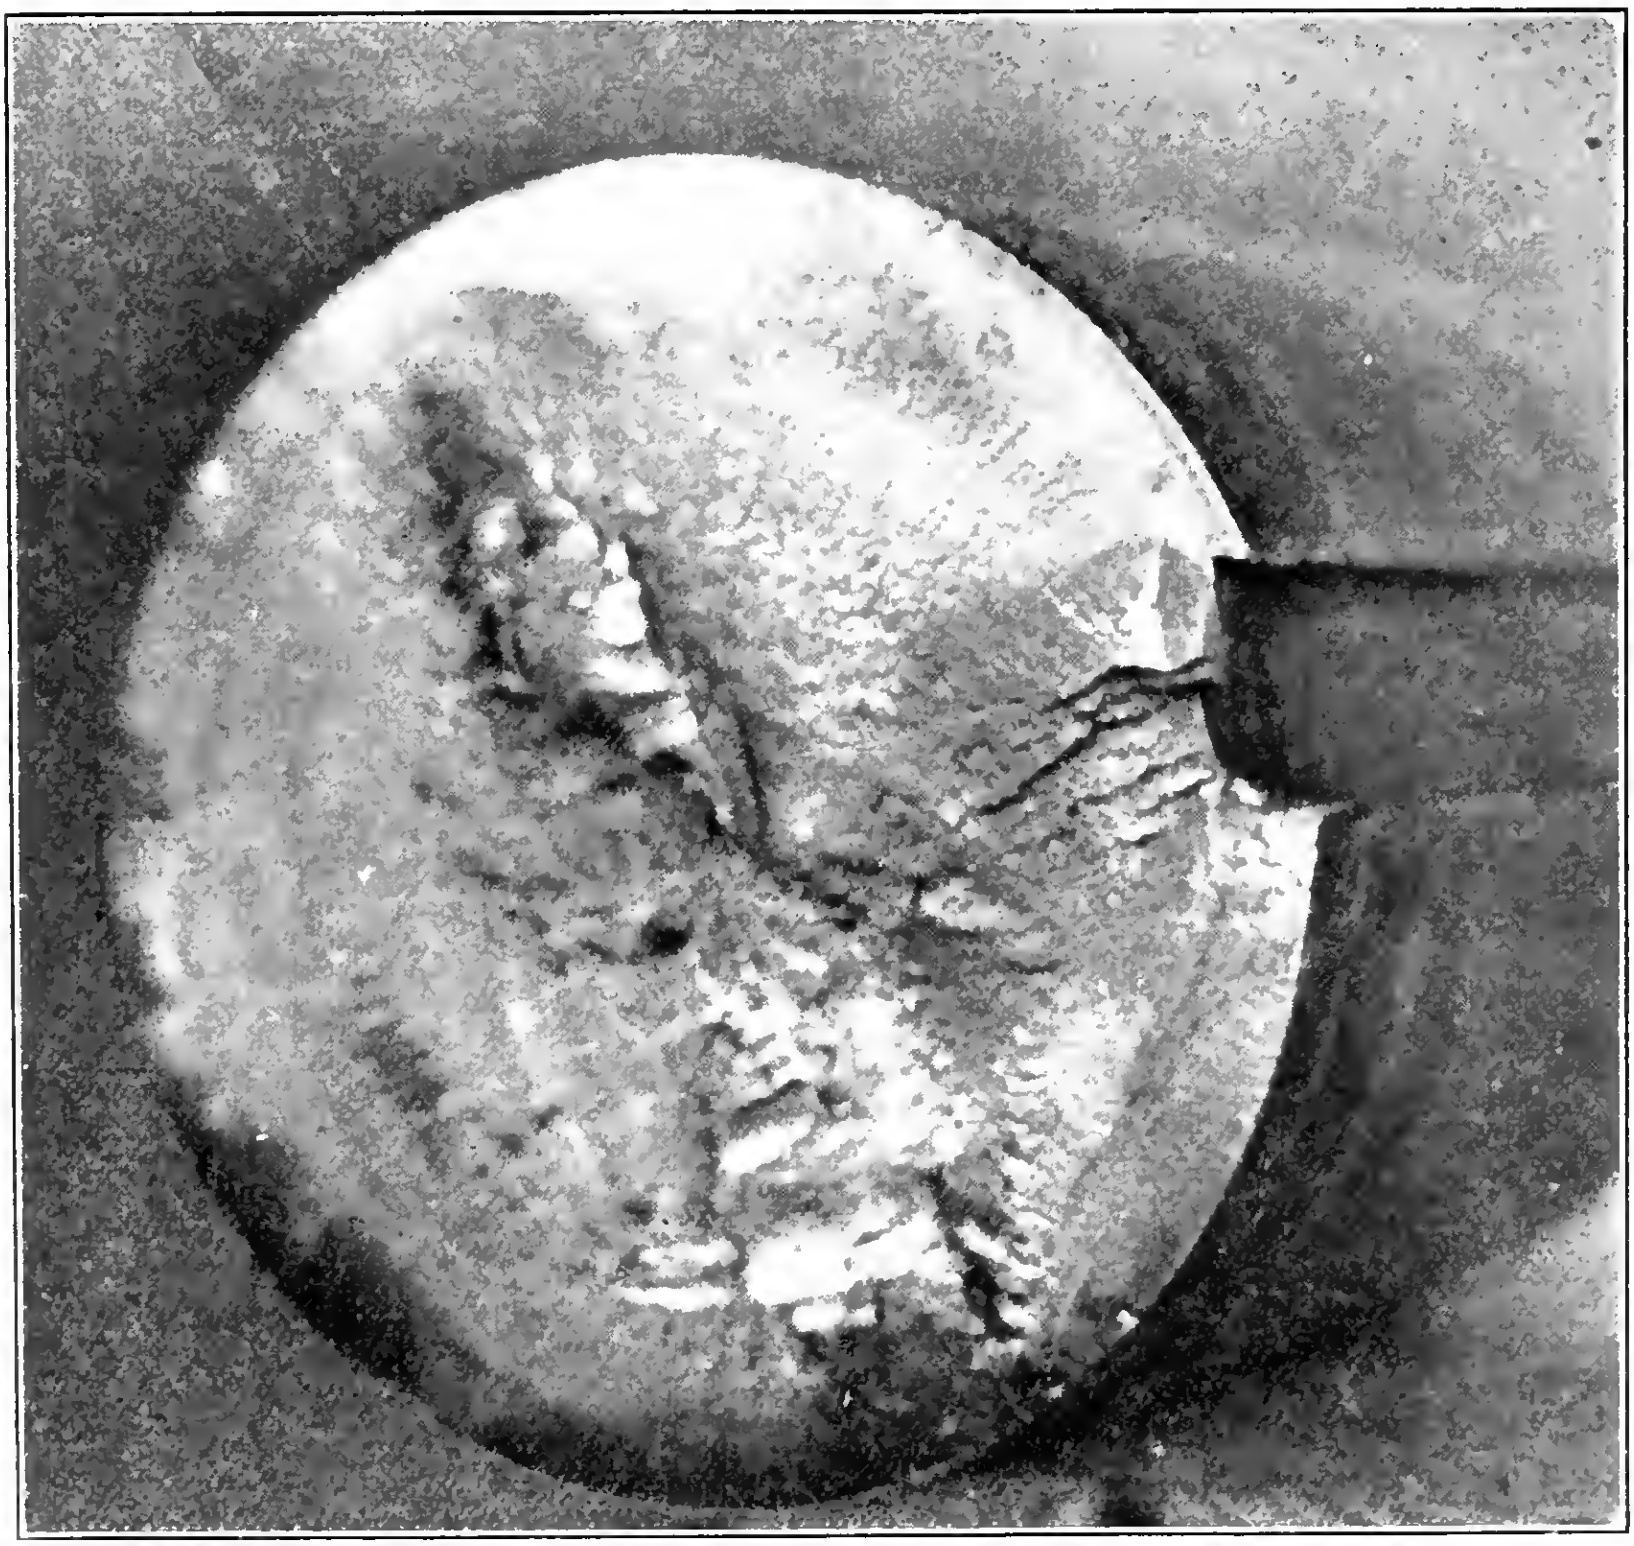
FRACTURE OF ENGINE SHAFT.

In view of the weakened condition of the coupling the service required from the engine was reduced about one-third until a few days later when permanent repairs were made by fitting and properly shrinking and keying a forged steel coupling 5 inches thick on the shaft end.
