# The Locomotive

THE HARTFORD STEAM BOILER
INSPECTION AND INSURANCE CO.

VOL. XXXIV.

VOL. XXXIV. HARTFORD, CONN., JANUARY, 1922. No. 1.

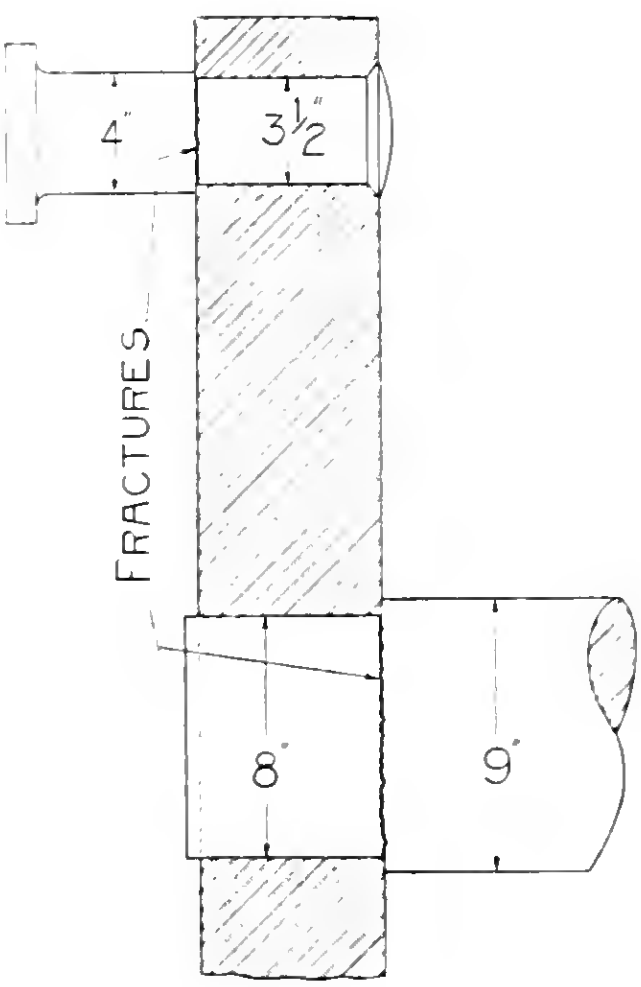
FIGURE 5.

Turning now to the consideration of a crank of the disc pattern, in which the failure of the crank pin or shaft frequently causes the wrecking of the entire engine, attention is called to the changes in diameter of the pin and shaft as shown in Fig. 5. In all cases where accidents of this kind have been noted by the writer he has found that the designer had overlooked the vital necessity of providing a fillet.

The crank pin is subject not only to slight torsional stresses, but also at the point where the diameter changes, it is subject to shearing and bending stresses. This stress is more pronounced when the pin passes through the two dead centers and is present to some extent regardless of the amount of compression provided in the cylinder.

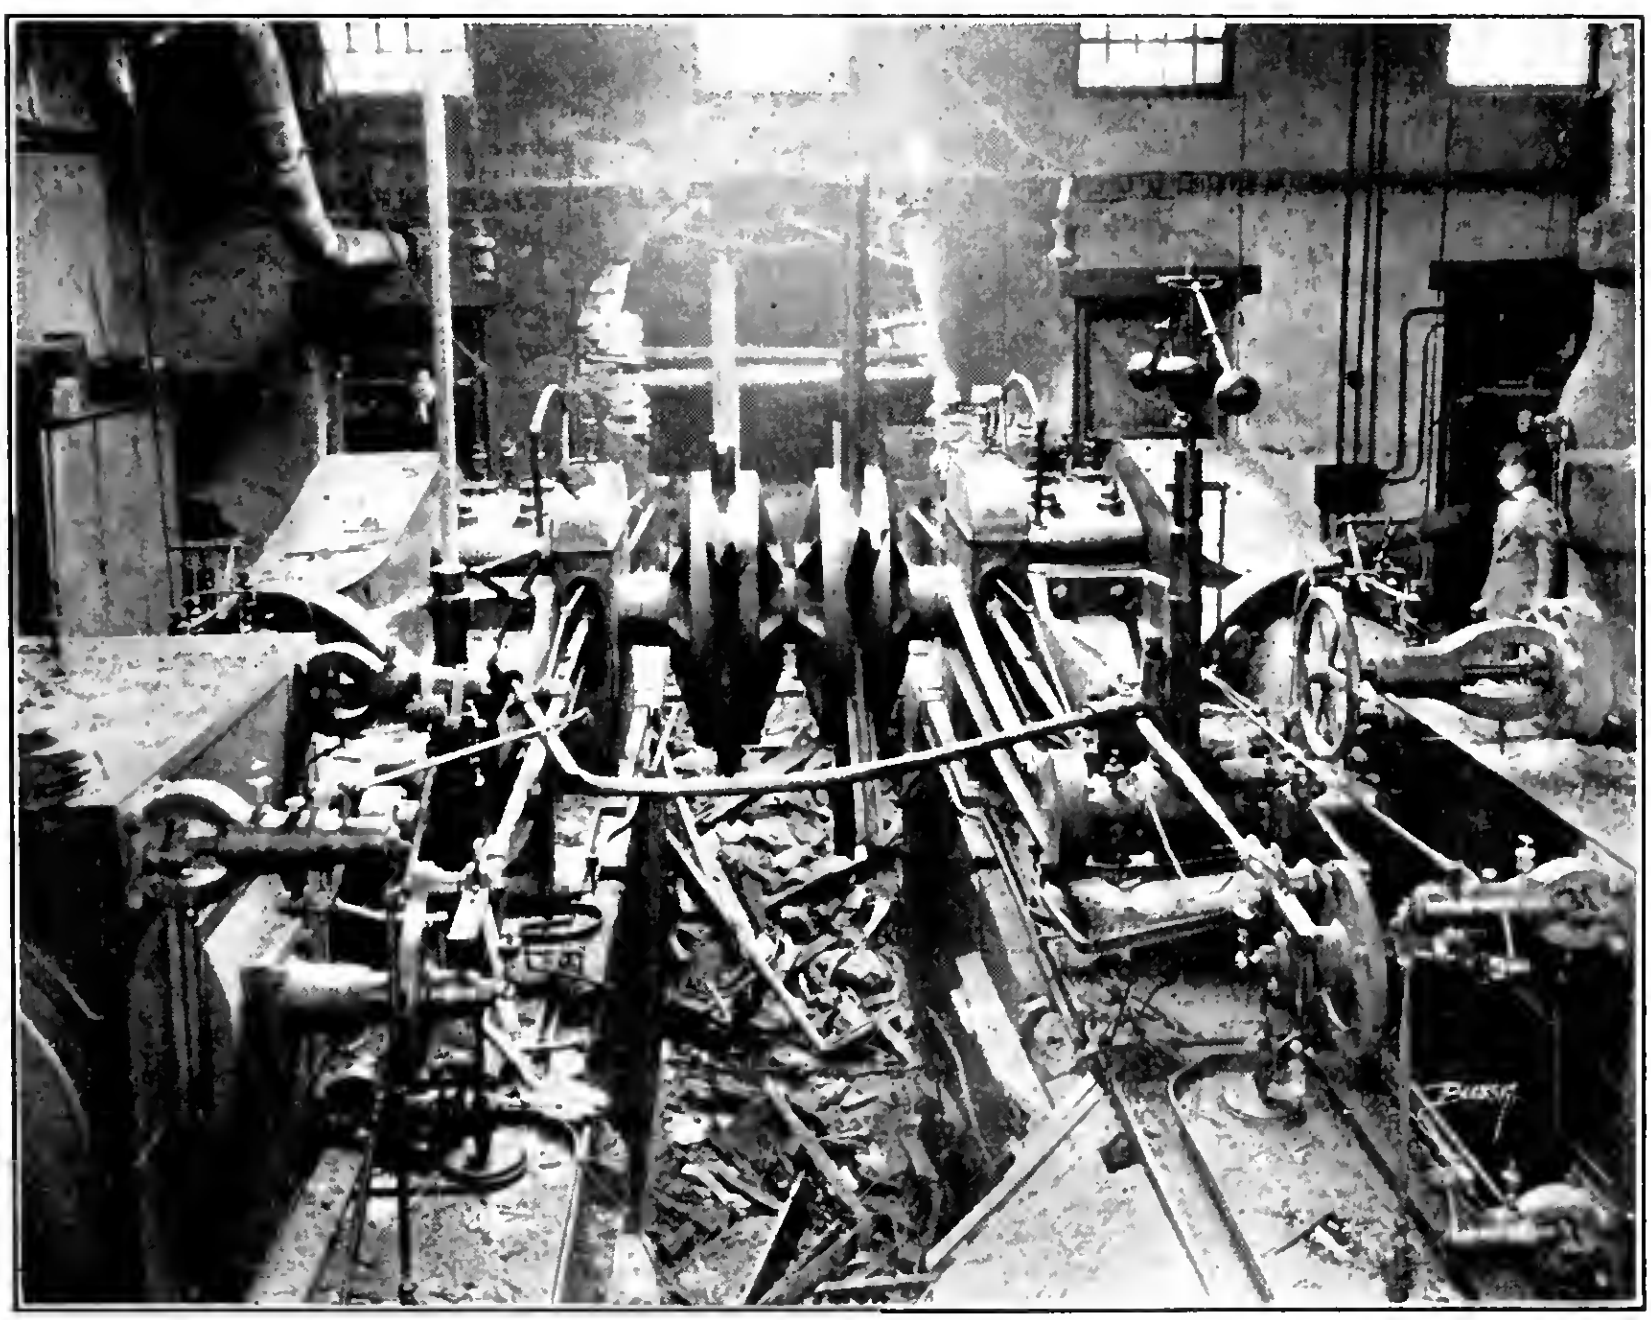
FLYWHEEL EXPLOSION AT A FIBRE MILL.

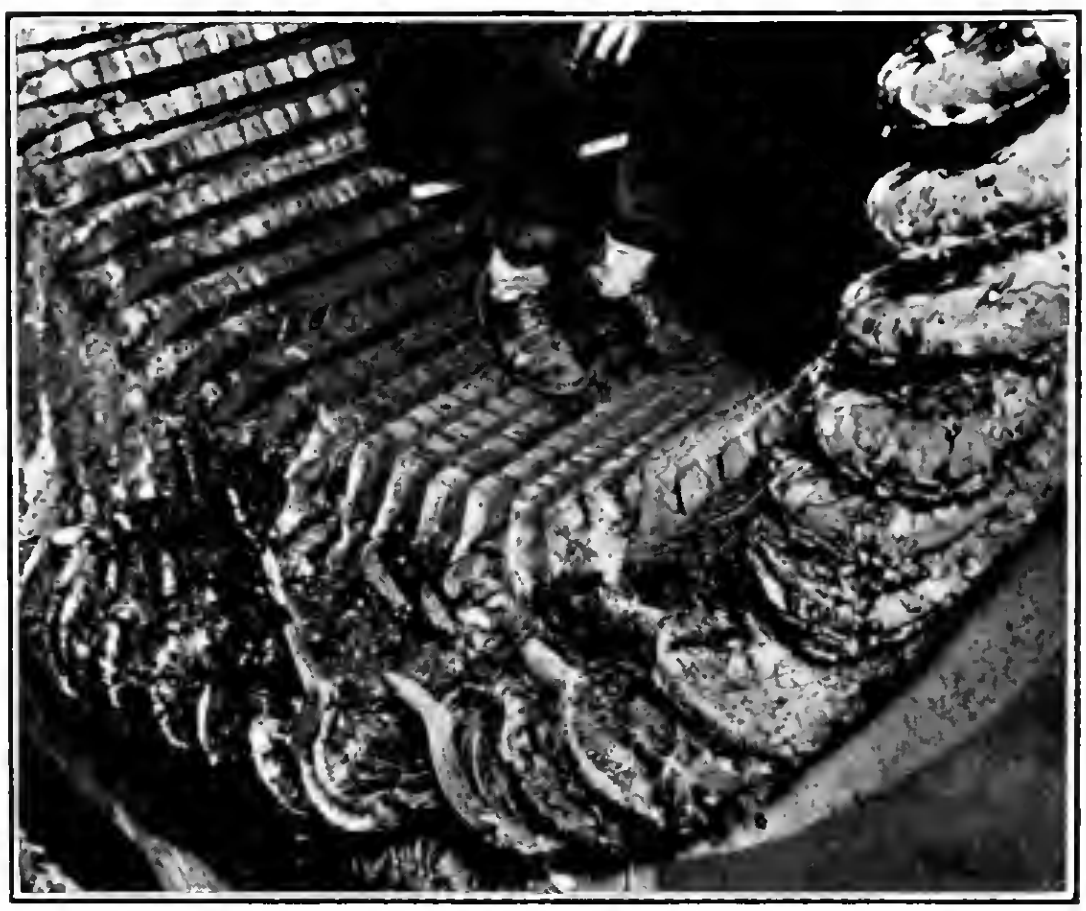
Burnout of the Stator Winding in a Large Turbo-Generator.

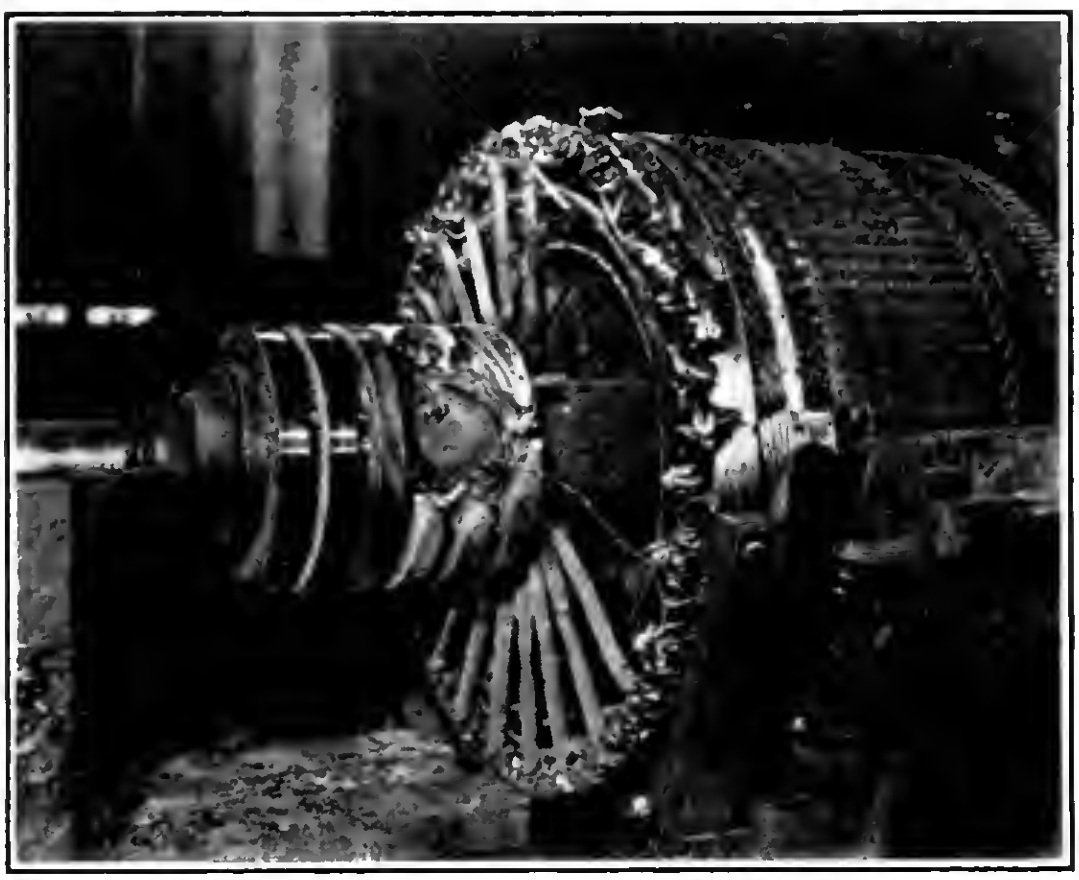
Armature Burnout of Rotary Convertor.

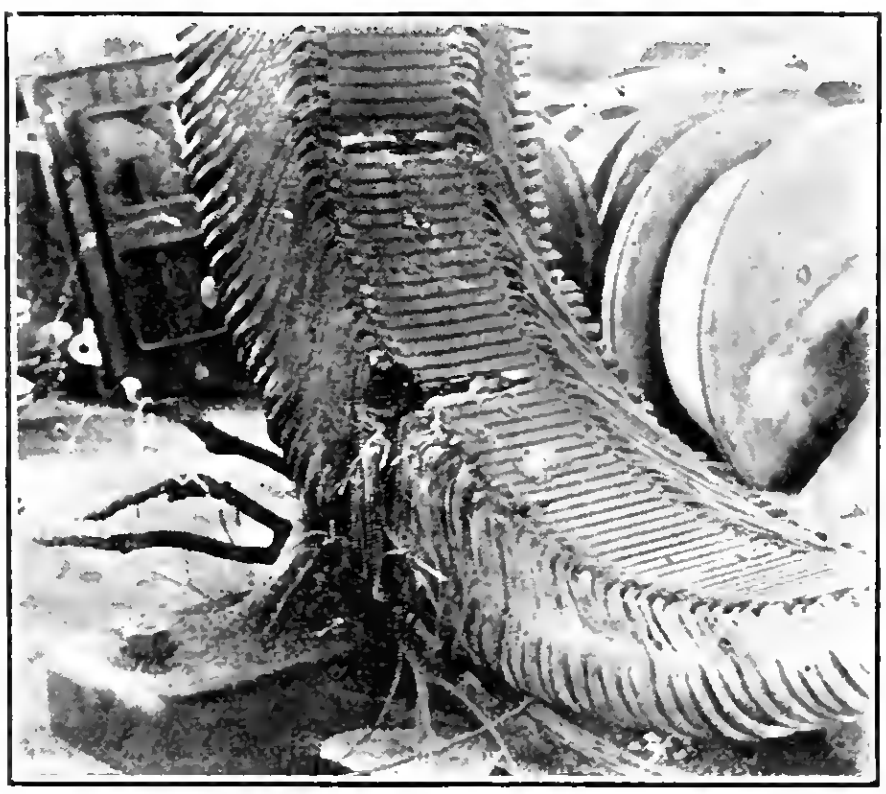
Burnout of Armature of Rotary Convertor.

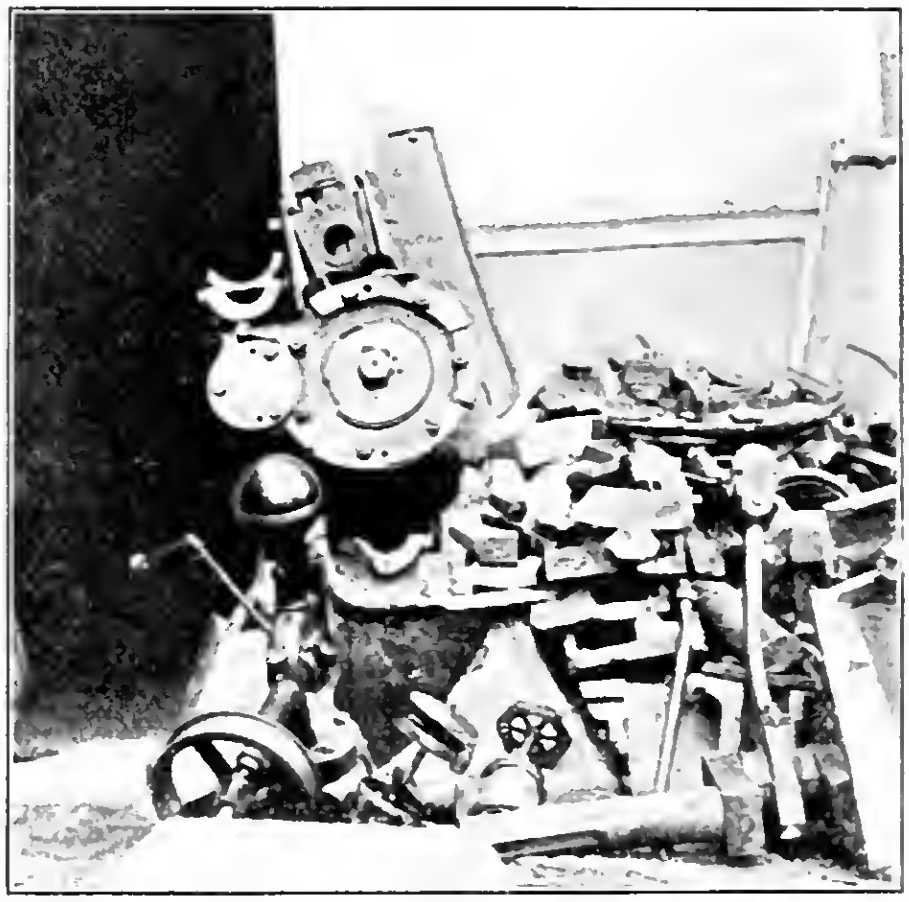
REMAINS OF WRECKED ENGINE.

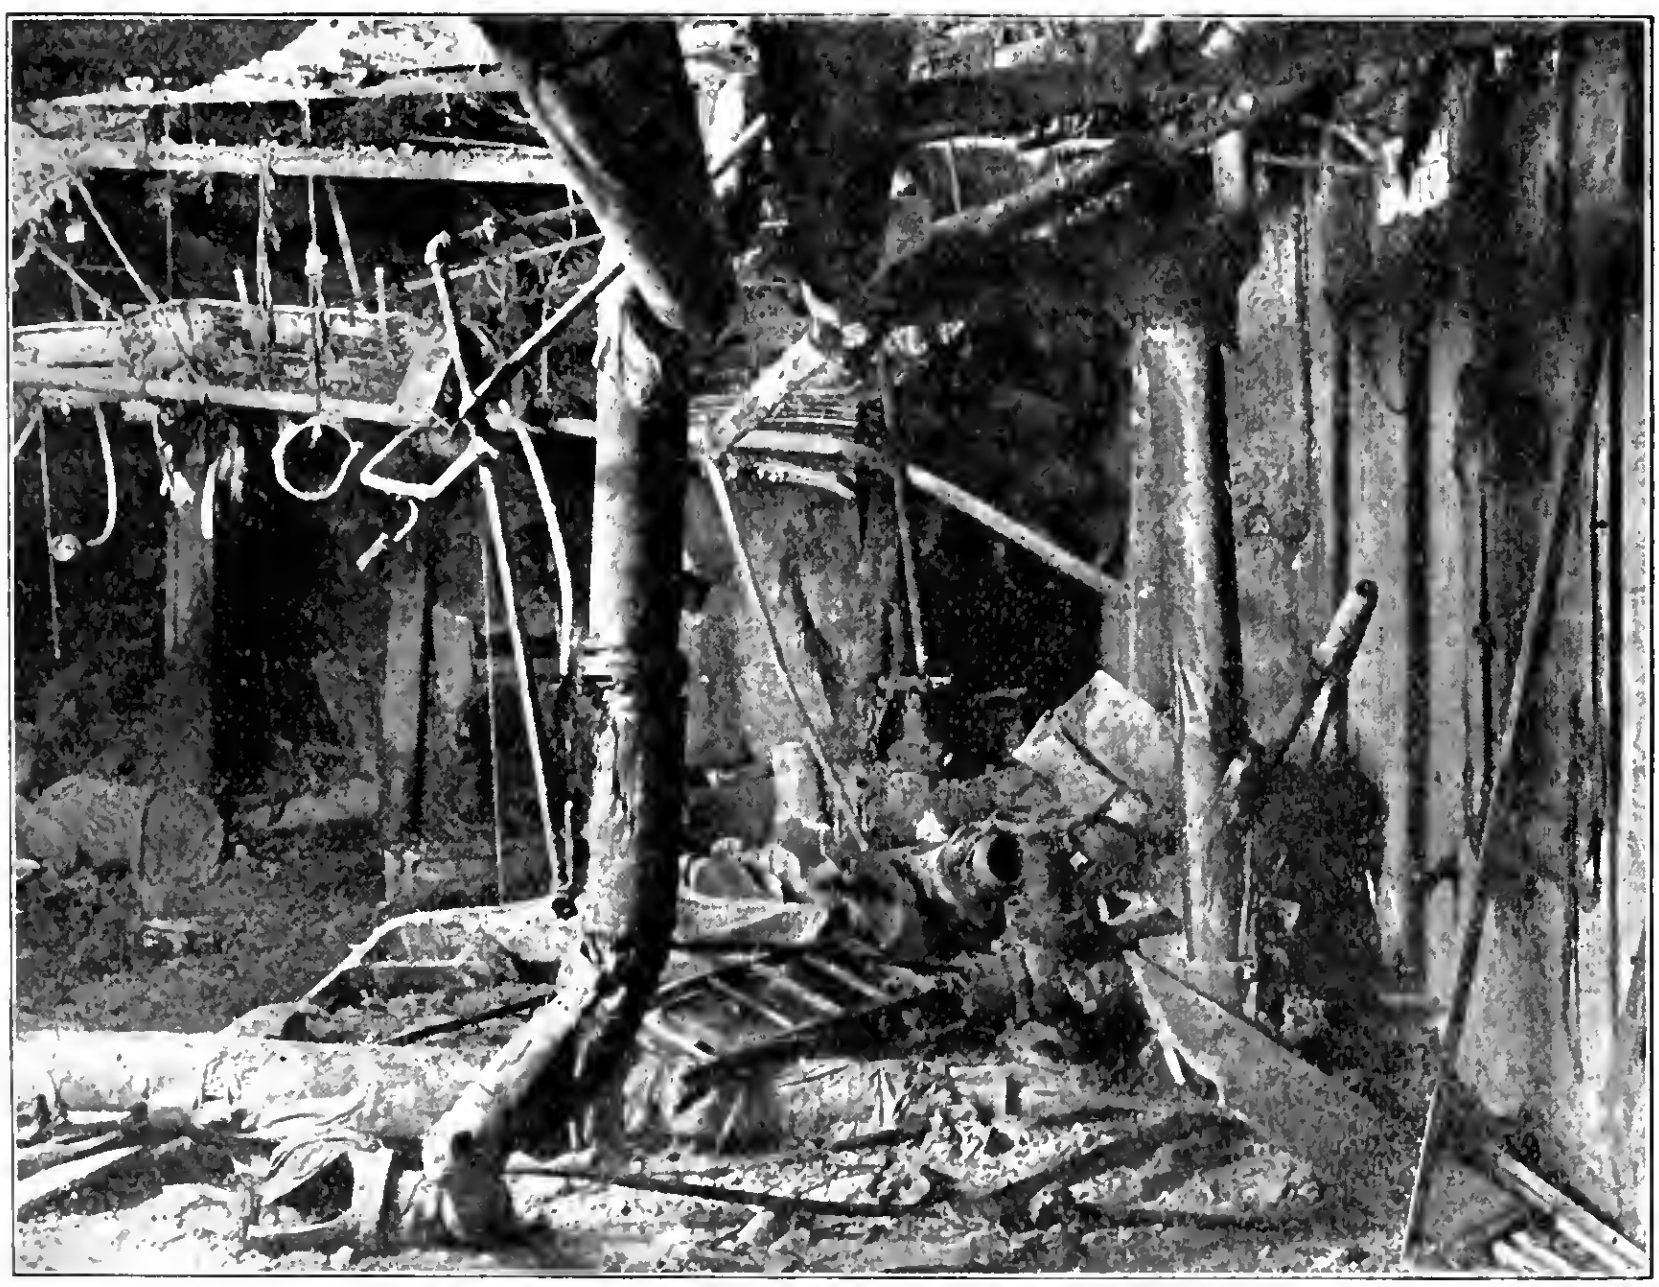
HEATING BOILER EXPLOSION AT ST. LOUIS.

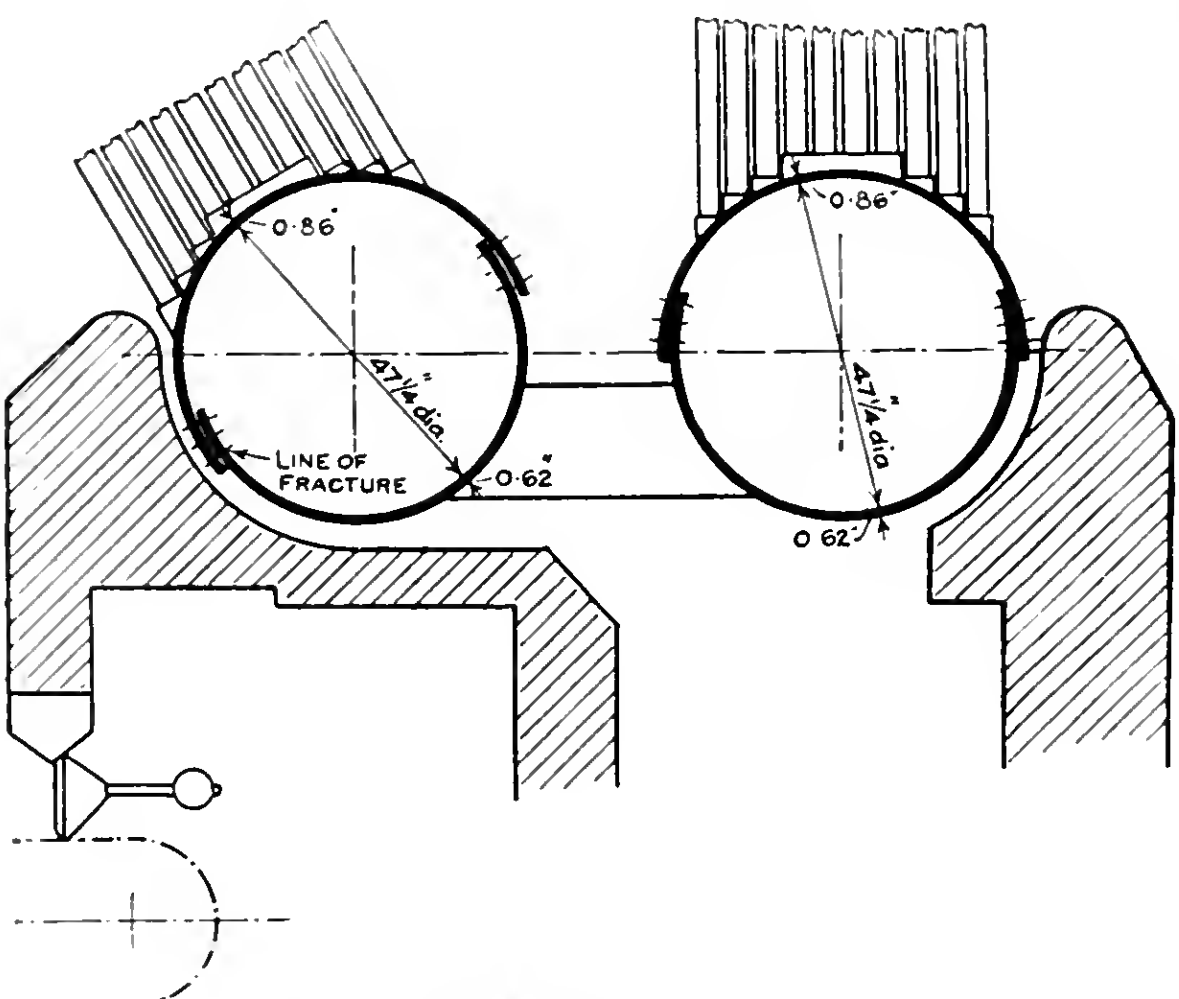
Lower Drums of Garbe Type Boiler.

On the 9th of March, 1920, a little after eight o'clock in the morning, one of these boilers exploded with disastrous violence, killing 27 people and injuring 14 others.

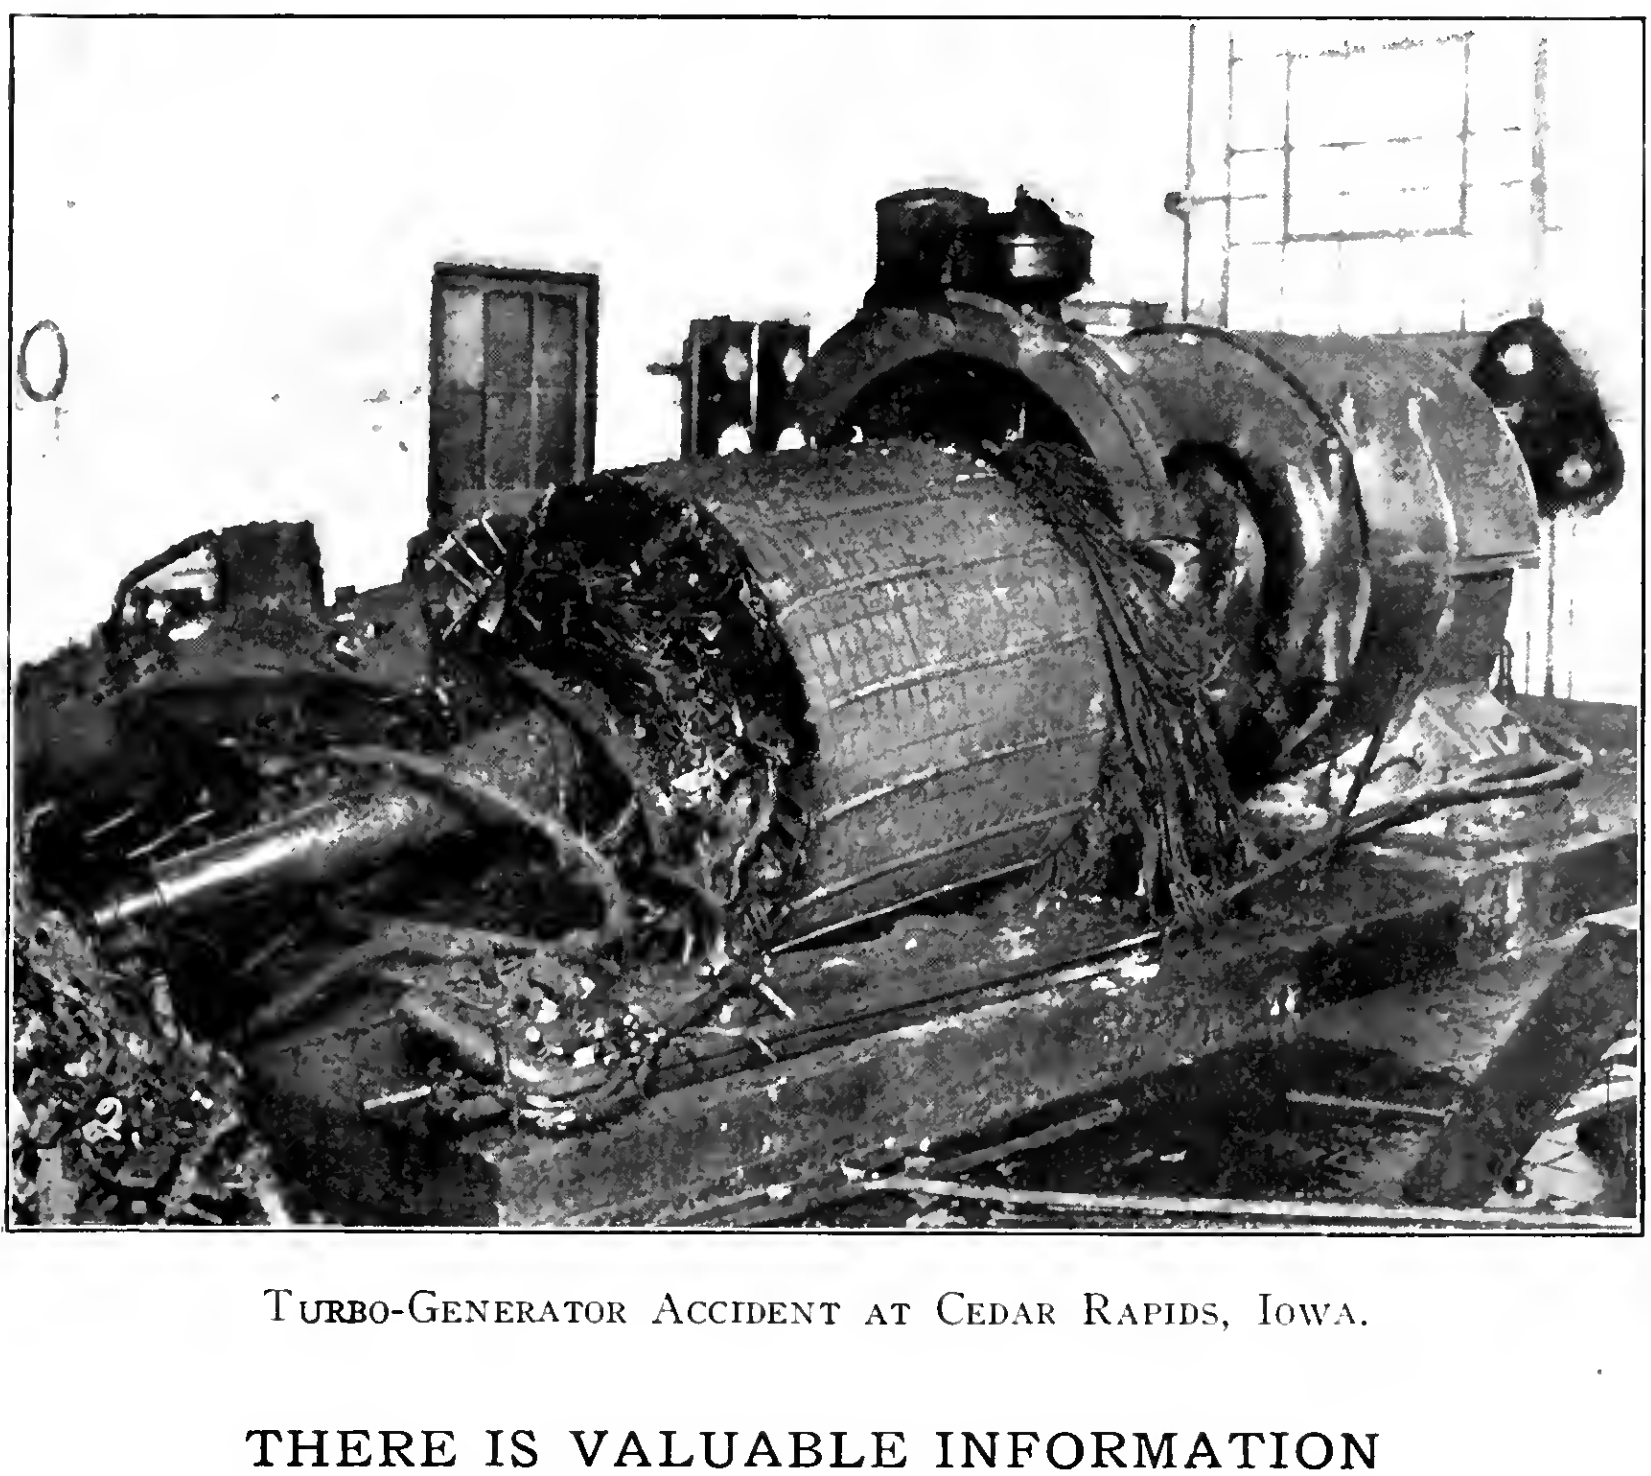
Turbo-Generator Accident at Cedar Rapids, Iowa.

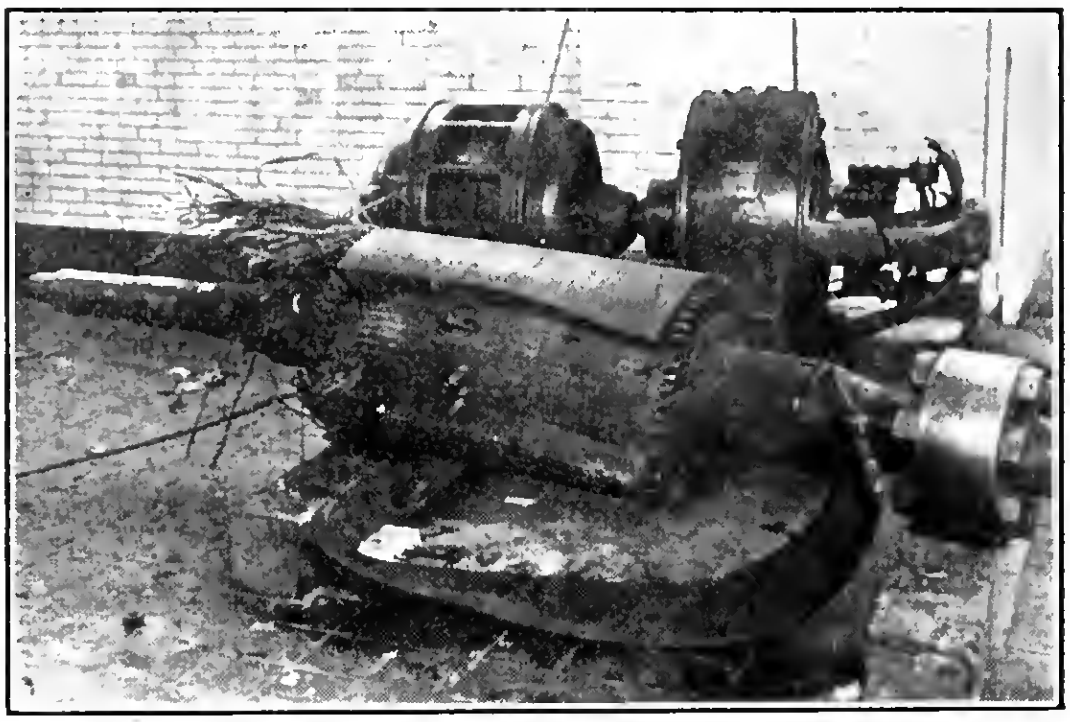
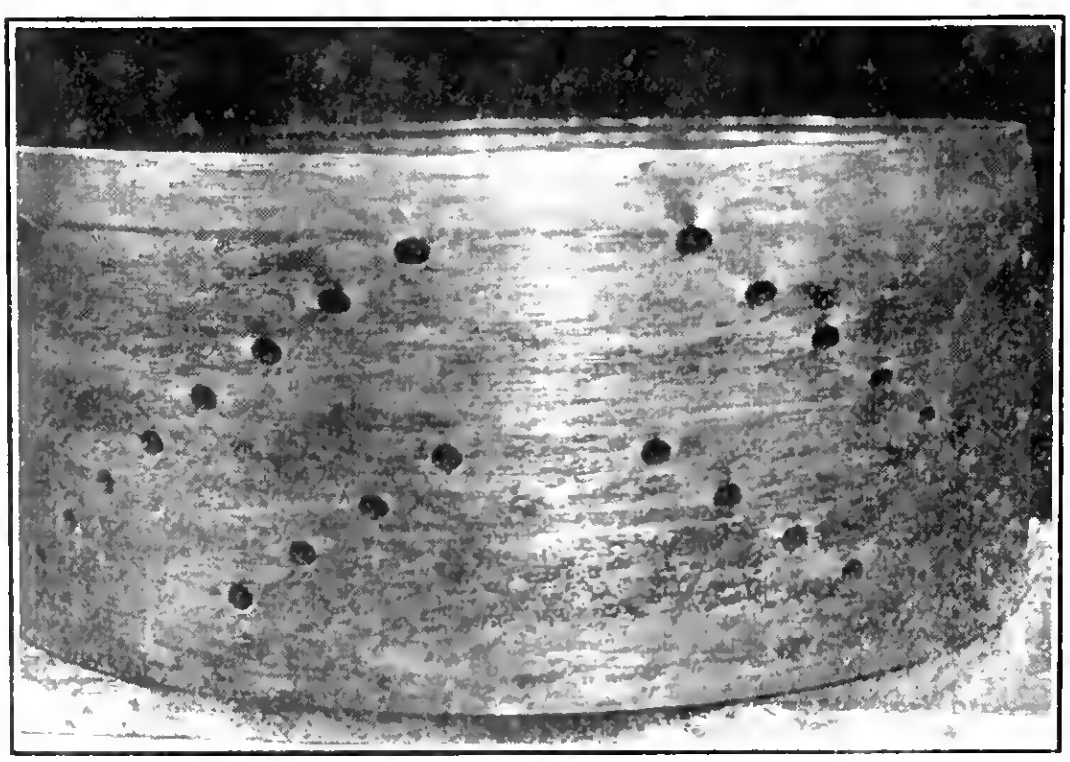
Fig. 1.

A SERIOUS accident occurred at the plant of Penick & Ford, Ltd., at Cedar Rapids, Iowa, February 15, 1924, when a 2,000 k.w. turbo-generator ran away. The entire unit was wrecked and, including damage to the building and to other apparatus, the total property loss amounted to $35,000, which was covered by a Hartford policy.

The direct cause of the accident is not clear, but the evidence indicates that in some way the machine lost its electrical load. An examination of the wrecked generator failed to show any signs of burning or other electrical disturbance, it apparently being electrically dead before disruption occurred. Evidence of overspeed, however was apparent and indicated that, when the turbine lost its load, both the governor and emergency stop failed to function quickly enough and the machine "ran away," although a recent inspection had indicated that these valves were functioning properly.

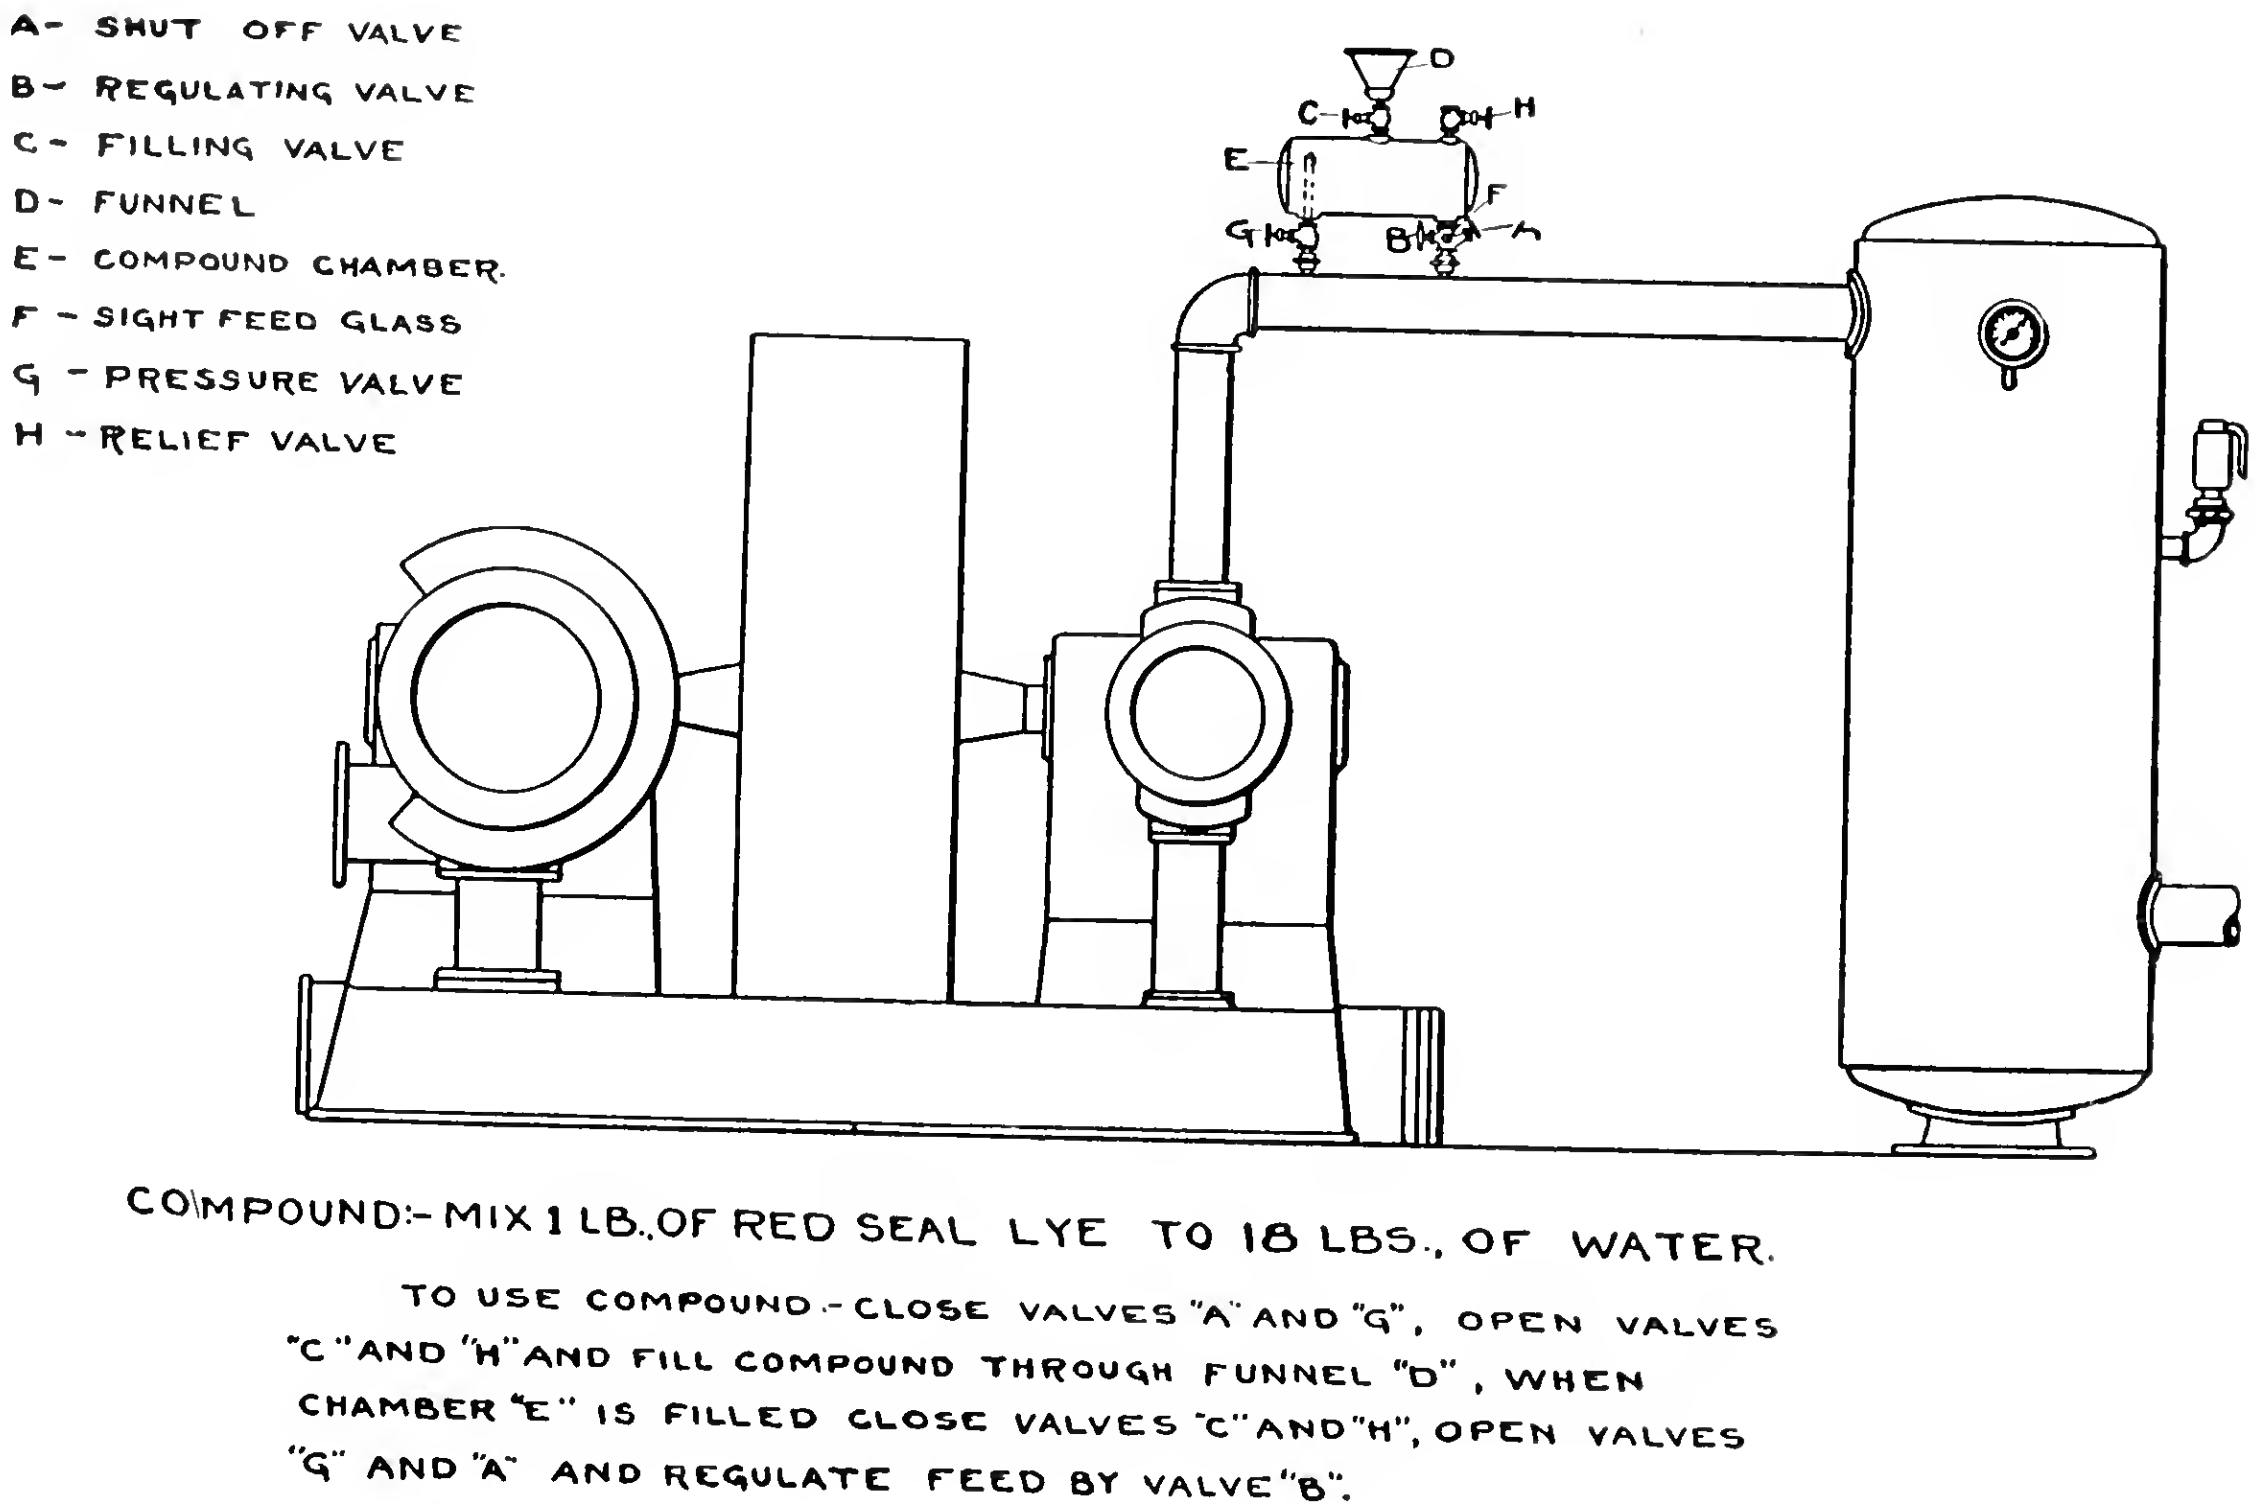
Fig. 1.

DEVICE FOR CLEANING CARBON IN AIR DISCHARGE LINE AND RECEIVER OF AIR COMPRESSOR

Another method of cleaning, suggested by the Compressed Air Society, makes use of a lye solution injected into the discharge line by a special apparatus made of 5″ or 6″ pipe, as shown in Figure 1. The solution is fed into the line at the rate of 60 to 70 drops per minute while the compresser is running, and should be used once a month or oftener as conditions require.

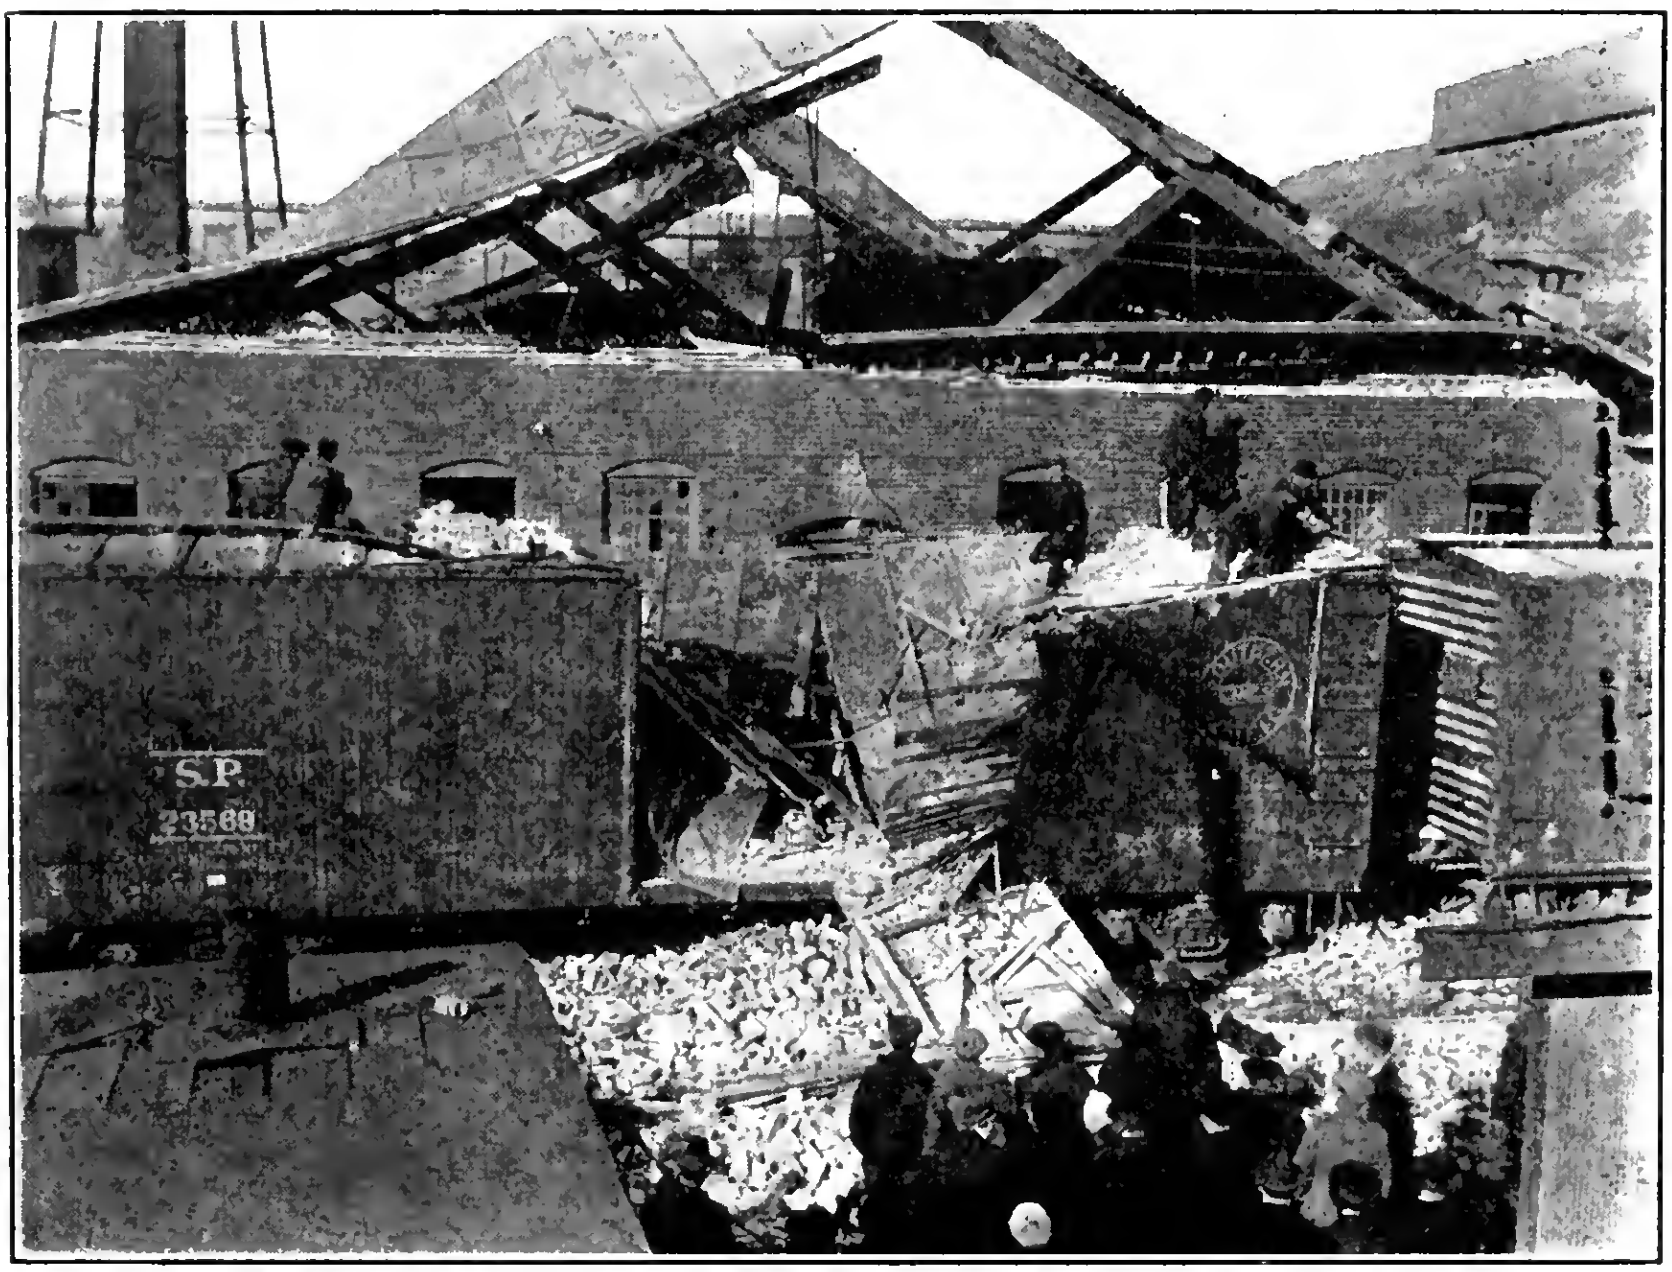
Paper Machine Drying Cylinder Explosion At Quincy, Ill.

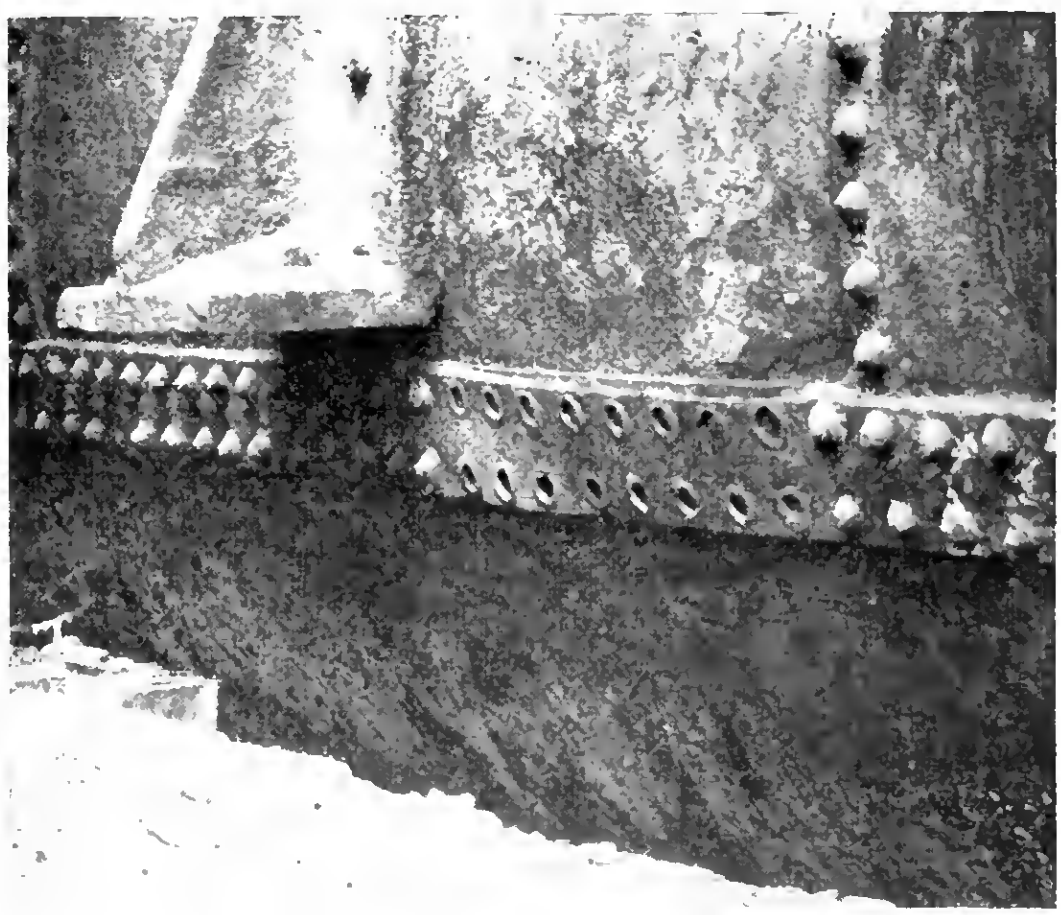
A Defective Butt Strap Discovered By Inspection.

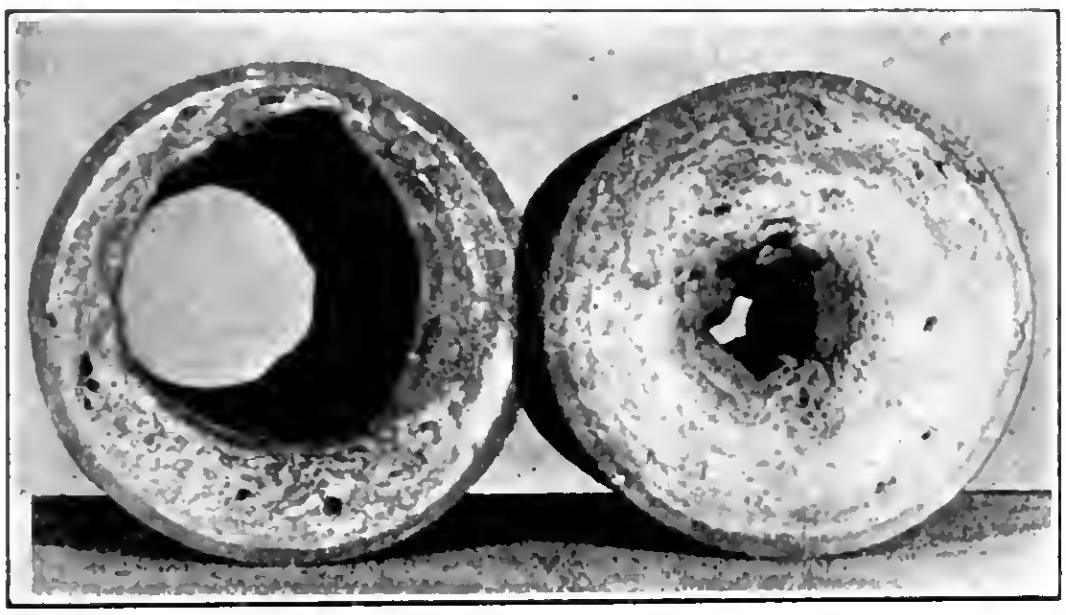
Badly Scaled Tubes.

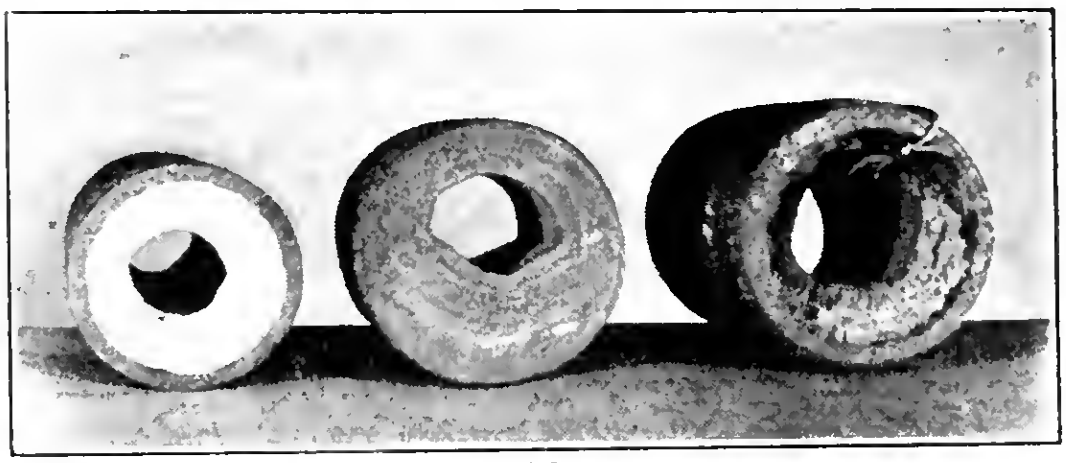
Scaled Nipples
The One On the Right Shows the Result of One Month's Run.
