# The Locomotive

THE HARTFORD STEAM BOILER
INSPECTION AND INSURANCE CO.

VOL. XXXIV.

VOL. XXXIV. HARTFORD, CONN., JANUARY, 1922. No. 1.

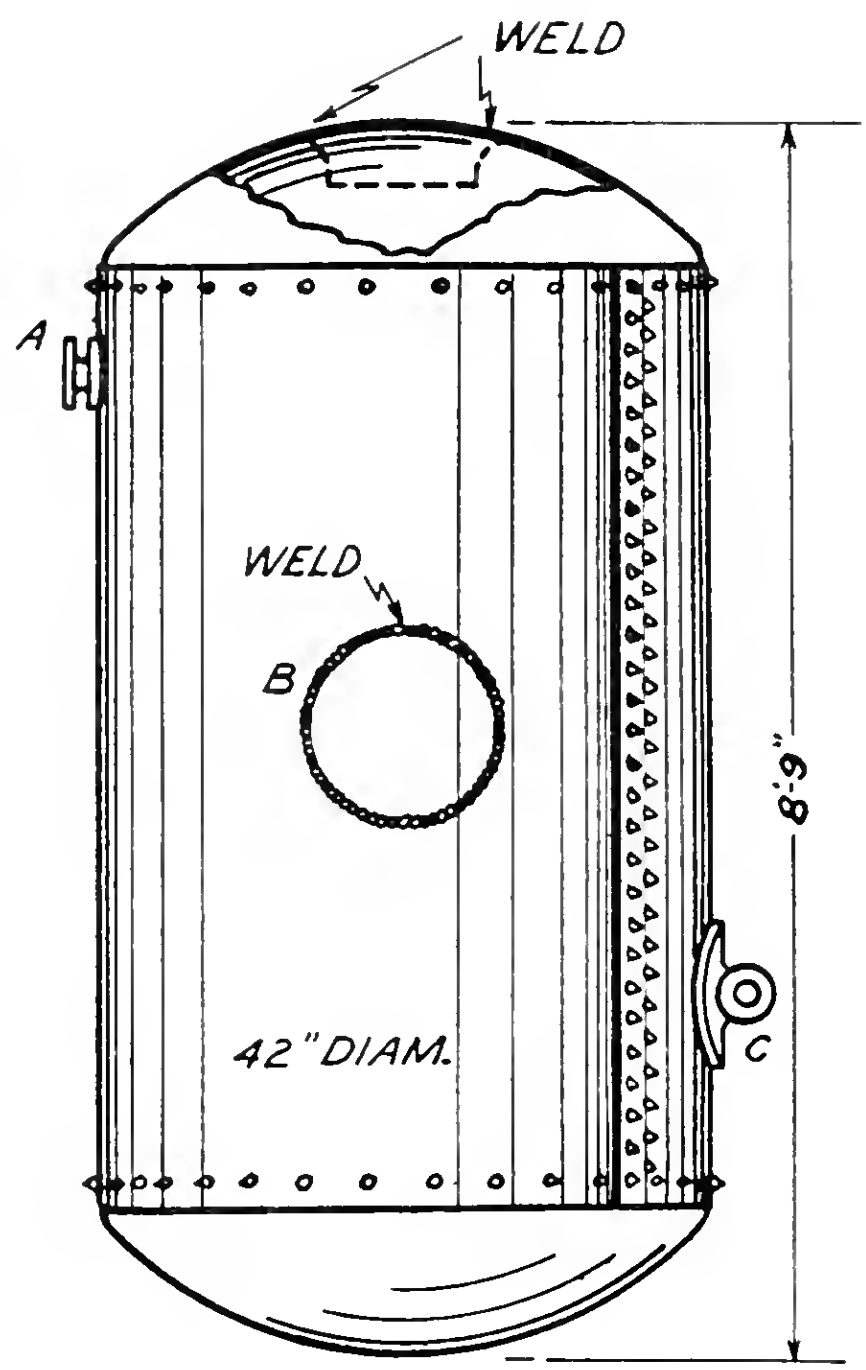
Fig. 1.

A tank of the dimensions shown in Fig. 1, formerly used as a container for compressed air and which had seen but very little service, was purchased for installation on the low pressure side of an ammonia refrigeration system of the absorption type. For some reason it was decided to remove the lower 3 inch cast iron nozzle, which was done by means of an oxy-acetylene cutting torch. A hole 10 inches in diameter in the side of the tank resulted, indicated by B in Fig 1 Into this aperture there was inserted, flush with the shell, a piece of steel plate formed to the contour of the vessel and attached to the shell of the tank by the process of electric arc welding. The manhole frame pressed in the top head had also been cut out and into the elliptical opening, 15" x 20", there had been inserted, flush with the head, a piece of steel plate fashioned to conform to the radius of the head and electrically welded to same. On completion of this work, the vessel was subjected to an air pressure test of 50 lbs. per square inch and was pronounced tight. The welder then left the premises considering his work finished.

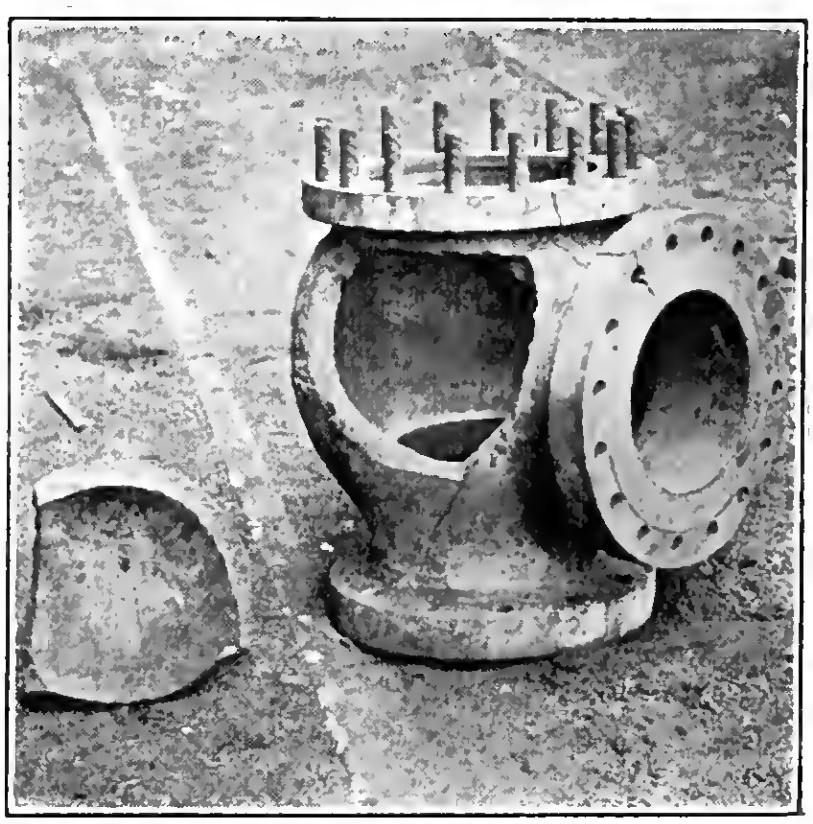
An illustration of the damage done by water hammer. In the plant where this accident happened, the fires had been banked for over the week-end, but on Sunday morning there was a sudden call for steam. The boilers were rapidly forced to meet the demand and, while doing this, water hammer developed in the main steam header. Three successive blows were delivered upon one of the stop valves which finally gave way as shown in the illustration. Fortunately, no one was injured by the accident. It was said the boiler on which the accident occurred was carrying a high water level and that the engineer was blowing down to overcome this when the rupture took place.

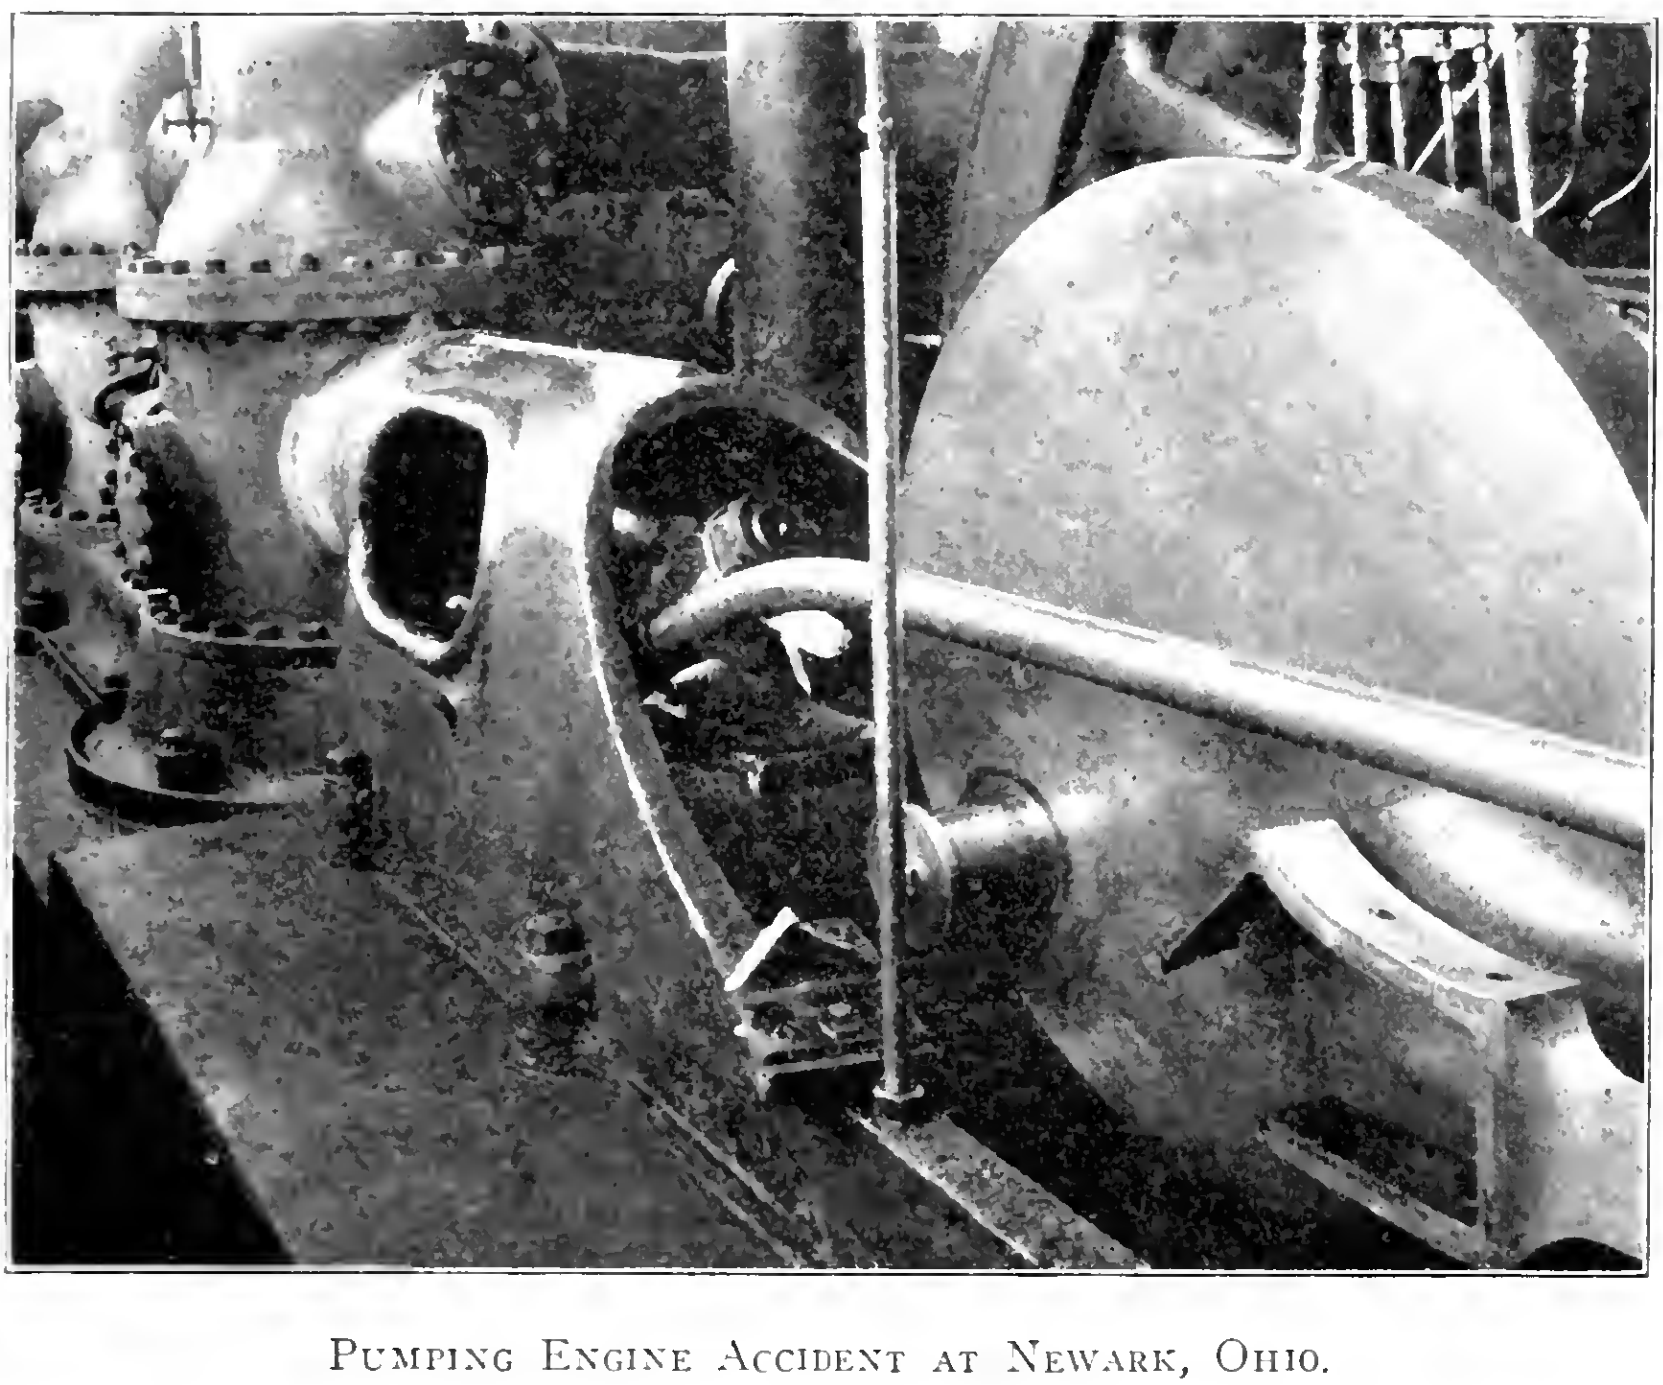
Pumping Engine Accident at Newark, Ohio.

The initial break appears to have been in the strap on the crank end of the connecting rod. This break shows very clearly in the illustration on the front cover. Released from the crank, the reciprocating parts were evidently driven forcibly against the head end of the cylinder.

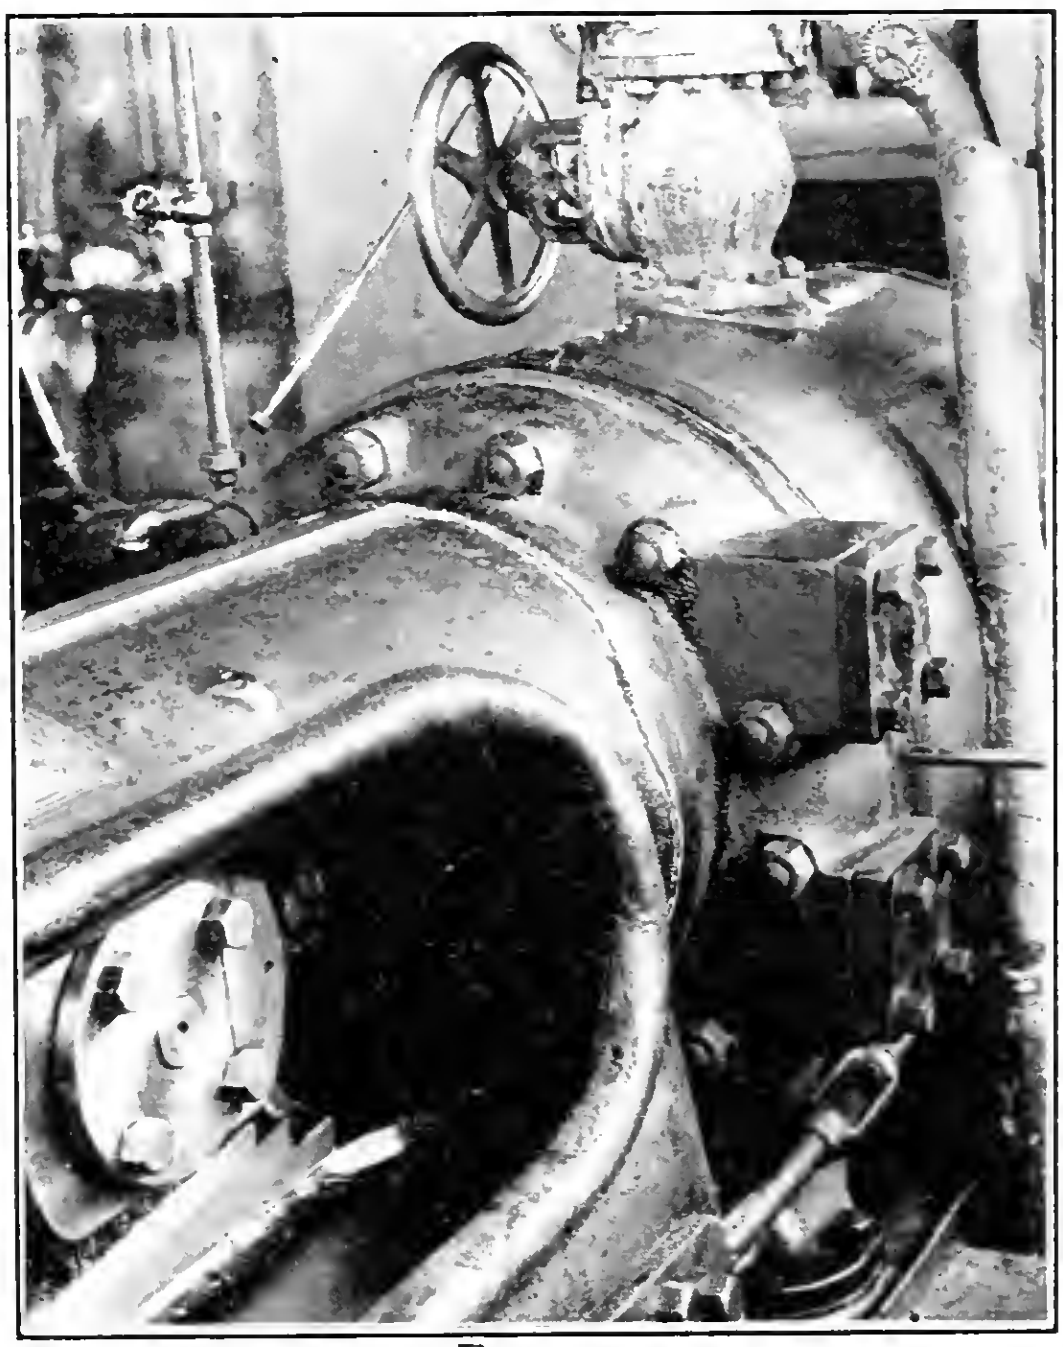
FIG. 1.

The most serious damage was the breaking of the main frame. This casting was 17 ft. in length, and the steam cylinder end was completely severed from the rest of the frame, as shown in Fig 1. When the cylinder moved to open up this crack, it also cracked the body of the throttle valve completely around. Besides the break in the strap, the connecting rod was bent. The piston was cracked in five places. The piston rod at the water end was broken off at the cross-head, and the cross-head itself was broken. The stuffing box gland at the water end was broken and the parallel rods, which connected the steam and water pistons, were badly bent and twisted. On account of the large casting which had to be replaced, repairs were expected to require considerable time. The engine was built in 1907.

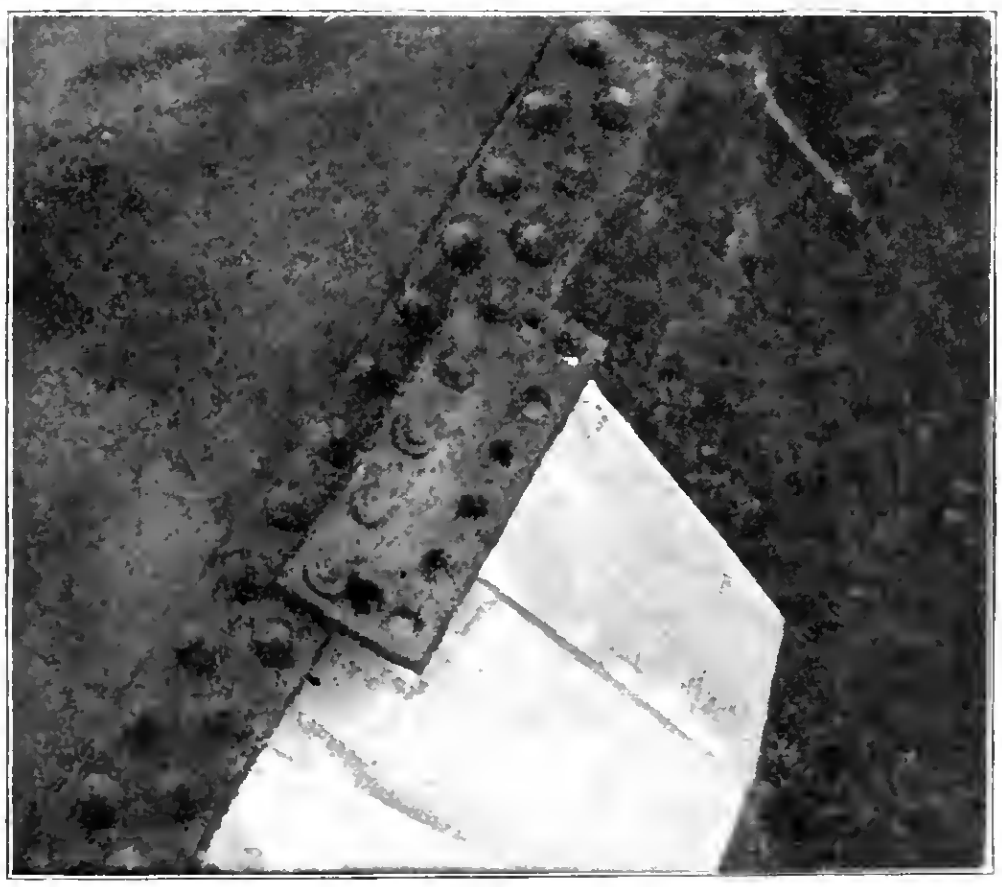
Soft Patch Used in an Unsuccessful Attempt to Repair a Longitudinal Seam Crack.

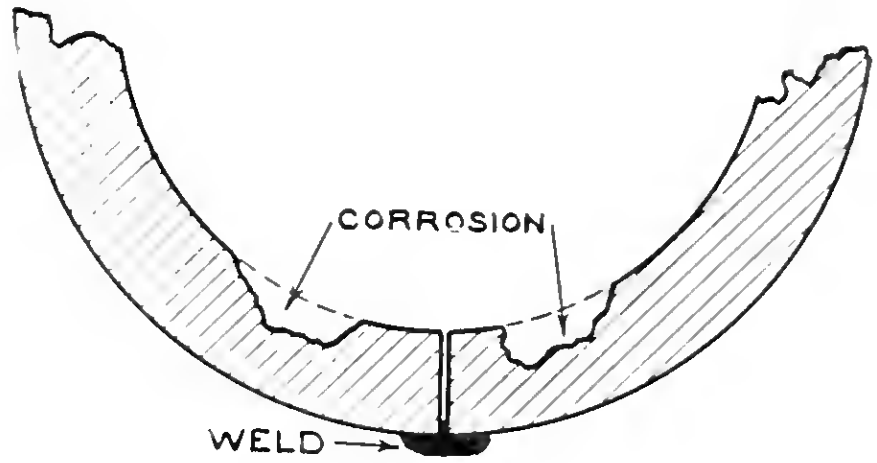
Examination of this tank subsequent to the accident revealed a very imperfect weld in the longitudinal seam as shown in the part cross sectional view, Fig. 2. Only a small amount of metal, built up on the outside, held the tank together. The weakest part of the weld appeared to be about 6 inches from one end, though it is difficult to say where the rupture originated as the whole weld failed, even the head girth seams. The nature of the failure is clearly shown in Fig. 3.

In connection with this accident it will not be amiss to point out the necessity for providing means for internal inspection of all pressure vessels no matter how small they may be. The poor condition of this weld would have been readily detected by such an inspection. In addition, as can be plainly seen in the picture and as indicated in Figure 2, serious corrosion had taken place forming deep grooves parallel and adjacent to the longitudinal seam. This was due to the fact that the tank was installed in a horizontal position with the seam on the bottom. If this tank had remained in use, even though the weld had been good, it is almost a foregone conclusion that it would have exploded before very long from weakness due to corrosion. Where provision is made for internal inspection, such dangerous conditions would most likely be detected and the tanks removed from service before failure.

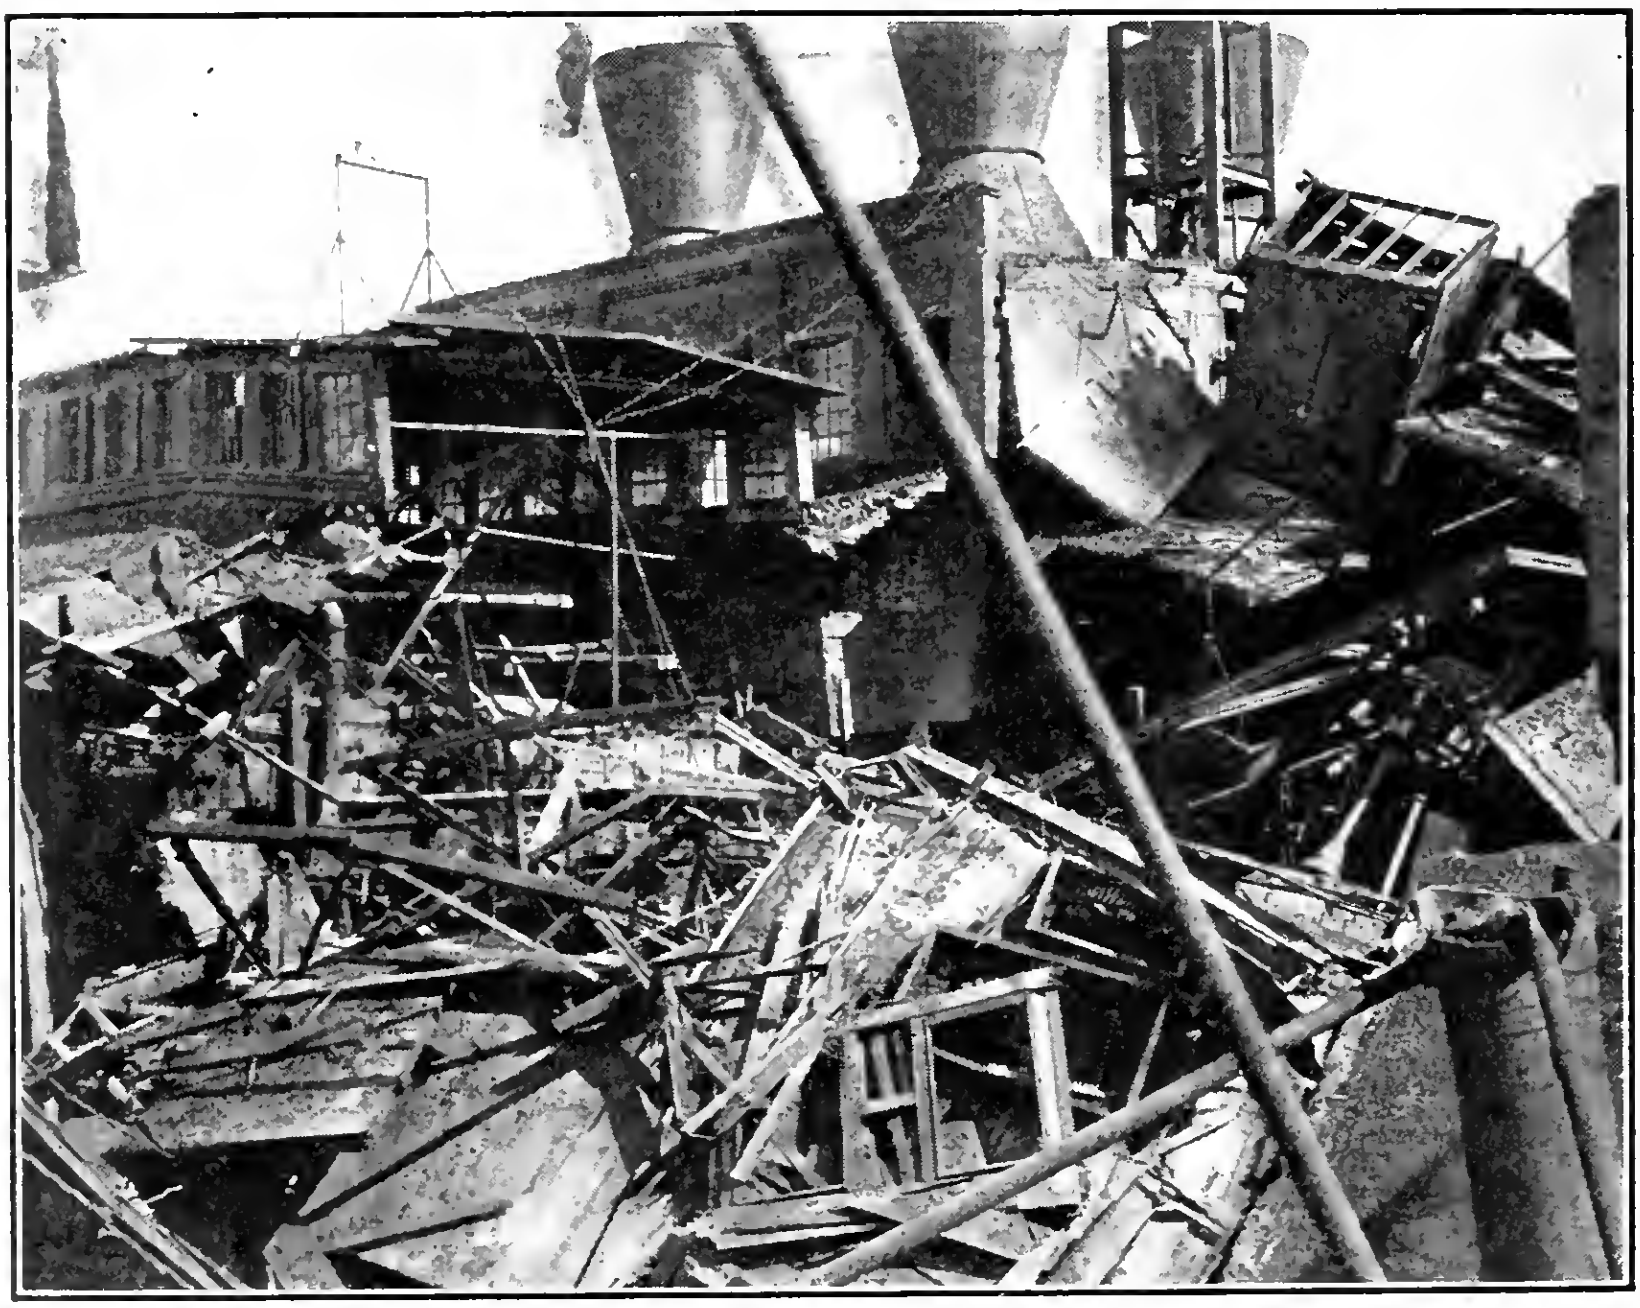
Fig. 1.

A DISASTROUS explosion occurred September 22, 1924, at the plant of the New York & Pennsylvania Company, Lock Haven, Pa. One of the sulphate digesters exploded, killing three employees and injuring four others, and resulted in a property loss of $150,000. There is no picture available showing all of the wrecked area, but the view on the cover and also Fig. 1, both taken from within the digester room, show a portion of the wreckage.

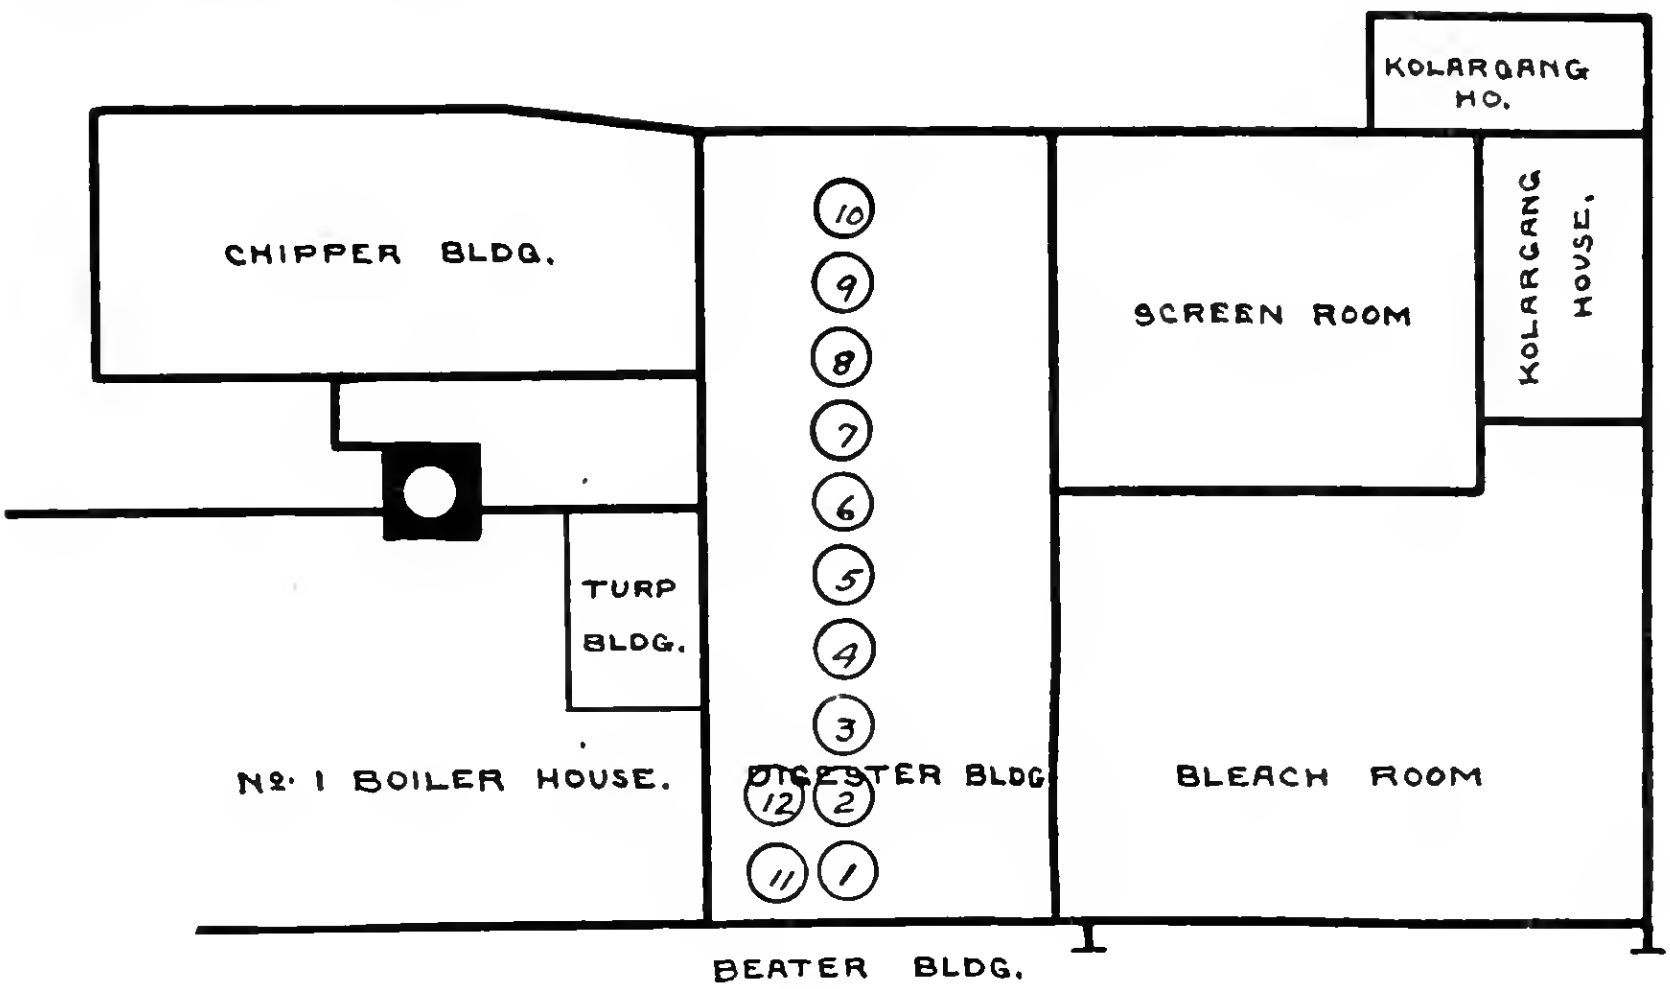
FIG. 2.

The digester that exploded was No. 7 of a battery of twelve arranged as shown in the plan in Fig. 2. All of them were either blown from their foundations and lying down or else in such dangerous positions that they had to be removed. The digester building was a complete wreck and parts of adjacent buildings were damaged. In accidents such as this one, flying pieces of wreckage usually do considerable damage at places quite remote from the scene. In this instance, however, the damage, though severe, was restricted to the comparatively small area in the immediate vicinity of the digester building. A heavy reinforced concrete charging floor near the top of the vessel undoubtedly exerted a smothering effect.

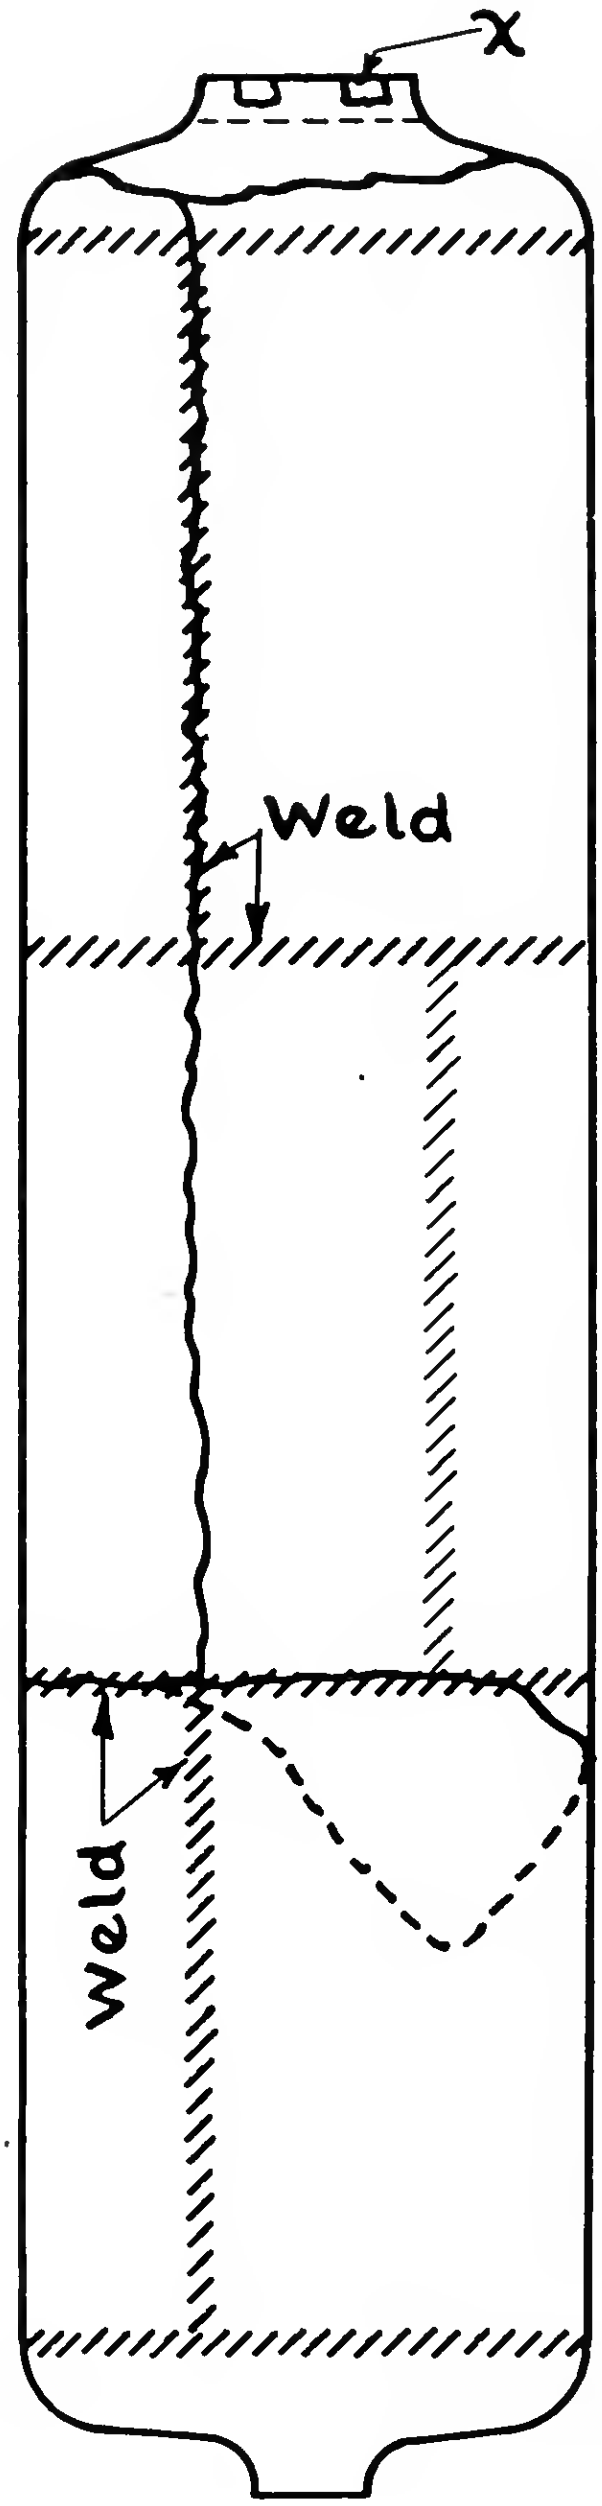
Examination of the wrecked vessel disclosed a separation into four parts as shown in Fig. 3. The bottom course and head were torn off at the first girth seam. The middle and top courses were torn across longitudinally and opened out flat. The top head blew out and in addition the manhole ring in the top head also went out by itself. As will be noted, the break seems to have followed the welds to a considerable extent and, from the character of the rupture, it would appear as if the explosion resulted from the weakening of an imperfectly welded joint by the gradual thinning of the vessel.

Because of the peculiar nature of the break there is some difference of opinion as to just where the initial failure occurred, that is, whether the upper head failed first or the lower portion of the shell. The indications point more strongly toward the latter. For about one-third of the distance around the lower seam there appears to have been very little of the metal actually joined in the weld and the two pieces of metal slipped apart at the scarfed joint with very little tearing. The only portions of the defective part of this joint that appear to have been thoroughly welded are at the edges of the scarf, as indicated by the line of rupture in Fig. 4A. Furthermore, in places the portion of the joint between *a* and *b* showed a polished appearance as if a small amount of movement had been taking place there for a considerable period of time. The wasting away of the interior of the digester removed part of the metal from the sound portion of the joint and thus seriously weakened it. Additional evidence that the initial break occurred here is given by the fact that the side of the shell opposite to the rupture caved in, apparently as the result of the

bending back of the lower course at this seam. Also the failure of the explosion to be widespread in effect, as previously mentioned, would indicate the initial failure to have been near the bottom of the vessel.

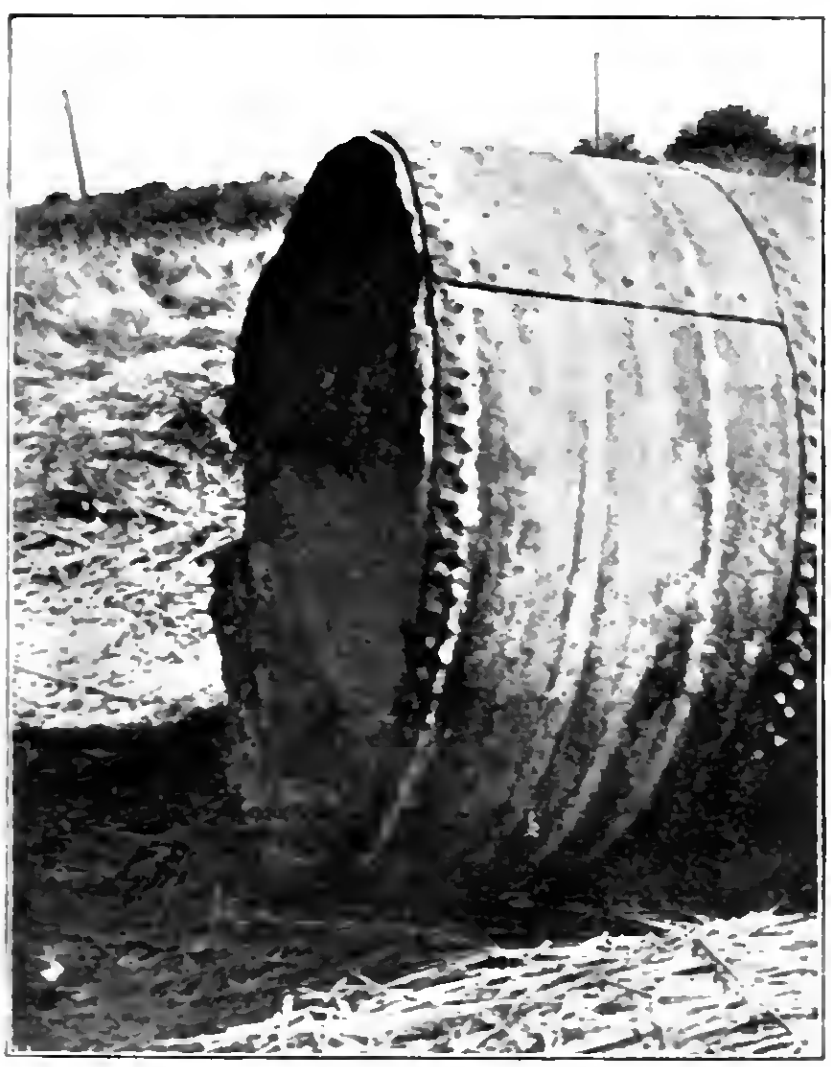
Fig. 3.

The initial failure was in one of the heads and an examination of the torn plate reveals the cause of the explosion. The rupture clearly shows that a crack ran for a considerable distance along the bend of the flange, and the indications are that this crack had existed for some time. Serious external corrosion had taken place and perceptibly thinned both the shell and the heads. Thus weakened, the head plates probably underwent a slight expansion and contraction, or "breathing," as the vessel was alternately under pressure and released from pressure. The result would be a continual bending action at the turn of the flange, and finally a cracked head.

The shell of the boiler came out of the accident almost unscathed, but the opposite head suffered some damage, a large piece having been knocked out, most likely by collision with some other object.

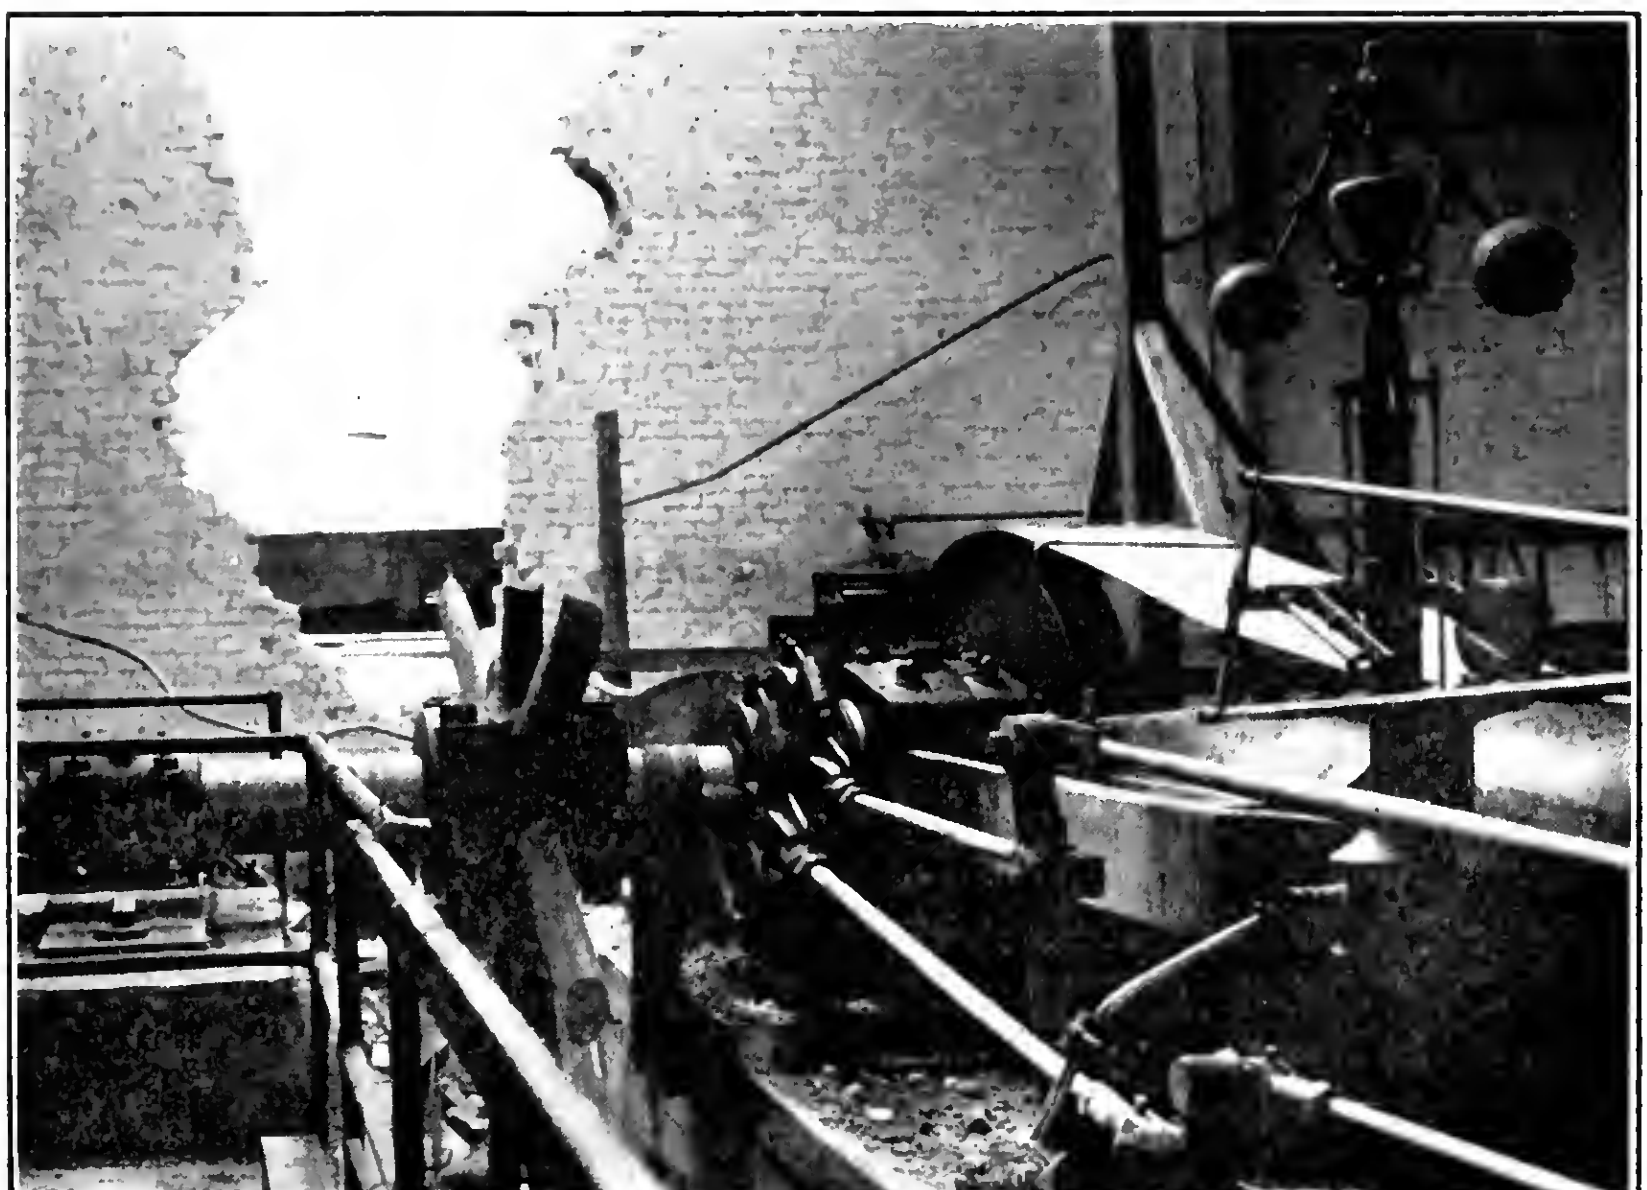
FLY-WHEEL EXPLOSION AT LUMBERTON, MISS.

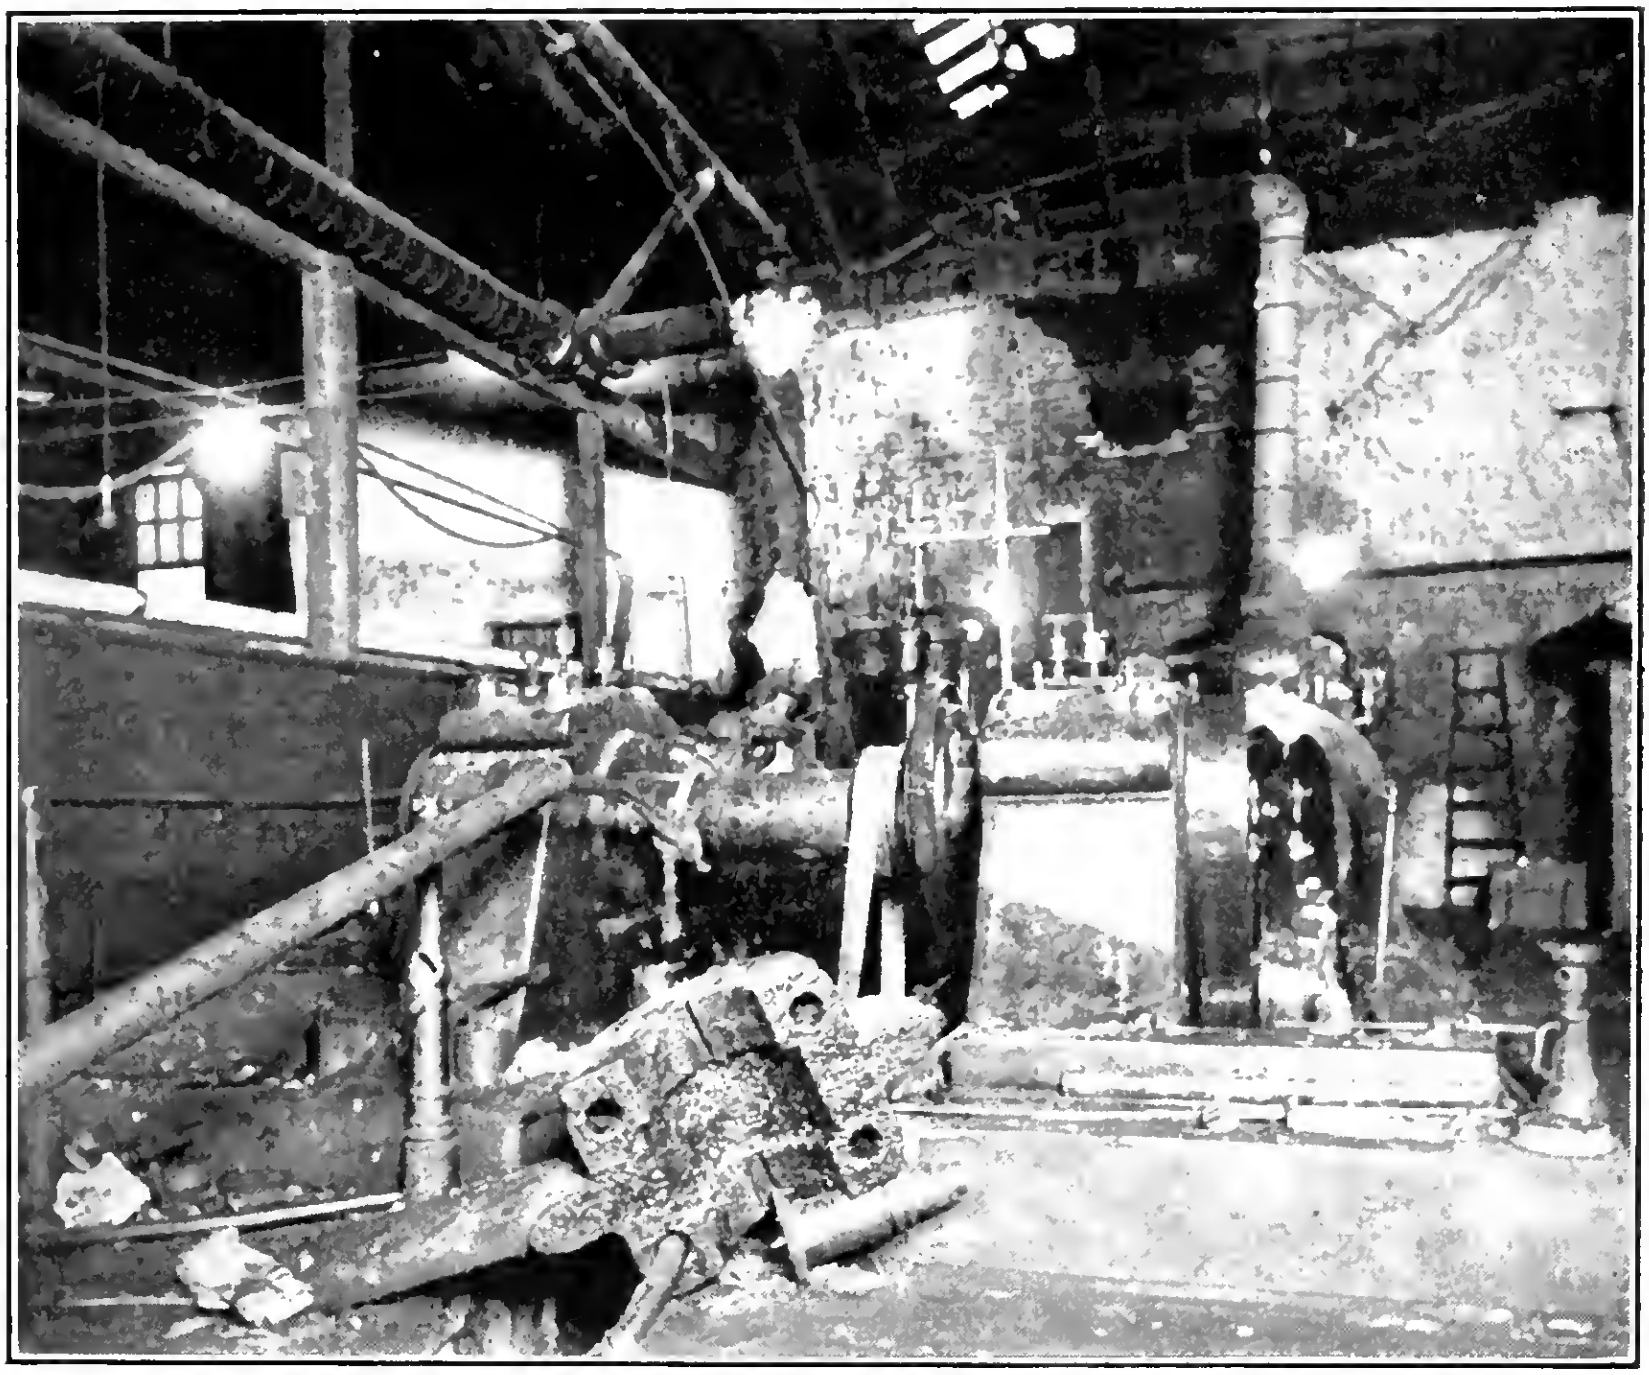
FIG. 1.

Another flywheel explosion, also resulting from a slipping governor belt and shown in Fig. 1, occurred July 18, 1924, at the Greenville Ice &

Fuel Company's plant of the Carolina Public Service Corporation. The suction valve pocket on an ammonia compressor failed and allowed the valve to drop into the compressor cylinder. The cylinder head was knocked out and the ammonia thus released. The engineer advanced toward the throttle spraying water from a hose into the fumes, and inadvertently wetted the governor belt. The engine immediately speeded to destruction.

The wrecked wheel was part of a 75 ton ice machine and was 16 ft. in diameter and weighed 18 tons. Pieces of it traveled over 300 ft. wrecking, amongst other things, the 10 ft. flywheel on another ice machine, several 12 inch x 12 inch reinforced concrete supports for the condenser tower, as well as some motors, piping, and other equipment.

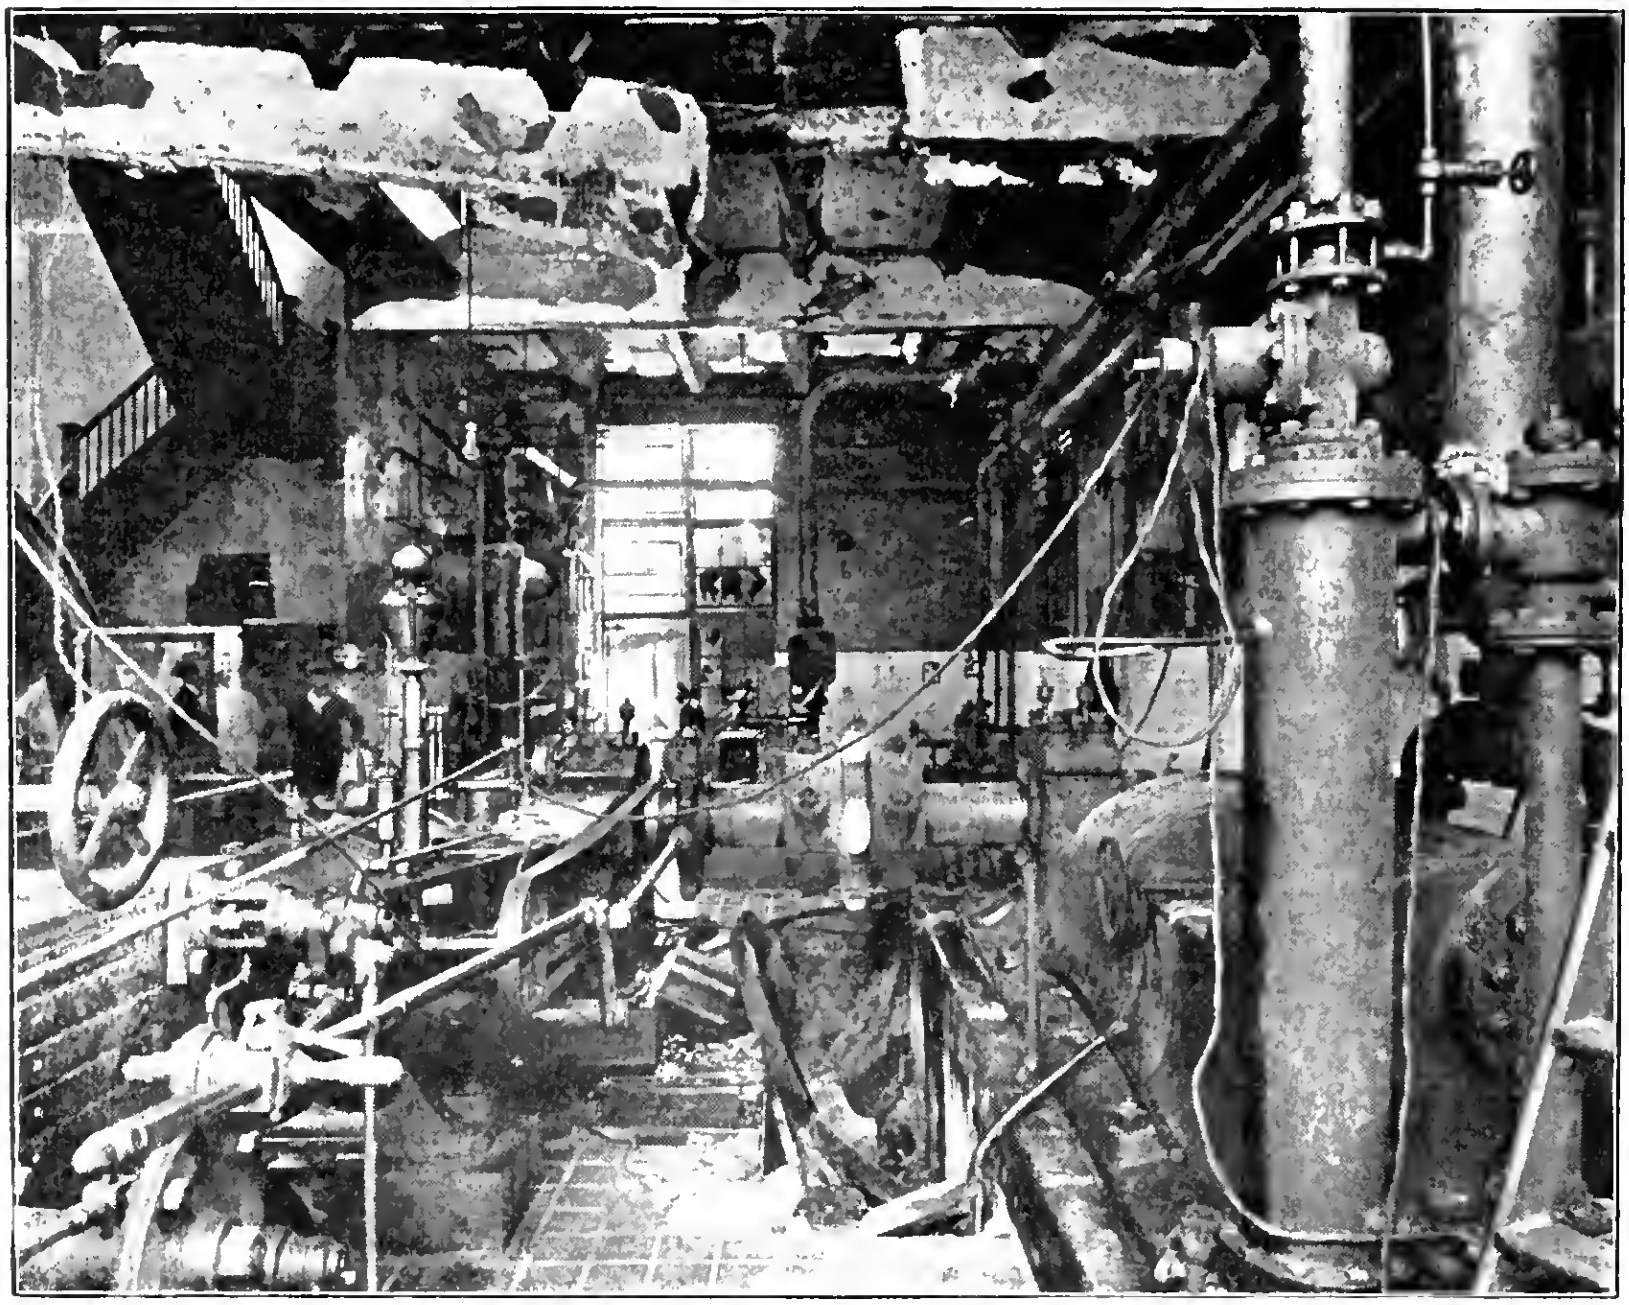
The results of still a third accident, the cause of which is also said to have been the failure of the governor belt, are shown in Fig. 2.

This was a 12 ft. flywheel and normally operated at 58 r.p.m. The immediate cause of the engine over-speeding is not apparent, but an examination after the accident revealed that the governor belt was not in good operating condition and undoubtedly ran off of the governor pulley. The belt was oily and slack on the pulleys. In addition, one

edge rubbed hard against the engine frame as shown by the worn condition of the edge.
