# The Locomotive

THE HARTFORD STEAM BOILER
INSPECTION AND INSURANCE CO.

VOL. XXXIV.

VOL. XXXIV. HARTFORD, CONN., JANUARY, 1922. No. 1.

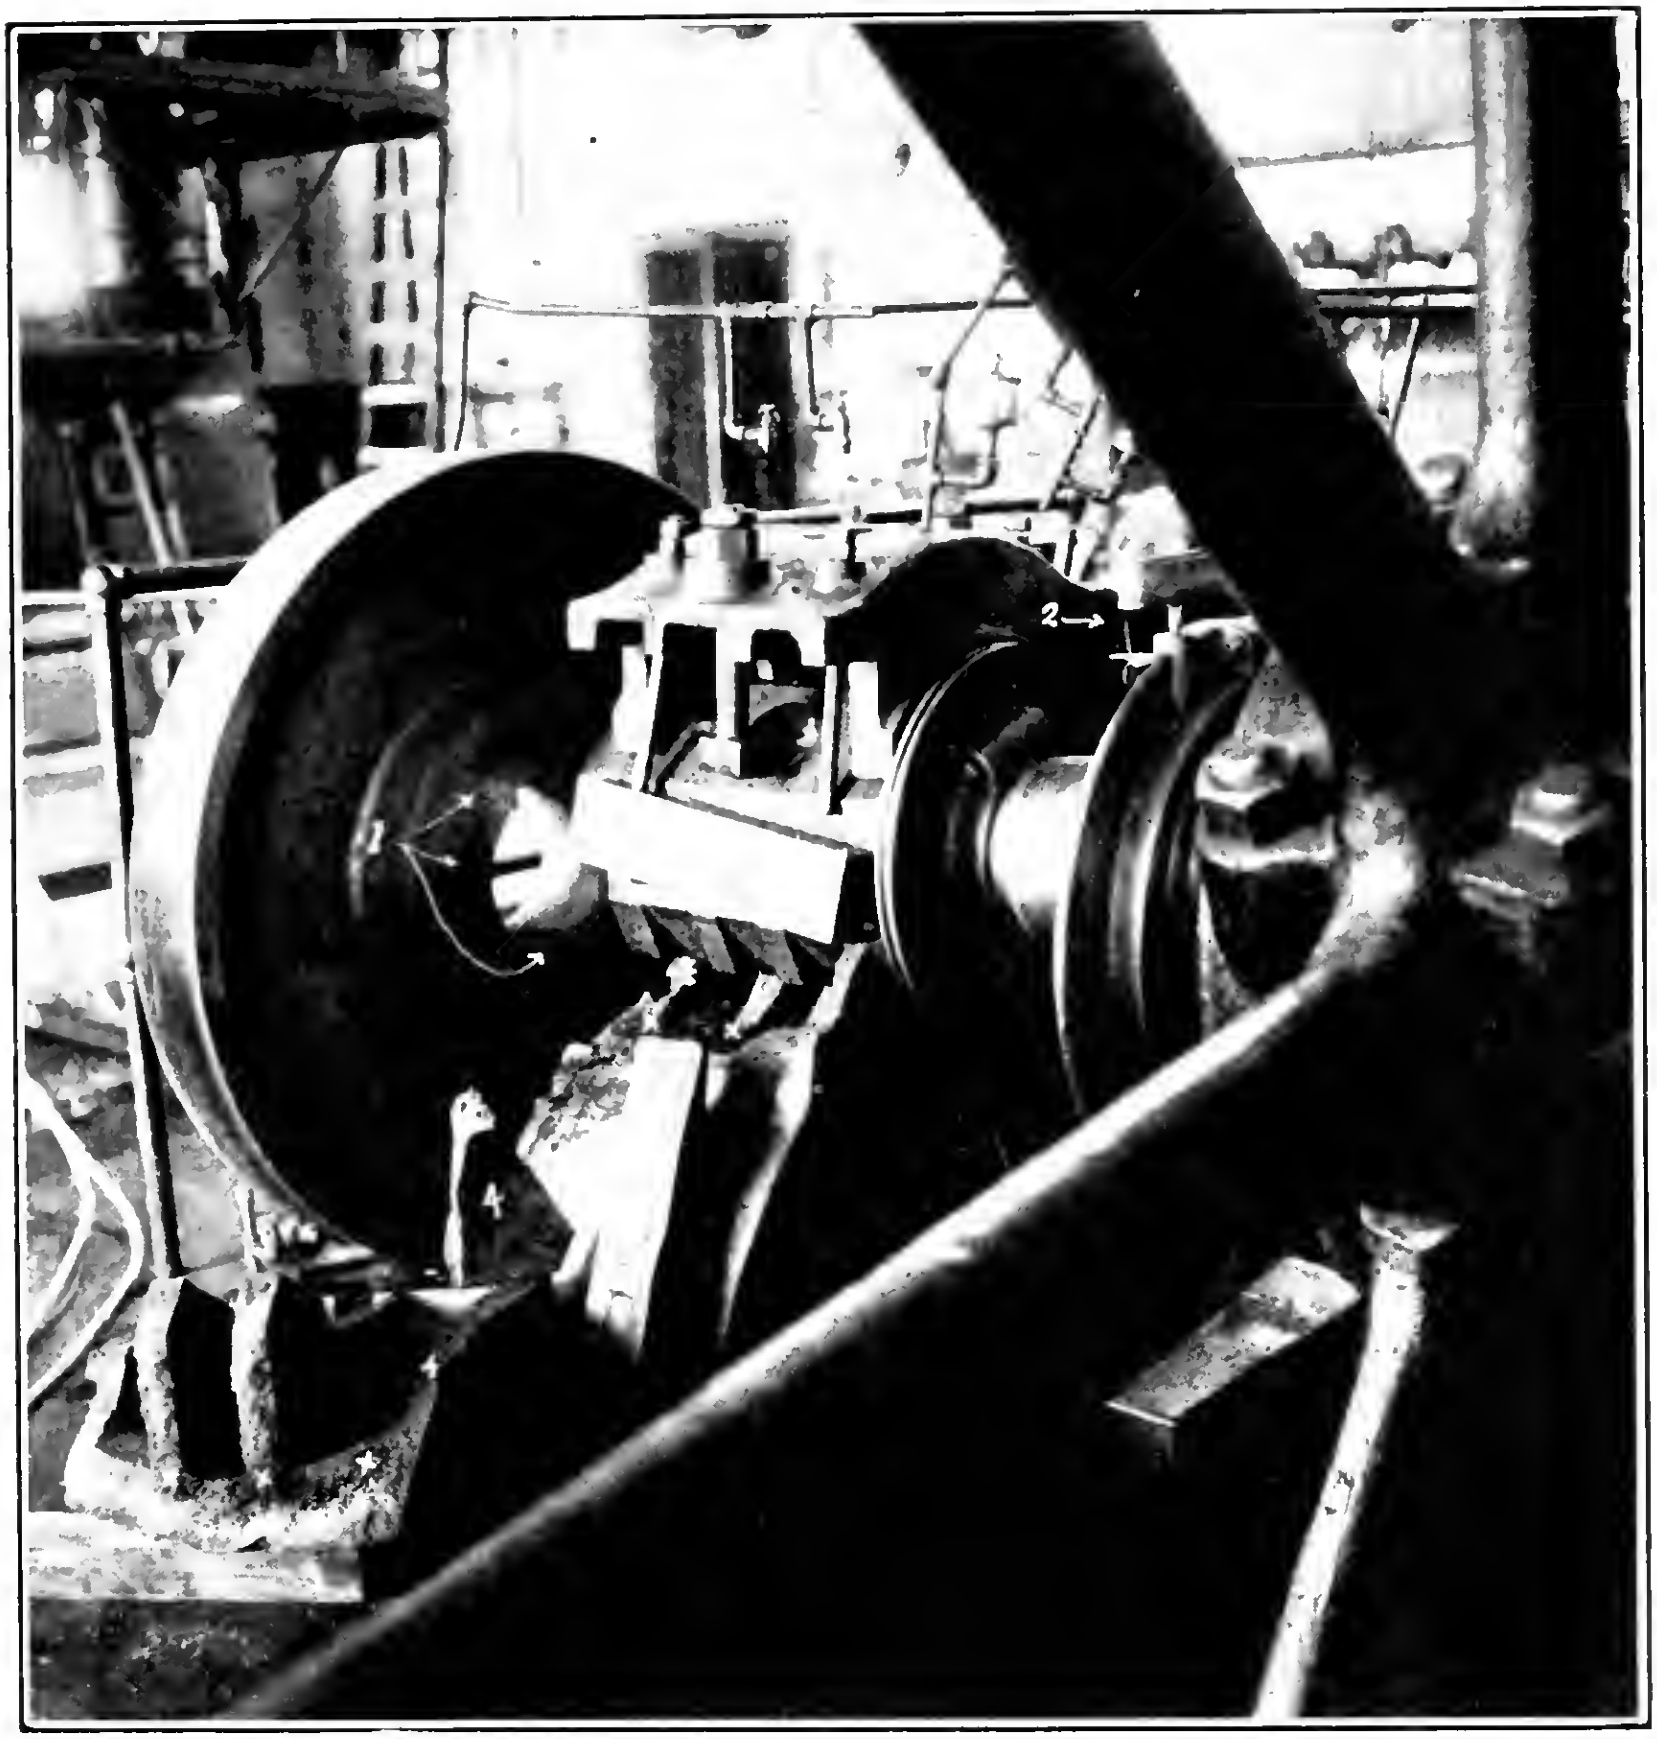
Engine Wrecked by Water in Cylinder.

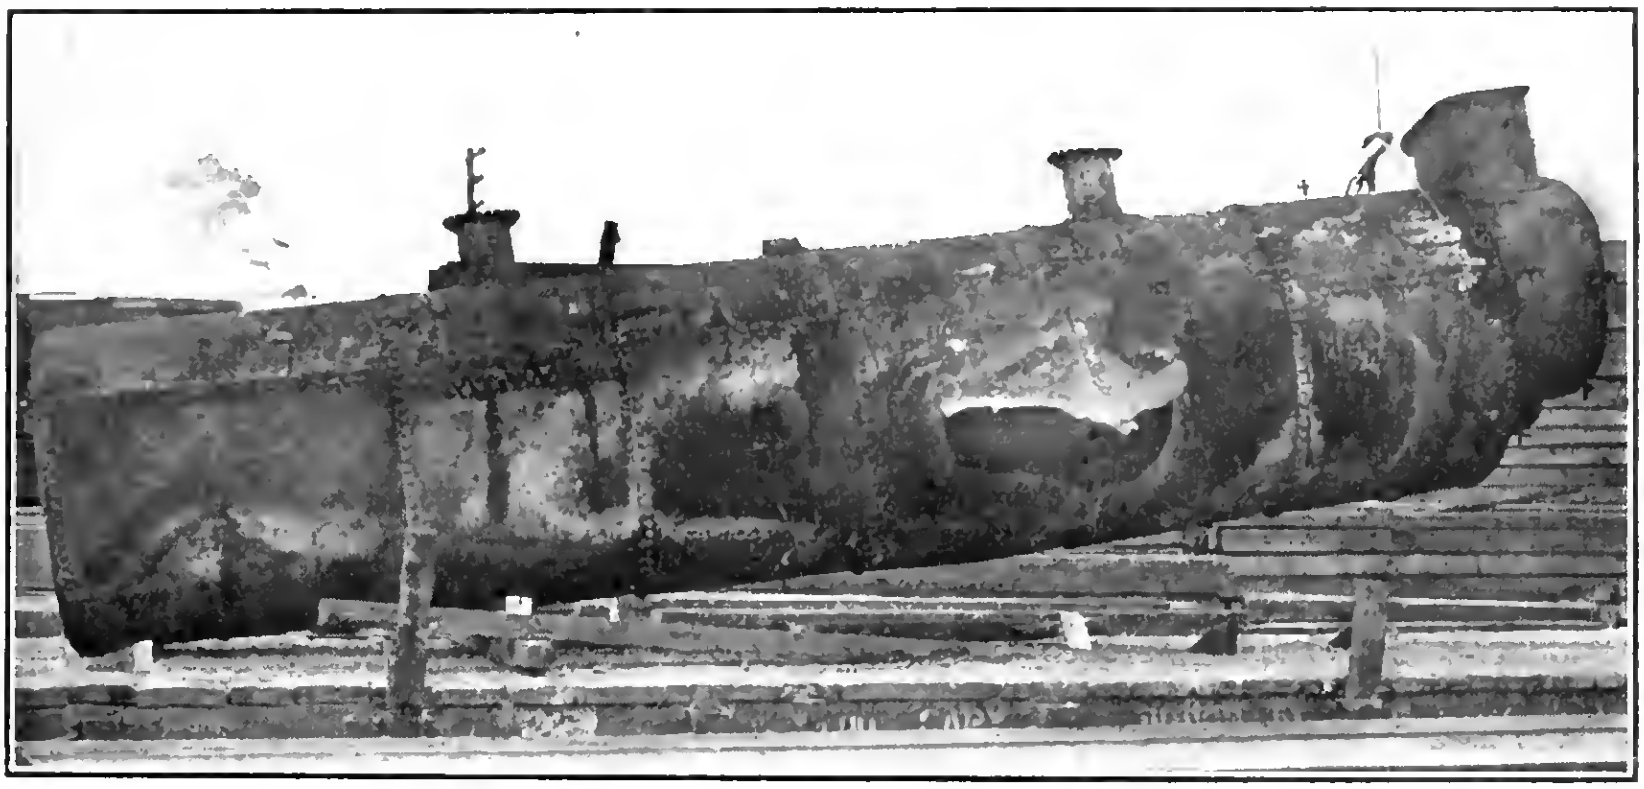
Boiler Burned and Ruptured as a Result of Low Water.
The Blow-Off on This Boiler Was Found Open When the Debris Was Being Cleared Away After the Accident.

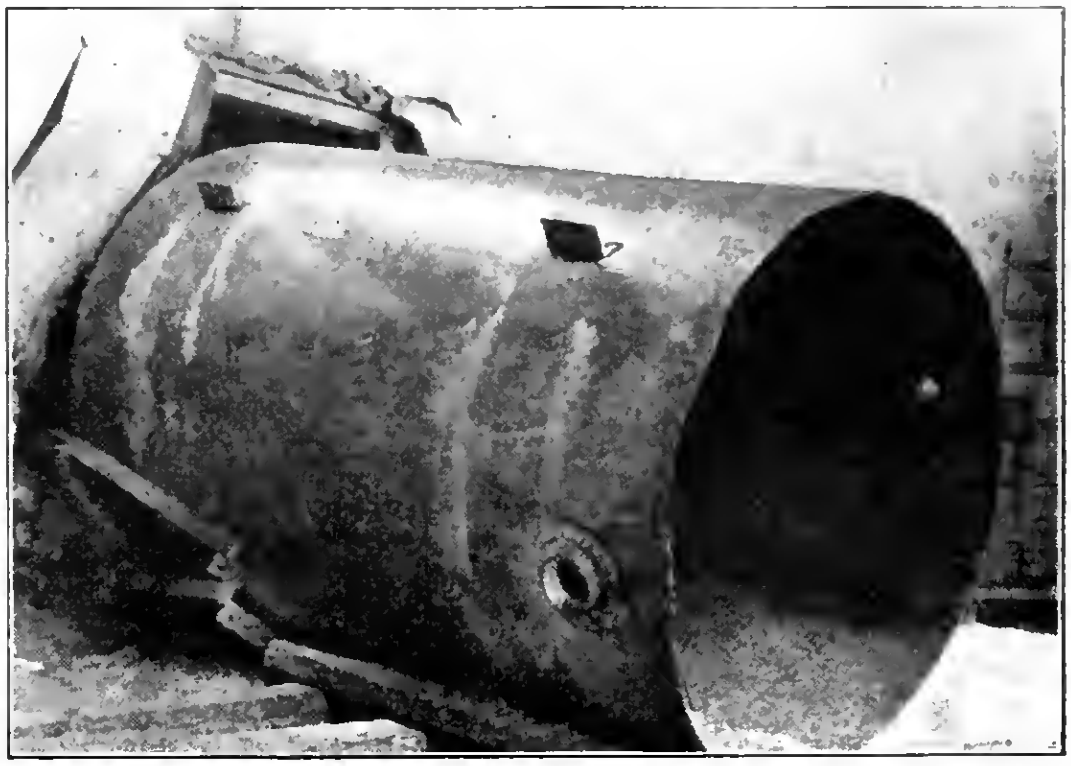
THE MIXER AFTER THE ACCIDENT.

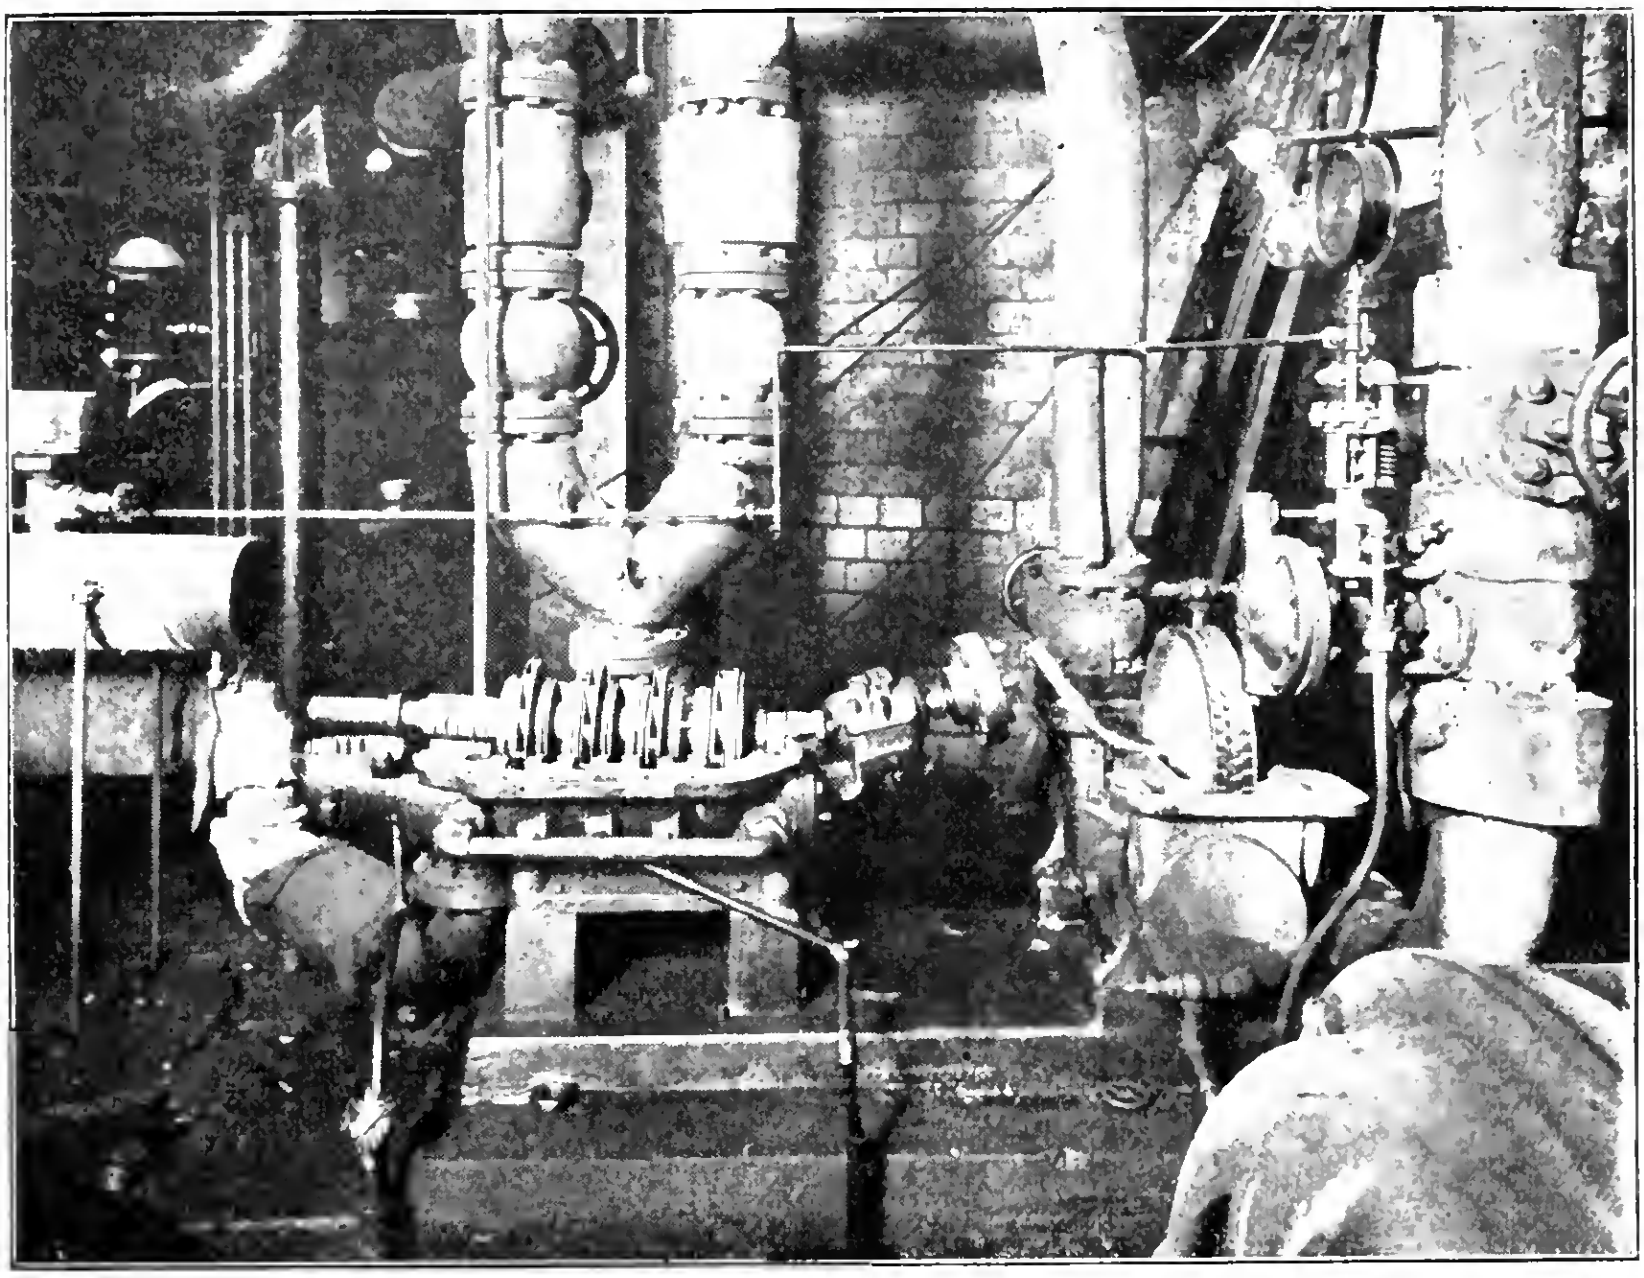
| 271 | | Tube pulled out of drum | | | Hodenpyle, Hardy Co. | Power Plant | Springfield, O. |

Figure 1 shows how the unit looked after the accident when the debris had been cleared away and the rotor replaced in the casing. The governor end of the shaft, shown in Fig. 2, broke off just beyond the bearing, and the other end of the turbine shaft was bent to an angle of approximately 45 degrees. Both bearings, which had been cast integral with the casing, were broken off, the top half of the casing shattered, and the nozzles torn out of the lower half of the casing. In fact, the turbine was completely wrecked. In addition the flexible coupling burst and considerable damage was also done to the pump, including the bending of the shaft.

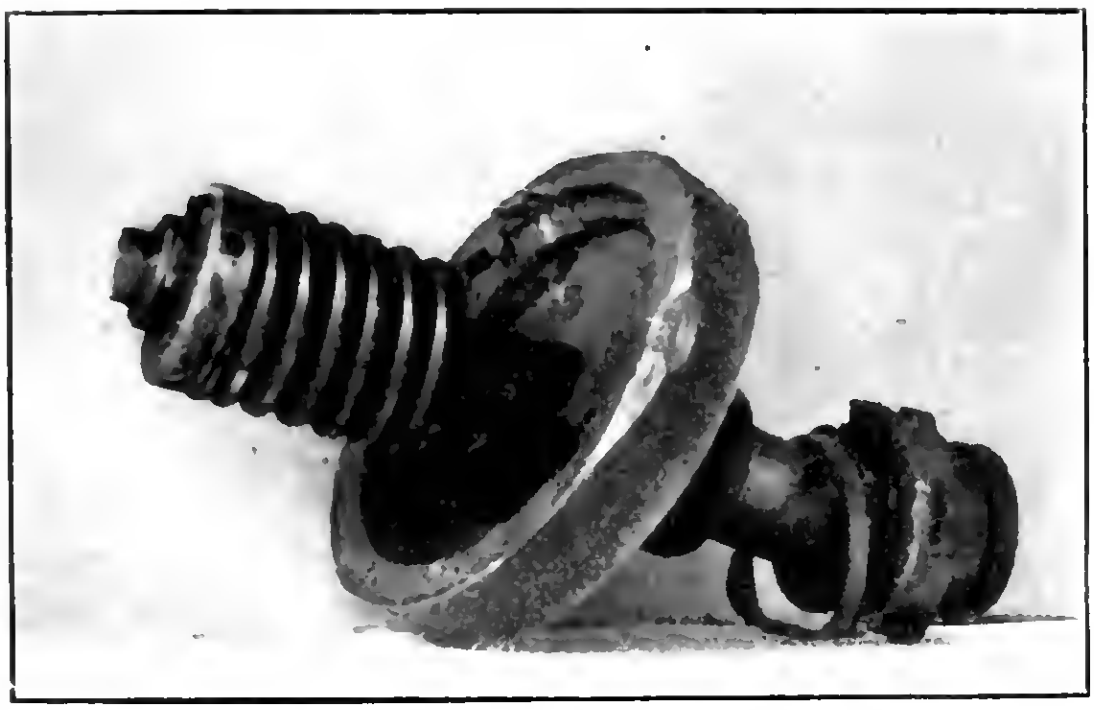
Fig. 2.

On June 12, 1925, a 60 horse-power turbine exploded in the plant of the Pittsfield Electric Co., Pittsfield, Mass. The turbine was direct connected to a boiler feed pump and operated at 2800 r.p.m. The governor, of the usual revolving weight type, was located on the end of the shaft. The evidence indicates that some part of the governor failed first and thus prevented the governor from functioning properly, finally disrupting it. With no counteracting force, the governor spring immediately opened the regulating valve and allowed the turbine to speed to destruction.
