The Locomotive

THE HARTFORD STEAM BOILER
INSPECTION AND INSURANCE CO.

VOL. XL

1934-1935

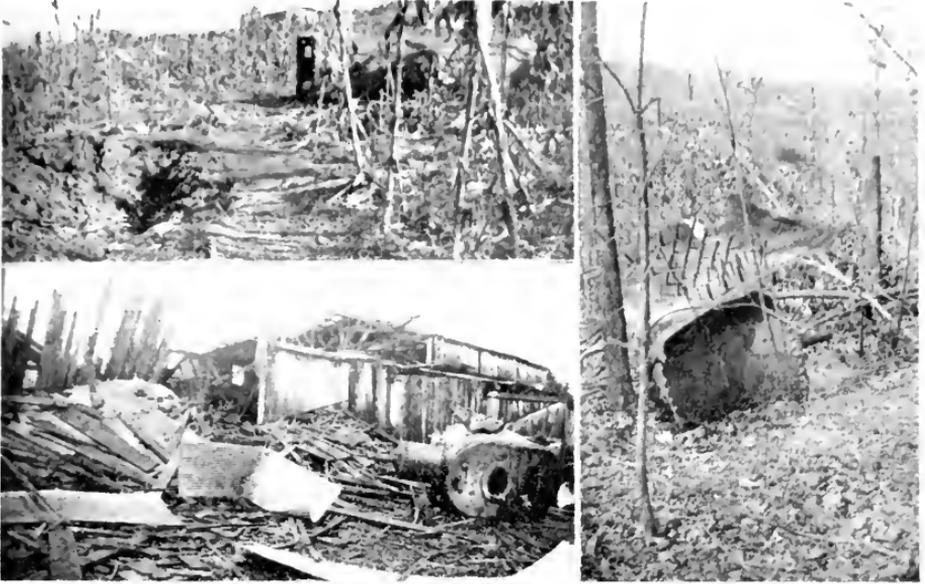
Upper left—Camden, Tennessee, boiler in a cornfield 300 ft from its setting; the hole at the left shows where the shell first landed. Lower left—results of an explosion in a Hohenwald, Tennessee, sawmill. Right—found two days after its explosion in a Powellsville, Ohio, sawmill. This part of the boiler traveled over a hill near the plant.

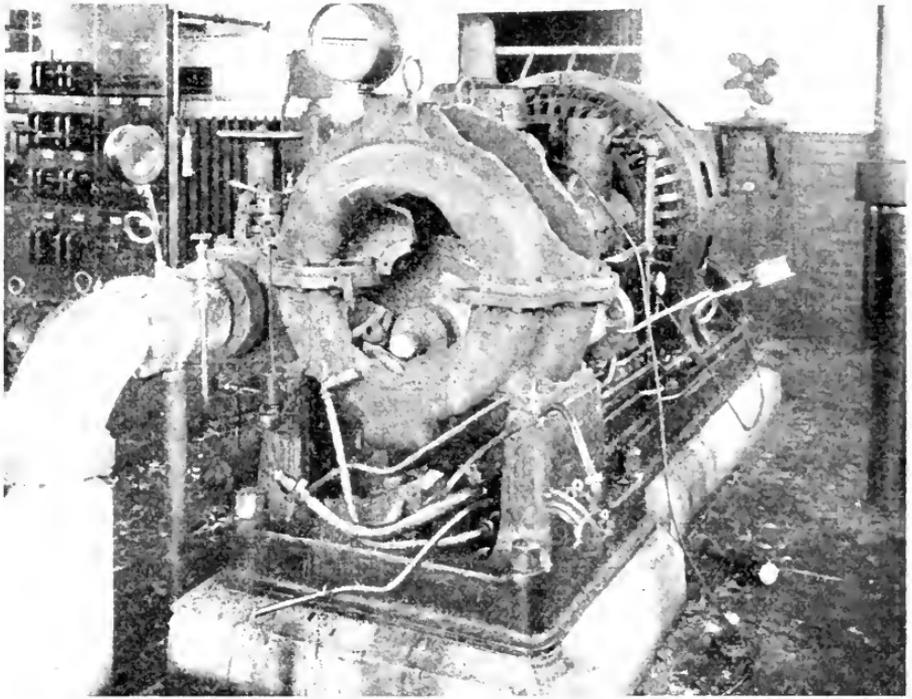
Two men were peppered with flying cast iron when the buckets came through the casing of this turbine. The shaft broke in three pieces during the accident, which was attributed to overspeed.

reached, the turbine should be shut down and proper adjustments made so that it will operate at, or somewhat below the approved speed. After the test has been satisfactorily completed, it is, of course, necessary to restore the control valves to their normal operating adjustments.

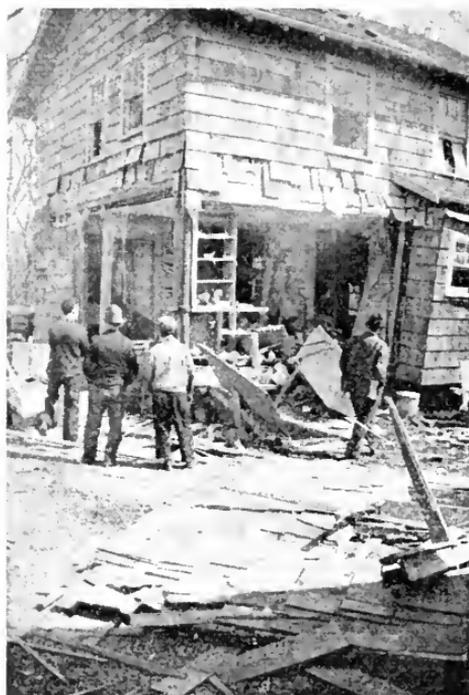
After a hot water tank exploded.

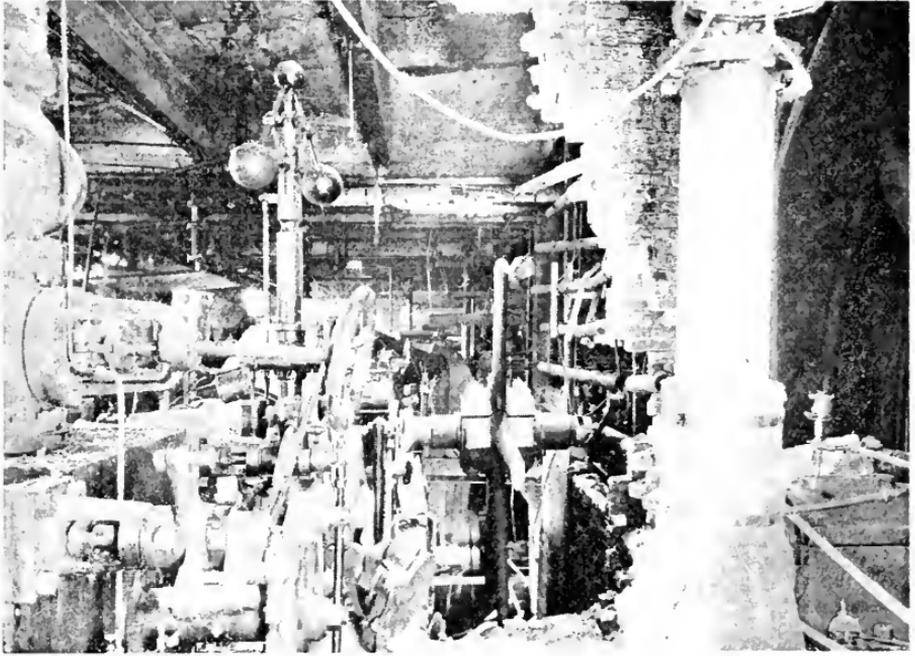
machine), then the screen box in front of a paper machine and finally an 8" x 8" steel column. It came to rest 115 ft from where it started. Another piece of the wheel weighing approximately 1900 lb tore a hole 4' wide and 11' long in the 6" reinforced concrete slab forming the floor of the second story. Still another piece of metal followed the second and went through the roof and finally came down again through the roof at another point. In all the damage to property amounted to more than \$7,000.

*"That whirled the wheel
That burst its rim"*

The wheel which exploded was 14' in diameter, of the belt type, and had a 31" rim.

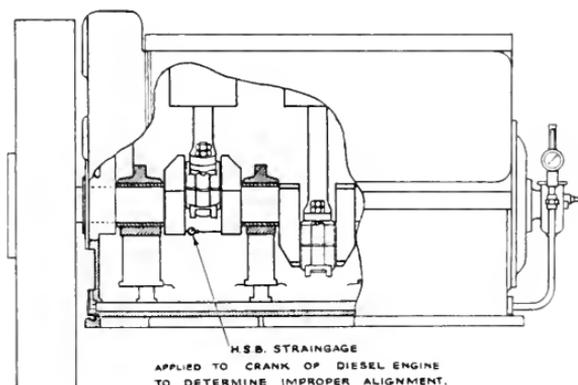
FIGURE 4.

When the crank distortion is measured by this method, it is usual to find some distortion in any crank under the most favorable conditions of bearing alignment. The distortion may be only a fraction of a mil, or so small that it is just barely perceptible on the gage, or it may be as much as 20 mils. Just what the permissible limit of distortion in any given case should

H.S.B. STRAINGAGE
APPLIED TO CRANK OF DIESEL ENGINE
TO DETERMINE IMPROPER ALIGNMENT.

When the apparent fibre stress in the crank webs exceeds 20,000 lb per sq in. by this method of investigation, the shaft should be taken out of service immediately, for it is reasonable to expect that dangerous progressive cracks will have already developed in the crank webs or in the fillets of the crank pin, or in the fillets of the journals.

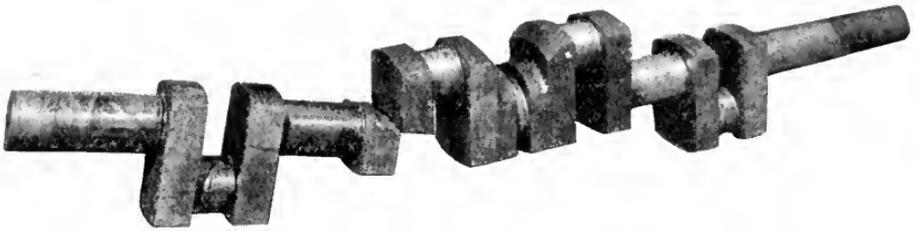
FIGURE 5—*The result of serious over-stresses in a crankshaft caused by bearing wear.*

considerably. Figure 4 shows how the gage is used between the webs of a Diesel crankshaft. The broken shaft shown in Figure 5 shows the baneful result of serious crank distortion caused by worn bearings.

By the regular periodic application of the Straingage to any center-crankshaft it is possible to prolong the useful life of the shaft very

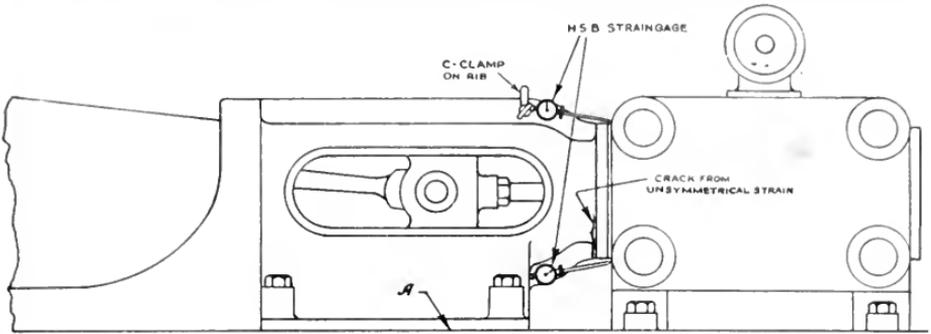
FIGURE 6.

APPLIED TO ENGINE FRAME (WHILE OPERATING)
DIFFERENCE BETWEEN TOP AND BOTTOM READINGS OF
THE STRAINGAGE INDICATES IMPROPER ALIGNMENT, CAUSING CRACKS.

The misalignment that causes the overstress which results in cracking the frame neck, is generally due to softening of the grouting by lubricating oil at "A", Figure 6. In any installation where lubricating oil is allowed to run down the sides of the engine frame and to soak into the foundation, it is certain that serious misalignment will eventually result because concrete and brick become quite soft and compressible when saturated with oil. After some years of operation under these conditions it becomes noticeable that oil is pressed out from under the frame at point "A" when the crosshead moves over that end of the guide barrel, and the oil is drawn in again as the crosshead moves to the crank end. When this occurs it is clear that the engine frame is not being properly supported at point "A" because the grouting has become soft and compressed. The consequence is that the downward force of the crosshead, acting on the guide barrel, is transferred through the frame neck to the nearest support under the cylinder which produces a bending action in the frame neck that is almost certain to result in a cracked casting. An example of the results of unsymmetrical strain in the frame neck is shown in Figure 7.

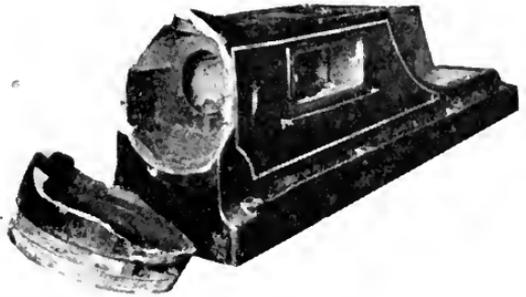
FIGURE 7—Result of crack in engine frame neck caused by unsymmetrical strain.

The vertical movement of the frame at the point where the grouting has become compressed has given some operators the erroneous impression that the nut of the nearest foundation bolt had worked loose. Tightening of the foundation bolt nut under such circumstances, while the engine was running, put such a severe bending stress in the frame neck in a few cases that it was only a matter of minutes before a long crack had formed. The tightening of foundation bolts of engines should never be undertaken without first carefully analyzing the real cause of the looseness of the bolts. The looseness as pointed out in the foregoing, may be the result of the softening of the grouting. If so, a re-aligning of the castings on the foundation and regrouting is necessary before the foundation bolts can be properly tightened.

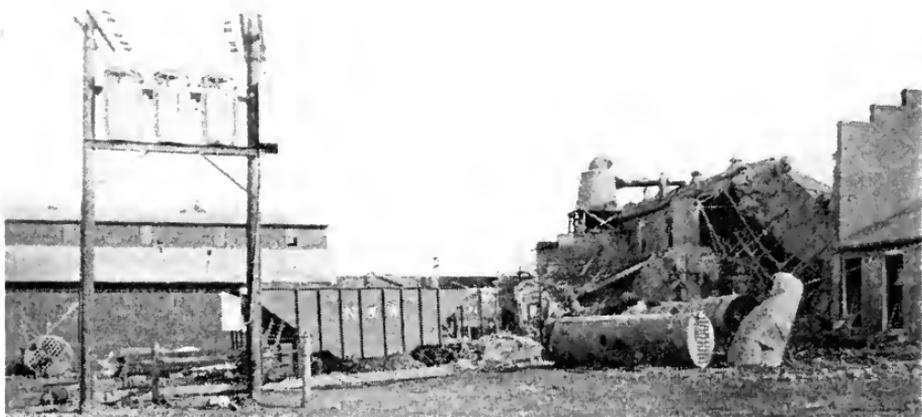
Another view of the mill at Hertford. In the foreground is No. 3 boiler and part of the stack. The front course of No. 2 boiler is shown at the extreme left where it fell after the explosion.

The accident had as its direct cause the weakening of the plate due to overheating. Overheating of a boiler comes about through two chief causes—low water or the presence of scale, sediment or oil within

Scale in the boiler was about $1/16''$ in thickness on an average and was as thick as $1/8''$ in places. Loosened scale, in conjunction with a binder of black sediment, consisting of sand, iron and vegetable matter formed a coating as thick as $1/2''$ in places and was probably thicker than this on the plate which ruptured. The appearance of the ruptured plate after the accident indicated that loosened sediment had accumulated in two distinct mounds about 3 feet apart on the rear course, these mounds being connected by deposits of lesser thickness.

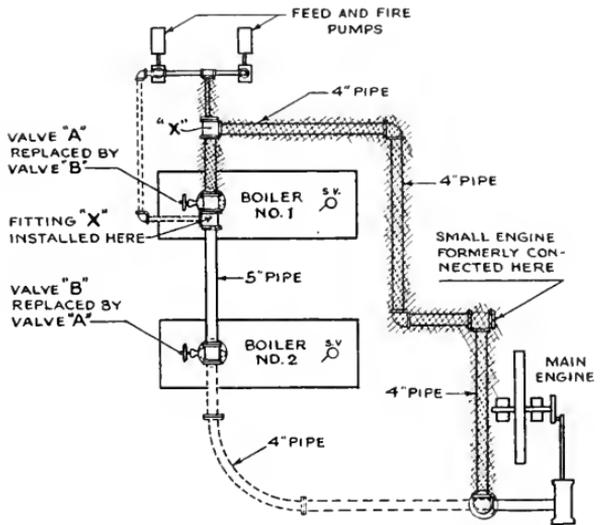
The general layout as he found it, was as shown in the cross-hatched portion of the accompanying sketch. The length of the piping between the boiler outlets and the engine consisted of 7 ft of 5" piping and 60 ft of 4" piping, making a total of 67 ft. In this length of pipe were 4 elbows and 2 tee fittings. Figuring that the resistance to the flow of steam due to the presence of 6 right angle turns would be about equivalent to the frictional resistance set up by the addition of 96 ft of 4" diameter piping, he concluded that in its passage from the boilers to engine the steam actually met with frictional resistance equal to that which would be set up by 163 ft of 4" diameter pipe.

With the exception of a 4" long-turn bend and the insulating material, the piping and fittings in position at the time of the investigation were utilized in a changed position. The indicator had brought to light evidence of a slight leakage of the engine admission valves, so

the assured was advised to have the cylinder ports rebored and new valves installed. This advice was followed and resulted in an appreciable saving of fuel.

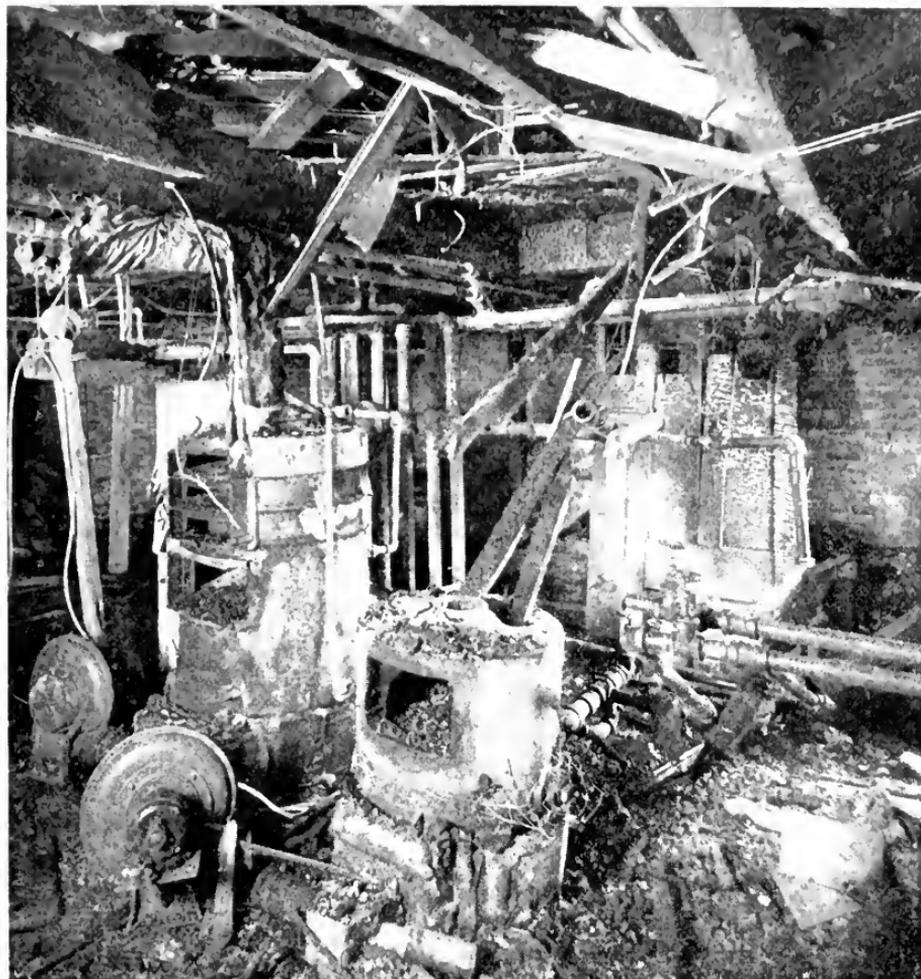
RESULT OF HEATING PLANT VIOLENCE

WHILE all available evidence indicated that an accident to cast iron sectional boilers used in an Ontario residence was due to the explosion of furnace gases, the investigators found it difficult to understand why the top section of the right-hand boiler was so badly shattered. The boilers were used in connection with a hot water heating system. The top section of the

smaller boiler went through two floors, hit the ceiling in the upper room and came to rest across the foot of the bed in which the housekeeper was sleeping. The opinion was expressed that internal steam pressure must have developed to some extent at least in a manner which available evidence did not make clear. No boiler insurance was carried.

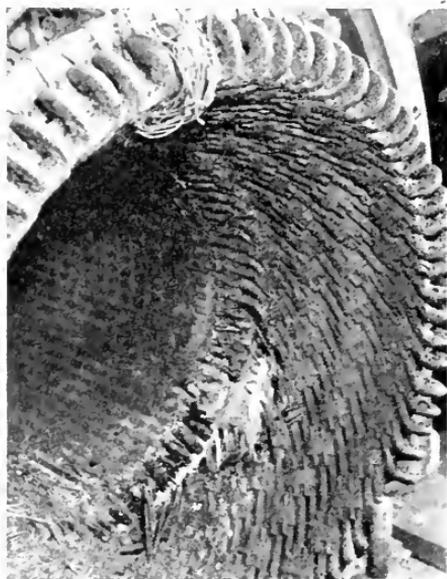
A small steel object resembling a part of a $\frac{1}{2}$ " bolt was found close to the radial end ring.

After Generator Burnout.

After the fire had been extinguished it was found that the coils in 44 of the 72 slots were entirely or partly melted, as shown in the accompanying photograph, and the field was grounded. The cause of the ground was attributed to molten copper finding its way inside the radial end ring and burning the insulation. Repairs included rewinding of both rotor and stator and the replacement of some of the iron.

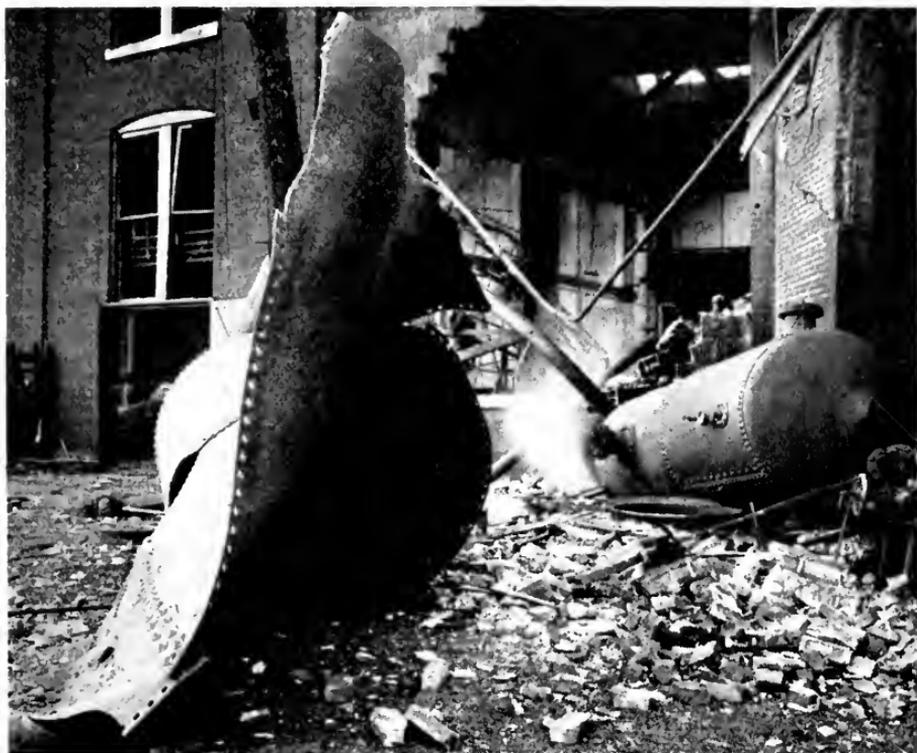
Following the ignition of lubricating oil vapor.

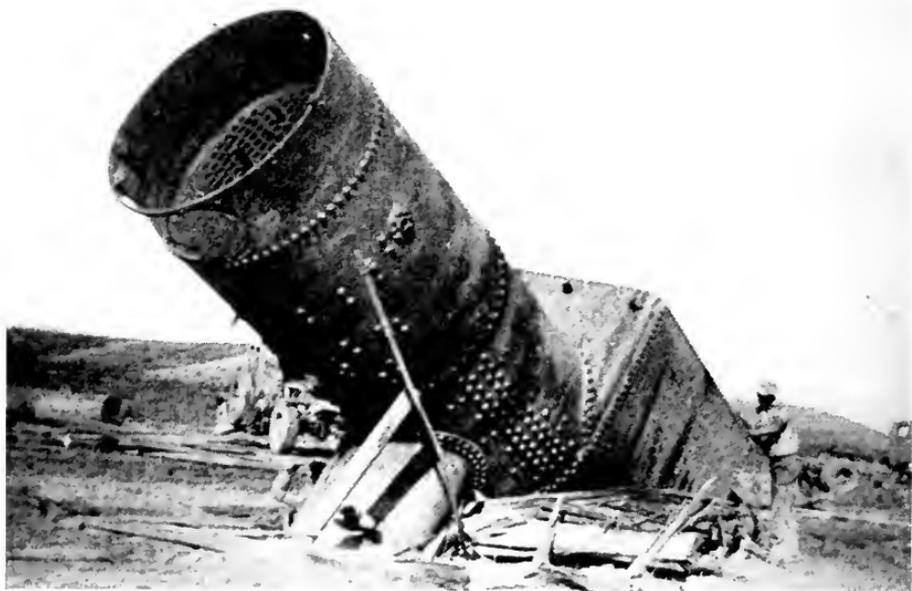
THE collapse of the crown sheet of a comparatively new 60" locomotive firebox boiler used at a Texas oil property hurled the boiler from its setting, caused property damage in excess of \$3,000 and burned a fireman about the face and arms. The boiler was the center one of a battery of three and in its flight it broke the steam connections to the other boilers and smashed the structure which held

After the crown sheet pulled off its stays.

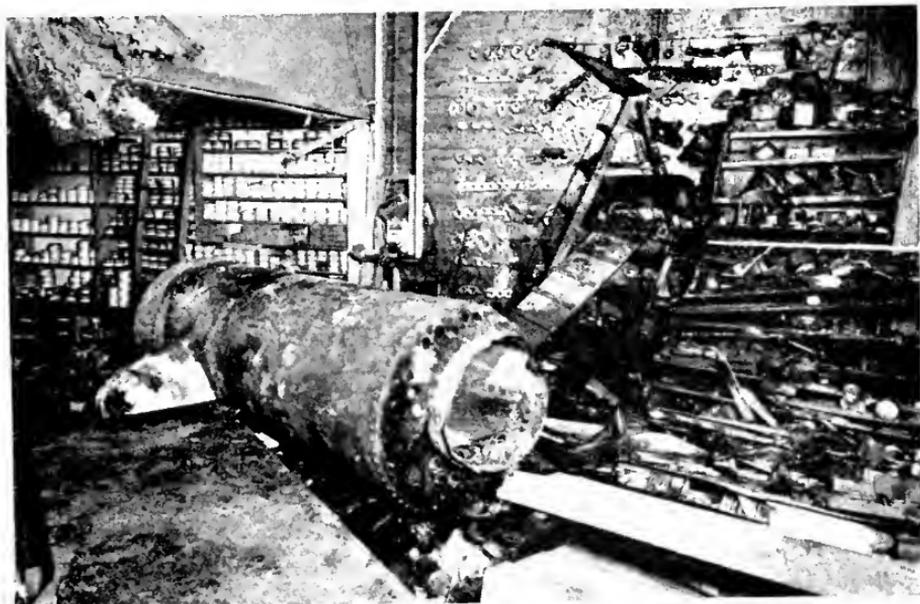
The 38" diameter boiler, where it landed in a neighboring store.

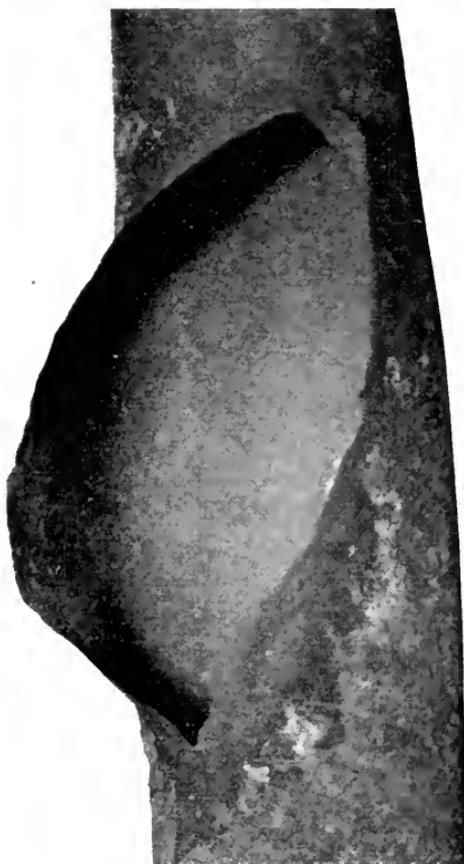
One man was scalded and more than 2,000 shoes workers in five plants were inconvenienced on February 9, 1934, when a 4" tube in a 500 hp boiler burst, putting out the fire and filling the boiler room with steam. Some power and heating needs were supplied by two 300 hp boilers which were brought up to pressure following the accident. However, other power needs were not filled until some three and a half hours later when an electrical connection was made with a local utility line.

Tube failure which had serious consequences.

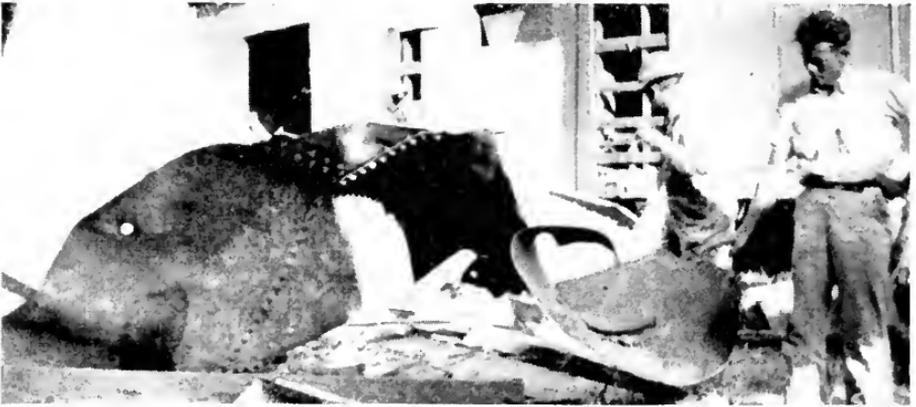
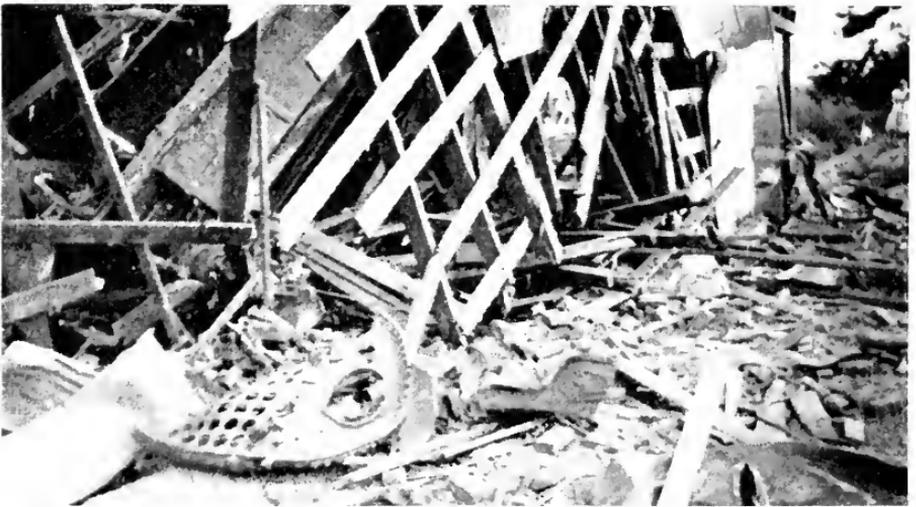
*Above—Middle and rear courses of Neal, Georgia, boiler.
Below—Where eight were killed in cotton gin boiler explosion.*

working around a cotton gin, or were watching the start of work on the 1934 crop. The gin structure was destroyed, and the bodies of two of the victims were hurled several hundred feet. The front tube sheet of

the 54" horizontal tubular boiler landed 600 feet from its former location and other parts were widely scattered. It was not determined what caused the accident although it was evident that there was considerable pressure in the boiler when the failure occurred.

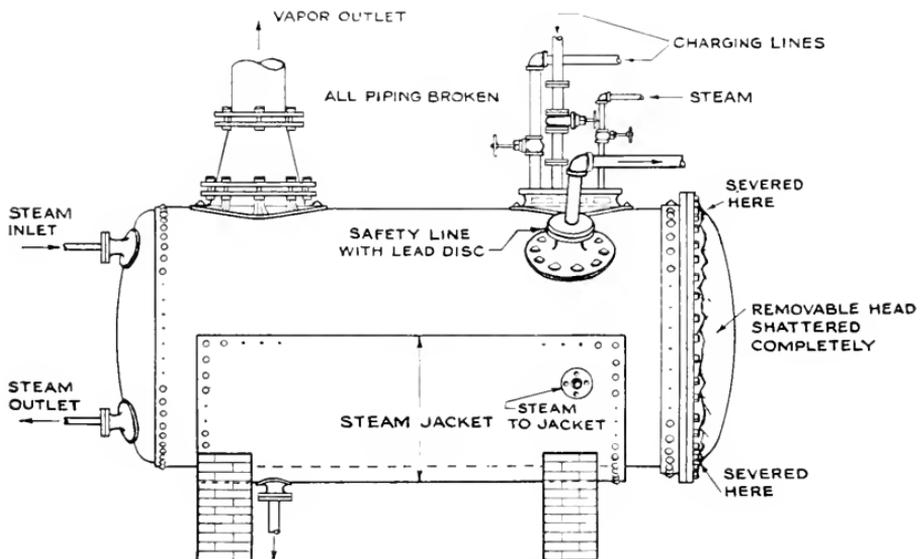
Figure 1—Diagram of still showing steam lines and head which failed.

THE explosion of a still used at a chemical plant resulted some months ago in property damage exceeding \$5,000. The cause was the accidental blocking of the pipe connected to the pressure relief arrangement, and the subsequent building up of steam pressure in excess of that for which the vessel shell was designed.

ture, it was customary, when starting, to admit steam to the shell as well as to the coils and the jacket in order to liquefy all of the still's contents. It was thought by investigators that the safety relief pipe was stopped up by the congealed material in the still at the time of the accident. In any event the safety relief failed to work and pressure built up within the vessel until the head gave way.

of 150 lb was used in the jacket and coils; and as the supplementary line leading to the shell contained no reducing valve, it was possible, with the relief valve inoperative, to subject the shell of the still to boiler pressure.

The force of the explosion shattered a removable cast iron cover at one end of the still and caused the rest of the vessel to leave its foundation and go hurtling across the plant. The connecting piping, which included a 10" diameter vapor pipe, was completely severed and the vessel itself passed through a brick wall where its progress finally was checked by a large storage tank. The parts of the cover were blown through the building, causing considerable damage.

that the chemical mixture had congealed in this pipe as well as elsewhere in the still and had prevented the functioning of the emergency pressure-relieving disc. To minimize the risk of a similar accident in the future, it was deemed advisable that the safety relief pipe be installed near the steam inlet to the shell itself in order that steam would enter the still above the contents in such a way that the space under the lead disc would be kept clear. In addition, a safety valve and also a reducing valve set at about 30 lb were recommended to be installed on the steam line to the still. This would make it less likely that boiler pressure would build up within the shell.

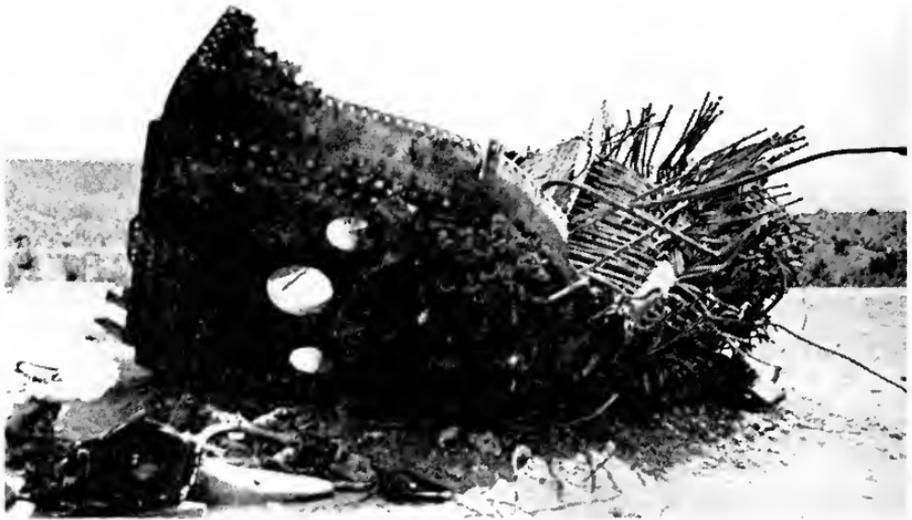
Part of locomotive's crown sheet and left wrapper sheet.

18, 1934, caused the death of three trainmen, and resulted in the derailment of eight cars and damage to freight and livestock.

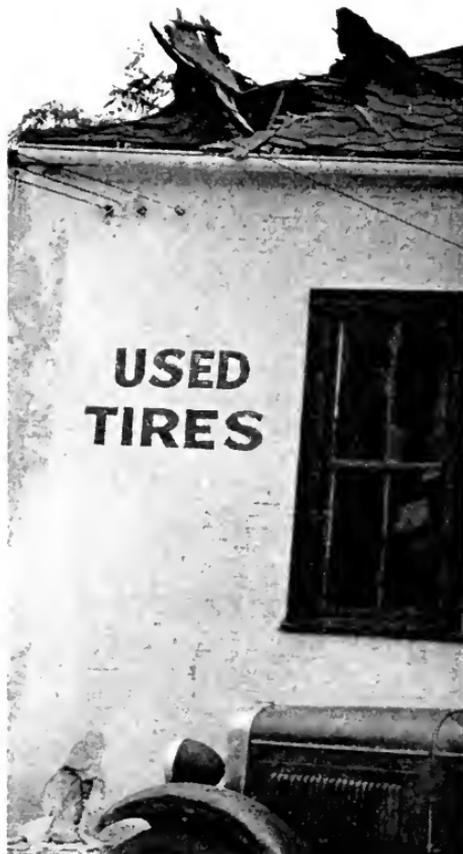
Buildings in the vicinity of the county fair grounds at Valparaiso, Indiana, were shaken when an air tank on the second floor work shop of a highway department garage exploded. The tank was 3' long and 1' in diameter, and according to witnesses was blown 100 feet into the air, scattering shingles in all directions. This explosion was attributed to the fact that the automatic cut-off failed to shut down the compressor at the proper time.

The air tank happened to go upward.

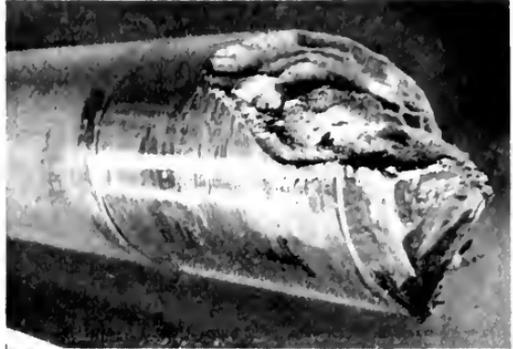
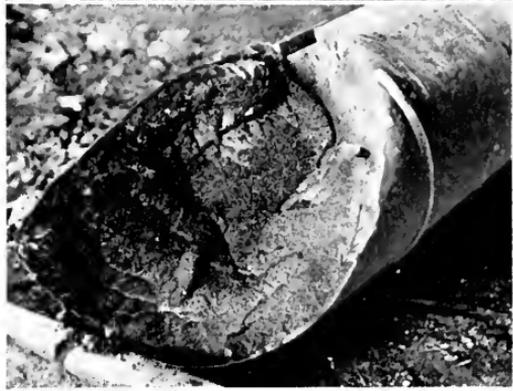
A progressive crack with stresses localized at the keyways was blamed for the fracture of a large shaft 15" in diameter and 17' long, used in connection with a mill roll train in an Ohio steel mill. The accident occurred on May 4, 1934, and consisted of a break in the connecting or extension shaft from the low speed gear coupling to the mill roll train. The part of the shaft which broke was enclosed in a bearing and the accident shattered the pedestal bearing cap, the shell and the pedestal itself.

The two pictures indicate the presence of an old crack at the keyway extending circumferentially about 9" and about 7" toward the center of the shaft. At the opposite keyway there was likewise an old crack which opened up about 1/16" and extended toward the center of the shaft several inches and circumferentially about 5".

Result of progressive crack in 15" shaft.

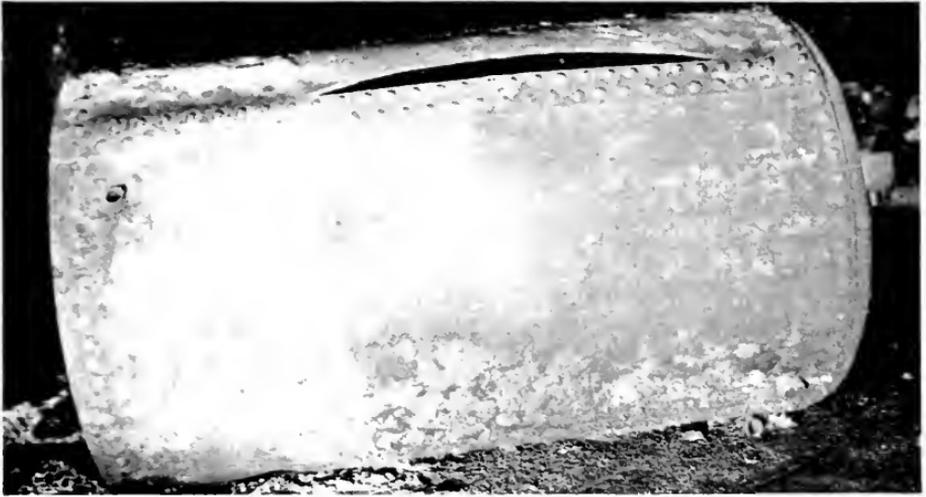
A lap seam crack in a 44" diameter vertical tubular boiler brought about an explosion in a New England utility plant on August 2, 1934, forcing the boiler

Lap seam crack inconveniences utility.

from its setting and projecting it across the boiler room. The accident caused little damage except to the boiler itself. The nature of the failure may be seen in the accompanying photograph. Following along the edge of the inside lap a distance of 41", the rupture extends from about 7½ inches below the top head seam and to within about 3 inches of the top staybolt. The boiler was under pressure of about 40 lb of steam at the time of the accident.

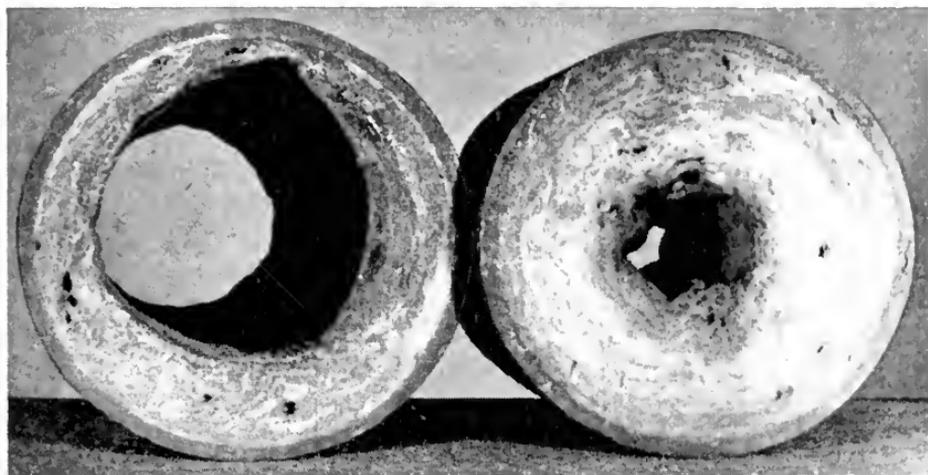
An extreme example of scale in boiler tubes.

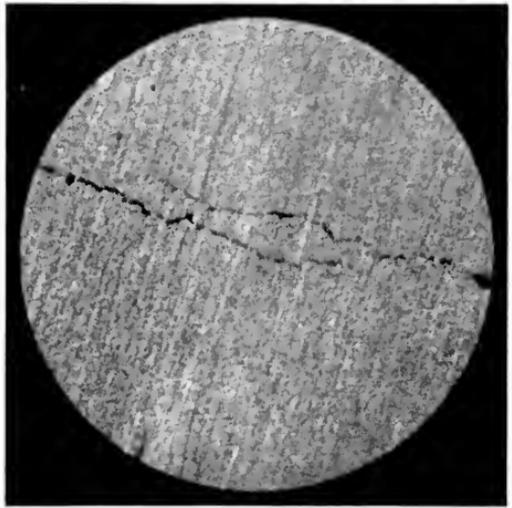
“Caustic embrittlement” under the Magniscope.

under the rivet heads; and second, stressing of the metal to about the yield point. It is an established fact that the zone of greatest stress in fabricated boiler seams is in the riveted area, and it is there that deterioration of the boiler steel, resulting from “embrittlement”, occurs.

There have been indications, based on laboratory research, that phosphates, tannins, chromates and other materials possess value for inhibiting "embrittlement" of boiler steel. At a few steam stations some of the materials, especially the phosphates, are now being employed, under competent supervision, and the recommended sulphate ratios disregarded.

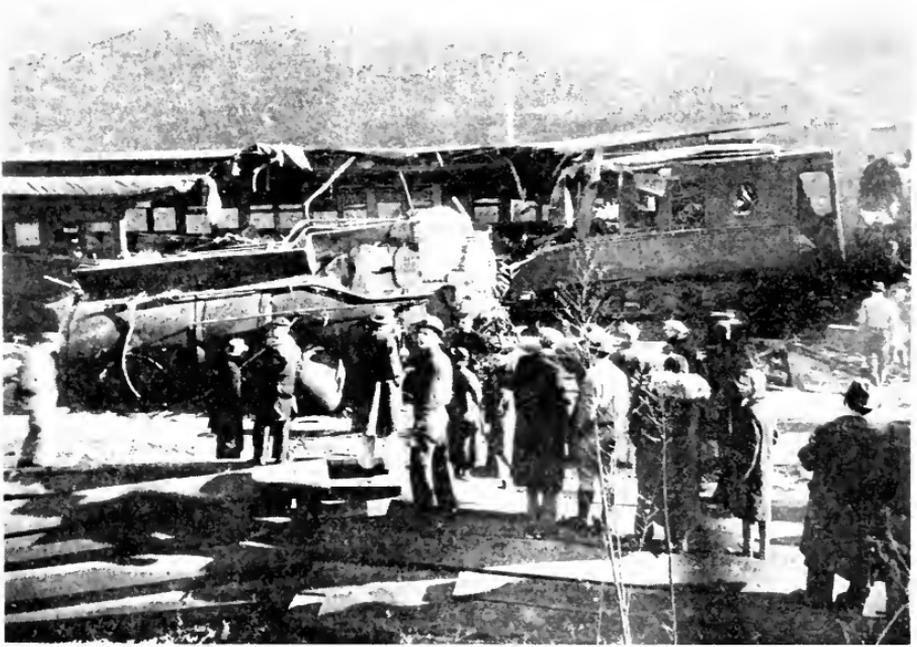
SIXTEEN men lost their lives and forty-two were injured, some of them seriously in the early morning of December 27, 1934, when a railroad locomotive boiler exploded, hurtling in the air and crashing down on a wooden passenger coach.

Where 16 miners lost their lives in locomotive boiler tragedy.

Failure, which was attributed to low water and overheating, evidently occurred in the crown sheet, the released steam tearing off the engine's smoke box cover and hurling it into the first car, which was coupled to the front end of the locomotive. Simultaneously the boiler was blown up into the air, and came down in the center of the leading coach, tearing away the top and one side. The cab was hurtled through the roof of a nearby house.

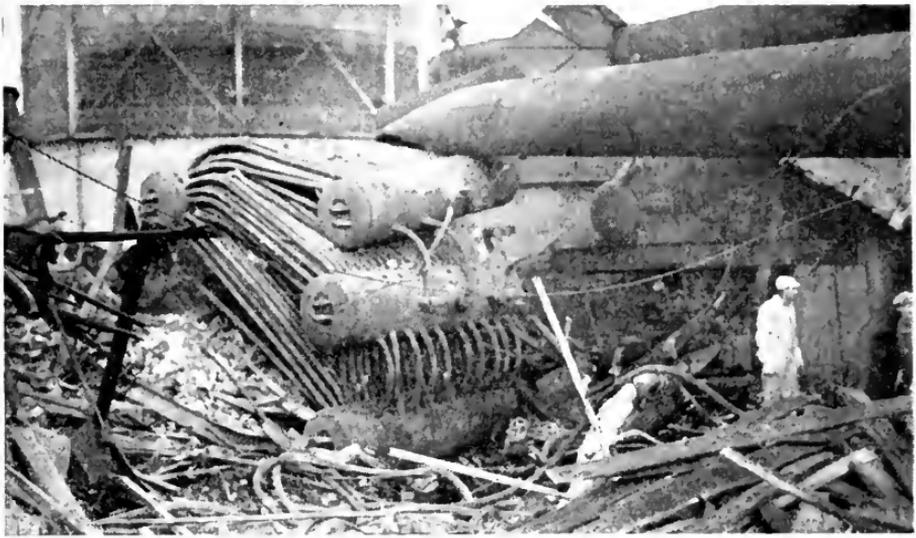
The explosion was attributed to the failure of the concealed head

Wreckage after failure of concealed mud drum head.

of the lower drum in a 250 hp bent tube type boiler. The blank head is reported to have plowed through the setting of a second boiler, bending the shell, smashing through the tube banks and passing out through the setting on the other side.

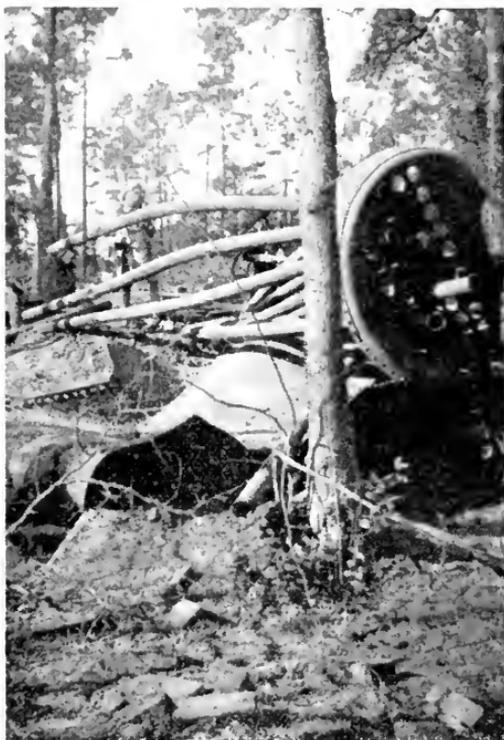
SIX men lost their lives when a second-hand horizontal tubular boiler exploded at the scene of hard-wood lumber cutting operations near Baggs Bay, 15 miles south of Claxton, Georgia, on December 12, 1934. The photograph shows a section of one of the heads and some of the tubes. An investigation revealed that the initial rupture probably occurred in the rear tube sheet around the manhole opening. The sheet had become thin at that spot as the result of corrosion from a leaking manhole gasket. The boiler was of the horizontal tubular type, 48" diameter and 12' long. Its two courses had double lap riveted longitudinal seams.

*Part of exploded sawmill boiler
in Georgia forest.*

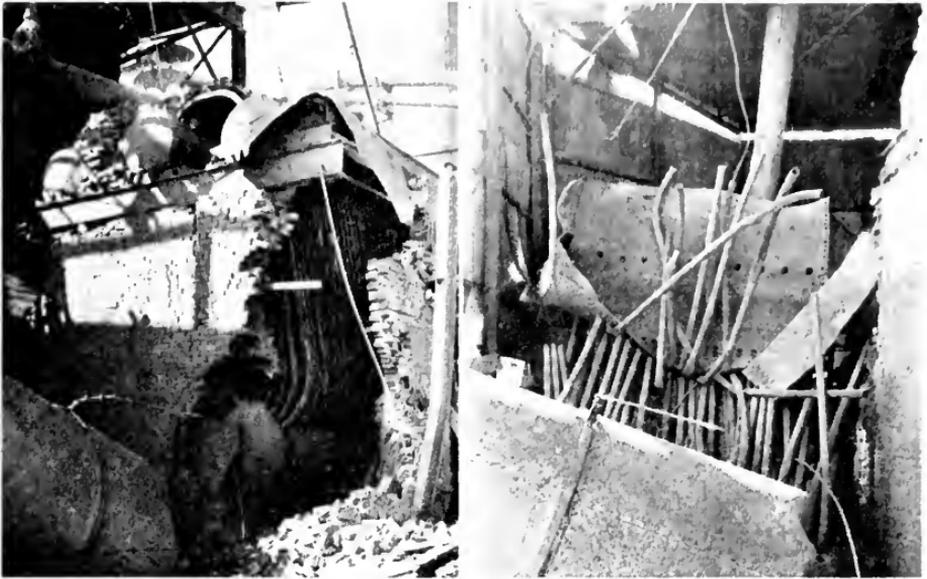
THE top rear drum of a bent tube type boiler operating at 89 lb exploded on October 22, 1934, at a southern cooperage works, causing property damage and minor injuries to three men. Failure started in the double-riveted lap-joint of the longitudinal seam. The tear ran through the row of rivets next to the caulking edge for about 6 feet, then through the solid plate to the heads at each end

and finally into the heads themselves. So severe was the blast that it demolished the setting of an adjacent boiler, blew down the sheet-iron boiler shed, and brought the steel smokestack crashing down on the ruins.

Damage from explosion of water tube boiler after seam failed.

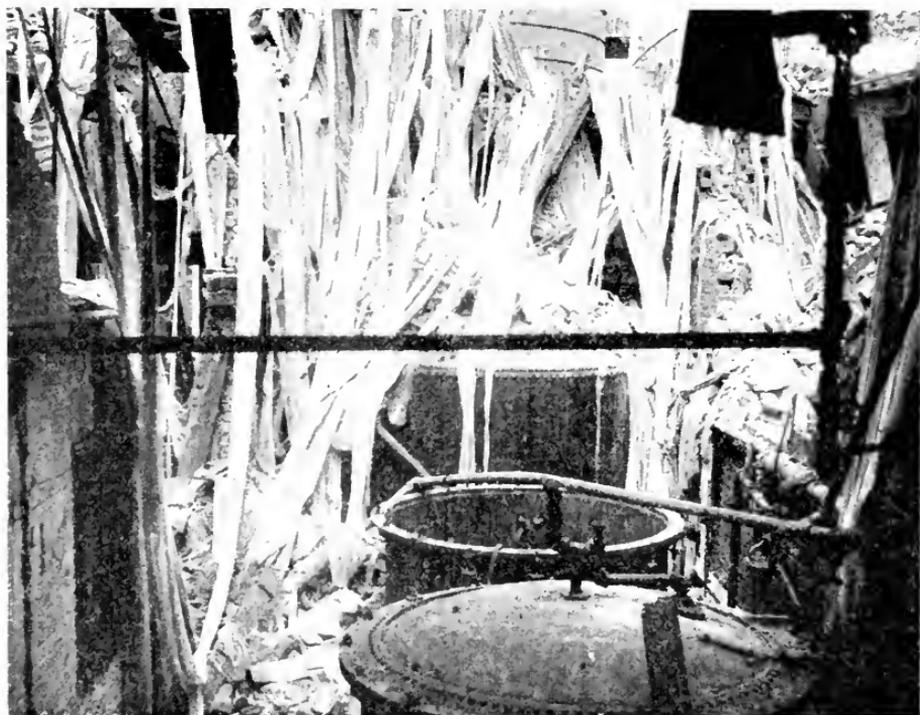
Empty kier and contents. The head landed in a nearby street.

The accident blew the 1000 lb cover over an adjacent one story building, the heavy metal disc coming to rest in a street about 80 ft away. The contents, which happened to be 30,000 yards of cheesecloth, were hurled in the opposite direction and strewn over nearby buildings, draping them in fantastic fashion much to the interest of the residents of the thickly settled neighborhood. The brick walls and roof of the building housing the kiers were wrecked, and bricks and large stones, which were hurled onto the roofs of four adjacent houses, resulted in some damage to them and in minor injuries to their occupants.

The train of events which led to the explosion probably never will be accurately known, but probably the circulating pipe became clogged, thereby permitting pressure to accumulate in the lower part of the vessel to such an extent that the entire contents were moved upward toward the top of the kier, eventually closing the relief valve outlet and the outlet to the steam regulator. This would have caused the regulating device to remain in full open position and admit boiler pressure to the vessel, which was more than the head of the kier could stand.

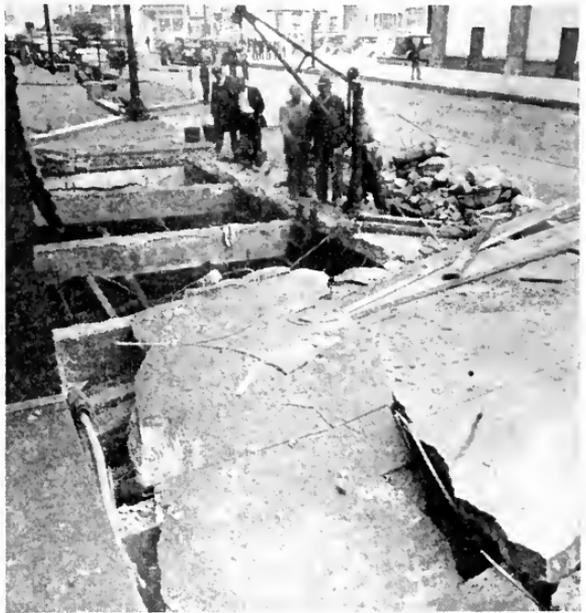
ONE of the most disastrous accidents of its kind occurred on October 12, 1934, at the plant of an Illinois cold storage company, when a bursting steam engine flywheel ruptured an ammonia condenser, releasing liquid ammonia which vaporized, mixed with air, and exploded with great violence. Two men were killed, seventeen were injured, and property was damaged to an extent estimated at \$80,000. The steam engine, direct connected to a generator, had been brought up to speed and the generator had just taken over the load when there was a flash in the generator and it started to burn. The engineer immediately closed the throttle, but at that instant the 5'2" engine flywheel burst.

It is impossible to say in just what order subsequent events occurred. However, it was reported that when an oil separator broke under the impact of a fragment of the wheel, the oil was ignited and caused an explosion of minor violence. A little while later, ammonia gas having been released from an ammonia condenser and from a high pressure ammonia pipe, both damaged by the flywheel, there was another explosion of extreme violence which shook the surrounding neighborhood and greatly damaged the buildings of the cold storage company. Girders were blown from their moorings and tossed against a building across the street, a part of the lower floor wall was hurled down, and a stretch of concrete sidewalk was torn up for almost the full length of a city block. A part of the damage outside the building is shown in the accompanying photograph.

Result of ammonia explosion in cold storage warehouse.

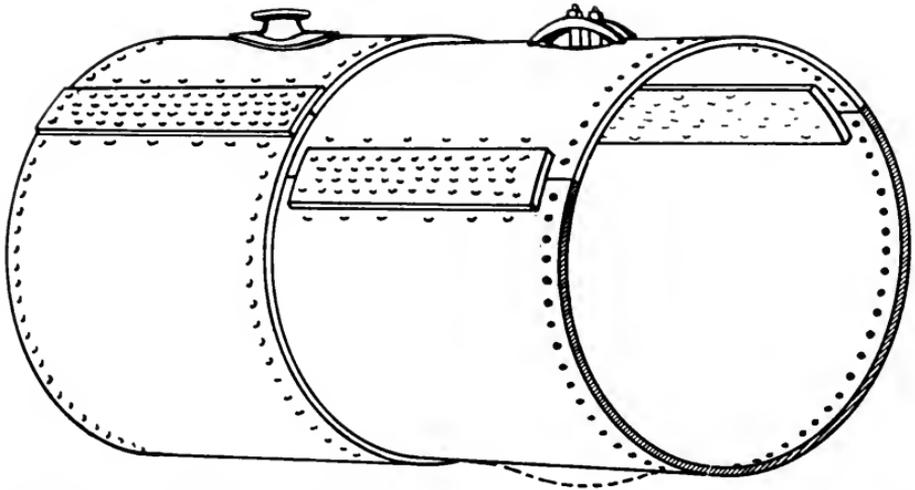
Figure 1—Repair of a bulge caused by overheating because of an oil deposit on the plate.

When a new fire sheet is installed, the longitudinal seams must be located well above the fire line. It is good practice to attach the new

sheet on one side at the original longitudinal seam of the course. On the other side the new seam should be located so that it will "break joint" with the longitudinal seam of the adjoining course, that is, the two seams should not be at the same point on the circumference of the boiler. (Figure 1). The cost of a repair of this kind, when made with the boiler in place, may exceed the cost of putting on a complete new course at a well equipped boiler shop. The expense of removing the boiler from its setting, shipping it to and from the boiler shop, the repair work (which is likely to include a number of new tubes), and the reinstallation of the boiler will probably equal, if not exceed, the cost of a new bare boiler. All of these factors, in addition to the question of safety, must be taken into consideration when deciding upon what repairs to make and how to make them.

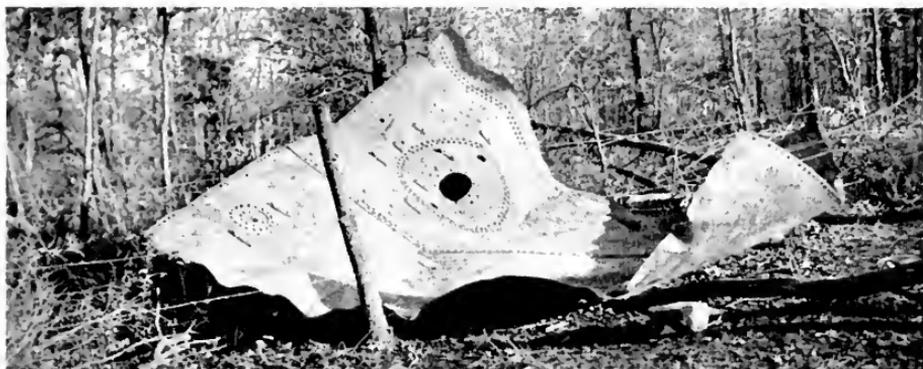
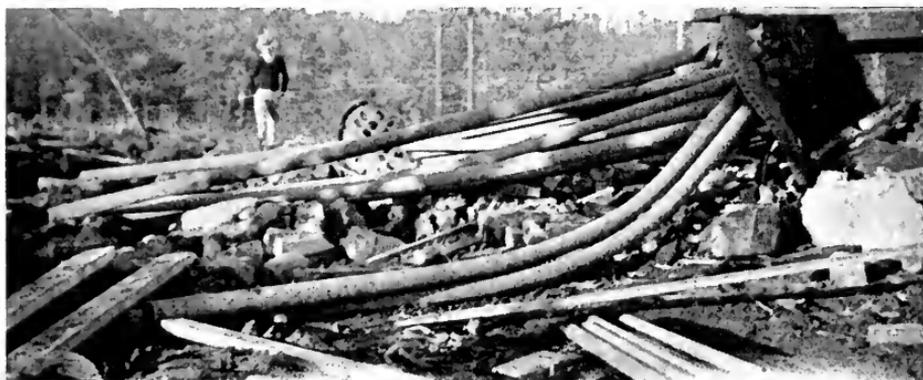
FOUR men lost their lives as the result of a sawmill boiler explosion at Woodman, Kentucky, on January 2, 1935. A crack in a lap seam of a locomotive firebox type boiler opened up with force sufficient to blow the boiler over a slab pile 20 feet high. A steam engine nearby was demolished. The men, who were eating their lunch

Parts of mine boiler following its explosion.

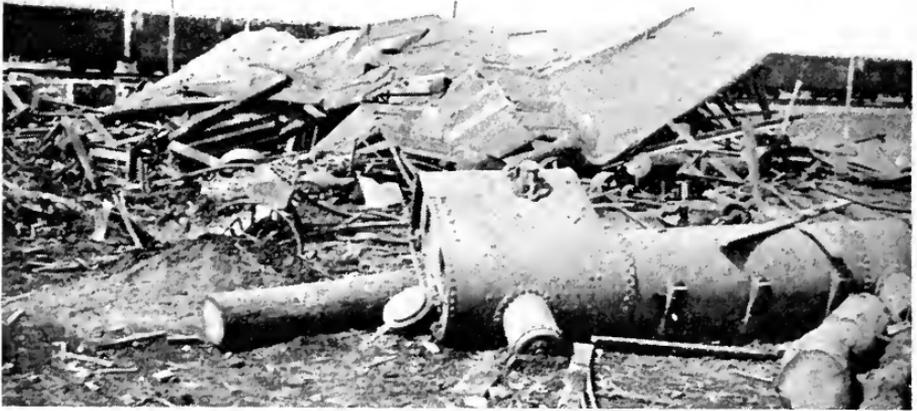
Complete destruction of a southern mill by a boiler explosion.

ago. Attention was called to the boiler by its safety valve blowing. As the negro fireman went to attend to the boiler, it exploded, killing him instantly. Overheating and rupturing of the fire sheet because of low water was given as the cause of the accident.

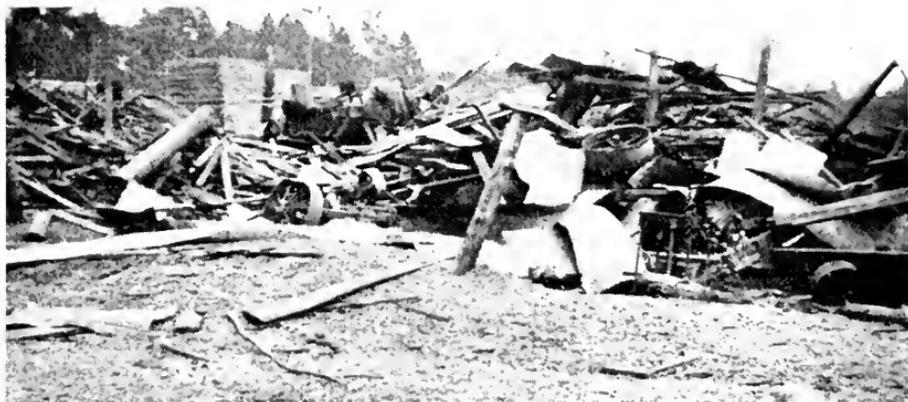
The above photograph shows wreckage after a boiler explosion at a Southern lumber mill in June. Two persons were killed instantly and four seriously injured. Property loss was estimated at \$5,000.

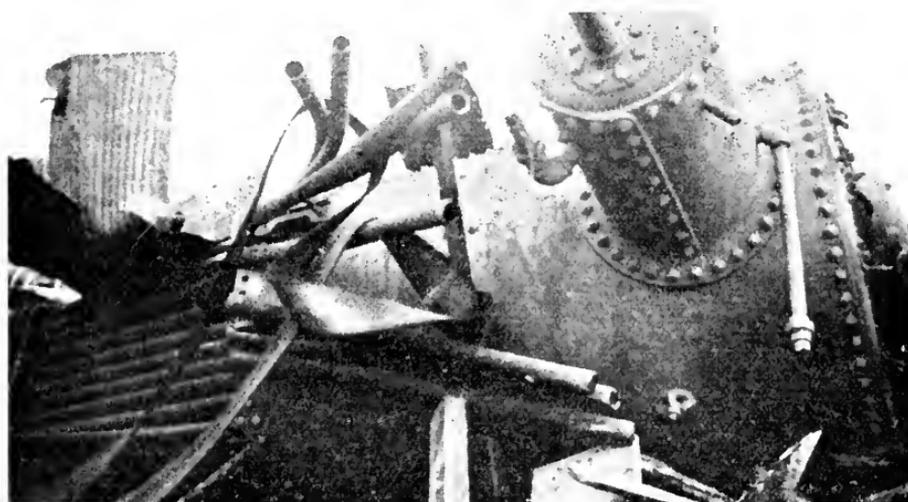
This boiler caused the wreckage in the picture at the top of the page. It is a dry back marine type and was mounted on wheels. An investigation revealed that the accident was caused by the cracking of the shell plate along the edge of the inside butt strap. The plate gave evidence that there was an old interior crack which had spread through the plate as the result of flexing action. The force of the explosion hurled the boiler about 25 feet.
