The Locomotive

THE HARTFORD STEAM BOILER
INSPECTION AND INSURANCE CO.

VOL. XL

1934-1935

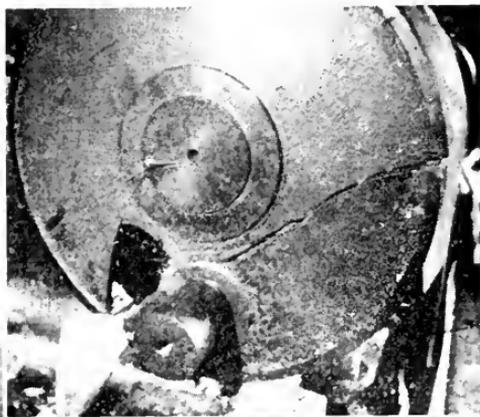
WHEN a crank disc of a paper mill engine broke on May 22, 1935, the engine and its 6' belt wheel stopped suddenly, the wheel flew to pieces and the 200 hp variable speed twin engine was wrecked beyond repair. Large paper machines rolled to a stop and a New Jersey mill faced costly delays because it could not fill its orders. Insurance took care of the direct damage loss to the machine and of the use and occupancy losses, but the mill wanted to make paper. Its customers wanted delivery.

Spoke stumps and a tangle of belts and machinery after the engine stopped suddenly. Above—The cracked crank disc.

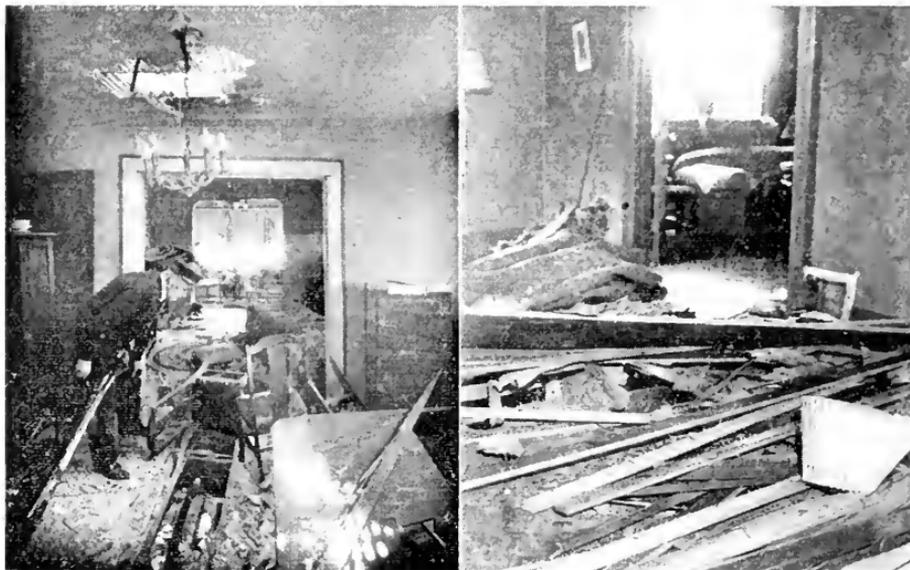
Forgetfulness in leaving non-automatic burners in service was blamed for the two accidents to small hot water tanks in residences pictured on this page. That at the left occurred in a Middle Western residence which was lifted from its foundations. The hot air furnace

After hot water tanks hurtled upward.

was demolished and several rooms damaged as the tank forced its way through floors and the roof. The photograph at the right shows the living room of a New York residence, after a hot water tank had exploded. Passing through two floors and the roof, the tank landed 70 feet from the house. The force of the explosion and actual physical damage by the tank itself virtually wrecked the dwelling. Both accidents were attributed to a combination of over-heating and over-pressure. On automatically controlled installations and on an increasing number of manually operated burners, pressure and temperature relief valves are being used to reduce the likelihood of accidents of this sort.

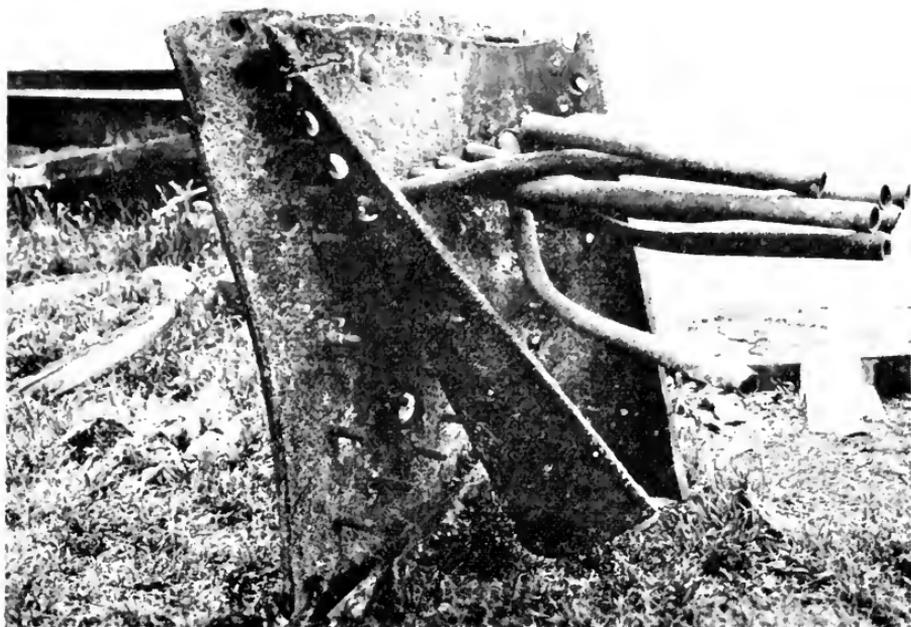
Once part of a hot water supply system.

was of fusion welded construction and was operated without automatic control, although there was a relief valve set at 105 lb. The normal service water pressure was 90 lb.

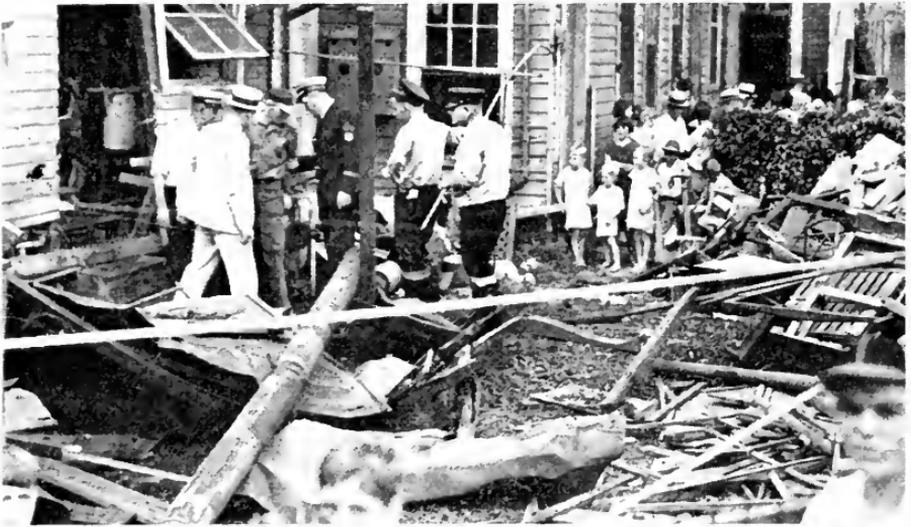
At 7:01 A. M. on June 2, 1935, the boiler operator of a Southern cleaning and dyeing company was attending his boiler. At 7:02 A. M. he was 30 feet in the air looking over buildings at traffic in a street some distance away. Then he plunged back to a friendly plot of soggy earth. His injuries proved slight. The 42" dry back marine boiler, which had caused the trouble, went 200 feet, demolishing part of the building housing it, carrying off a porch, and damaging a store and an apartment kitchen in its flight. The injured operator said the explosion occurred just as he was about to "turn some steam into the plant pipes." Apparently the furnace of the boiler collapsed as pressure rose. Part of the damage is depicted in the photograph.

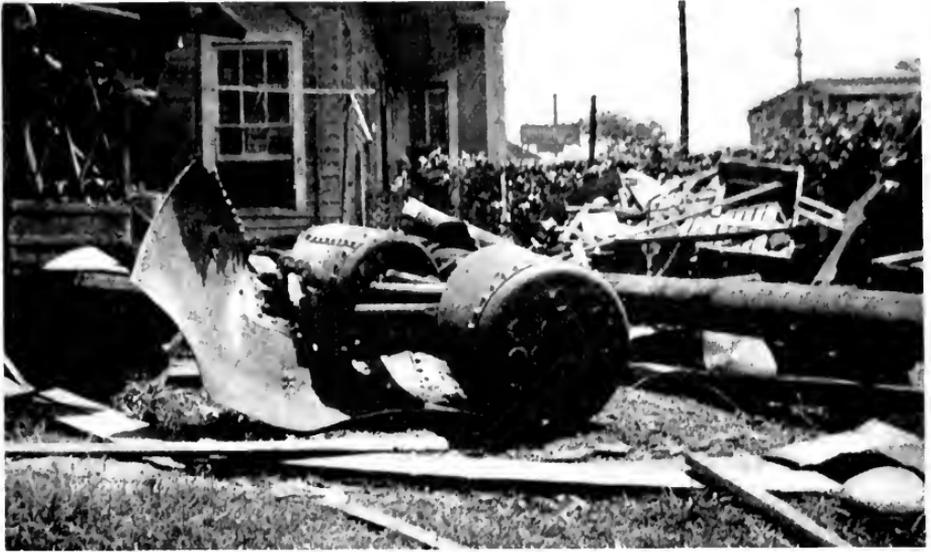
The woman proprietor of another Southern cleaning establishment sustained serious injuries when the small vertical boiler, 20" in diameter and 4' high (shown above), exploded on June 4, 1935. Corrosion just above the base ring, a common cause of failure in this type of boiler, was blamed for the accident. The woman's shop was wrecked.

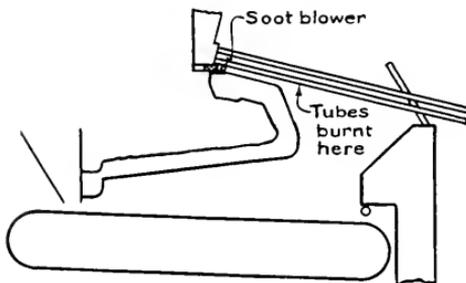
Repeated burning out of the bottom-row tubes in a battery of water tube boilers caused much speculation at a Springfield, Illinois, plant. Failures always occurred at some distance from the front header, and looked as if a blow-torch had been directed on the tubes. The trouble, according to Julius Brodsky in *Power*, was traced to the soot-blower. The arrangement of the soot-blower steam jets was such that it was impossible to keep an air seal

between the bottom of the header and the ignition arch. With air flowing through this opening and contacting unburned gases from the furnace above the back end of the ignition arch, combustion occurred with blow-torch intensity and damaged the tubes. The soot-blower arc of travel was changed so that steam would not impinge on the header, and an air seal was provided under the front header by laying a row of brick, caulking with asbestos rope and finishing with asbestos fire-clay plaster. Provisions were also made for admission of additional air over the fire, so as to complete combustion of gases before they struck the tubes. After correcting the conditions, no further tube failures occurred.

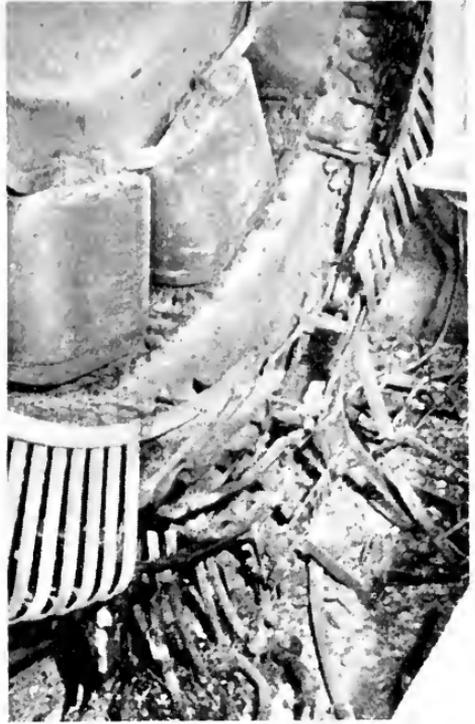
SHORT circuiting and fire in a water-turbine generator at a New England power plant some months ago, resulted in a loss of more than \$8,000 to the unit and smudge and fire damage in the room housing it. The 3-phase, 2,300 volt machine had been re-wound only a few months before the accident. This fact, coupled with an excellent system of maintenance, made the possibility of gradual breakdown of the insulation remote. The immediate cause of the accident, however, was a short circuiting which originated in the leads between the winding and the machine terminals. Investigators blamed the trouble on an electrical disturbance outside the plant, which produced a line surge that broke down the lead insulation. Repairs involved the reinsulating of 12 field coils and 202 bar conductors, and replacement of damaged wires, cables, conduits, and lightning arrestors. The loss was covered by insurance.

Windings and leads damaged by short-circuiting and fire

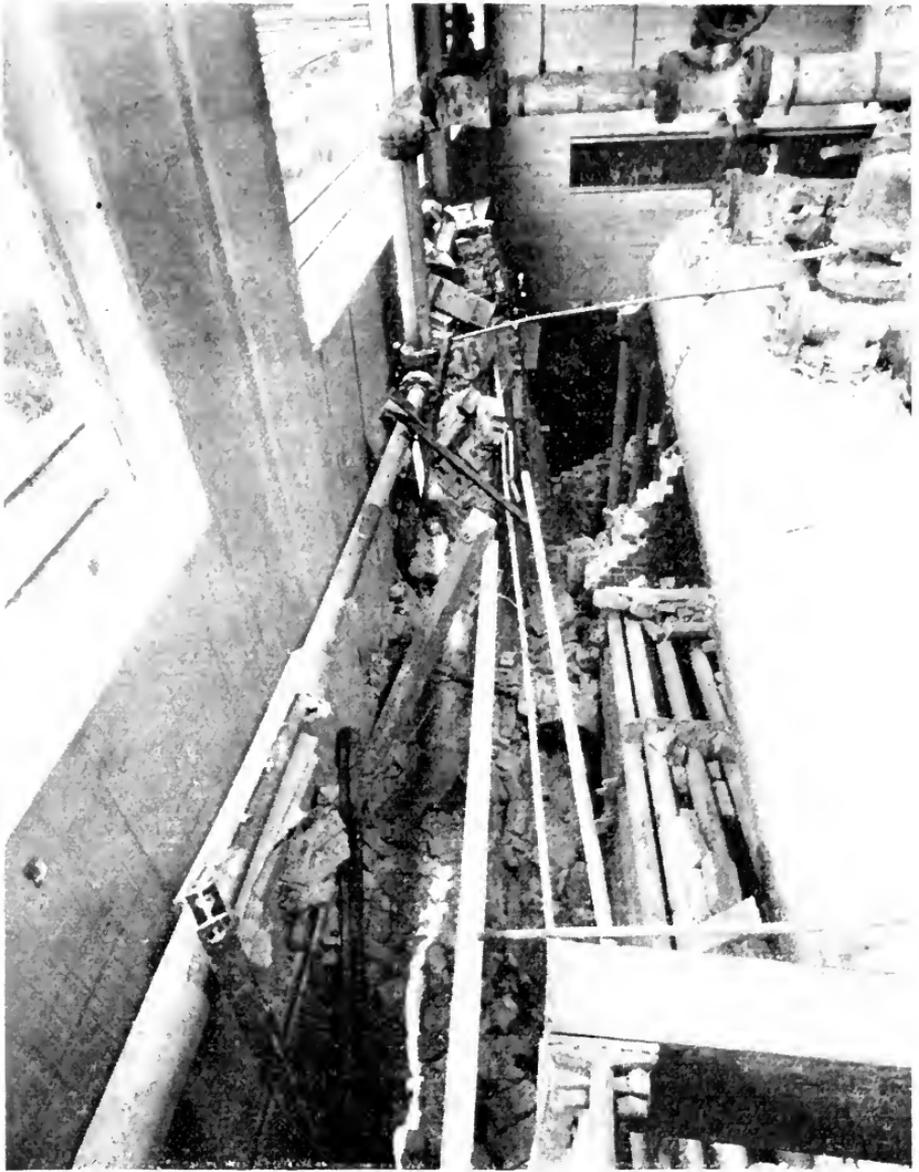
IN USING natural or manufactured gas as a boiler fuel, straight way plug cocks are necessary in the lines to each burner, if the proper degree of safety is to be maintained. A recent furnace explosion accident in the West was directly attributable to a leaky globe valve which permitted gas to accumulate in the setting of an idle boiler. The resulting mixture of gas and air was accidentally exploded with force sufficient to blow down the boiler setting, as shown on Page 249.

Two water tube boilers were connected to the same breeching and separated by a center wall. Both boilers were off the line and the furnace brickwork of boiler No. 2 was being repaired. In order to dry out the brickwork, a small fire had been built in the furnace. It was this fire which ignited the gas in No. 1 boiler setting.

Brick masons worked night and day to rebuild this setting.

had not presented itself. In any gas-fired installation the pipe to each burner should be provided with a straight-way plug cock marked in line with the passage, and there should be a rising spindle gate valve or some equivalent device which indicates positively whether the valve is open or closed, and which can be seen from a distance.

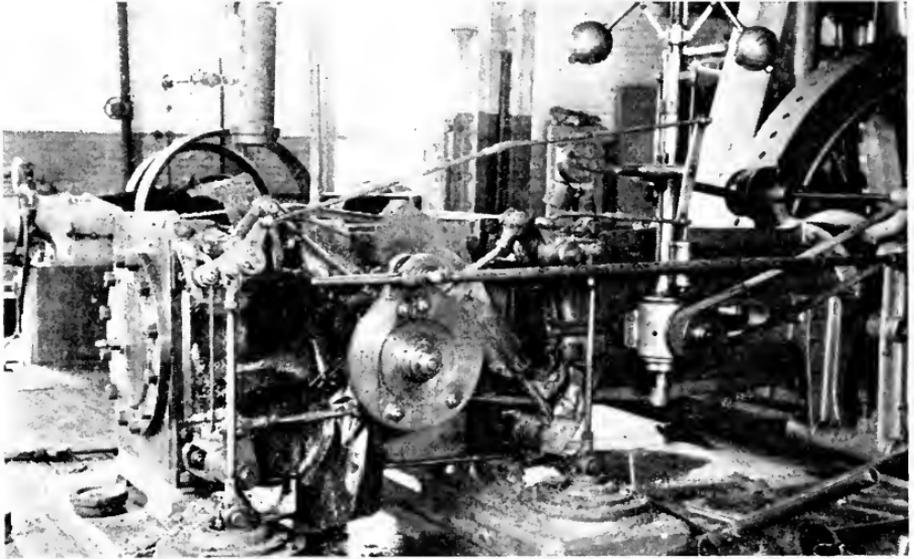
Steam end of compressor after the blowing out of the exhaust-steam cylinder-jacket.

could finish the operation, the exhaust steam chest blew off the cylinder, bending various reciprocating parts and breaking the throttle valve and piping.

In seeking the cause of the accident, investigators considered several contributing factors. Although the steam pipe was well drained by traps, they felt that water may have gotten into the cylinder at some prior time and the "bump" then sustained may have started cracks in the cast iron. The face of the break showed two old defects, each about 2" long, but otherwise the metal was clean. A new 18" steam cylinder, a new throttle valve and the repair of the valve gear and other parts were necessary to restore the compressor to service.

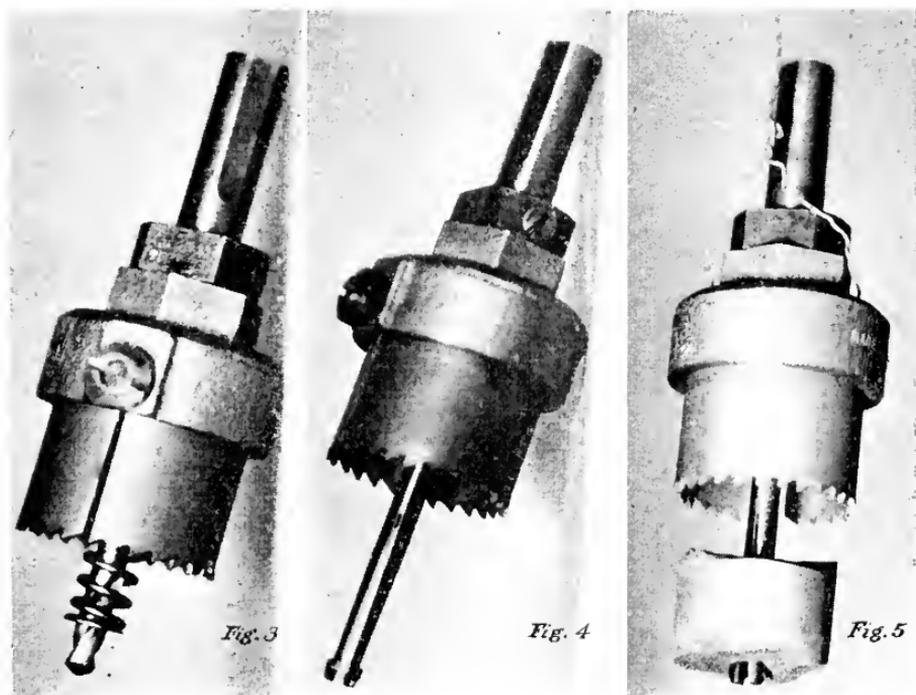
Figure 3—Tool used for trepanning a plug from a welded seam.

Figure 4—Special spring and split pilot developed for trepanning tool.

Figure 5—How the plug is withdrawn from the hole.

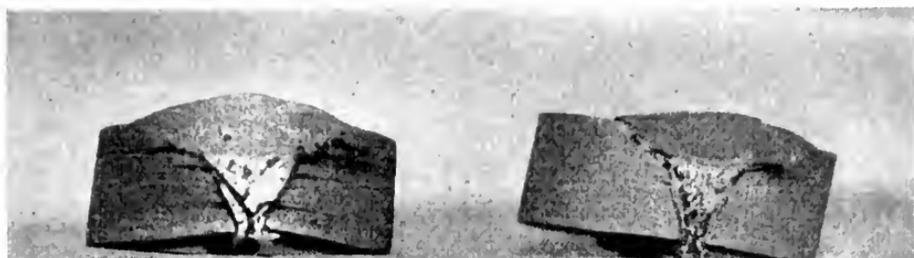
*Fig. 6*

Figure 6—Specimens from a fusion welded ammonia brine cooler.

Some examples of plugs that have been cut from questionable vessels will be of interest. Figure 6 shows specimens removed from a fusion welded ammonia brine cooler which had been in service for several years. It is interesting to compare these plugs with the etched cross section of the weld shown in Figure 3. What might have happened if the vessel, from which the plugs were cut, had remained in service may readily be conjectured.

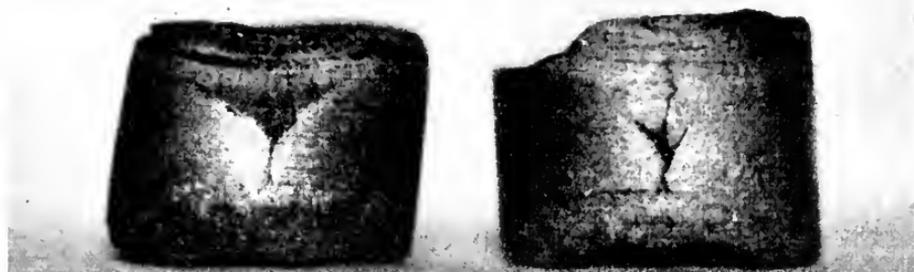
*Fig. 7*

Figure 7—Plugs cut from a fusion welded ammonia generator.

Figure 7 shows plugs cut from a fusion welded ammonia generator in an absorption system. After seeing these plugs, the owner decided to replace the vessel.

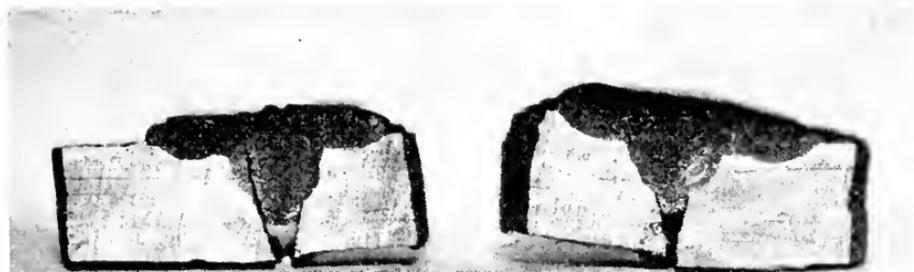
*Fig. 8*

Figure 8—Plugs from a fusion welded soap kettle.

Figure 8 shows specimens cut from a fusion welded soap kettle. The defective seam of this vessel was rewelded by a competent operator.

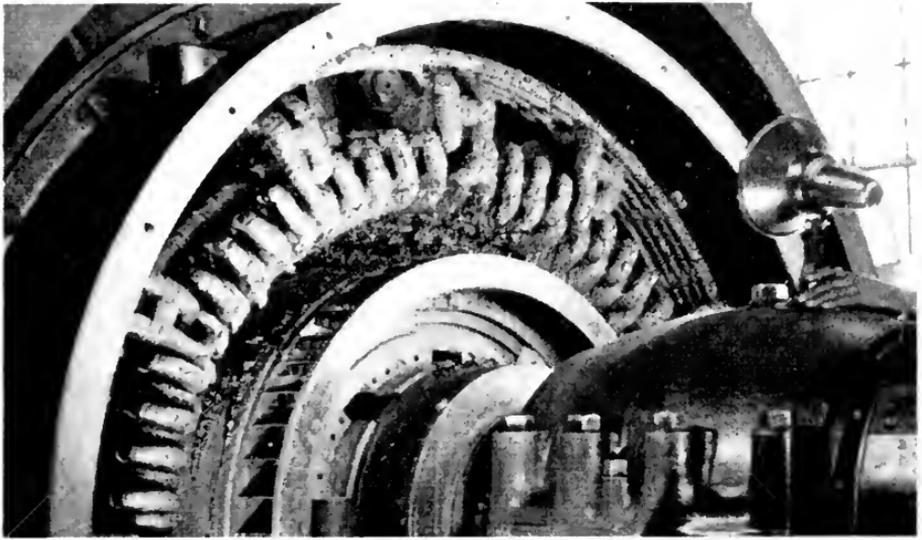
It was found afterward that neither the generator oil switch had been opened nor had the field control functioned because this equipment had been damaged by the arcing and ensuing fire at the control box on the oil switch. While the switchboard operator was attempting to clear the board, the turbine floor operator tripped the throttle on the turbine driving the alternator which was feeding power into the arc at normal frequency until the steam was shut off, and then at a decreasing frequency until the turbine unit came to rest. The No. 1 Edison feeder

Collector ring end of the idle alternator after its electrical burnout.

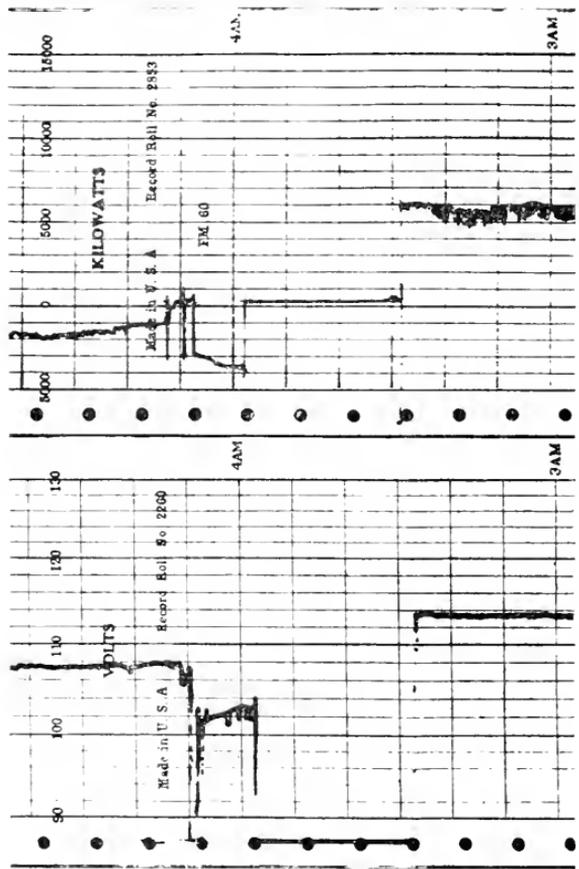
A terminal connection in the middle cell of the oil switch for the generator in operation heated and started little pin arcs. This trouble gradually grew until a sufficient arcing developed to vaporize some of the brass or copper. The arcing followed the vaporized metal and finally involved all three phases. The energy for the arc was supplied from the operating 10,000 kw alternator and the No. 1 Edison feeder. The arc-

An accident in graph form. Above—Wattmeter chart showing power conditions on No. 1 Edison feeder. The generator stopped supplying power at about 3:28 A. M. The plant was dark until 3:58 A. M., when utility power was admitted for ten minutes, burning out the idle alternator. Below—Bus voltage chart for the same period revealing why the plant's direct current motor-generator sets would not start during the 10-minute interval mentioned above.

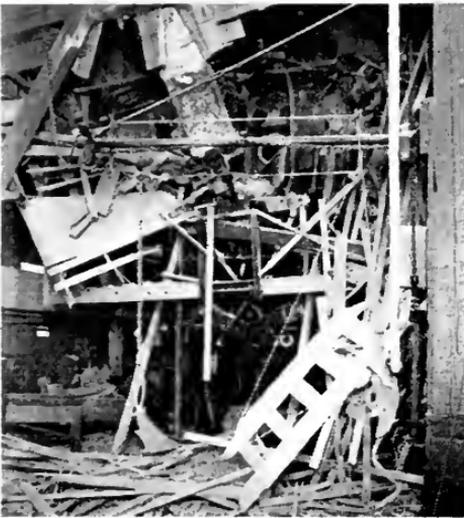
*Cotton compress after explosion
of its steam cylinder.*

The cause of this accident was undetermined, but it is probable that a crack had weakened the cylinder, which is open at the top and is of massive construction with girthwise reinforcing ribs and a heavy flange at the top. The cylinder broke into four pieces, each of them weighing many hundred pounds.

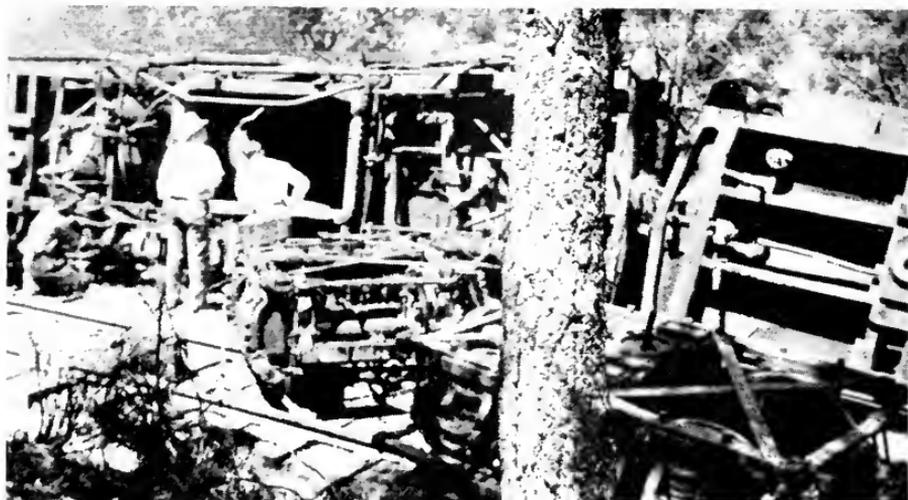
FIVE men were injured on July 29, 1935, when a locomotive fire box type boiler at an Illinois saw mill exploded, supposedly because the safety valve was corroded in its seat. When the rising pressure could not be relieved by normal means, it blew out the lower sheet of the barrel. The force thus released virtually demolished the mill. One man was thrown against a shed, the blast tearing off his overalls

Scene of logging locomotive explosion.

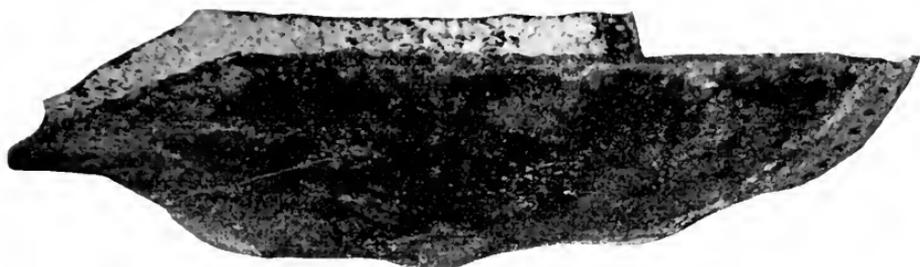
Bagged plate showing bulges and scale accumulation.

Southern lumber mill on October 5, 1935. The bagged area was on the rear course near the blow-off flange and extended approximately 50" girthwise of the boiler and 40" lengthwise. The most serious bulge was 8" in depth and there were two ruptures, one 3" long and another 3½" long, at the bottom of the bag. The bulging had caused the rear tube sheet to pull forward about 2" and the lower rows of tubes to distort. According to the plant manager, the first warning of the trouble was the fireman's report that he could not keep water in the boiler. It is evident from the photograph that the inside of the plate carried a heavy coating of adhering scale. In addition to this, however, there undoubtedly was a large accumulation of loose scale which fell off when the section was removed.

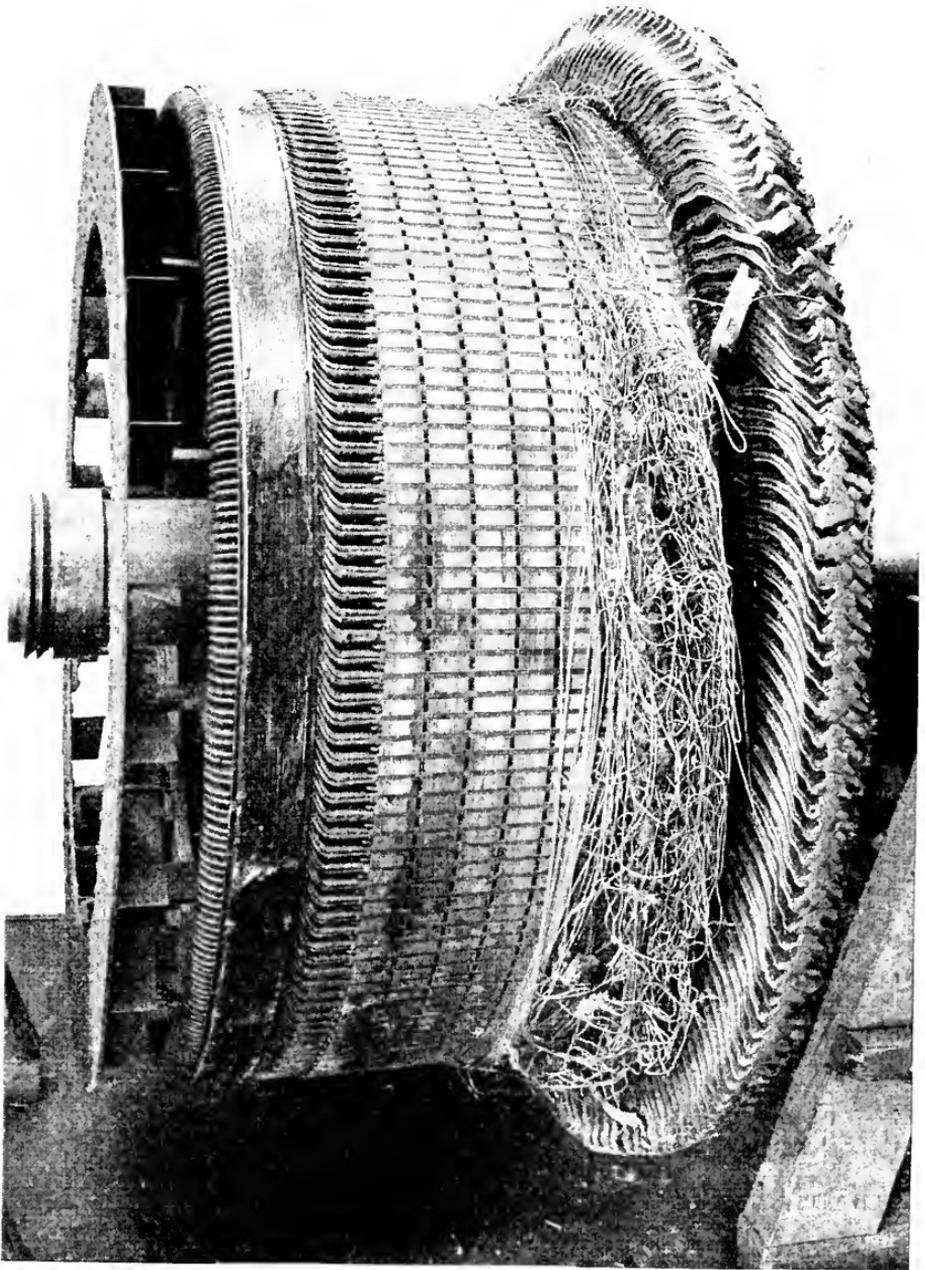
The flaring out of the rotor windings, as is shown in the photograph, added to the braking effect of the slipping band brake so that the car with its heavy load slid to the bottom of the grade without developing such speed as to cause damage. It was estimated that the maximum speed of the motor was between $2\frac{1}{2}$ and 3 times normal.

The lining on the emergency brake was 14" wide and $\frac{3}{4}$ " thick and was of asbestos and brass wire composition. An examination showed that a strip 6" to 8" wide and 1 fabric thick had been torn off of the lining surface the entire length of both shoes. The two outside strips were smooth and glazed, but there was no oil on the surface of the drum. The only reason that can be advanced for the brake lining not holding is the fact that it was probably glazed. In the regular operation

900 Hp Hoist Motor Damaged Because of Overspeed.

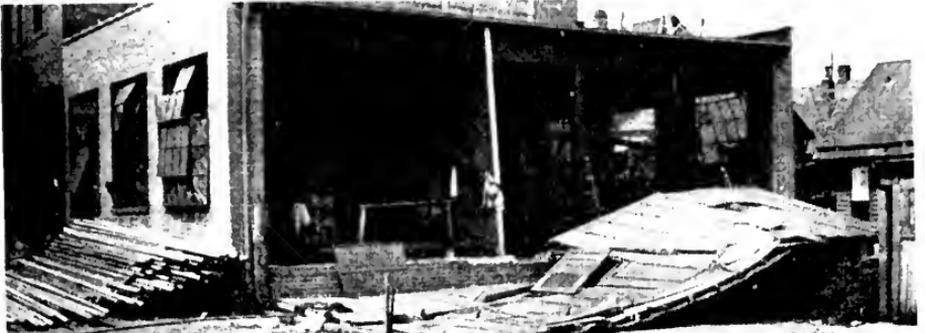
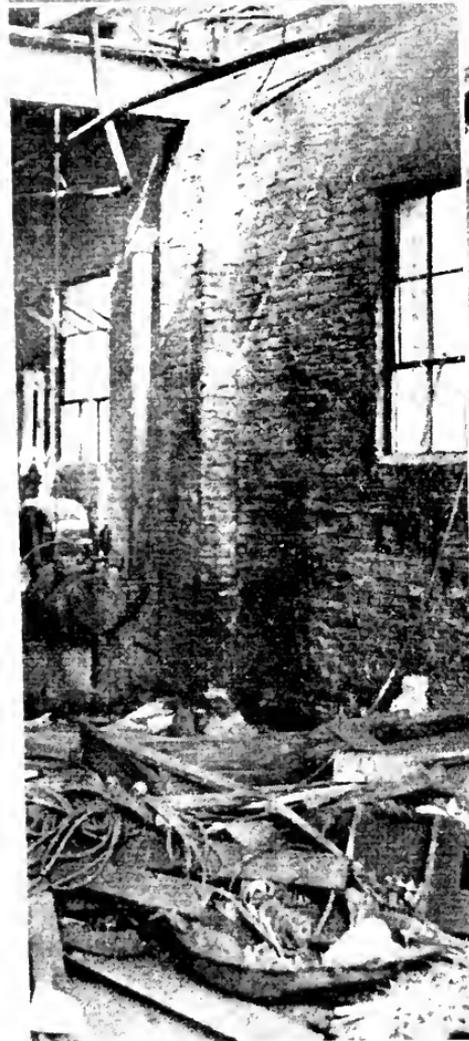
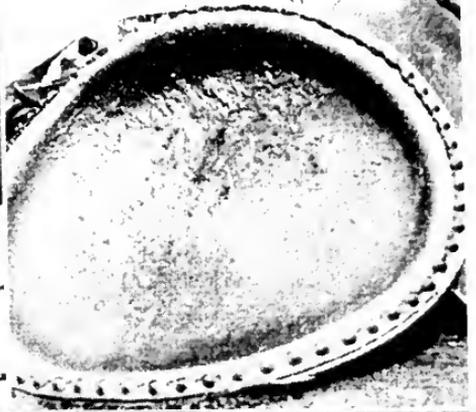
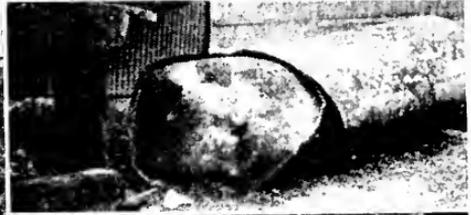
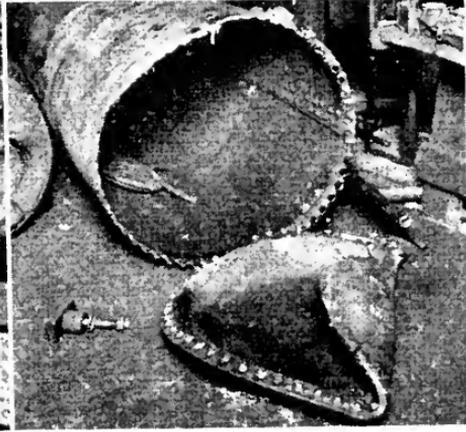
AIR TANK ACCIDENTS

Top—Side of building blown out by the explosion of the tank shown at the lower right. Upper right—Minus head reversed by oil vapor explosion. Center right—Failure caused by corrosion of rivets. Lower left—One man died and two were hurt when an air tank exploded and soared through the roof.

drained, since the latter routine removes only such oil as is in a fluid state in the bottom of the tank. The vessel was equipped with a 1" safety valve apparently in good condition, but it is doubtful if any safety valve could have relieved the pressure developed by the explosion.

An Ohio scrap-iron baling plant was wrecked by the explosion of an air receiver 3' 6" by 7' with a minus head $\frac{3}{8}$ " thick. Again it was the reversal of the minus head because of an oil vapor explosion which tore open the tank. In this case, just prior to the blast, flame was noted issuing from the safety valve. Employees also reported that the safety valve had been operating intermittently and that the discharge pipe from the compressor was red hot. The air compressor was definitely in need of extensive repairs, and as its large oil feeders were filled at least twice a day, it may be assumed that an abnormally large amount of lubricant was used. The head of the tank is shown in the accompanying illustration.

In the prevention of such oil vapor explosions, proper maintenance of the compressor is essential. It is important to use the correct lubricant, to see that discharge valves are kept in good condition, and to have a clean water jacket. Leaky discharge valves on the compressors probably were responsible for the temperature rise leading to at least one and perhaps all of the above accidents. (For a discussion of air compressor explosions because of combustible oil vapor see THE LOCOMOTIVE, July, 1934, Page 66).

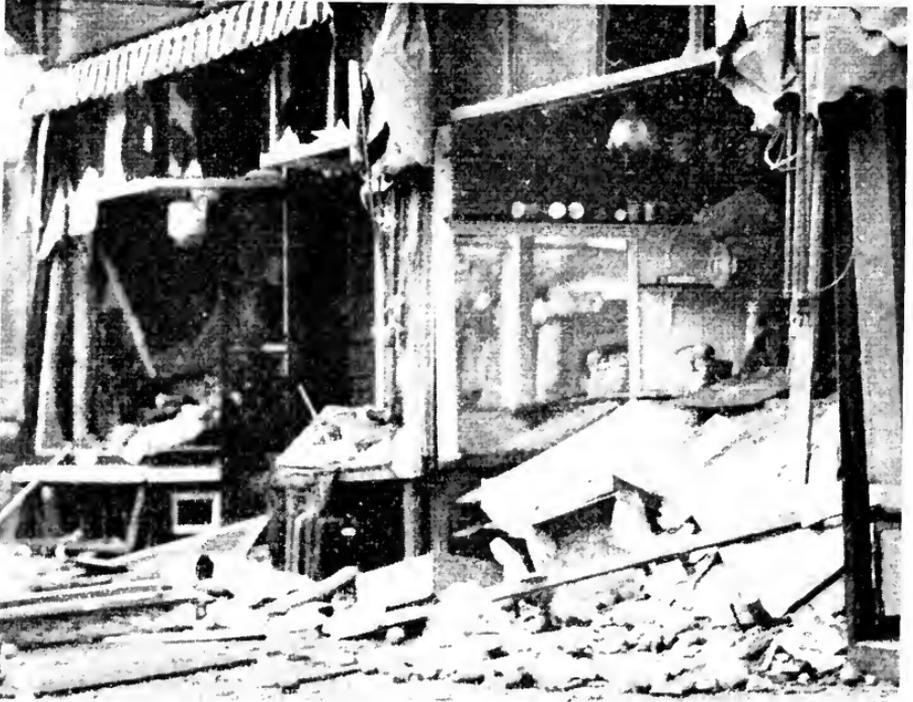
Heating Boiler Explosion

A cast iron boiler explosion on November 18, 1935, injured four persons and wrought damage estimated at \$10,000 to these stores.

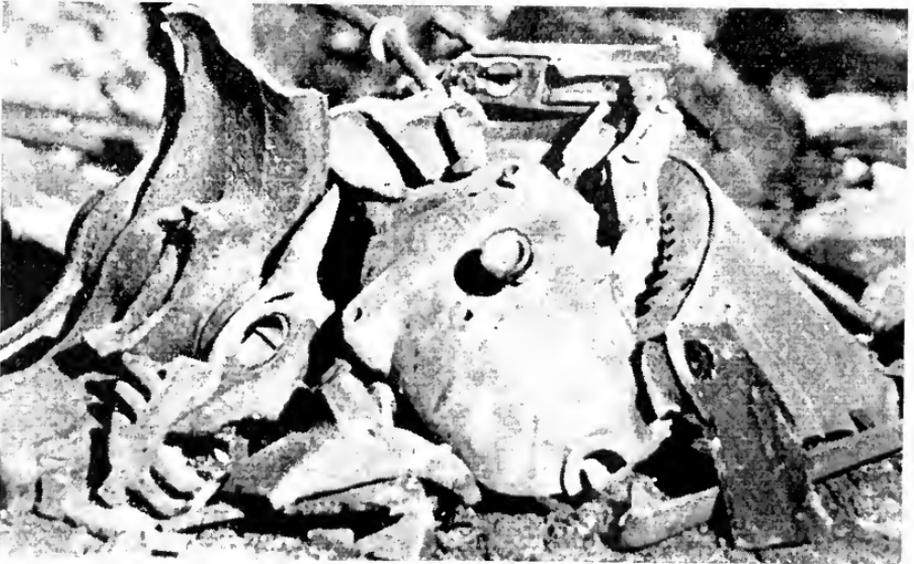
Parts of the boilers which were picked up after the accident. The boiler, which was one year old, was not insured.

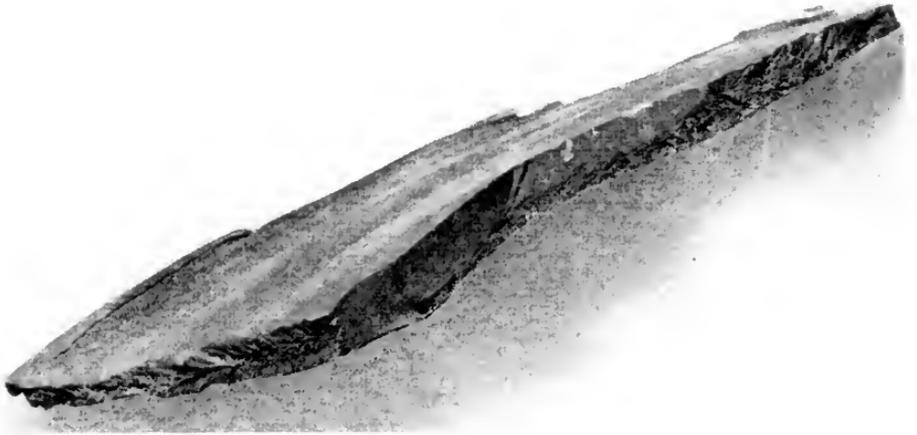
A 3,500 kw impulse turbine driving a generator at a Southern cotton mill was destroyed when the 3rd stage disc exploded because of

Section of turbine disc which exploded because of a fatigue crack.

a progressive crack. Replacement of the machine, which was about 12 years old, involved an estimated cost of more than \$100,000. The explosion took place while the emergency governor was being tested. When the machine reached 8 per cent above its operating speed, vibration suddenly increased and the accident occurred. The steam end was wrecked, there was serious damage to the generator because of the distortion of its shaft and the rubbing of the field against the stator, the foundation was cracked in several places, and extensive damage was suffered in the condenser room. As the severed section of the wheel did not go through the steel turbine casing, there was no loss of life or serious injury to the operators, although the jolt knocked a helper off his feet. It was felt that, although the testing of the emergency governor may have hastened the time of the ultimate failure, the accident would have occurred at some later date under ordinary

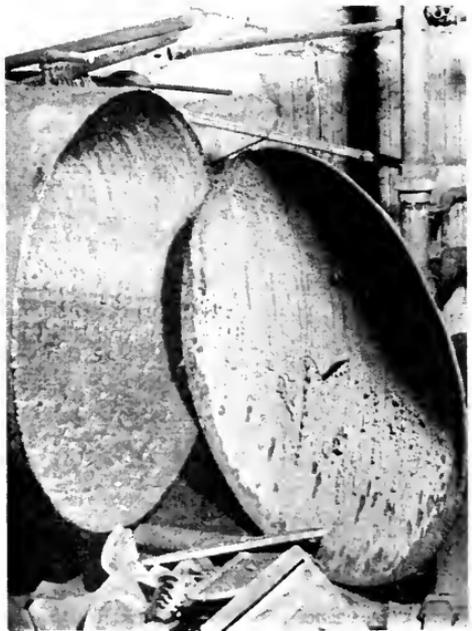
Hydro-Pneumatic Tank Fails Due to Poor Weld

This hydro-pneumatic tank with its saucer-shaped head failed because of a poor weld. The pressure at the time of failure was 35 pounds. The dimensions of the vessel were 14' by 42", and both the shell and the heads were of $\frac{1}{4}$ " thickness.

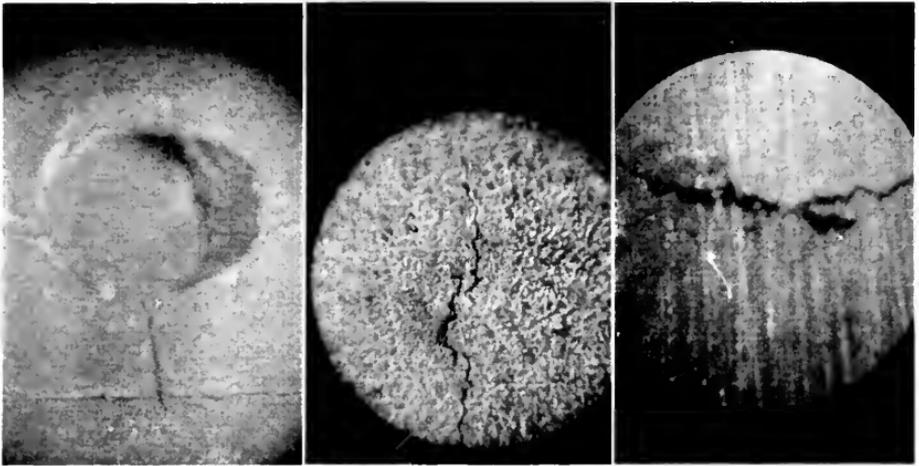
Embrittlement

ON inspecting a power boiler at a Mid-West plant, the insurance of which Hartford Steam Boiler was recently asked to take over, the inspector discovered a leaky seam which showed evidence of having been caulked repeatedly in a fruitless effort to make it tight. He noticed, too, that several new rivets had been driven in the seam. Inquiry developed the information that the seam had been giving trouble for some time and that rivet heads had been found broken off

Left—crack which caused the leakage. Center—the crack at the left as it appeared in the rivet hole. Right—characteristic embrittlement cracks with which the plate was affected.

from time to time. As these symptoms pointed to the probable existence of serious distress, the inspector took steps to verify his suspicion. His investigation led to the discovery of a case of plate embrittlement which had progressed to a dangerous degree.

for most of its length by a multitude of embrittlement cracks. A test of both the raw and the treated feedwater showed that either could have led to the development of the condition.

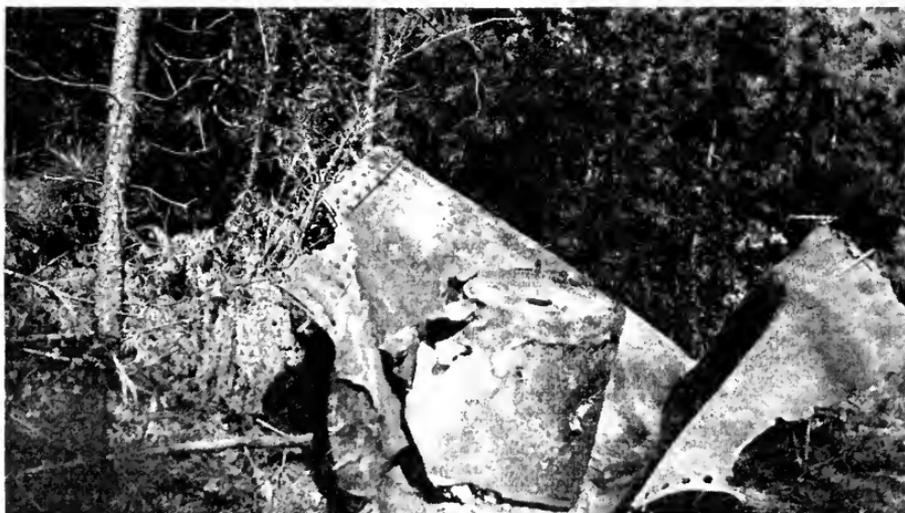
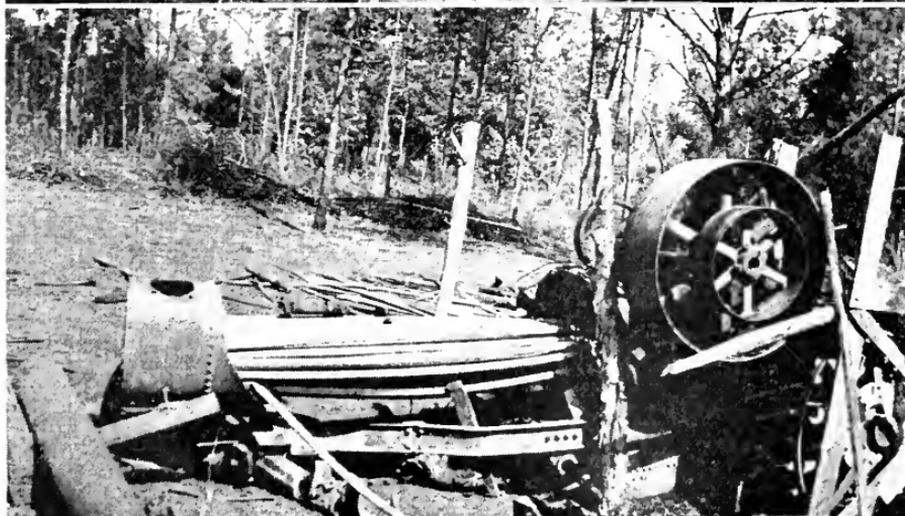
Portable Sawmill Boiler

One man was killed and another injured at a portable sawmill in Virginia, when a welded repair broke loose on a locomotive type boiler, causing a rupture the entire length of the longitudinal seam. The barrel of the boiler tore away at the front head and at the throat sheet, demol-

Above—The barrel of the boiler where it came to rest 400 feet from the sawmill. Below—The remainder of the boiler, showing the torn plate.

ished the engine, and came to rest in the forest more than 400 feet away. The internal surface of the shell plate along the longitudinal seam was pitted and grooved throughout most of its length. In the middle of the joint was a $\frac{1}{2}$ " wide weld that had been applied externally parallel to the seam for about 2 feet, obviously to stop leakage, because the pitting and grooving had extended through the plate. The man who was killed was thrown more than 30 feet and the other workman sustained a broken leg and a scalded thigh. The boiler was uninsured.

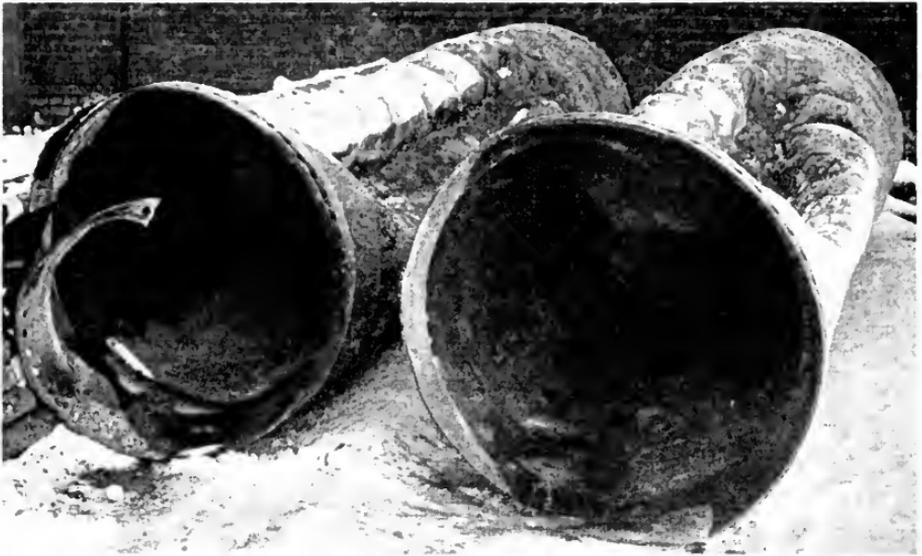
Scotch-Marine Furnaces Collapse

Two corrugated furnaces in a 103" diameter Scotch-Marine type boiler collapsed at a Pennsylvania textile mill early this year. The fires had been banked, but the fireman had been directed to bring the boiler up to pressure—125 lb. The fireman said that because the gage glass

Collapsed Scotch-Marine boiler furnaces, the result of overheating.

was full of water, he had opened the blow-off valve, letting the water down to about half a gage, but had not disturbed the banked fire. About a half hour later he observed smoke issuing from the front of the boiler and on opening the fire doors saw that the furnaces had collapsed and were pressing against the grates. Whatever the train of events, it was evident that the furnaces, each 36" in diameter and 13'3" in

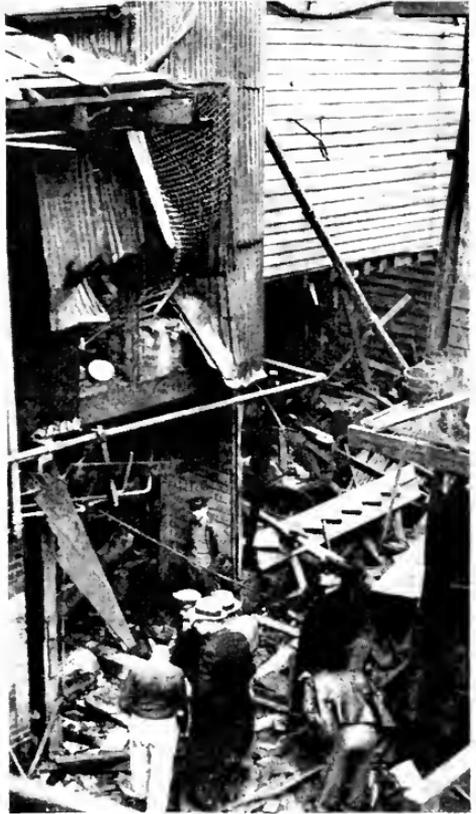
The explosion of a 48" diameter vertical tubular boiler at a New Jersey laundry caused the death of a watchman and an oil burner mechanic and the severe injury of a boilermaker on January 17, 1936, as they were making repairs to the burner. The upper tube sheet bulged outwardly, breaking away from the tube ends and projecting the stack and breeching upward. The explosion blew off the roof, and broke a large plate glass window about 80 feet from the boiler. The men were blown against the wall of the boiler room and were sprayed with burning oil. This accident was attributed to low water and over-heating in a vessel which, it was reported, was not covered by insurance.

Damage following explosion of vertical tubular boiler.

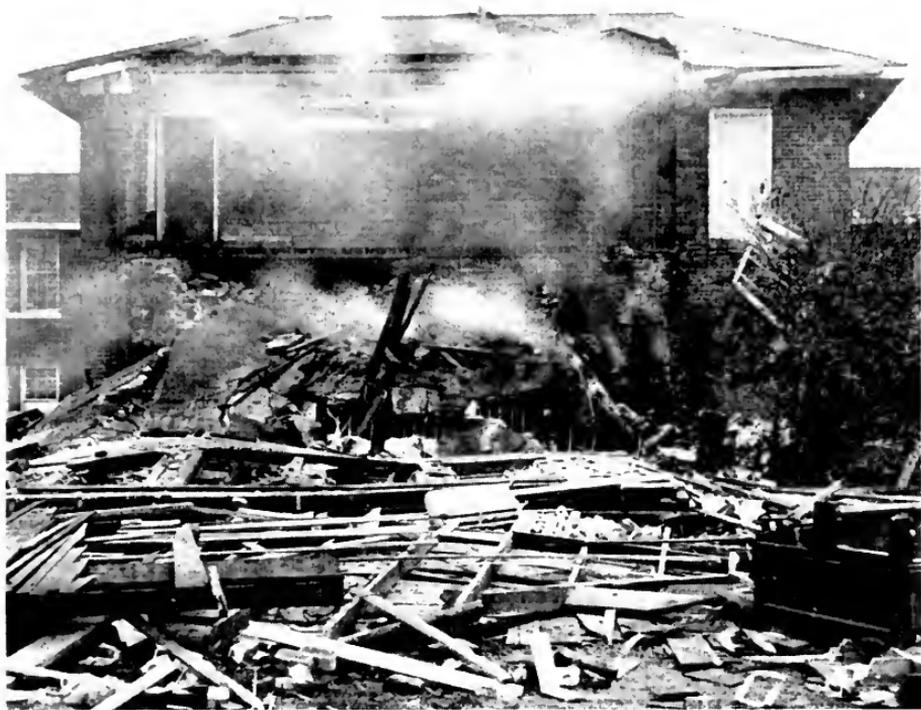
Hot Water Tank Explosion Kills School Teacher

A YOUNG music teacher was killed when a hot water supply tank exploded in the boiler room of the consolidated school at Horn Lake, Mississippi, on the morning of February 17. Fortunately a recess saved the children. The sixth grade had left the music room, situated over the boiler room, barely five minutes before the explosion, and the school quartet was due there for rehearsal in another

Wreckage of music room and boiler room after explosion.

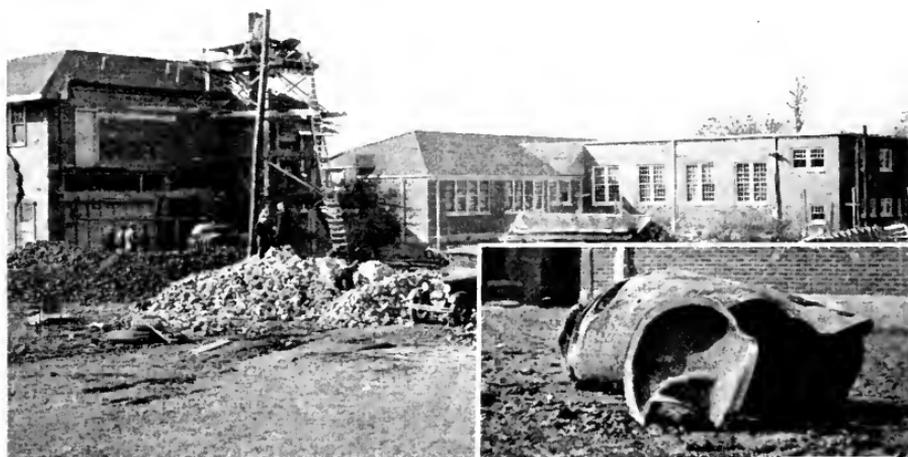
Water for it was heated in pipe coils in the fire box of one of two cast iron sectional steam heating boilers. Inquiry subsequent to the accident revealed that there had been a check valve in the cold water supply to the tank and that there had been no relief valve on the sys-

Repairing damage after explosion. Observe the 3' hole (boarded up) in brick wall of gymnasium, extreme right of picture by small double windows. Inset—Remains of tank showing reversed minus head.

tem. As it was a cold day, both boilers were in operation, but due to stoppage of drains in the shower room, no hot water was being used. Pressure built up in the tank until the minus head reversed and tore away, striking one of the boilers. The rest of the tank broke its way through the six-inch reinforced concrete floor of the music room, ripped down one of the brick side walls and hurtled across 150 feet of lawn to the gymnasium where it knocked a large hole in the wall, showering bricks and debris on boys who were playing basketball there.

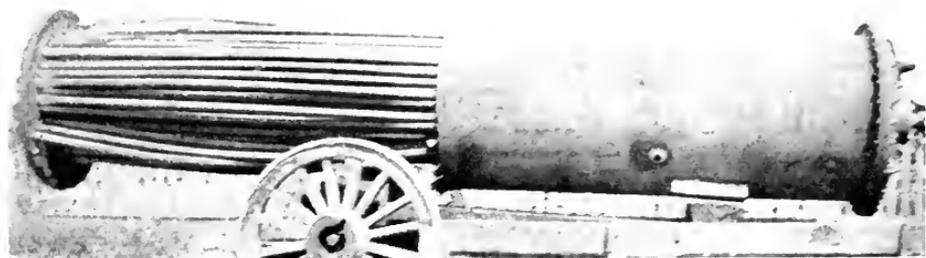
Investigations by "Hartford Steam Boiler" of welded vessels constructed anywhere from five to twenty years ago have disclosed positively that there were as many questionable welds as good ones produced, if, indeed, there were not many more poor ones. These questionable welds were made not because of any negligence on the part of

Fusion welded ammonia condenser which failed; welding procedure and testing have advanced greatly since this vessel was built.

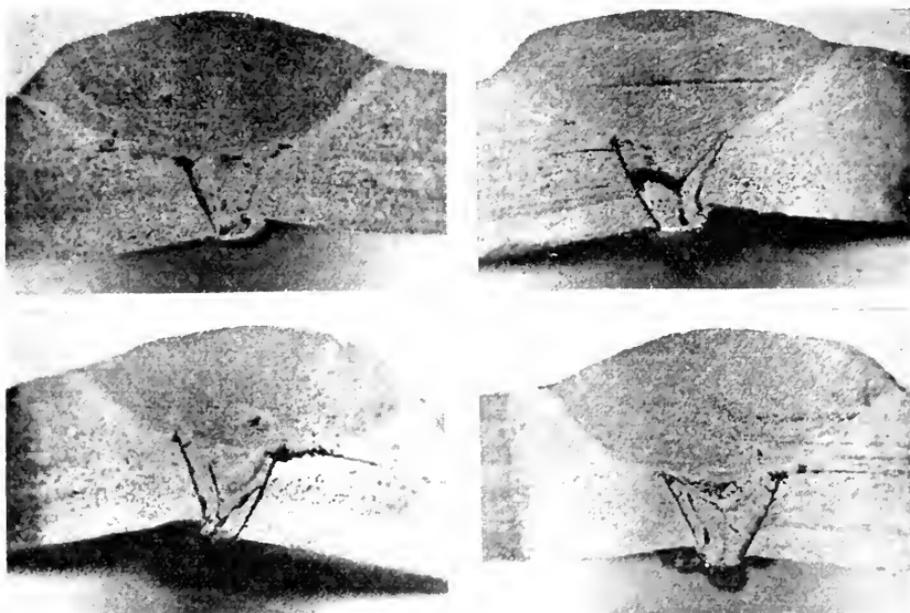
Samples of characteristic defects in welded seams.

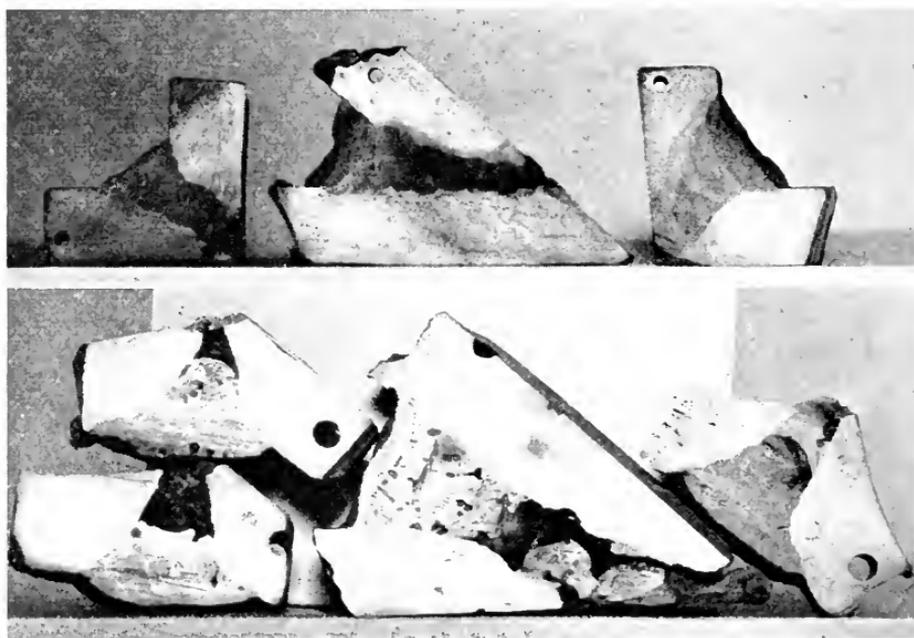
Good and bad fusion in pipe joints.
