The Locomotive

THE HARTFORD STEAM BOILER
INSPECTION AND INSURANCE CO.

VOL. XL

1934-1935

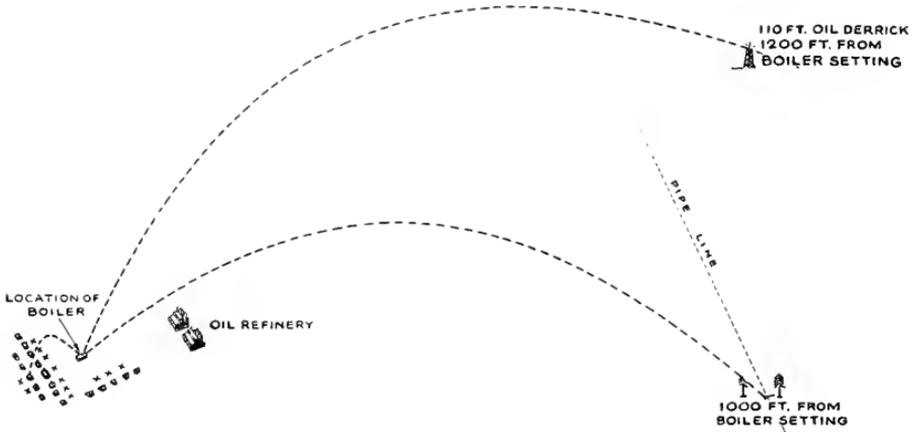
EIGHT persons were injured and property over a wide area (as shown in the sketch) was damaged when a locomotive type boiler exploded at a Texas oil well location in April. The accident, clearly a case of over-pressure, tore the boiler into several pieces and resulted in damage to property as far distant as 1200 feet from the boiler setting.

Path taken by parts of boiler which exploded at a Texas oil well location. The boiler was used to furnish power for pumping oil through various pipe lines.

aged. One piece of metal passed over a two-story hotel and crashed into a hut behind it, the metal falling in such a way that a negro woman was pinned in bed, but was not seriously injured. Other pieces hurtled over the refinery building, one whole course passing through the top of a large pine tree 1000 feet distant, cutting a 6" oil pipe buried about 2 feet underground, and making a deep gash in a second tree. Another piece of the boiler broke off the top of a 110' oil derrick which was 1200 feet from the boiler.

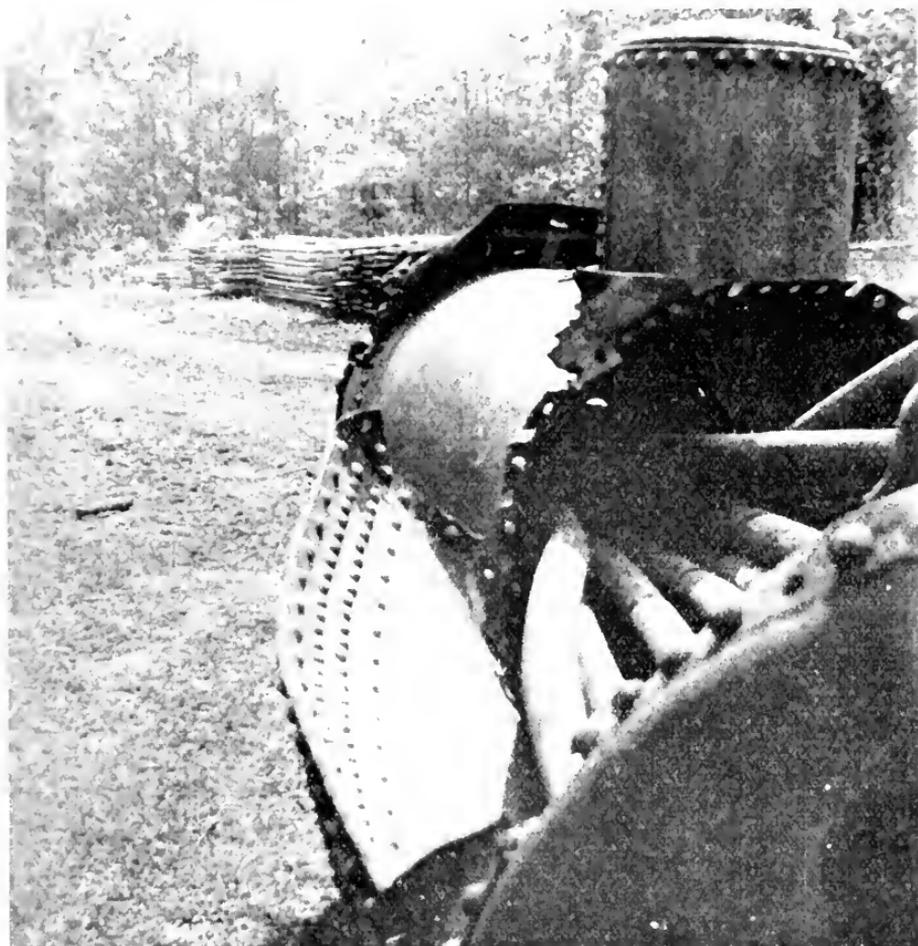
An old crack in the rear course of a 36" diameter horizontal tubular boiler, used at a Southern sawmill, in April brought about the result shown in the accompanying photograph. The vessel was projected 60

After the boiler had traveled 60 ft.

feet from its setting. Although the setting was made of mud and stones and was scattered over a wide area, only one of the nine men about the mill at the time was injured. A pair of mules escaped injury when the shell landed immediately in front of them. The 20-year-old boiler had been idle for two years. It had been fired up only a few hours when the shell tore along the crack which extended for almost

the full length of the 6' course and nearly through the plate. The photograph shows the inside of the butt strap and the line of failure adjacent to the top edge of the strap. The crack bore evidence of having existed for a long time and the metal adjacent to it was reported to be nearly as brittle as cast iron. The accident was attributed to inferior metal and excess pressure over a prolonged period.

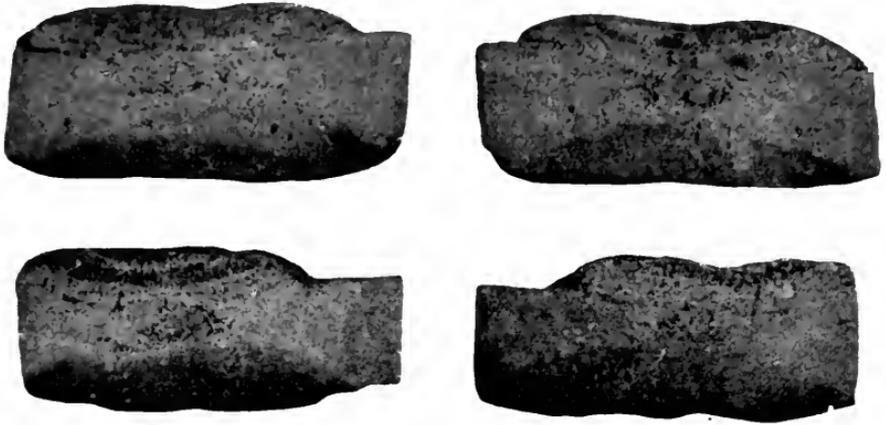
Figure 1

Figure 1. Although the weld is well fused the metal contains con-

siderable impurities. The four sections are from two plugs removed from the same seam.

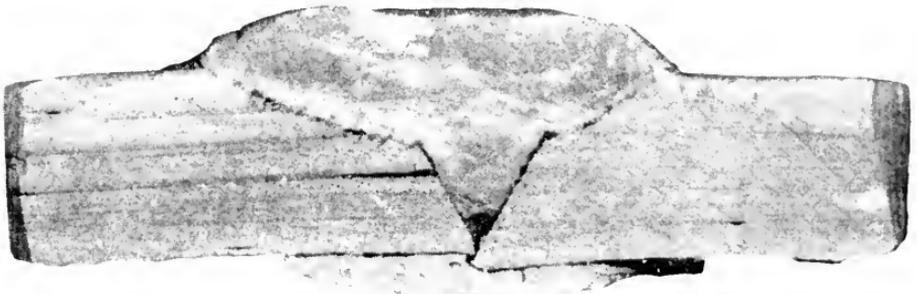
Figure 5

Figure 5. Illustration of an extreme case of lack of fusion in the lower half of the welding groove, slag on the fusion line and almost entire lack of fusion of reinforcement on the underside.

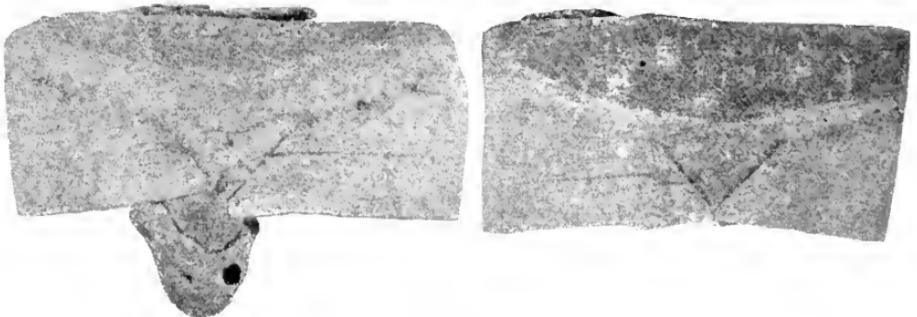
Figure 6

Figure 6. An example similar to that shown in Fig. 4. The two plugs are from the same seam.

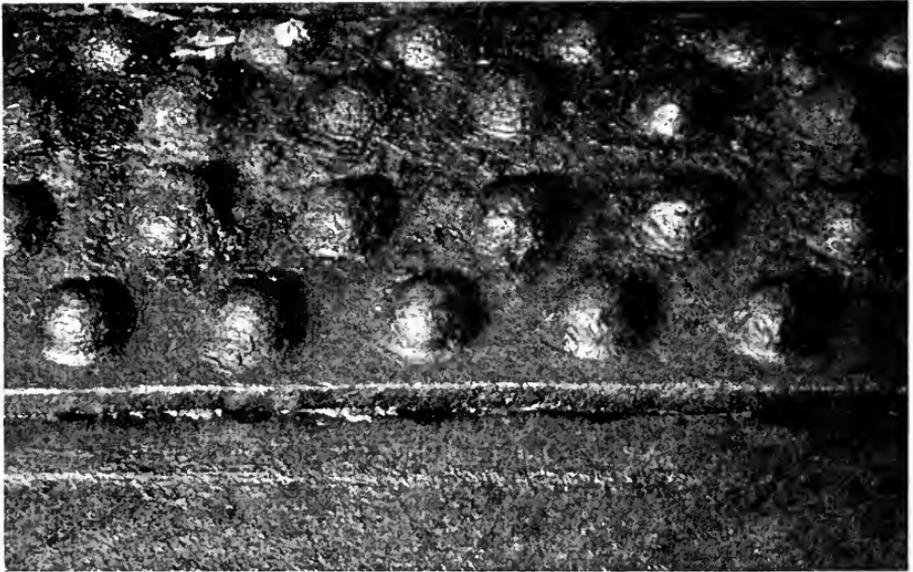
Figure 1—Seam which pulled apart for 6 feet after embrittlement had developed to a serious extent.

would be made by the rupturing of a small tube, but the accident obviously was more serious than a tube failure since a sufficient volume of water escaped to put out the fire. An examination of the boiler after the accident brought to light the condition shown in Fig. 1. The metal of the shell plate had separated as much as $1\text{-}5/16''$ in places until the rivet holes were actually visible where they had pulled out from beneath the butt strap of the lower or mud drum. This drum was $48'' \times 16' 9''$, and seams were double riveted with $1\text{-}1/32''$ diameter rivet holes and $3''$ pitch. The plate had cracked for a distance of $6'$ along the outer row of rivets and there were also cracks in the outer butt strap between

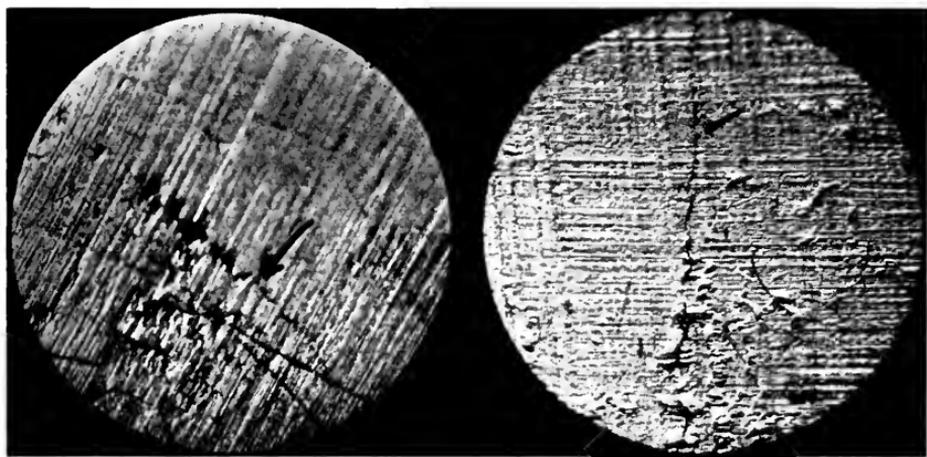
Figure 2—Characteristic embrittlement in another boiler of the same battery as the affected vessel.

the rivet holes in the top row. These cracks were characteristic of embrittlement in its final stages.

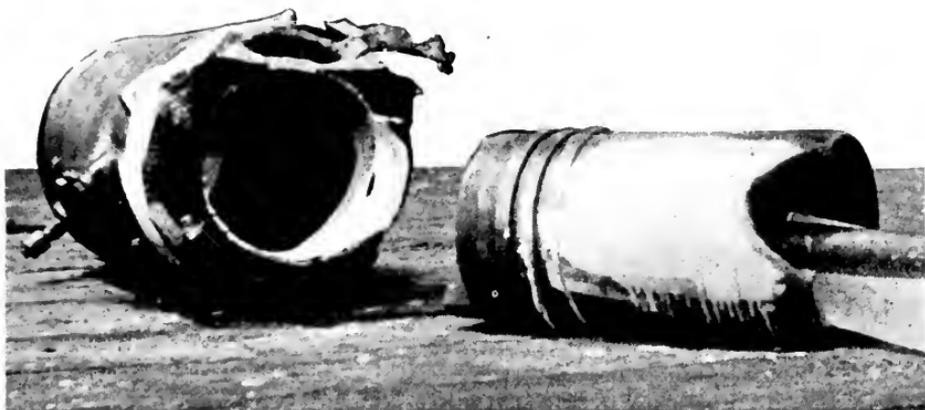
Figure 8—Piston and part of cylinder which broke off due to overheating. The machine was a small two-cylinder engine.

effect of the silicon. It may well be asked why this action does not take place on the surface of the piston. The theoretical explanation of this is that the separated carbon is re-fused into the solid solution by the higher temperatures at the top of the cylinder and further, that the oil which comes in contact with the piston top saturates it and acts as a protective influence. At any rate the distortions because of "growth" in Diesel engines occur as is shown in Figures (1) and (2). From these it will be seen that the "growth" itself is only part of the difficulty, as its presence leads to a distortion of the entire cylinder, which distortion is contributory to the eventual seizing of the piston.

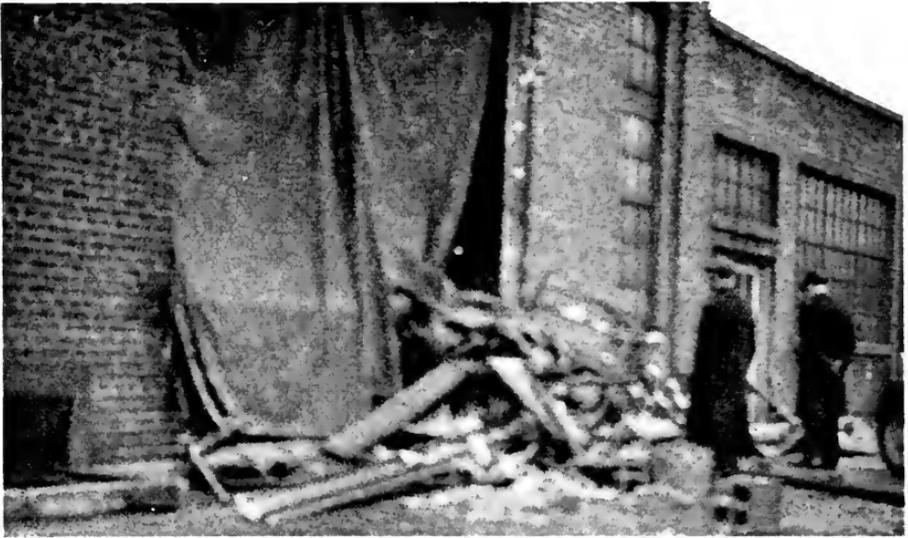
AN open type feedwater heater under normal operation is not subject to pressures exceeding a few pounds, but the piping is often connected so that it is possible for the heater to receive steam at full boiler pressure. When this occurs, even with the feedwater heater relief valves operating, pressure may not be relieved rapidly enough to prevent an explosion.

Damage caused by the explosion of an open type feedwater heater.

lar boilers operated at 120 lb pressure. The heater was six years old, of fusion welded plate steel construction, and was supplied with exhaust steam when enough was available. It also was connected to the high pressure steam lines through a pressure regulating valve, so that when exhaust steam was not available the feedwater was heated by live steam.

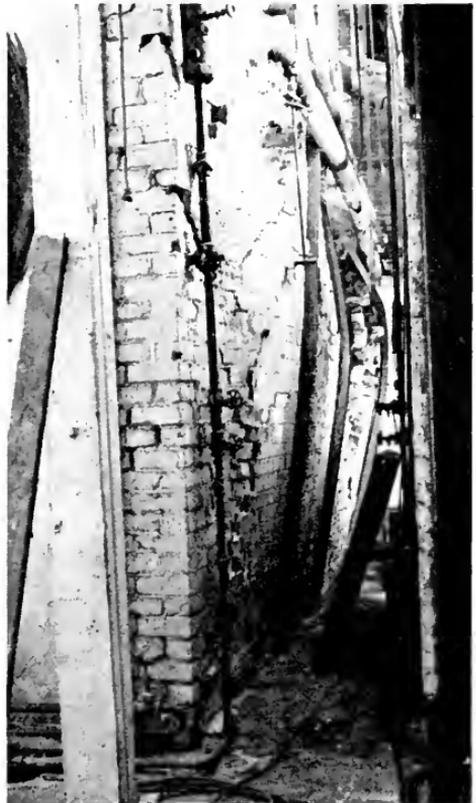
A LEAKY stop valve on the pilot light and a leaky plug cock on the main burners of a gas-fired power boiler—No. 2 of a pair in a California plant—caused a furnace explosion which did \$2,500 damage to the boiler setting. The escaping gas, which had filled the furnace and flues of the idle boiler, was ignited through cracks in the center brick wall between the two boilers five minutes after the No. 1 burner had been lit. The rear wall was budged and pushed back about nine inches. The right side wall was blown out entirely, leaving no support under that side of the boiler, as the boilers were set on brickwork instead of being supported from the beams. This caused an excessive strain on the main steam pipe which held the boiler in place. Fortunately, there was no water in the boiler at the time, for that added weight would probably have caused the piping to break and the boiler to fall.

View of right side wall of No. 2 boiler showing the damaged setting. The boiler is 72" in diameter and 16' long of the horizontal return tubular type.

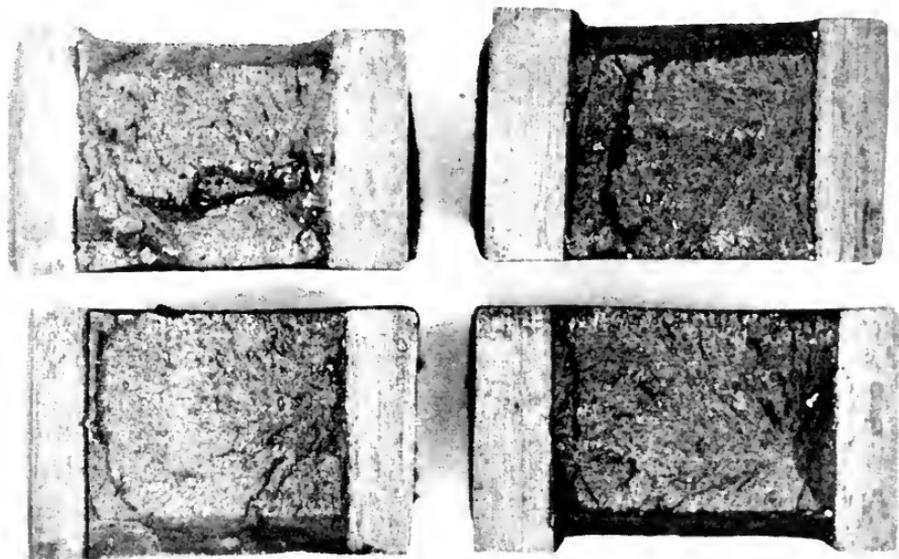
Figure 8

The side break test is somewhat new. It had been felt that the nick break specimen might not reveal defects that might exist on the side walls of the welding groove. To investigate this matter a defective weld was made in which there was a slag streak of somewhat minor proportions on the side wall. The weld was X-rayed and it was found that the defect continued throughout the length of the weld. Four nick break specimens and three side break specimens were removed. Two of the nick break specimens were broken in the customary manner with a quick, sharp blow, and the other two nick break specimens were broken by a slow bending. All of the nick break specimens broke directly through from notch to notch as shown in Figure 8. The side break specimens broke through the side wall defect as shown in Figure 9.

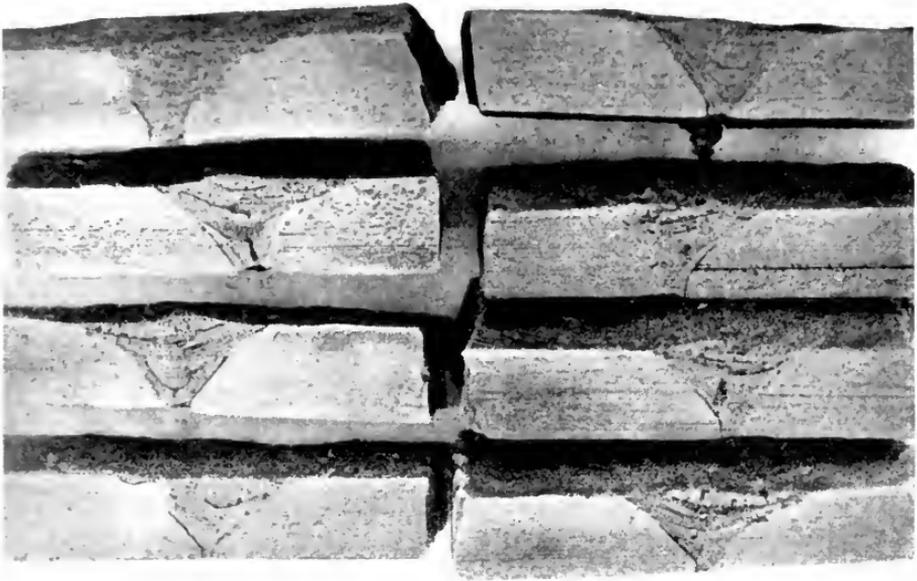
have been constructed by operators who had demonstrated their ability to make sound welds, yet joints cut from the line have revealed unsound welds. Figure 11 shows an example of this. A constant prodding thought in the mind of a welding operator, to encourage him to do his best work at all times, will have a most beneficial effect and will be the most effective instrument that can be used to secure properly welded joints

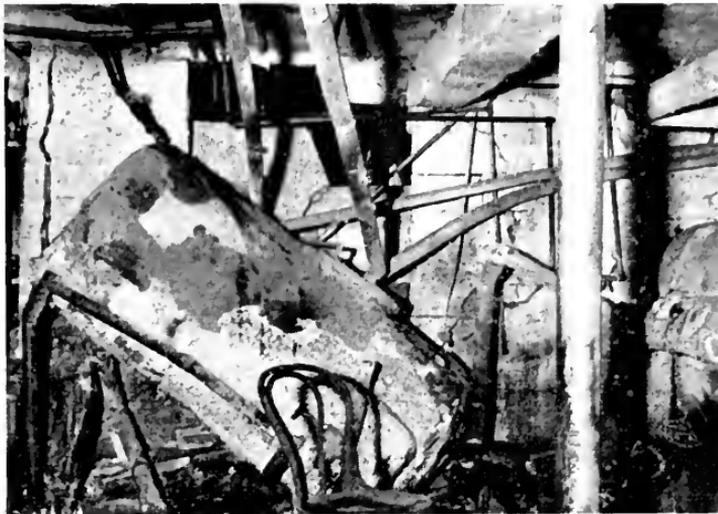
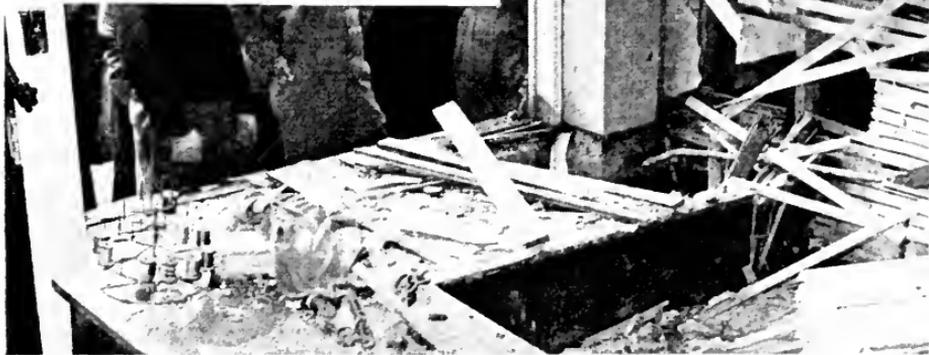
Upper Right—A hot water heater failure in a Pennsylvania business block injured a woman and resulted in property damage estimated at \$5,000. The blast tore loose the 750-gallon hot water tank shown in the photograph. **Lower Right** — A welded quill pipe steam radiator exploded, scalding an employe and damaging equipment, walls and show window of an Iowa shop. Windows were shattered in automobiles parked in the street in front of the store.

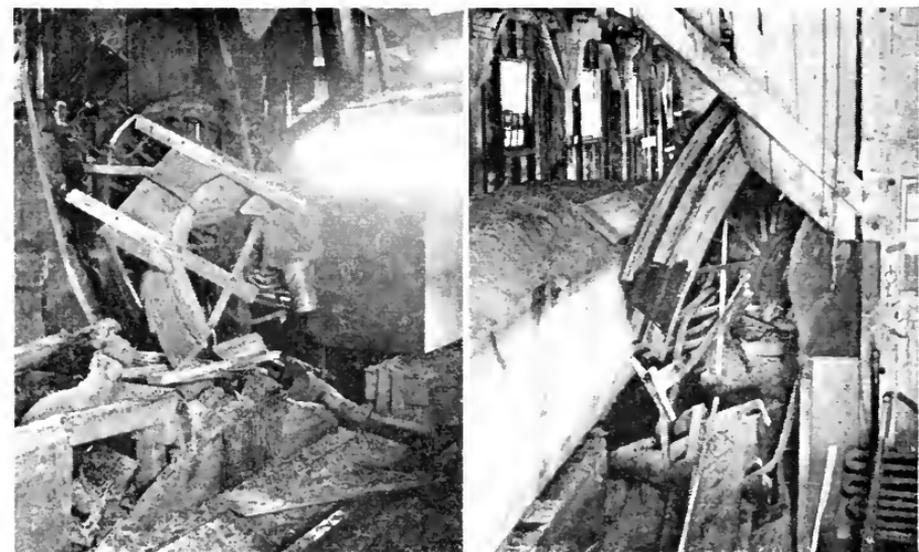
Wreckage following a band saw wheel explosion at a Western mill.

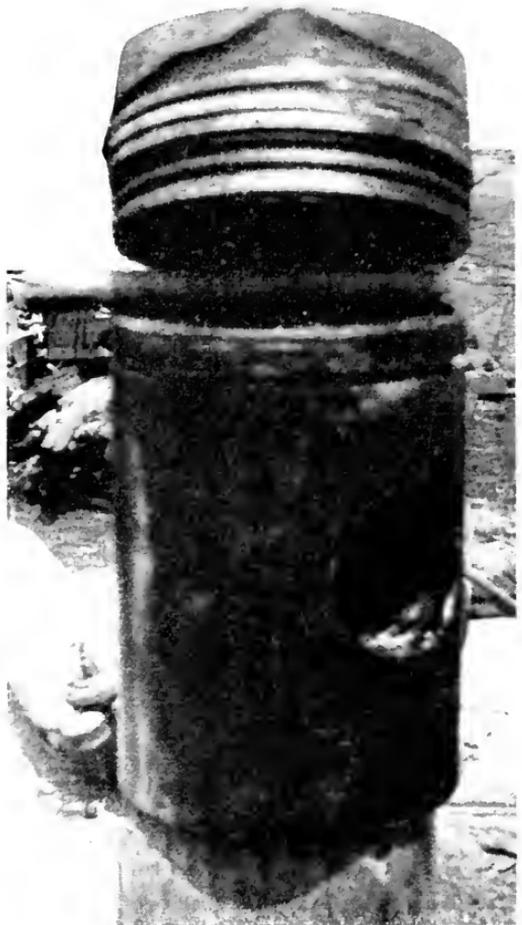
When an 8-cylinder Diesel engine on a dredge in Southern waters was operated for a considerable time under an over-load, its 11½" pistons became so over-heated and distorted that one of them broke, as shown in the photograph. Each of the other pistons was scored and at least one ring on each piston was broken. The photograph shows the piston head and skirt, separated by a bar to bring out the peculiar burning away of the top land, which permitted the top ring to break and become distributed in small fragments in the cylinder. Obviously the cylinder liners were all so badly scored that they needed replacing.

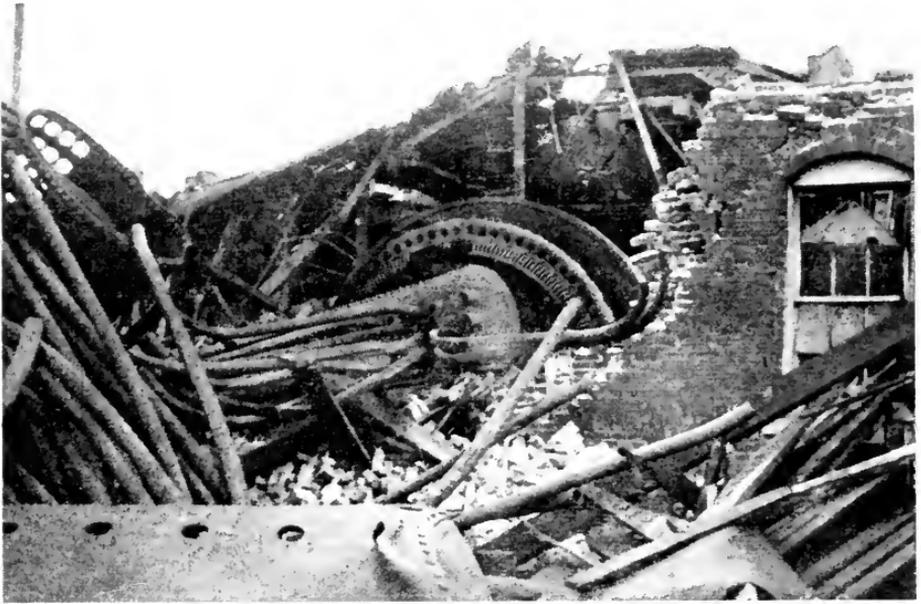
WHEN the lower drum of a bent tube type water tube boiler failed on October 30, a Middle-Western utility's power plant was demolished, five employes lost their lives, and a sixth was injured. Damage to the building, two engine-generators, electrical equipment, two other boilers, and auxiliaries involved a replacement cost estimated at \$100,000 and seriously hampered the utility's service. The

Wreckage following a lower drum failure at a Middle-Western utility.

supply of electricity for five towns was cut off and light, power, telephone and water service interrupted until supplementary hookups could be completed or emergency power plants, long out of service, could be started. The photograph illustrates the extent of the demolition.

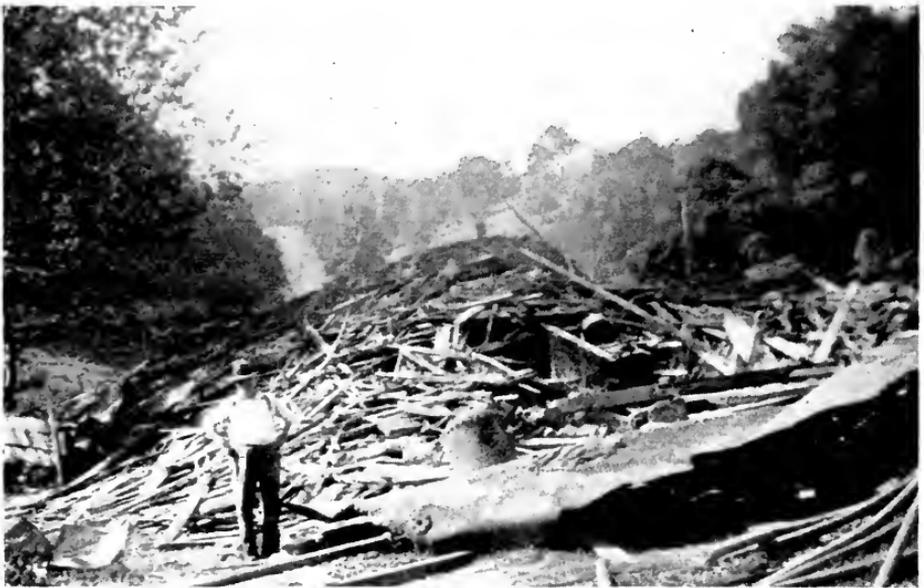
Deep grooving of the under plate of a horizontal tubular boiler and a sticking safety valve were causes contributory to an explosion at a West Virginia mill on June 4. A workman was on top of the boiler trying to fix the safety valve when the boiler exploded, tearing the shell from head to head, shearing off the front head completely and

After a sawmill boiler explosion in West Virginia. The scene is typical of wreckage following this type of accident.

ripping about nine-tenths of the way around the rear head. The illustration gives an idea of the accompanying wreckage. The man on top of the boiler and another workman were killed and a third was seriously injured. The mill was wrecked and parts of it and the boiler were strewn as far as 500 feet.

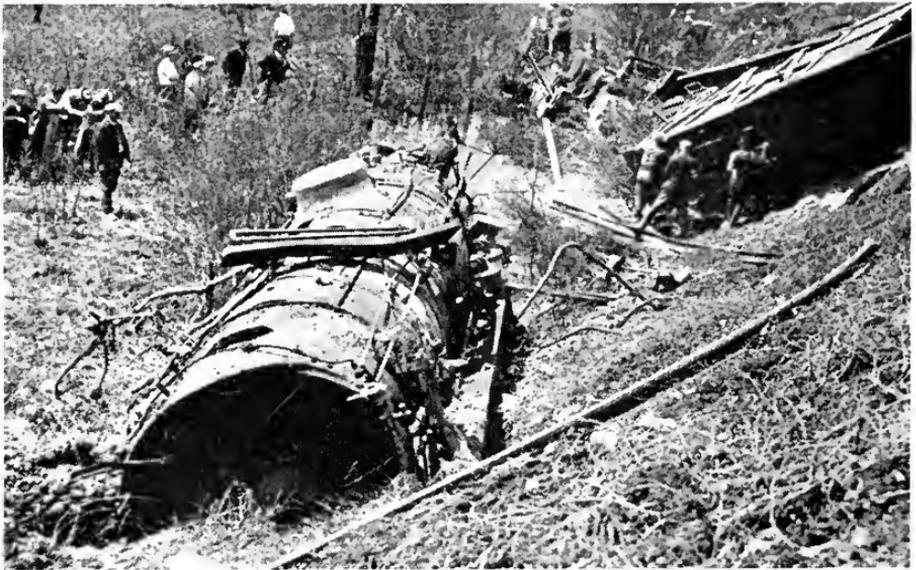
The engineer, fireman and head brakeman of a freight train traveling at about 15 miles an hour near Alexander, New York, on May 7, were killed when the crown sheet dropped, probably because of low

Main shell of locomotive after explosion which probably was caused by low water.

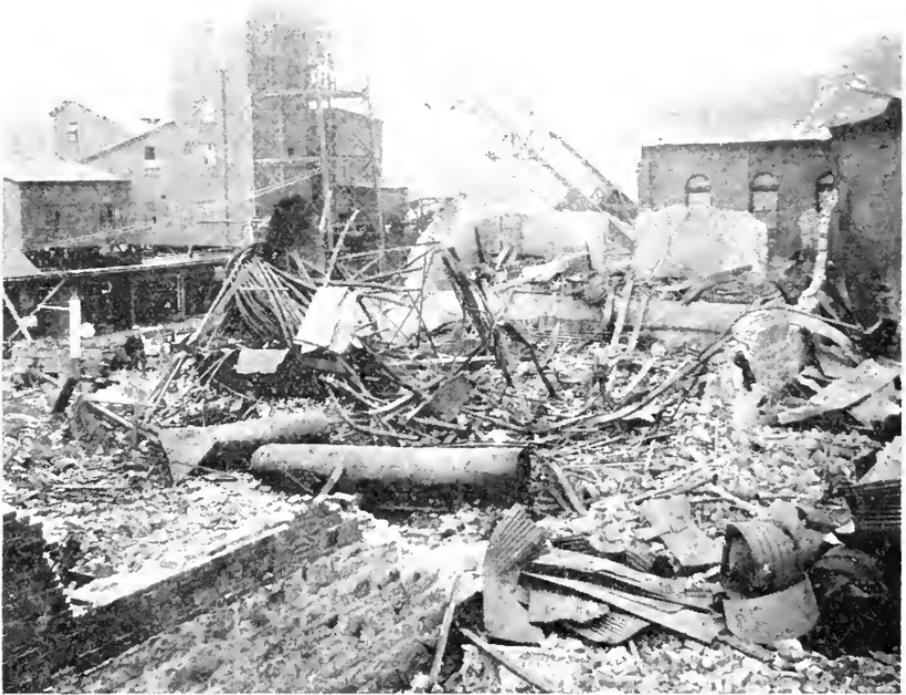
Wreckage at the mine following the boiler explosion.

The accident occurred after the top shell plate of the boiler became unduly thin because of hidden external corrosion which attacked the metal under the brick insulation.

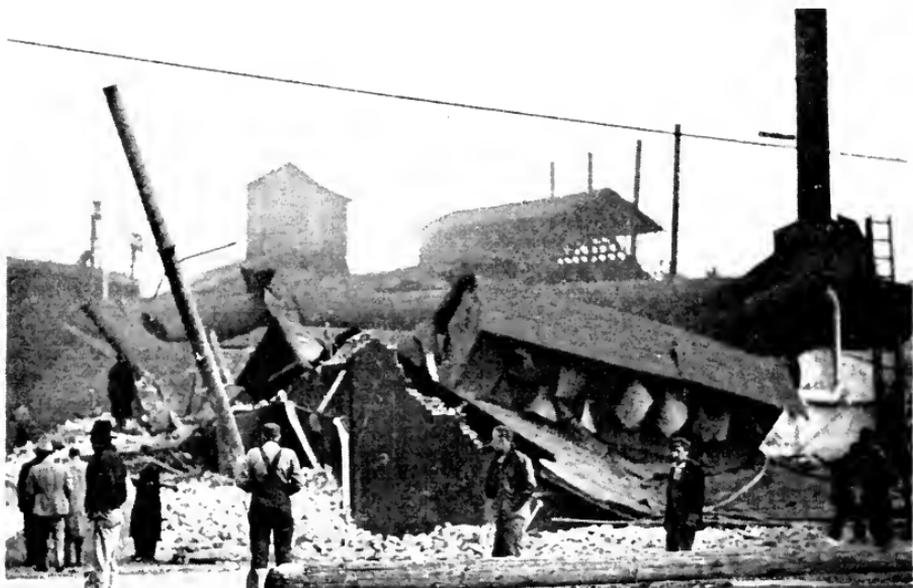
Result of external corrosion of a blank head in a bent tube type boiler.

examination absolutely necessary. By far the greatest hazard exists in the blank heads, which, as has been frequently pointed out, should never be embedded in the setting walls. Of approximately 6,500 drum heads once concealed in setting walls, 10 per cent were found to be corroded appreciably and about 1 per cent were in a very dangerous condition and no longer serviceable. Had any of these boilers failed in service, the property damage would have been severe and there probably would have been loss of life. There have been a number of such failures in the past.

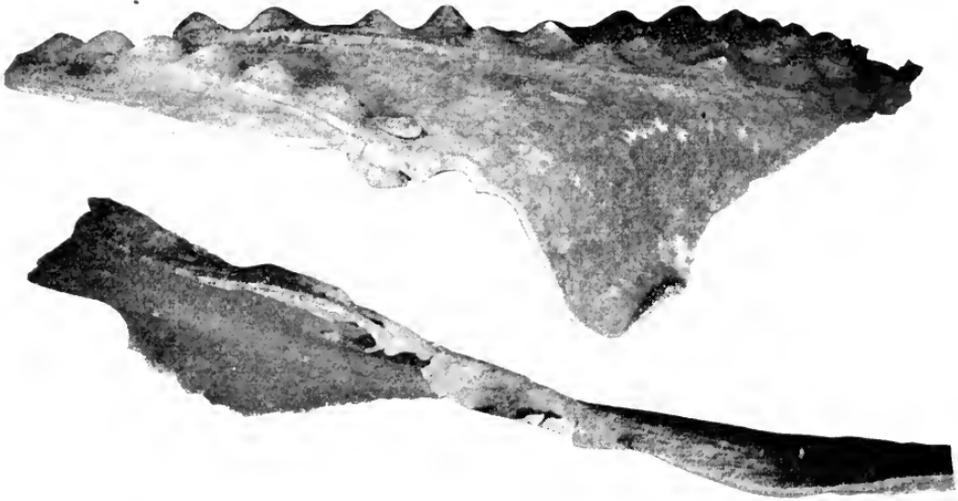
Typical thinning because of external corrosion in boiler plate originally 7/16" in thickness. In places this plate had thinned to less than 1/8".

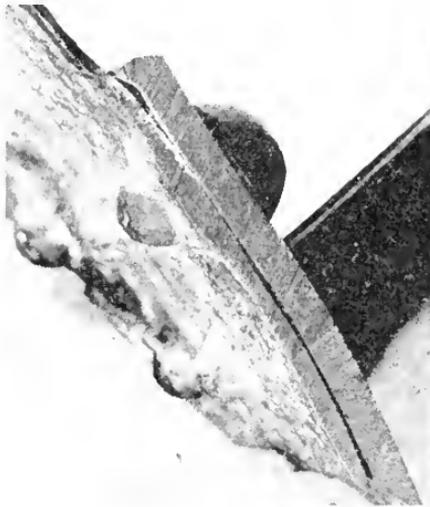
Figure 2

exploded at its normal operating pressure of about 100 lb, the outer lap of the rear course tore along a line about $\frac{3}{4}$ " from the edge of the inner lap and parallel with the girth seam. The fracture extended through the girth seam and then tore almost all the way around the other course.

Although the vessel had been in use for only two years, the plate had been reduced on the average to about half of its original thickness and the wasting was quite general.

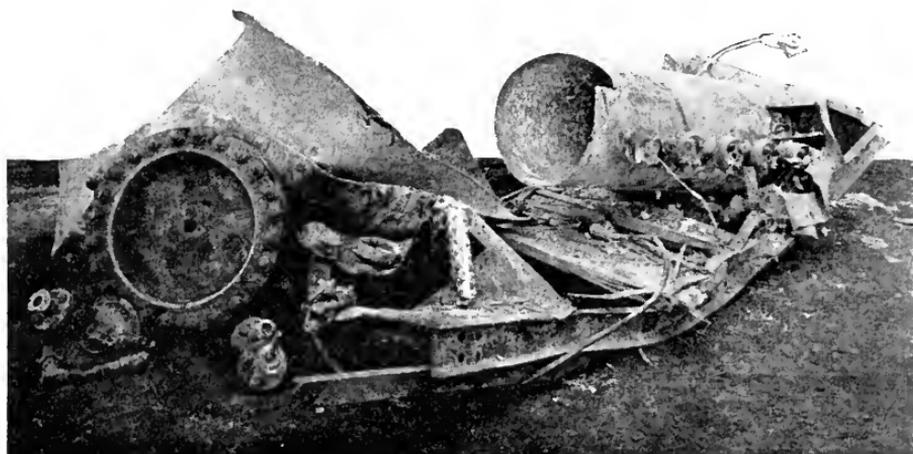
THE failure of a welded seam in a vessel constructed from a corrosion resistant non-ferrous alloy demonstrated what can happen when an inadequate technique is employed in welding such alloys.

Figure 1. Parts of the destroyed vessel gathered together after the accident.

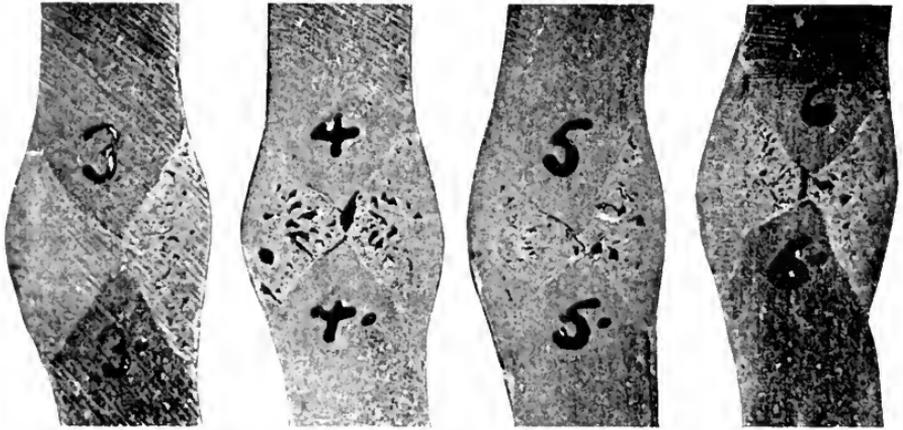
Examination of the weld metal, as illustrated in Figures 3-6, revealed a definitely defective weld, which, coupled with the fact that the vessel was subject to periodic fluctuations of pressure and temperature, may have combined to bring about the failure which occurred during its normal operation.

Figures 3-6. Etched specimens of welds from the vessel which failed, showing lack of fusion and general porosity in specimens 4, 5 and 6.

As the contents of the vessel was largely water, the release of energy because of the failure caused the solid plate to tear from the defective seam girthwise adjacent to the fillet welded flange seam

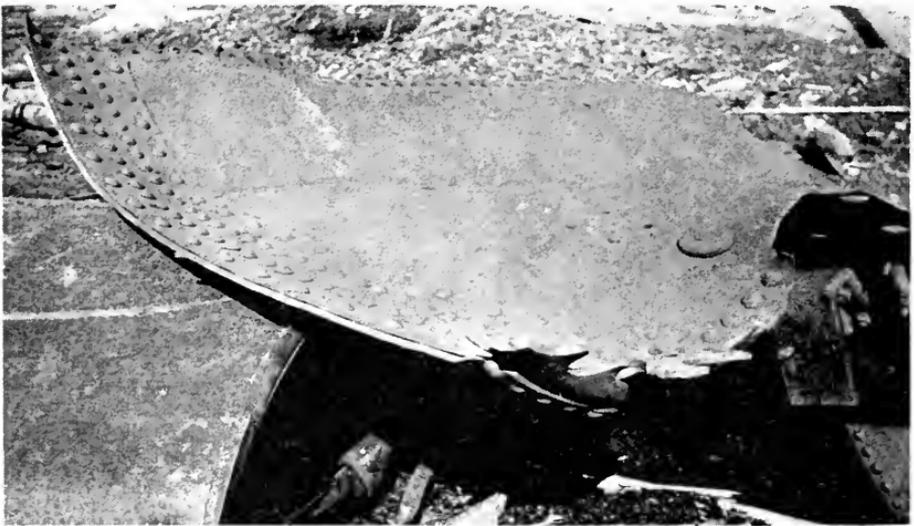
In an investigation of the accident, it was learned that the failure started at a crack in the plate near the butt seam, as revealed by the

Part of the boiler plate after an explosion which killed three.

accompanying photograph. The white line along the edge of the plate indicates the thickness of the metal, which measured from $1/16''$ to $1/8''$ instead of the normal $11/32''$. It was said that the boiler had leaked at the crack for some time prior to the accident.

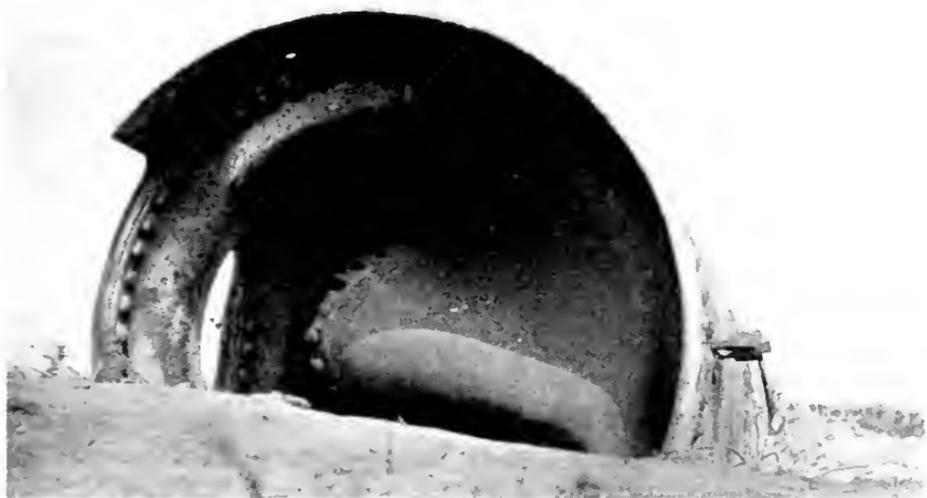
This 39" diameter boiler buried itself 14 inches in a field after traveling 340 feet.

An examination of the boiler revealed a rupture near the girth seam where the vertical section of the furnace sheet joined the cone section.

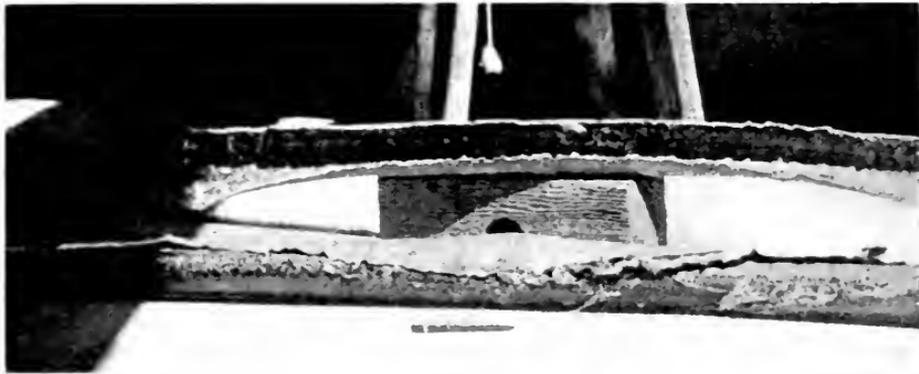
When the defective cable had been pulled and laid out on the floor, it was found that the lead was corroded through for about two-thirds of the length of the cable and could be stripped off without cutting. This condition is shown in Figure 1. There was no point on the cable

Figure 1—Cable attacked by corrosive caustics in seepage water.

indicating that injury had taken place during installation or afterward, except possibly at the lower end, which had rested on the edge of the duct. Apparently that was the point where current leakage had taken place and resulted in local heating.

Chemical analysis of the seepage water showed total alkalinity of 1264 parts per million consisting mainly of sodium hydroxide and some calcium hydroxide, both of which are active in corroding lead.

The cable which was selected to replace the damaged lead-covered cable was one with the copper strands properly tinned, these strands, of course, being spirally wound. Over the stranded copper was placed a 12/64" layer of rubber composition. This rubber composition was then wrapped with a layer of cambric tape over which was wound a copper shielding tape which could be grounded. A 7/64" outside jacket of 60 per cent tellurium non-hygroscopic compounded rubber furnished protection against moisture, mechanical injury and practically all chemicals.

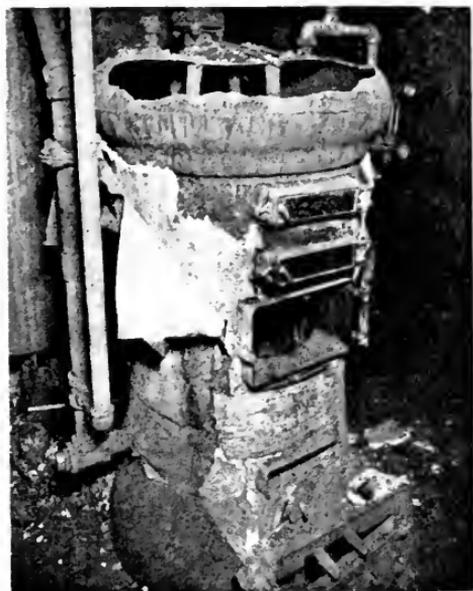
Explosions of cast iron steam heating boilers occurred principally in uninsured installations. A typical case is illustrated in Figure. 2. The residence, in which this boiler was located, suffered extensive damage and a woman occupant narrowly escaped injury. . . . In a church in a Mid-West town such an explosion severely injured the custodian and caused damage estimated at \$8,000 to the edifice, stained glass windows, organ and furnishings.

Figure 2. Partial damage following a cast iron boiler explosion.

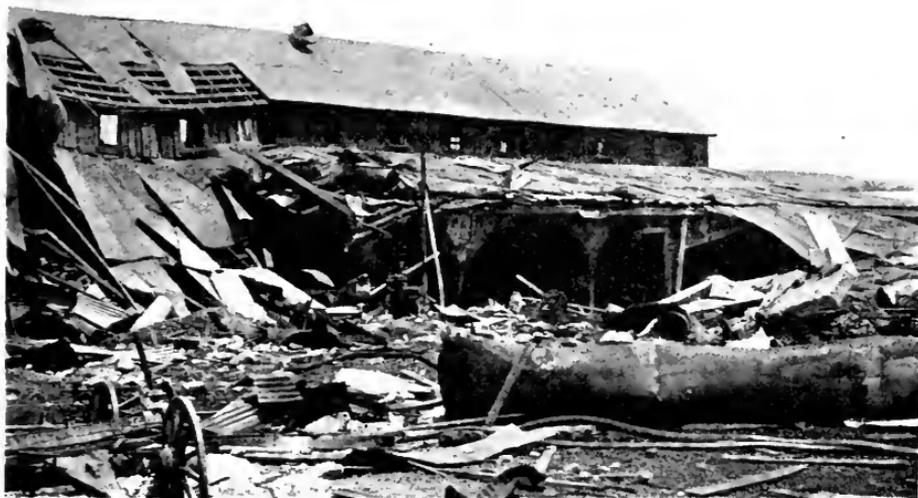
Figure 1. Result of a lap seam failure early in June.

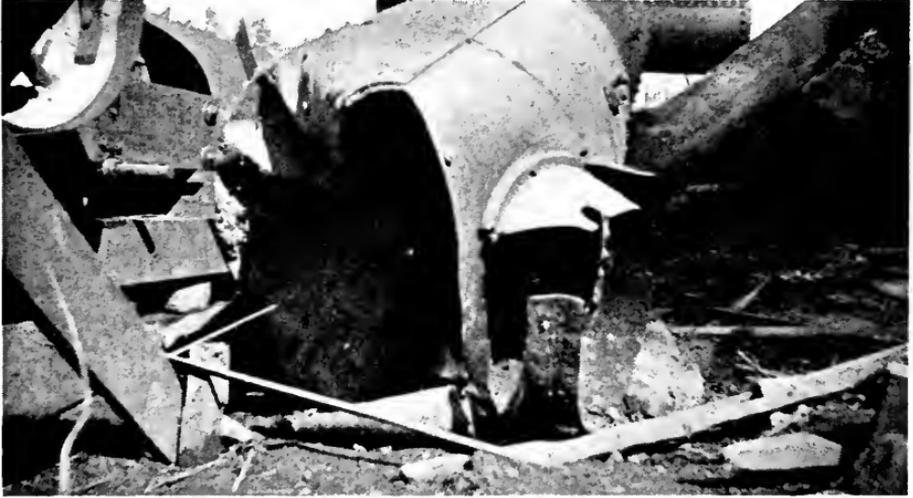
Figure 2. Aftermath of corrosion around the crown bolts of a locomotive type boiler.

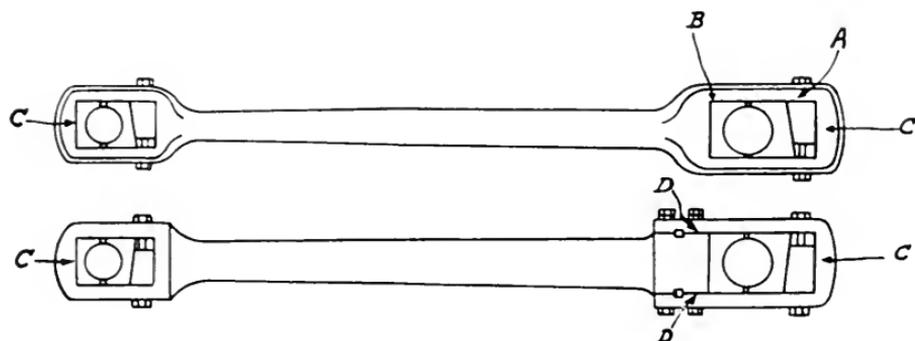
Cracks in the end members "C" are, as a rule, caused by sudden obstructions such as water in the cylinder. Weakness in these members usually occurs because the designer apparently assumed that the load was uniformly distributed over the entire length of the "beam." Actually, in view of the fact that the wedge may be considerably shorter than member "C," it is safer to regard the "beam" as having fixed ends and its load applied in the middle. In rods which are properly designed, "C" is made very heavy.

Figure 2 (above)—Solid-end type of connecting rod. Figure 3 (below)—Open-end type of connecting rod for center crank engines.
