The Locomotive

THE HARTFORD STEAM BOILER
INSPECTION AND INSURANCE CO.

INDEX
to
VOL. 42 - 43

INDEX TO VOL. 42—1938-1939

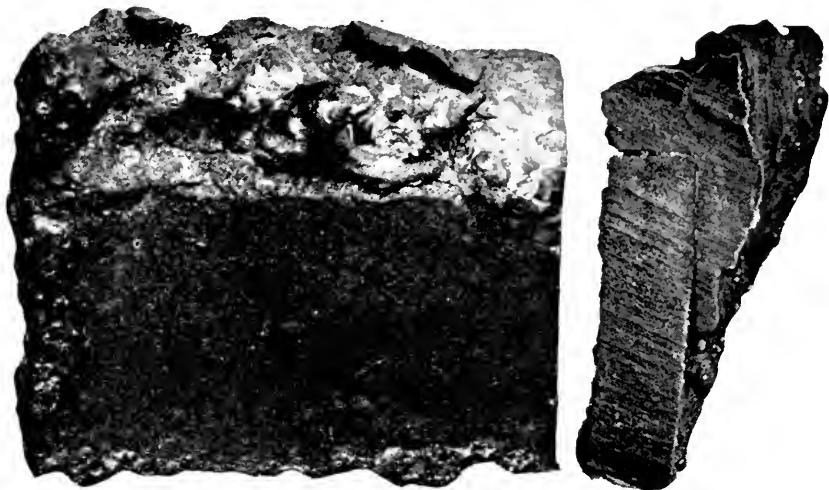
Figure 1. An example of uncontrolled welding. Parts of a 36" x 24" patch on a high pressure boiler are shown. The patch was welded flush with the shell plate and there was very little fusion. How little may easily be ascertained from the photograph at the right showing the cross section of the seam.

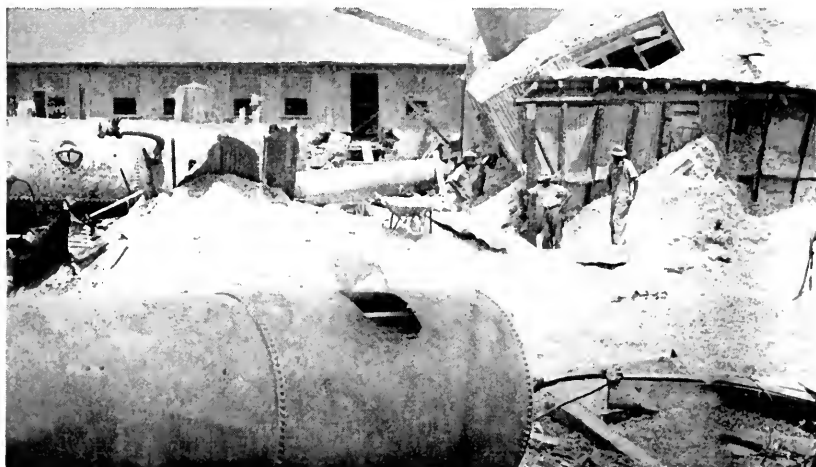
Figure 2. The shell, the hole where the patch shown in Figure 1 was attempted, and some of the debris which followed the explosion. Two other boilers were blown from their settings, the failing boiler rocketed 75 ft, the boiler house was wrecked, and one man was killed. It was reported that the boilers were not insured.

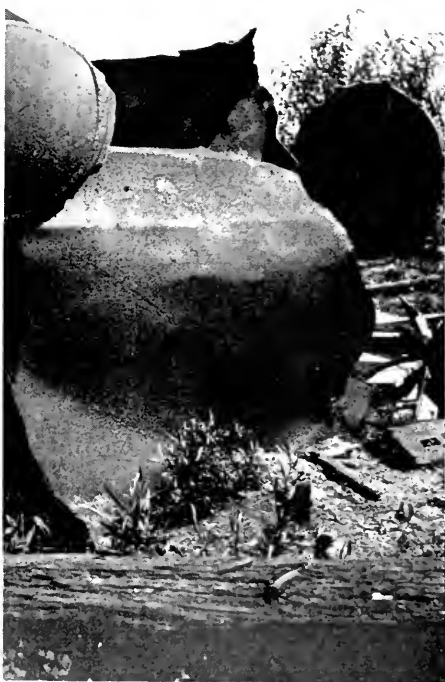
Figure 3. This uninsured air tank failure was traced by the inspector to lack of fusion in the welded longitudinal seam. The blast blew out a cement foundation and the air compressor and motor were hurled against the ceiling of the service station where the tank was used.

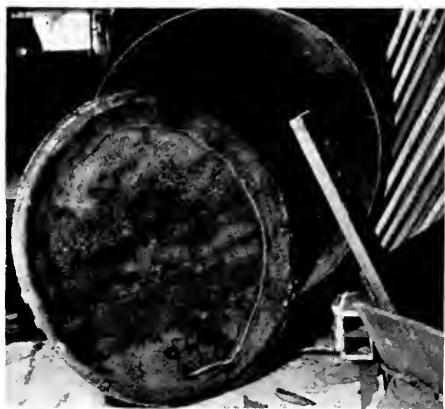
Figure 4. Head of a pneumatic tank which blew out when seal welding failed. Passing through a tile wall, the head damaged supplies in an adjacent room. The shell skidded in the opposite direction, breaking piping and sewer connections. Above the tank, floors and plaster were damaged. Insurance was not carried on the tank.

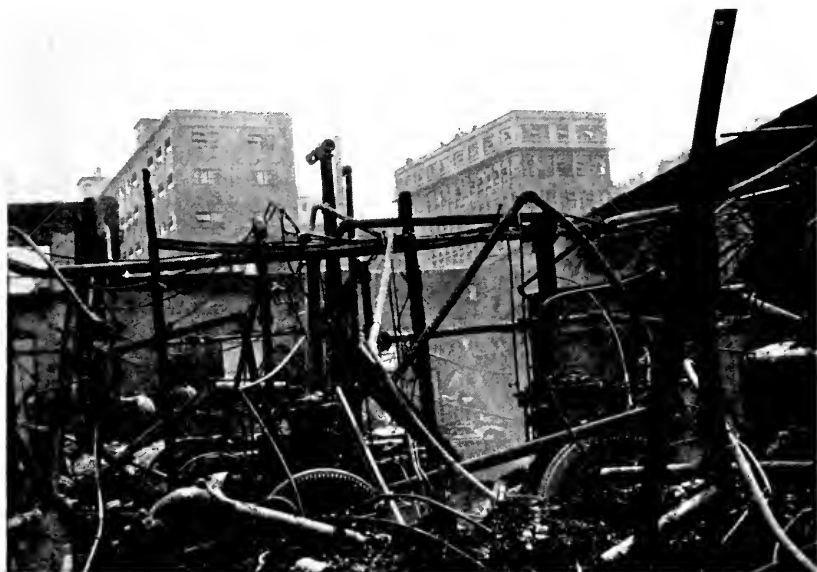
Wreckage following the explosion of a shell type brine cooler, the accident being attributed to tearing at the welded head and along the entire length of the longitudinal seam. There were points on both the longitudinal and head seams which indicated that the welds penetrated only about $\frac{1}{8}$ ". When the exploding cooler struck high voltage lines, a fire ensued which completed the destruction of the entire building.

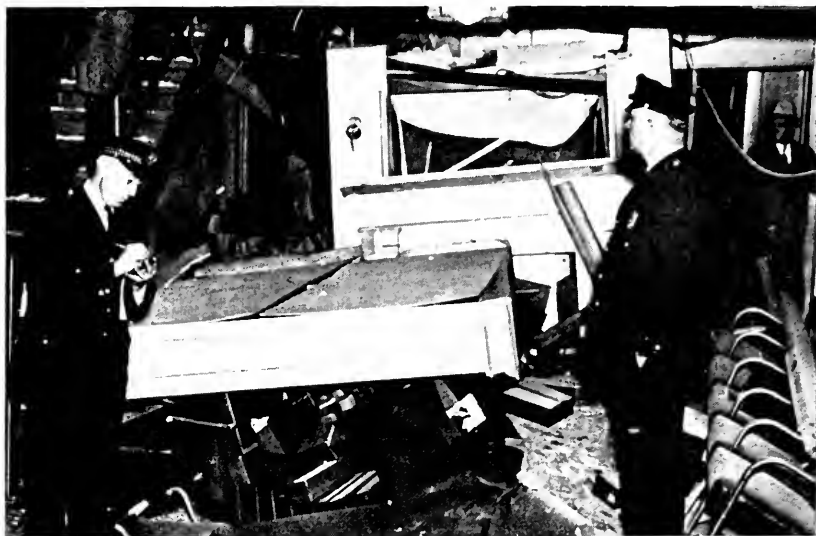
THREE persons were injured and property damage estimated at nearly \$10,000 resulted recently from the explosion of a single flue type steel hot water supply boiler in an Indiana hotel. Rupturing in the furnace sheet about 8" from the bottom of the boiler, the vessel tore loose from its setting, passed through a reinforced concrete floor above it, through the second floor of the building, struck the third floor and crashed down on an office desk. On the first floor was a store, the fixtures in which were wrecked, as is shown in the accompanying photograph.

Damage in a shoe store after an exploding hot water supply boiler had crashed through the floor and the ceiling.

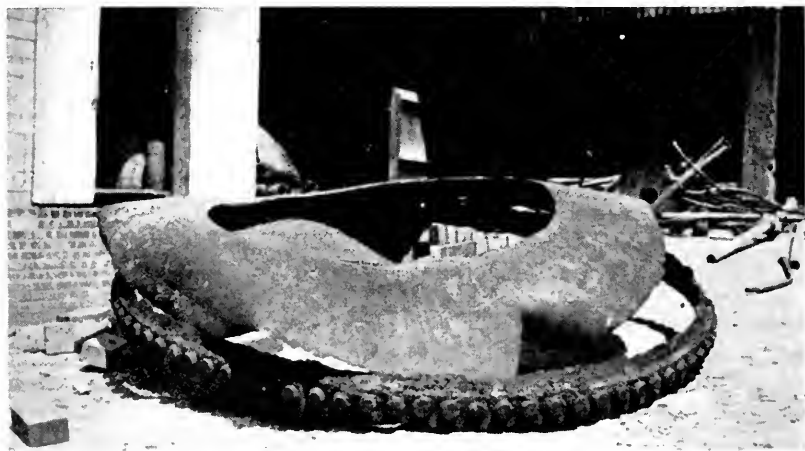
The top head of this tank had become so thinned that it ruptured at an operating pressure of about 72 lbs. The initial tear spread around

Head and seam of rendering tank which exploded after serious thinning because of external corrosion

the head at the knuckle just above the seam, and both head and tank crashed into 6" steel I-beams supporting the floor above. One of the beams was bent and two others dislodged from the brickwork. Wiring, piping and windows were also damaged.

While the head plate was somewhat corroded on its internal surface, the greater part of the thinning, from a normal thickness of $\frac{3}{8}$ " to an average of $\frac{1}{8}$ ", was on the outside. As the head of the tank was only 9" below the charging floor, it had been frequently subjected to moisture when the floor was washed. The photograph shows the defective part of the head, and the seam, which was cut away from the shell following the accident. The tear started at a point just to the left of the lap seam. The rip at the right occurred when the head hit a steel beam.

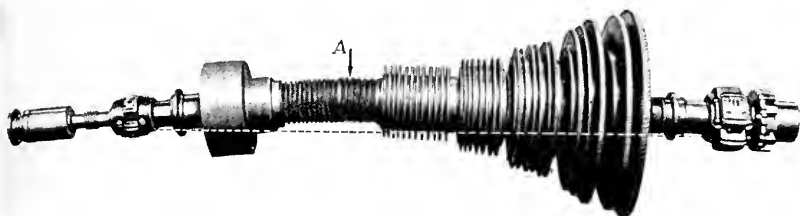
Figure 1—The photograph was purposely distorted to make clear how the shaft was bent and just where heat was applied. The distortion of the shaft is, of course, absurdly exaggerated.

was then applied at "A" (Figure 1) on the top of the spindle (the high side) by means of two oxy-acetylene torches. An asbestos ring was placed around the point that was to be heated, so that a quick heat could be obtained at that location. As soon as the heat was applied at the top, that side of the spindle began to expand and to rise, so that the bow in the spindle was even greater than before the heat was applied. This was seen on the dial indicator, which immediately began to show a plus reading. For the various heats, the torches were applied for periods ranging from 20 to 90 seconds which caused the indicator to show a maximum plus reading of 70 mils for the longest heat, but the best results were obtained by using a heat that raised the spindle only about 30 mils at each heating. As soon as the torches were removed and the top of the spindle began to contract, the drop of the spindle was rapid at first and then more gradual until the indicator again read zero within ten minutes' time. With further cooling of the spindle, the indicator began to show a minus reading until from minus 4 to minus 12 mils for each application was secured after 30 minutes of cooling. This

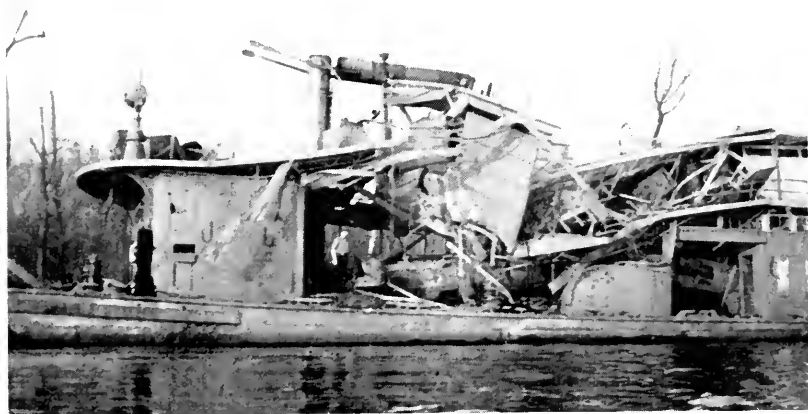
The cause of this accident was not immediately determinable because part of the boiler was blown into the river. Later the failing part of the shell was found. It revealed the probable cause of the accident to be over-heating and bulging of the second course of the boiler because of an accumulation of mud and scale.

As the section of plate which failed went overboard, it took with it the two firemen, who were on the deck. The rest of the boiler moved aft about 23 feet so that the rear head struck a condenser and an evaporator, damaging both. The smokestack and breeching which served the exploded boiler and another mounted with it were damaged, and the other boiler was badly dented. Living quarters of the crew and

Figure 1—Results of an explosion because of over-heating.

captain above the boiler room were wrecked, as is shown in the photograph, and there was other damage to the pilot house, coal bunkers, pipes and machinery.

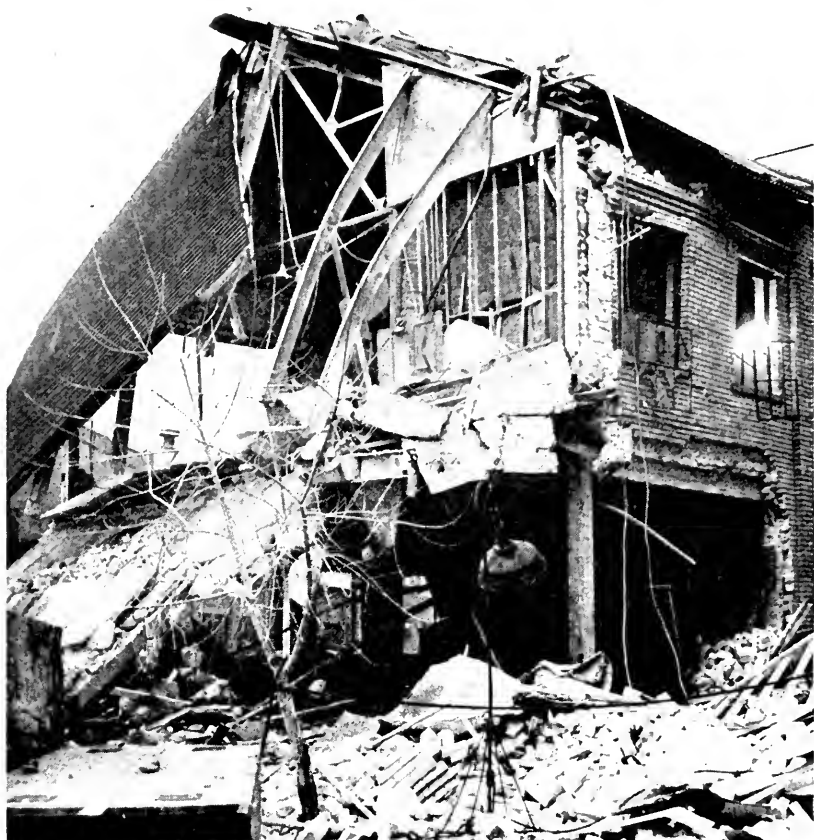
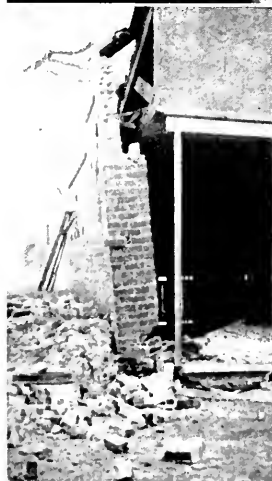
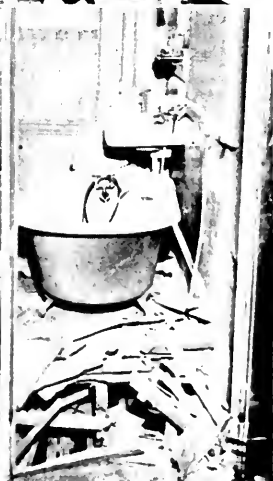
Figure 1—Top—Exterior of a factory building following a hot water tank explosion. Bottom Left—Part of the damage at a garage when a steel hot water heater failed. Bottom Center—Two views of serious damage following a hot water tank accident at an apartment. Bottom Right—The bathroom of a residence that was rendered uninhabitable when a small hot water tank exploded.

garage. In this case a plumber was renewing some of the hot water lines and in order to make a connection it was necessary to shut off the city water supply as well as the hot water outlet pipe from the tank. The automatic gas-fired hot water heater of the garbage burner type, however, was not turned off and continued in operation. This time the failure occurred in the heater, which was reported by an inspector to be the weaker of the two objects. The plumber sustained a skull fracture, and damage to the building and equipment was estimated at about

\$3,000. The condition of the garage wall following the accident is shown in the picture on Page 43, at the lower left.

In a New England apartment a forgotten gas burner led to a tank explosion which caused extensive property damage, as is shown in the picture on Page 43 at the bottom center. Two persons asleep in a bedroom miraculously escaped with minor injuries. The tank itself passed through the roof and came to rest on the roof of another apartment.

A similar accident in a New England residence so damaged the dwelling that a building inspector pronounced it unsafe for occupancy. The picture at the lower right on Page 43 shows where the tank went through the bathroom floor. According to newspaper accounts, every floor in the house was lifted out of position, walls buckled, and all window glass was smashed. The owner and his wife were sleeping when the blast occurred, and although both suffered from shock, they were able to make their way out of the house safely. Damage was estimated at between \$6,000 and \$7,000. The tank was equipped with a spring-loaded relief valve, but the device obviously failed to function. Windows in an adjacent house were blown in by the force of the explosion. The tank in this case was copper, the pressure having caused the failure at a brazed head seam.

• Similar accidents are reported periodically in all parts of the country, and demonstrate the need for inspections of hot water supply equipment. Such inspections include careful checking of the installation, the adequacy and condition of relief devices, and a search for the presence of corrosion or other weakness.

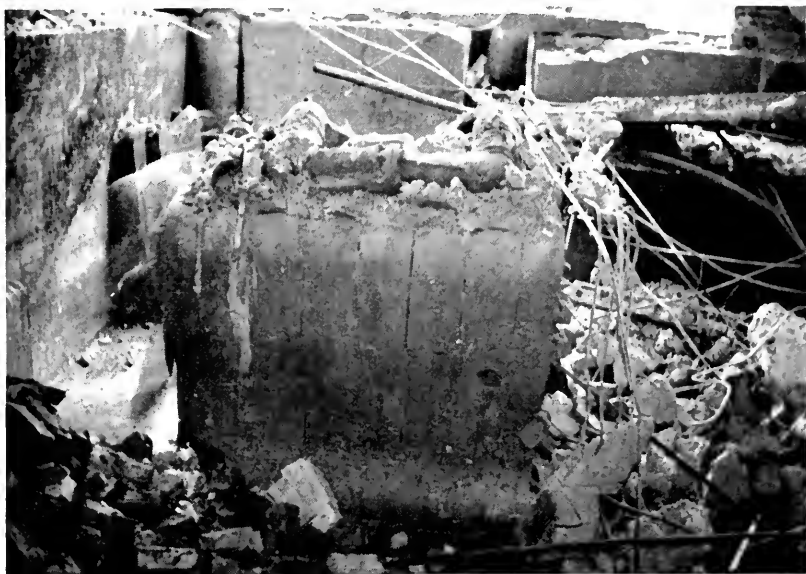
Figure 2—Basement of an automobile showroom after the explosion of hot water equipment. Three automobiles fell through into the basement when the floor was destroyed by the blast.

An explosion involving a hot water heater and tank in an auto dealer's showroom in the Chicago area demolished the basement, ripped up the floor and lifted three automobiles up against the ceiling. They fell back into the basement. Inasmuch as the system was of the closed type and the accident occurred in the evening when no water was being used, it was concluded that over-pressure was the cause. The storage water heater was completely demolished and the bottom head of the tank, which was welded to the shell, blew out. A view of the basement

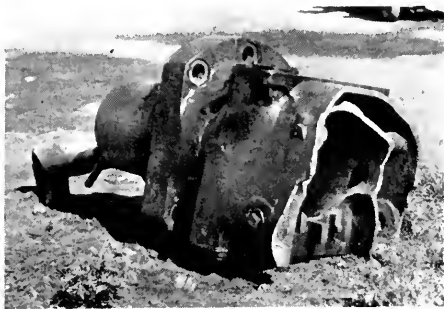
WHEN fuel oil tanks overflowed and some of the oil found its way unnoticed into the air ducts beneath the floor, the result ing over-speed wrecked a modern 2-cycle crankcase-scavenging 600 hp Diesel engine at a Middle West municipal utility. Replacement cost of the machine was estimated at \$35,000.

Figure 2—A cylinder from the wrecked engine.

It was estimated that the engine was running about 1000 revolutions per minute when the breakdown occurred, and although the centrifugal force caused the flywheel to crack, it did not explode and add to the havoc already wrought.

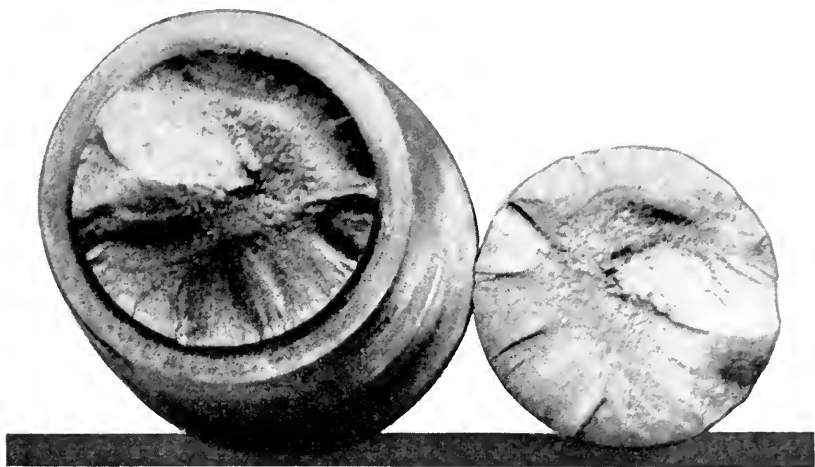
A shaft failure that occurred on a 300 hp wound rotor motor driving rubber rolls through a magnetic clutch and reduction gears. This failure occurred at the inboard end of the journal and at a location not ordinarily accessible for inspection. Vibration developed suddenly and the machine was taken out of service before breakage actually occurred. The shaft was broken in order to study the character of the crack, which was attributed to misalignment or improper adjustment of parts at some prior time.

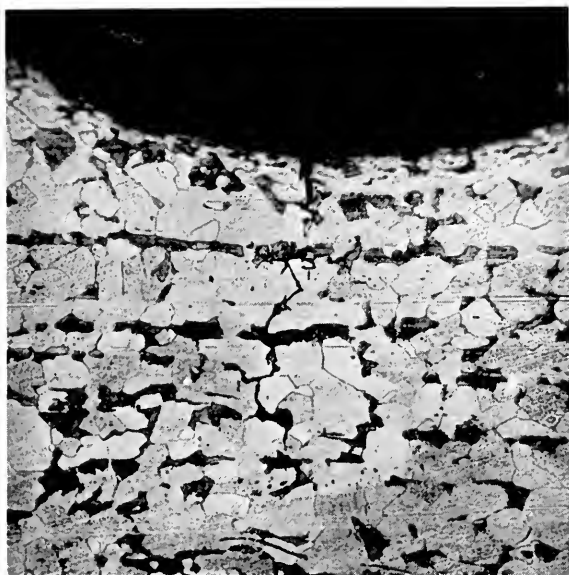
Figure 2—Embrittlement at 225 magnifications. The defect shown here was produced in the University of Illinois tests. The progress of the fissure may be compared to that in Fig. 3.

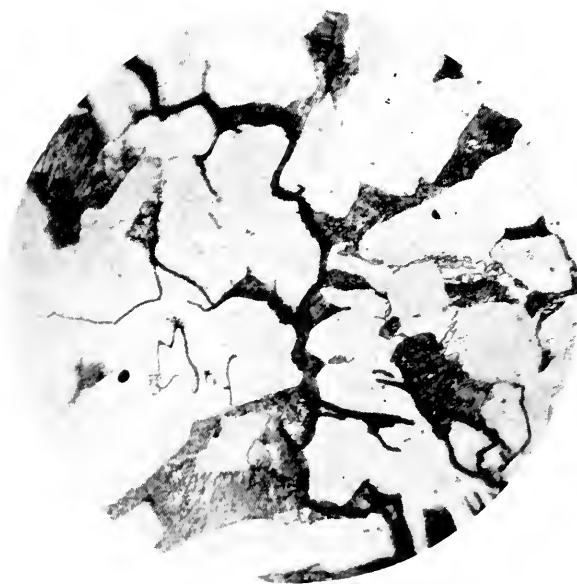
Figure 3—Embrittlement at 500 magnifications. This defect developed in a boiler under ordinary operating conditions. The characteristic intercrystalline path of the disintegration is clearly shown and is directly similar to the disintegration produced in the laboratory and shown in Figure 2.

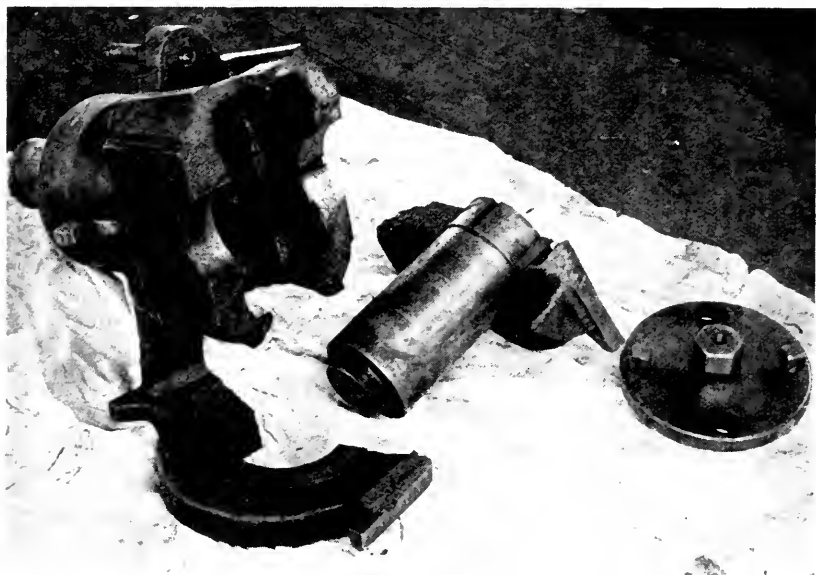
Figure 1—Broken parts following the failure of a cast iron crosshead. A dismantled inspection probably would have prevented this accident.

Figure 1 illustrates a failure that occurred on a cross-compound Corliss engine having a 56" low pressure cylinder. A crack on the back side of the cast iron crosshead, on the high pressure side, progressed until the solid metal on the front side was broken. Both cylinder heads were pushed out with subsequent breaking of other reciprocating parts. The damage amounted to more than \$8,000.

The frequency of cracks in crossheads has brought a recommendation for the replacement of cast iron crossheads with crossheads of steel. The reason for this lies in certain inherent properties of the two metals. Cast iron has very little elasticity or ductility so that the shocks which inevitably occur on a reciprocating engine will more readily start a crack in a cast iron crosshead.

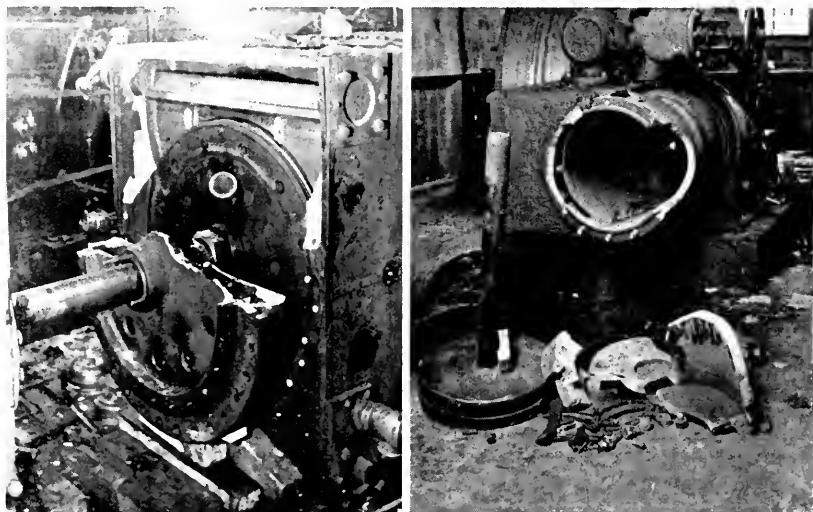
Figure 2—(Left) the result of a connecting rod crack. Figure 3—(Right) the result of a failure in the threads on the piston rod just inside the crosshead.

Recently, the connecting rod on one side of a large twin-tandem-compound steam engine broke and caused this side of the engine to be almost completely wrecked. The failure resulted from a progressive crack in the eye of the rod at the crosshead end. An accident not involving the connecting rod, had occurred to the same side of this engine several years previously and, at the time of this first accident, a close examination of the connecting rod revealed no defects. However, the previous accident probably started the crack and if a definite routine of dismantled inspections had been carried out, this costly failure could have been avoided. Figure 2 shows what happened to the cylinder after the connecting rod broke.

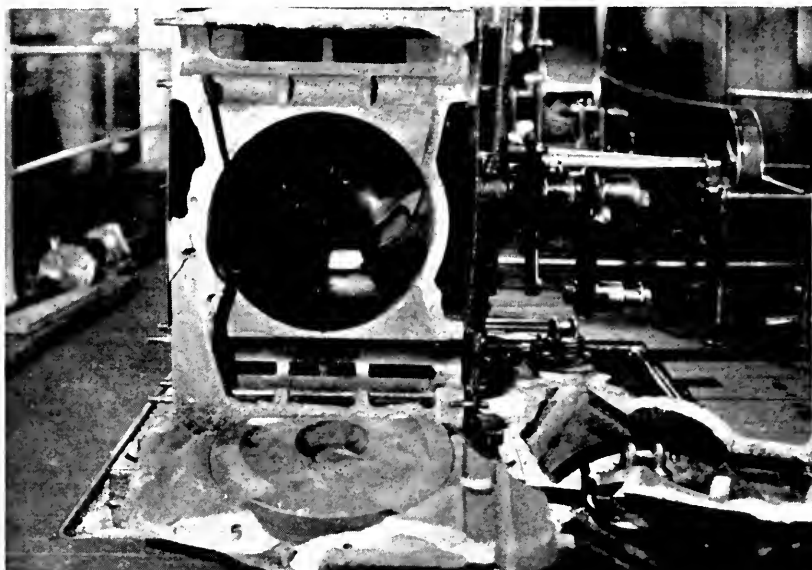
Figure 4—An accident attributed to the failure of follower bolts.

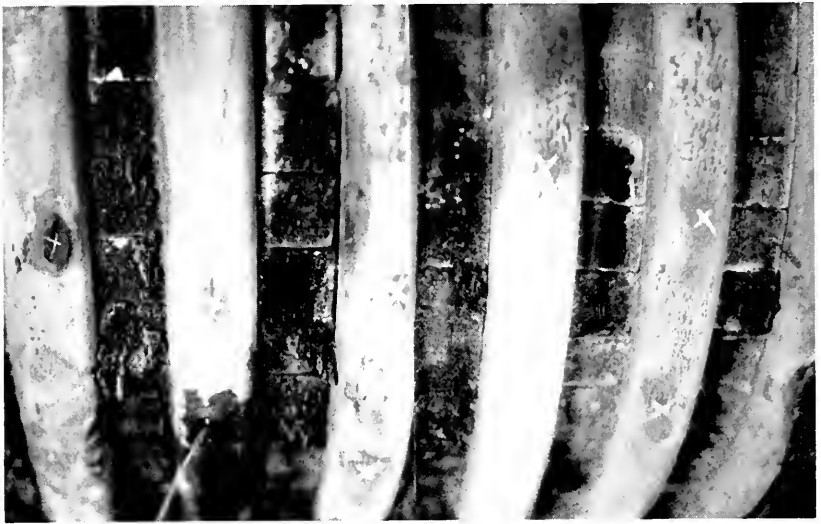
Figure 1—Deposits of scale at the bends in these tubes permitted general over-heating of an entire row. Finally one of the tubes burst (second from the left in the picture), but the warning came too late.

Figure 1 shows 6 of 17 water wall tubes in a medium sized boiler. One of the tubes has ruptured and wherever an "X" has been placed on the photograph, there, bulging and thinning has occurred. The eleven other water wall tubes were similarly damaged. Several factors may have played a part in this accident. Examination after the accident revealed the presence of $1/32''$ to $1/16''$ scale at the bend in the water wall tubes immediately above the stoker at a point of high radiant heat impingement. As an identical boiler in another part of the country operates satisfactorily scale-free, it was evident that the troublesome variable at the plant where the accident occurred was the feedwater or the feedwater treatment. In this case a condition which may have aggravated the situation was an attempt to operate at extremely high ratings by means of forced draft.

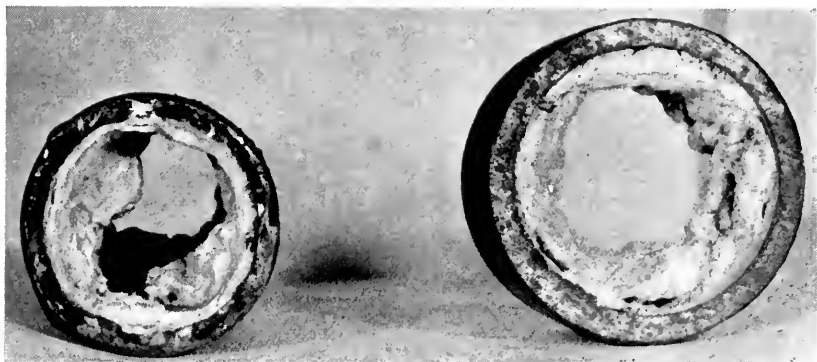
Figure 2—Superheater tubes from two boilers in widely separated parts of the country. Carry-over of solids in the steam rapidly builds up such deposits.

from affected sections of the superheaters, contain a hard scale which in some of the tubes nearly filled the steam space. These deposits occurred in boilers operated only four or five weeks and were from wet steam carried over from the drums. Impurities in the feedwater were the primary cause, but other factors such as the height of the water in the boiler, the arrangement of steam scrubbers, circulation and gas passes were contributory.

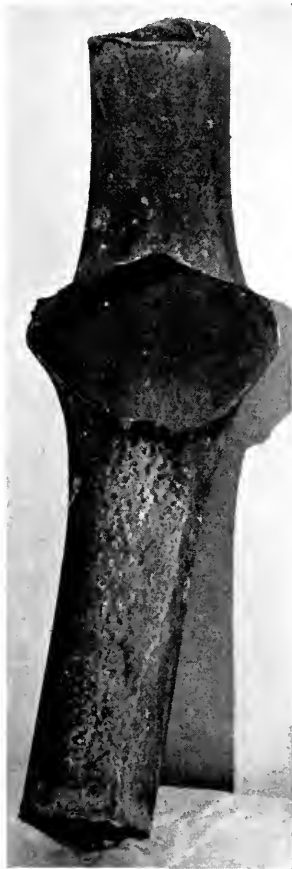
Figure 1—A close-up of the tube which signalled the difficulty illustrated in Figure 3. The rupture is 7" across.

tube in sufficient amount to bring about the tube rupture shown in Figure 4. When the bursting of one tube signalled that there was trouble in the boiler, the over-heating had progressed so far that it was necessary to remove 272 tubes. This boiler contained no oil, scale or sediment and there was no evidence of low water. It is sought to prevent a repetition of the difficulty by a change in the arrangement of baffles.

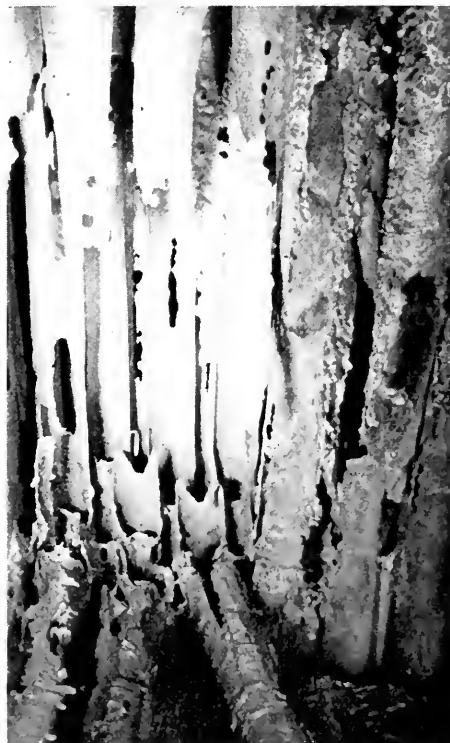
Figure 5—Rear wall of the furnace after forgotten open blow-off valves had drained the tubes.

Figure 5 illustrates the costly results of a forgotten open blow-off line with the boiler in service. Forty tubes were burned in the manner illustrated. Other instances of low water have been brought about by

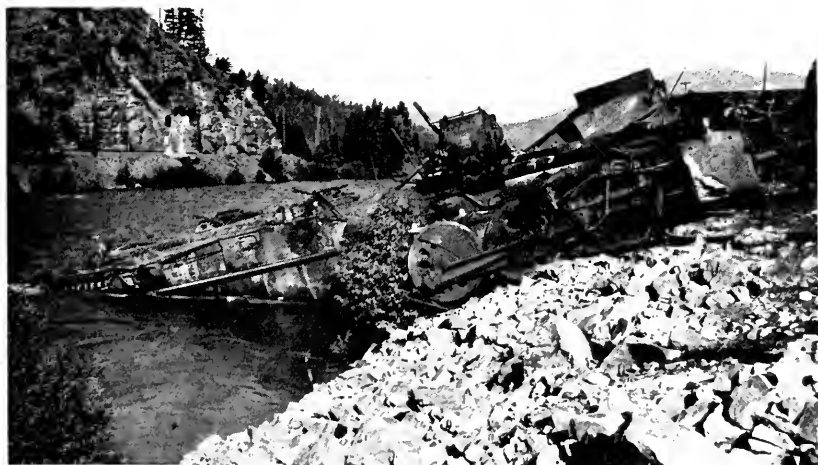
Figure 1—300 tons of locomotive toppled into a Montana river by the explosion of the boiler.

The most serious accident was the explosion at about 11:00 P. M. on July 7 of a large Z-6 type freight locomotive (4-6-6-4 wheel arrangement) in Montana. The 300-ton locomotive up-ended, fell across transmission wires and crashed into the Clark Fork River as shown in Figure 1. In addition to the engine, property damage included destruction of about 200 feet of track and 7 boxcars. The engineer, fireman, brakeman and two transients were killed and four transients were seriously injured when the sudden stop knocked them from the train or piled them up inside of cars. The fact that the accident occurred at night added to the confusion.

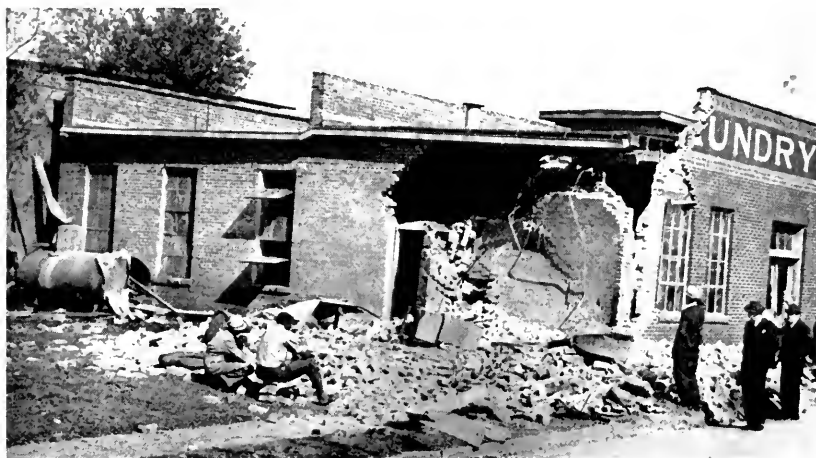
Figure 3—Damage following a boiler explosion at a laundry.

of this type of boiler to a stationary installation. The laundry where it was used was stopped because of the accident. It so happened that the boiler was hurled across the street into a cemetery instead of into the main part of the laundry, so that employees escaped injury.

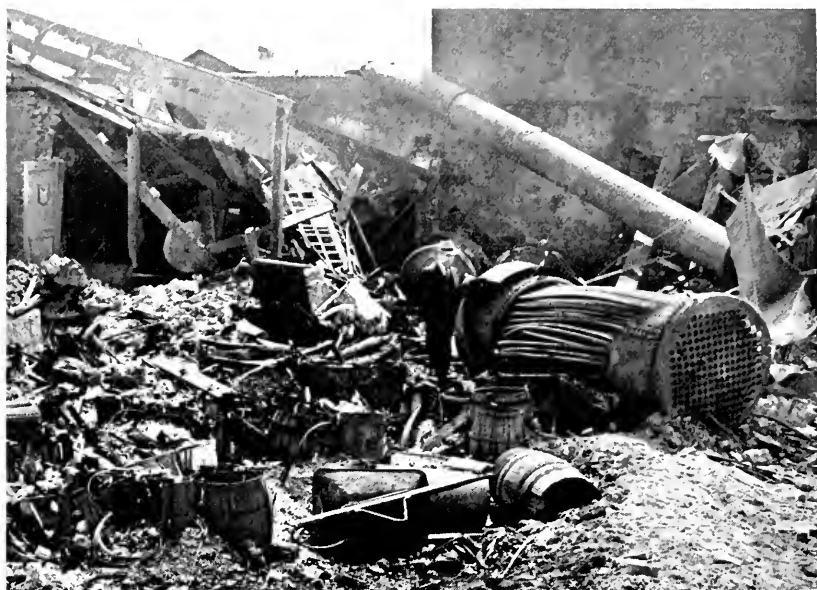
Figure 4—A building demolished by an explosion of a vertical tubular boiler which had been poorly patched by welding.

Figures 4 and 5 reveal the tragic effects of attempts to repair fire tube boilers by means of welded patches. Although welding engineering has advanced rapidly in recent years, the technique of welding boiler

patches on fire tube boilers of all types is still far from standardized. Such repairs are not yet recommended.

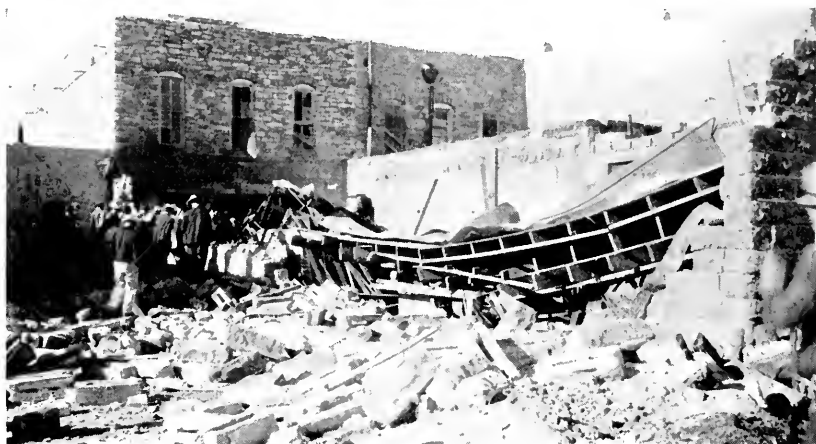
Figure 5—Wreckage after the failure of a welded patch on a Scotch-Marine type boiler.

In the case shown in Figure 5 at a Southern tailor shop, the explosion of a Scotch-Marine type boiler, which failed at a welded patch, leveled a part of the building and blew out the front of the structure. Part of the boiler went through a neighboring store and windows were broken in buildings across the street.

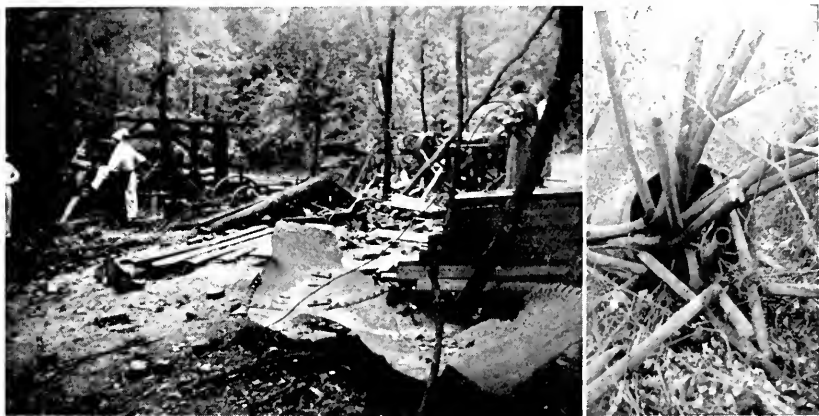
Figure 6—Left—Scene of an explosion in which two persons were killed and two injured. Right—Result of a lap seam crack. Three persons were injured by the explosion.

similarly with respect to several explosions at Southern lumber mills. Corrosion, failure to maintain relief devices properly or actual lack of them, lap seam cracks and careless operation figure in most of these explosions with their toll of deaths and injuries. Figure 6 shows two lumber mill scenes, that at the left revealing a plant demolished by a boiler explosion and that at the right showing parts of a boiler at rest in a wooded area.

The second accident demolished the mill and injured 3 men. Insurance was carried in neither case. In fact, an inspector, on visiting the second accident scene, wrote, "Had this boiler been subject to inspection, its hazardous condition would have been detected and the catastrophe averted."

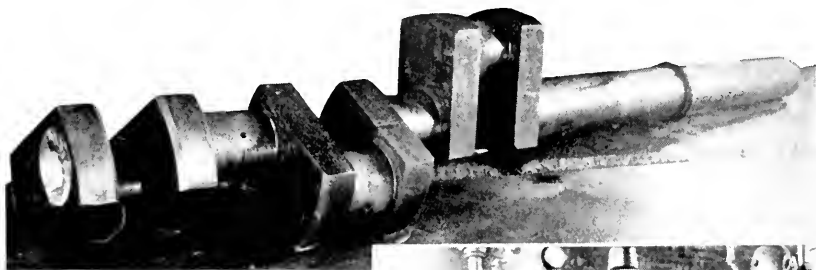
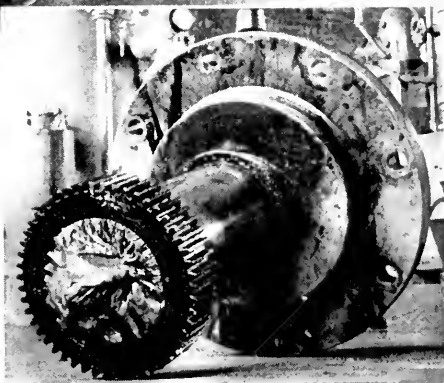
Engine Crankshaft Failure

THE breakage of this crankshaft in a 140 hp Diesel engine used at a New England ice plant was attributed chiefly to torsional vibration. Starting around the circumference of the shaft under a fillet at a web, cracks progressed into the shaft and so weakened it that it broke after about one year's service.

The failure, which was roughly conical in shape, is typical of torsional vibration breaks with their radial failure lines. In this installation the timing gear was immediately adjacent to the break. Beyond it (to the left in the top picture) was a main bearing and outside this a 5,700 lb flywheel. It is felt that the weight of the wheel added to the stress at the point of failure and hastened the break. The direct damage loss, which amounted to nearly \$4,000, was covered by Hartford Steam Boiler.

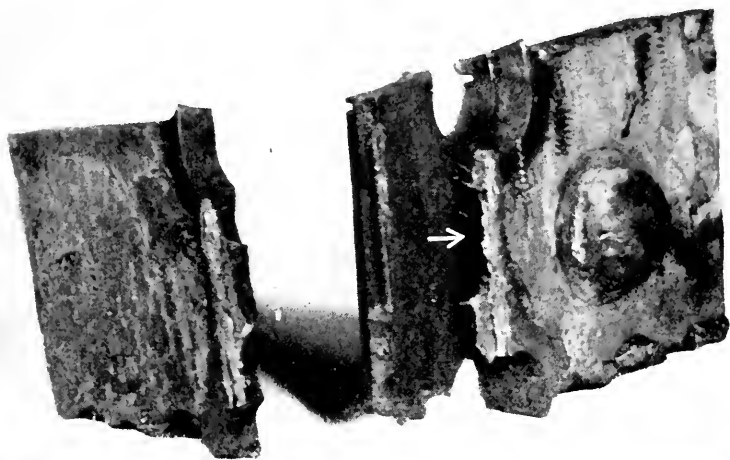
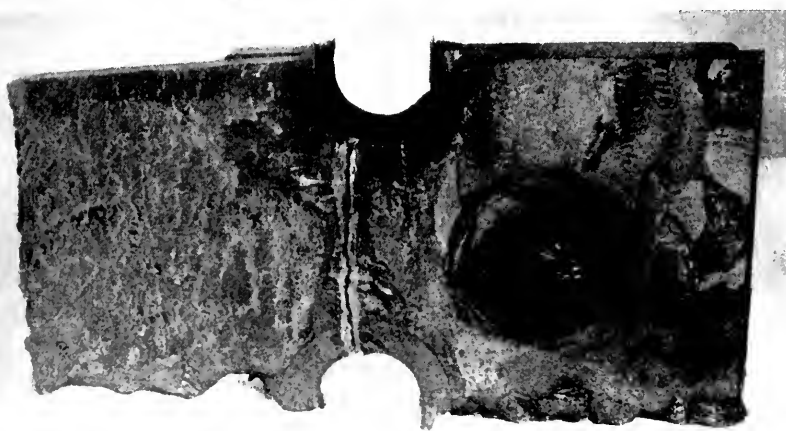
The line of rupture was found to have followed a series of defects which started at the walls of the rivet holes near the interface, or hidden surface of the shellplate forming the inside lap of the seam. It should be understood that the hidden surface becomes the outside surface beyond the line of caulking.

In a general way, development of those defects was in the zone of greatest stress and was toward the adjacent rivet holes. As the defects progressed, they penetrated the sheet to a greater distance from the interface. The result of this combination of developments was a number of areas where the grains of the steel were in intimate contact, but without the strength afforded by the grain binder. A similar defect is shown in Figure 2 in which the dark areas are those in which grain binder corrosion has developed and the bright areas show the break

Figure 2—A fully developed embrittlement defect in metal from one of the steamer's boilers. The lower picture shows the rivet hole to rivet hole direction of the disintegration. The top picture is of the same pieces of metal as the lower, the dark areas in the break illustrating the development of the embrittlement (see arrows).

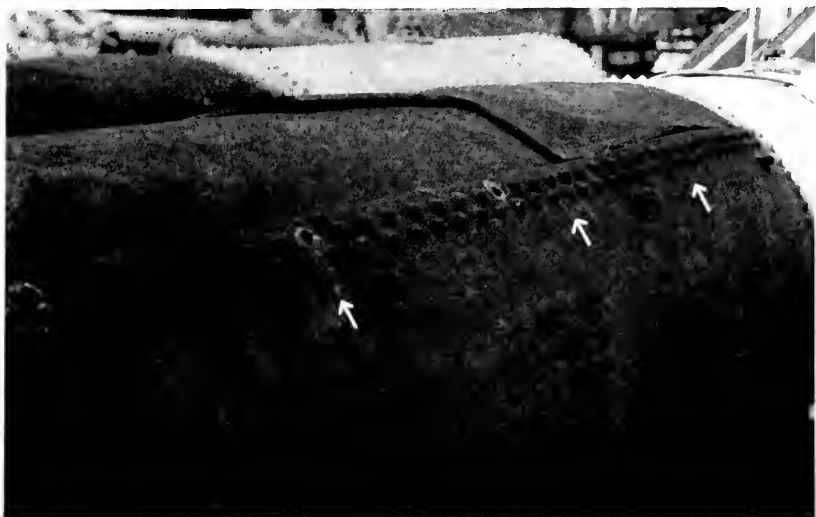
Figure 4—Failure in Boiler No. 3 after the hydrostatic test. The break at the right is clearly from embrittlement. The continuation of the failure across the boiler is a stress tear similar to that in Boiler No. 2, which exploded under steam pressure. The lap seam crack slots are indicated by the arrows.

rivet hole to rivet hole for a distance of 45 in. from the third girth seam as shown in Figure 4. At that point the path of the break changed to a girthwise direction with another change to a longitudinal direction when the top of the boiler was reached. There was a third change to a path diagonal with the girth seam and longitudinal seam. The entire length of the rupture was nearly 100 in.

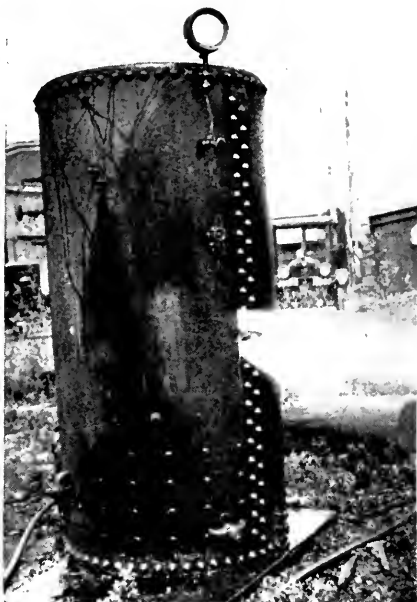
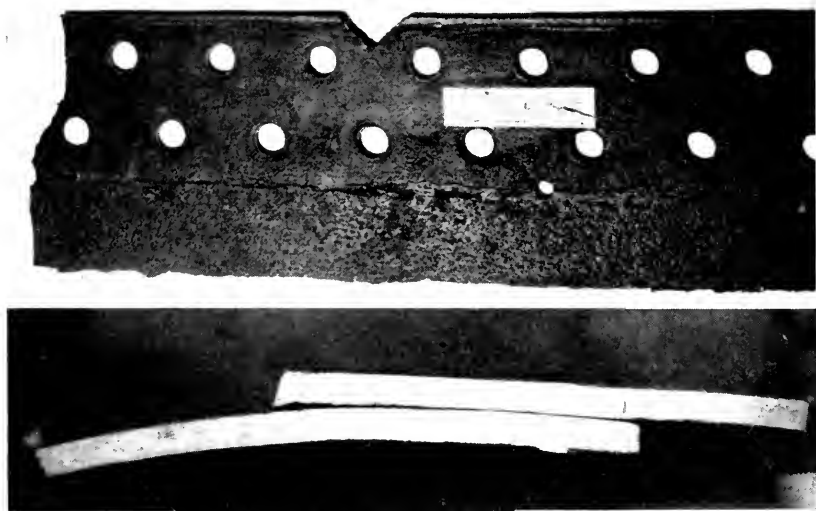
If a lap seam crack had developed to a depth of $\frac{1}{8}$ in. from the inside surface of the plate, where such a crack normally develops on a line close to the edge of the rivet heads, as shown in Figure 5, some of the slots would have reached the crack and permitted leakage when the hydrostatic test was applied. Such leakage did not occur.

Figure 5—Top and end views of a typical lap seam crack. Notice that this defect is on the opposite side of the seam from the failures shown in Figures 1, 3, and 4. The picture at the upper right shows a lap seam failure under hydrostatic test.

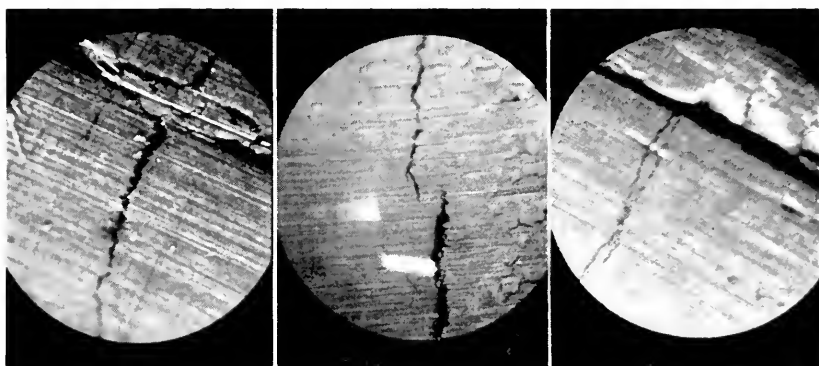
Figure 6—Embrittlement defects from Boilers Nos. 1, 2 and 3 (from left to right) as seen in rivet holes through the Hartford Steam Boiler magniscopes.

Many of the defects were then visible to the naked eye. Photographs of these defects at 40 magnifications in boilers Nos. 1, 2 and 3 are shown in Figure 6. In Figure 7 is shown a defect of the same sort at 225 magnifications as photographed at the University of Illinois laboratories during recent embrittlement research. In Figure 8 is a photograph at 500 magnifications of an embrittlement defect from the No. 1 boiler.

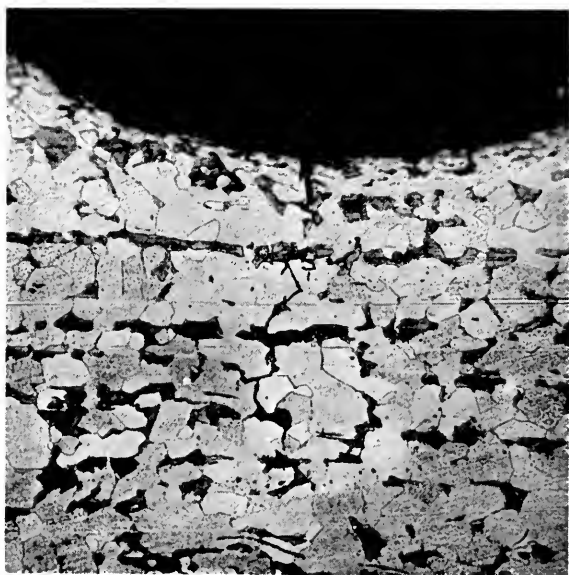
Figure 7—Embrittlement disintegration at 225 magnifications as produced in the laboratory.

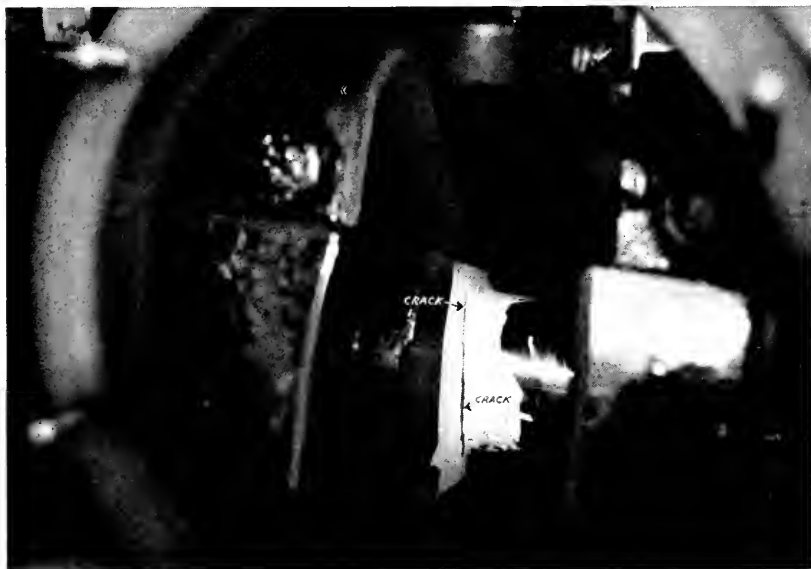
Figure 1—Crack in the fillet of the crankweb and crankpin of a Diesel engine. It was located by means of the whitewash test without dismantling the engine.

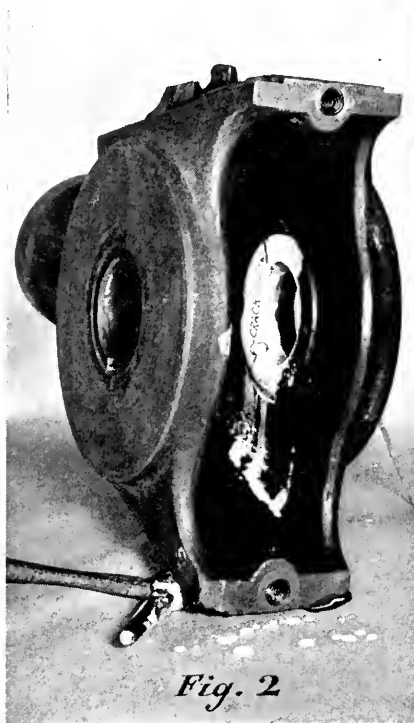
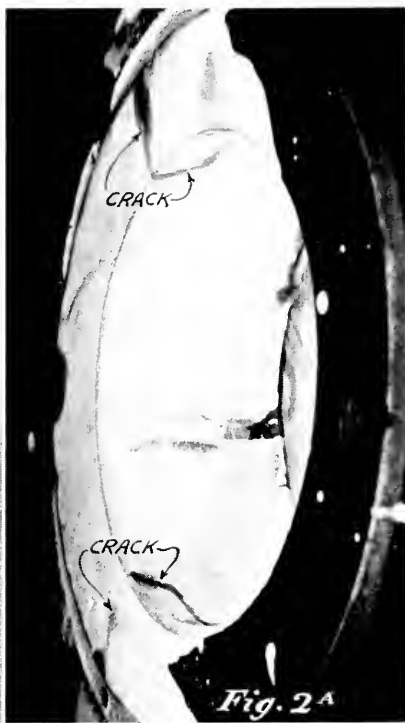
Figures 2 and 2A—Whitewash test showing crack across one of the eyes on the inside of a crosshead.

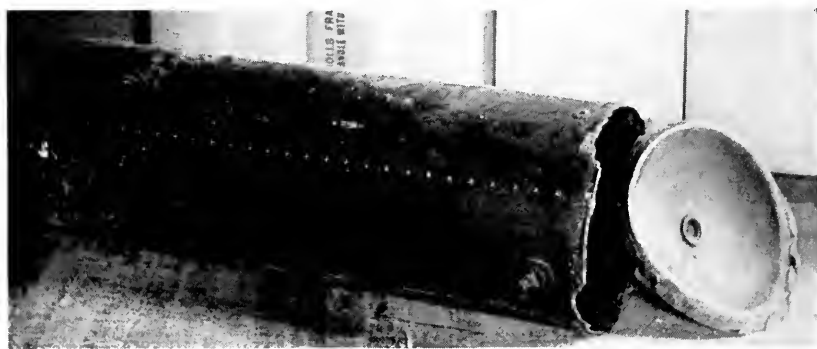
Figure 2—Reversed minus head An improperly adjusted safety valve permitted the building up of excessive pressure.

2. To mount air tanks with the minus head at the top if set vertically and provide a drain at the lowest point of the vessel. Two plus heads are preferable.

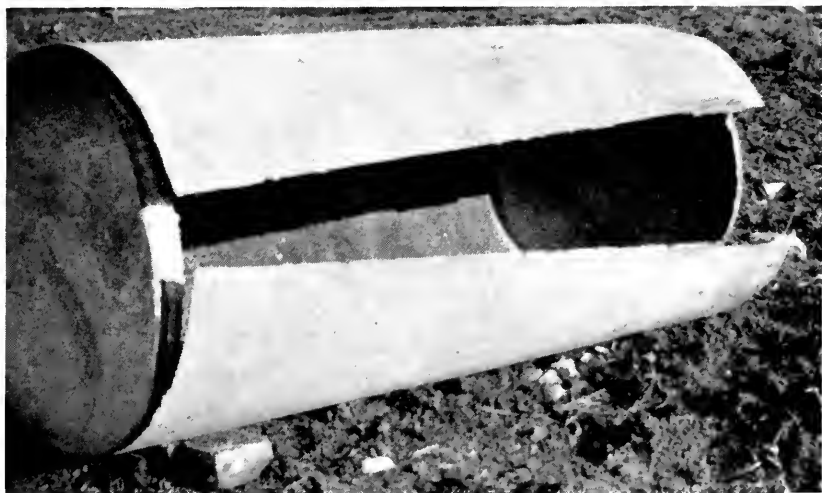
Figure 3—Failure of the longitudinal seam. Faulty welding was given as the cause of this accident.

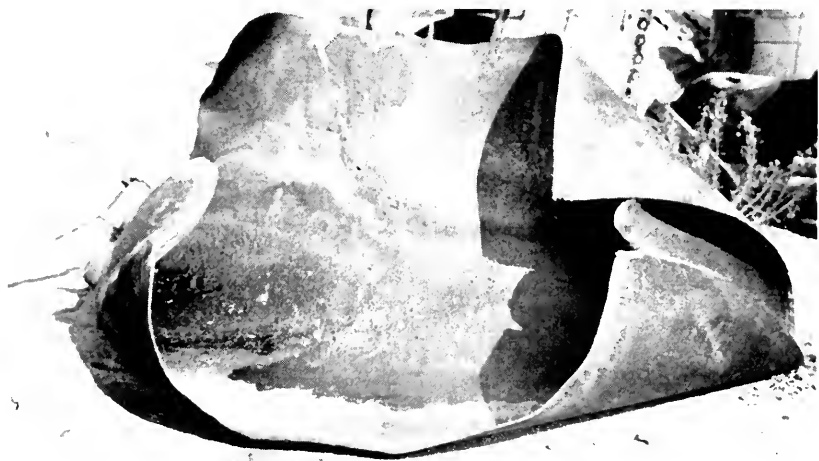
The causes of these accidents were much the same as those for air tanks. One failure (See Figure 5) occurred because of progressive cracks in the crimped edges of the shell, five were over-pressure failures such as that shown in Figure 6, one resulted from a lap seam crack and the eighth because the minus head was made of steel which was too light for the pressures carried. In four of the five accidents

Figure 6—Hydro-pneumatic tank which ripped open because of overpressure.

caused by over-pressure the failure was attributed to non-operation of pressure relief valves or electrical cutoffs to the motor or both. The fifth tank was equipped with no relief devices whatsoever.

As in the case of air tanks, hydro-pneumatic tanks should be properly constructed for the pressures carried, should be protected by reliable and adequate relief devices, and should be inspected periodically to check on the system in general, the operation of relief valves, and the growth of defects from such causes as corrosion.

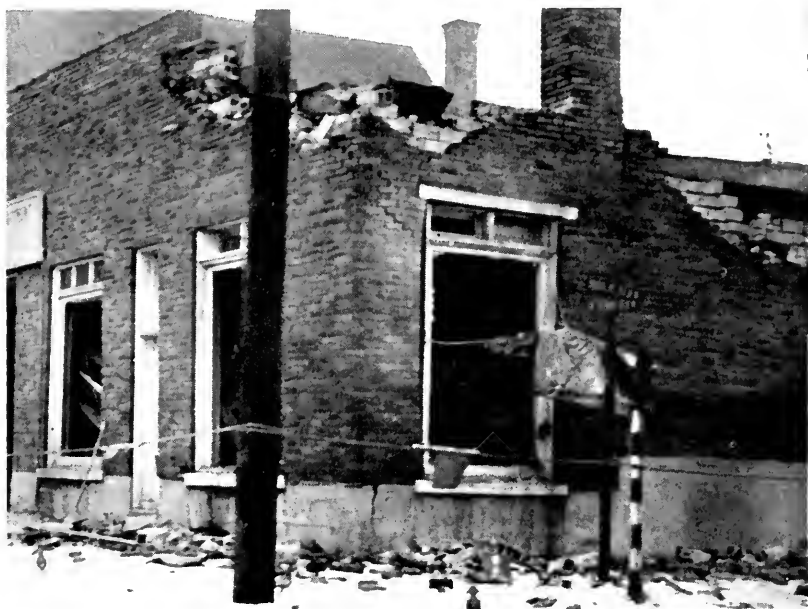
Figure 1—Damage to the exterior of a large garage because of a hot water tank explosion.

a distance of 30 feet each way from the corner of the building, as shown in Figure 1.
