The Locomotive

THE HARTFORD STEAM BOILER
INSPECTION AND INSURANCE CO.

INDEX
to
VOL. 42 - 43

INDEX TO VOL. 42—1938-1939

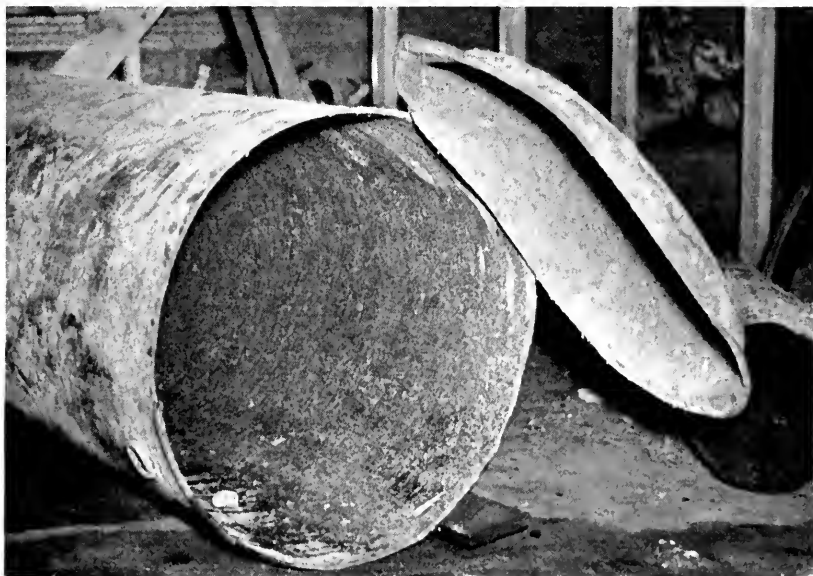
The boiler which supplied water to the tank was blown from its base and a steel heating boiler damaged. The brick chimney, part of which is shown in the photograph, was so damaged that it had to be torn down. As the safety valve opened readily at 100 lb when tested after the accident, it was considered that the most likely cause of the explosion was a minus head of a construction which was inadequate for the pressure carried. This head reversed as shown in Figure 2.

Figure 2—The tank which failed. The reversed minus head is clearly shown.

the hot water supply boiler did not permit a rapid enough lowering of the temperature and pressure before the tank failed. Although the safety valve tested satisfactorily after the accident, it may not have functioned fully before because it might have been partially stuck. Stuck valves have often been jarred loose by the force of an explosion.

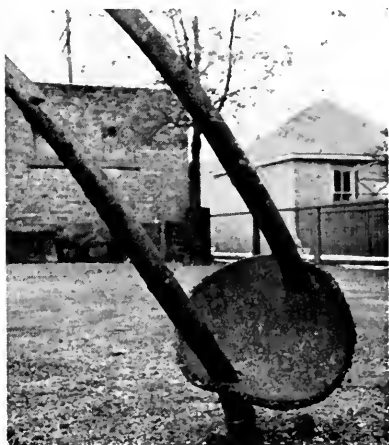
Figure 1—Head from a refrigerating vessel which failed at 150 lb pressure when the welded head seam gave way.

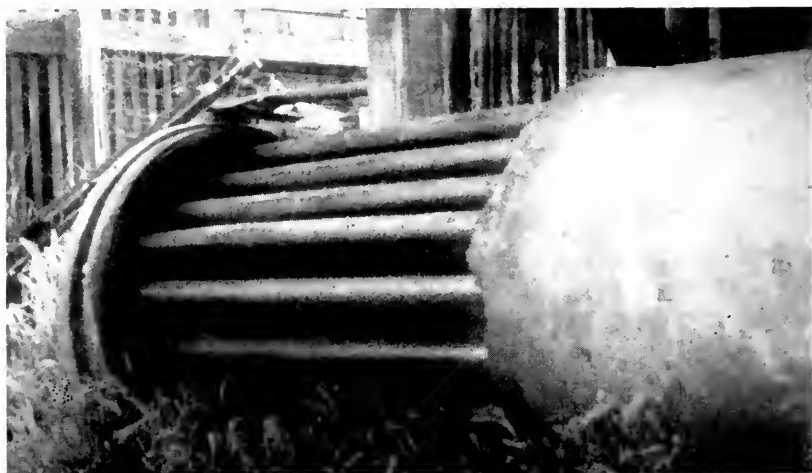
Figure 2—Condenser which exploded when poor girth seam welding permitted a 34" piece of plate to tear out.

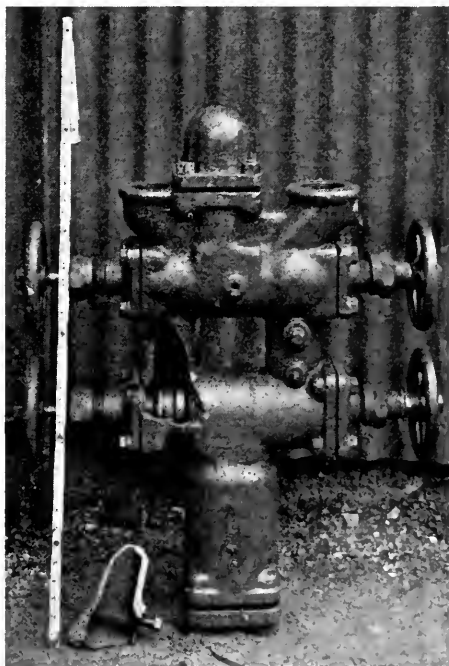
Figure 1—Ammonia compressor manifold which exploded because of an excess of pressure within it. The failure led to the death of an engineer, who was drenched with the refrigerant.

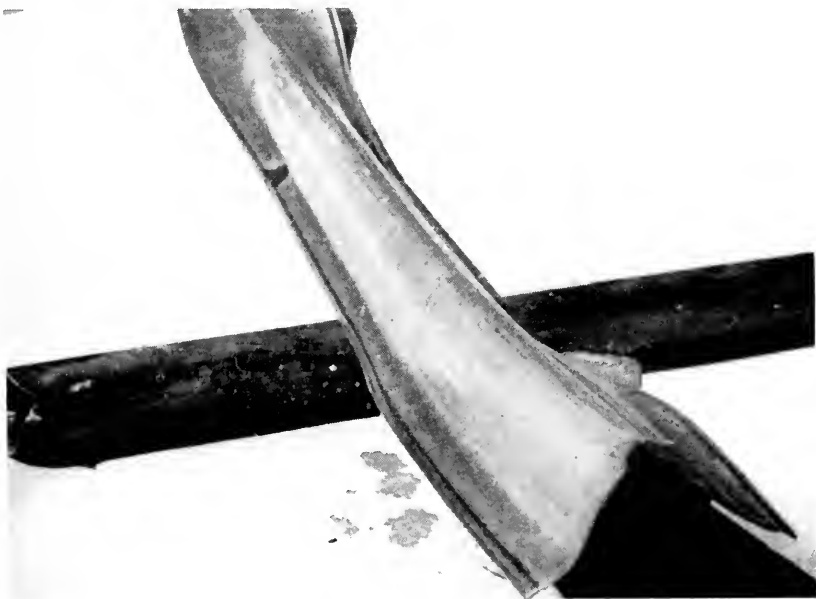
Mistakes in operation sometimes play an important part in accidents. Figure 5 shows a piece of stainless steel pipe which blew open for a distance of 67 inches. The pipe was a part of a cooling coil installation in a brewery, the beer being cooled by running it over the coil. Contrary to orders, a workman had used boiling water to wash this piping while it was under pressure with the system charged, a procedure which is believed to have cracked the piping along a special fin. Its

Figure 5—Stainless steel ammonia piping which tore open in a brewery.

subsequent failure released a large amount of ammonia and shut down the plant.

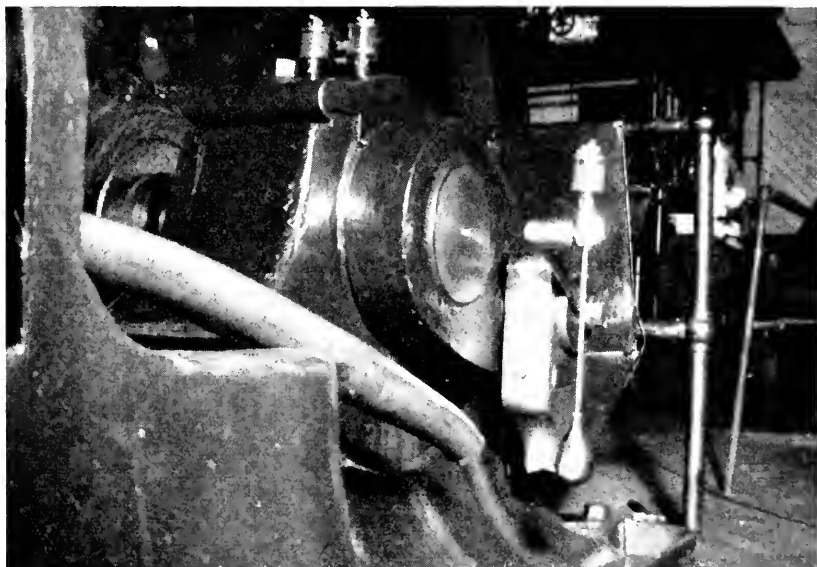
Figure 6—Broken connecting rod of a 150 lb ammonia compressor. The accident was attributed to an attempt to start the compressor 3 times in spite of burned out fuses. The discharge valve had not been opened.

through: Periodic dismantled inspection to detect incipient cracks and other faulty conditions such as valve troubles, adequate purging of non-condensable gases, proper draining of lines and proper charging to eliminate slugs of liquid, proper attention to compressor cooling water and compressor lubrication, opening of discharge valves on starting, and not using welding for repair purposes when there is a likelihood that that repair may set up stresses which will lead to cracks.

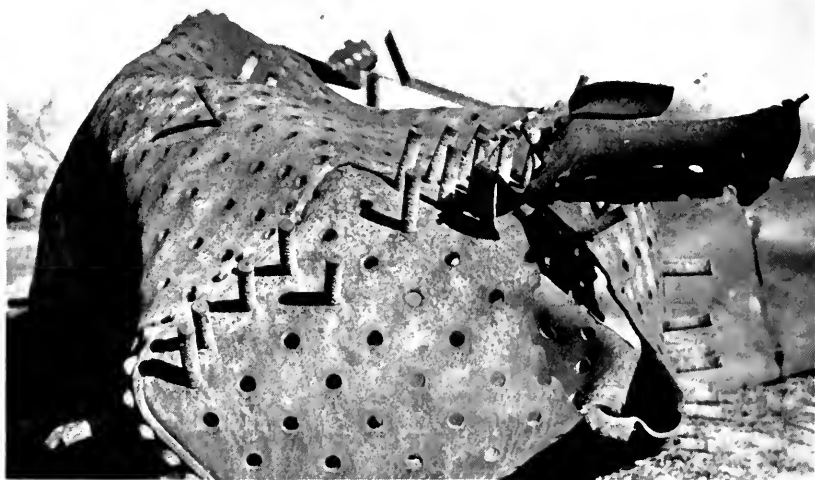
Figure 1—Firebox of a locomotive type boiler in an oil field after its explosion due to low water and over-heating.

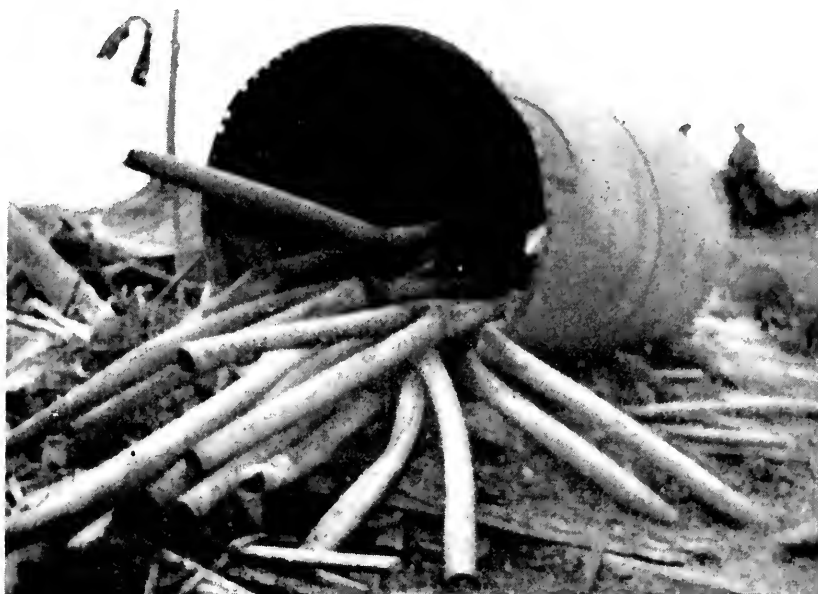
Figure 2—Two courses of a three-course horizontal tubular boiler which exploded because of corrosion.

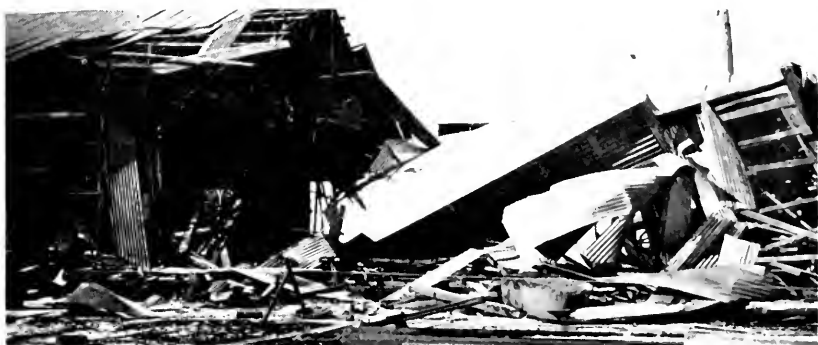
Figure 3—Wreckage following the explosion of a horizontal tubular boiler in New Mexico.

three others were injured. An investigation revealed that the boiler was seriously thinned by both internal and external corrosion.

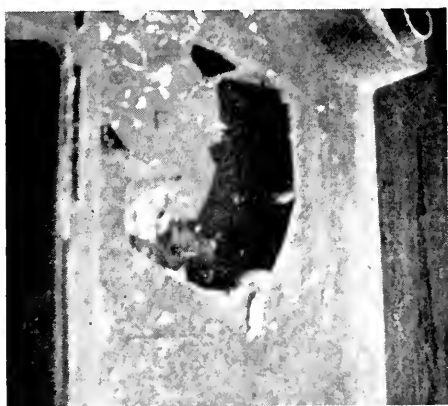
Four hundred fifty persons walked in orderly fashion from an Illinois theater after a cast iron hot water heating boiler exploded beneath the stage. Although the stage was wrecked and some of the debris was blown into the seating floor of the theater, all but two women escaped, and they suffered but minor injuries. The boiler exploded, it was said, because of the non-operation of the relief valve. A piece was blown out of the boiler as shown in Figure 4 and sections were torn apart. It was estimated that the damage was approximately \$4,000.

Figure 4—Failing section of a hot water heating boiler in a theater.

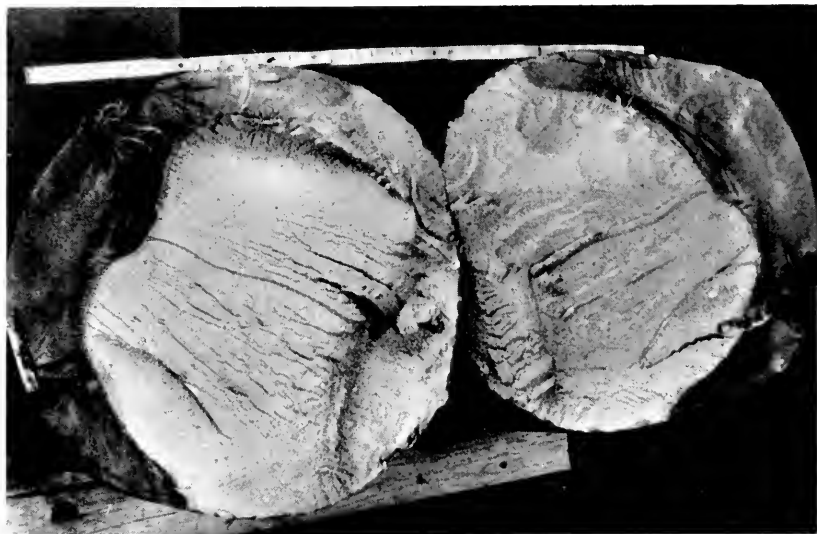
"Yes, the size doesn't make much difference. Notice this picture showing the shaft in two pieces. When Benson found the crack it was

"The darker metal shows how far the crack has progressed."

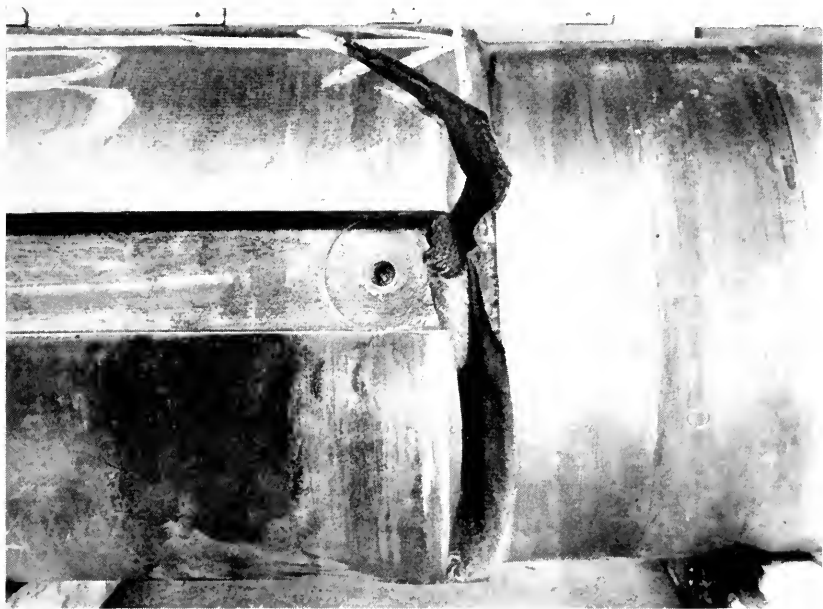
"The two ends of the shaft are held together."

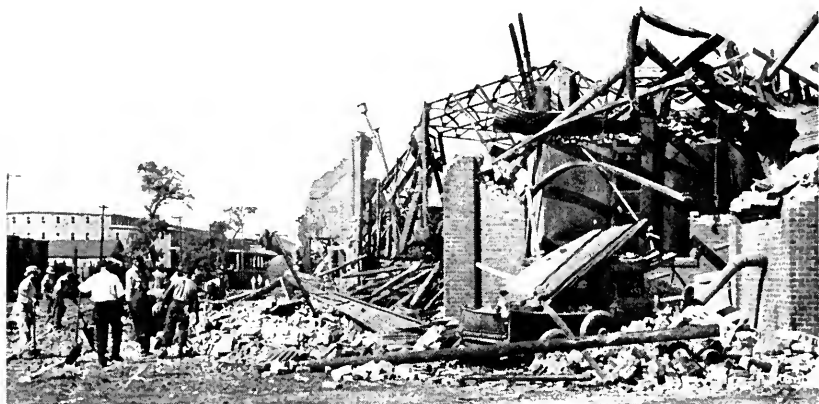
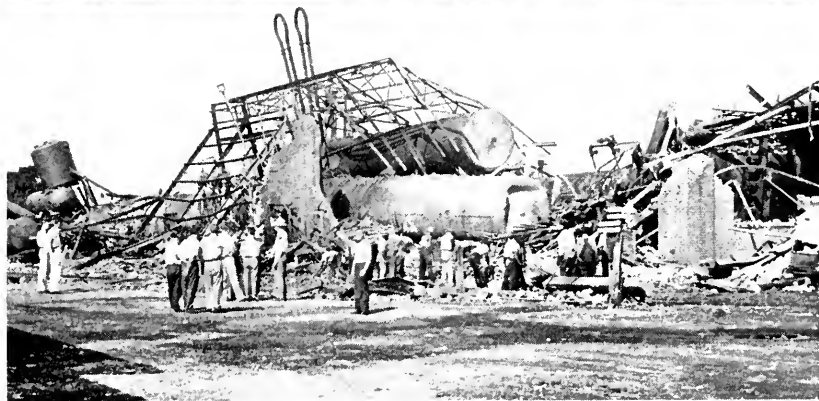
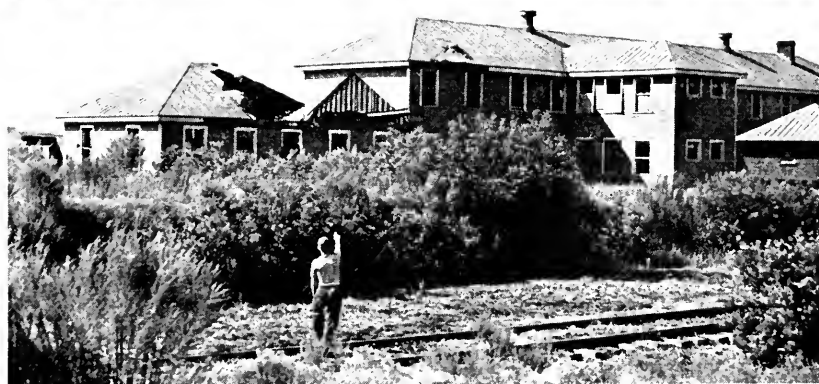
Figure 1—Top page 226—Damage after the explosions of a creosote tank and a water tube boiler at a southern plant.

ONE man was killed, three persons were injured and property damage estimated at between \$150,000 and \$200,000 resulted from the explosion of a creosote tank at a Charleston, S. C., wood treating plant on September 6. The fatality was suffered by a fireman who was in the boiler room.

Earlier in the night the creosote had been heated and the air pressure applied to force out the creosote. At midnight the tank was "empty" and no change was noted except that the tank cooled and the compressed air gradually dropped in pressure to about 70 lb. The blast came without warning at 3 o'clock in the morning.

Although the exact cause was not determined, presumably the explosion in the 9' x 80' Reuping tank was a combustion detonation. One end of the tank blew away and the rest slid into the boiler room, striking or knocking debris against a water tube boiler operating at 150 lb pressure. The blow caused a girth seam to fail and brought about the second explosion. Most of the boiler was hurled about 100 feet.

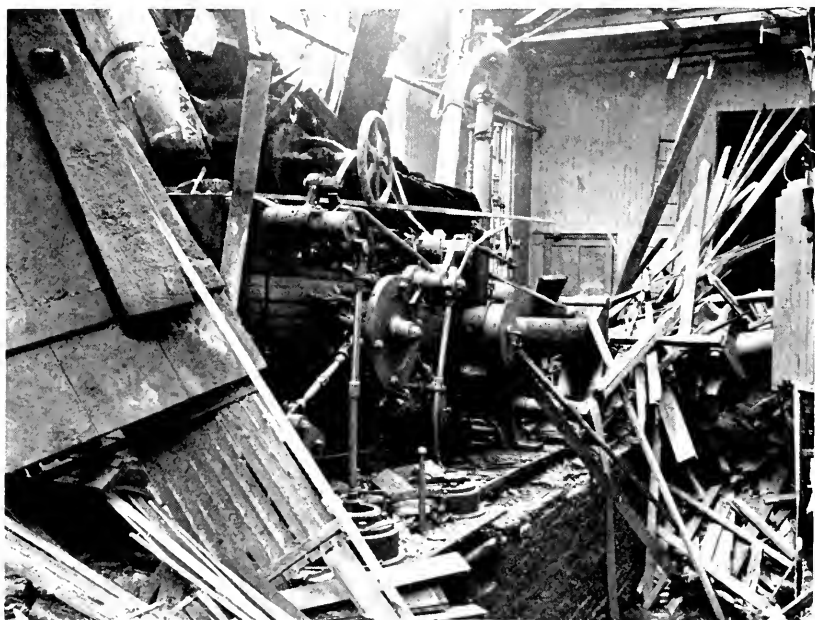
Wreckage Following Flywheel Explosion

A FLYWHEEL explosion at an eastern manufacturing plant caused the havoc presented in the accompanying photograph. Parts of the wheel went through the roof of the engine room, causing it to fall, and also crashed through an adjacent roof into a room where about 100 women were working. In the ensuing confusion, according to a newspaper account, two of the women were injured when

they fell to the floor. An operator who was near the engine was killed. The steam engine was wrecked, and several other machines were damaged because of the over-speed. To reassemble the control devices following an accident of this sort in a search for the cause of the accident is not easy. In this case two factors probably contributed to the failure. One was a breaking governor belt and the other the fact that the safety cams were undoubtedly out of adjustment because, although they were set at the farthest point of adjustment away from the latch arm, they did not prevent the opening of the steam valves with the governor in its lowest position, as they should have done. There was no insurance on the engine.

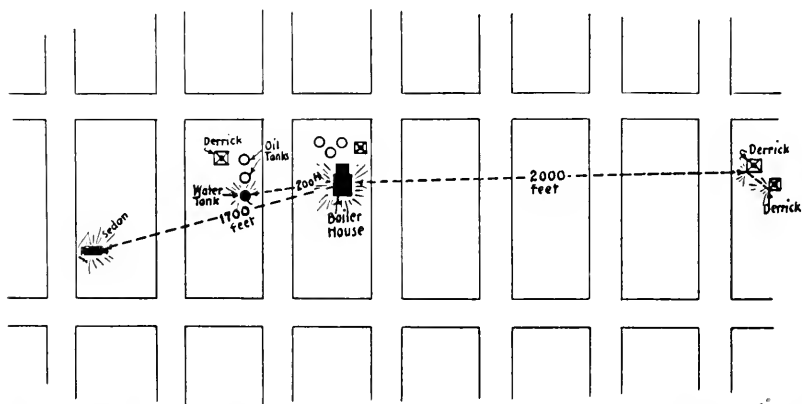
This diagram represents several sparsely settled city blocks in a western town where oil drilling operations are under way. The explosion of a horizontal tubular boiler early in the year demonstrated more than the terrible force of such failures; it gave evidence of uncanny marksmanship. About 1700 feet away was a small automobile. A piece of the boiler tubing crashed into it. About 2000 feet in the opposite direction was an oil derrick. The door of the boiler not only hit it but ricocheted into another derrick nearby. About 200 feet away was a water tank, an easier mark, into which smashed the shell of the boiler, crushing the tank nicely. A partially wrecked boiler house, an automobile buried in debris beside it, and bricks scattered like bird shot in all directions were other details. The accident was attributed to mud choked safety valves and over-pressure.

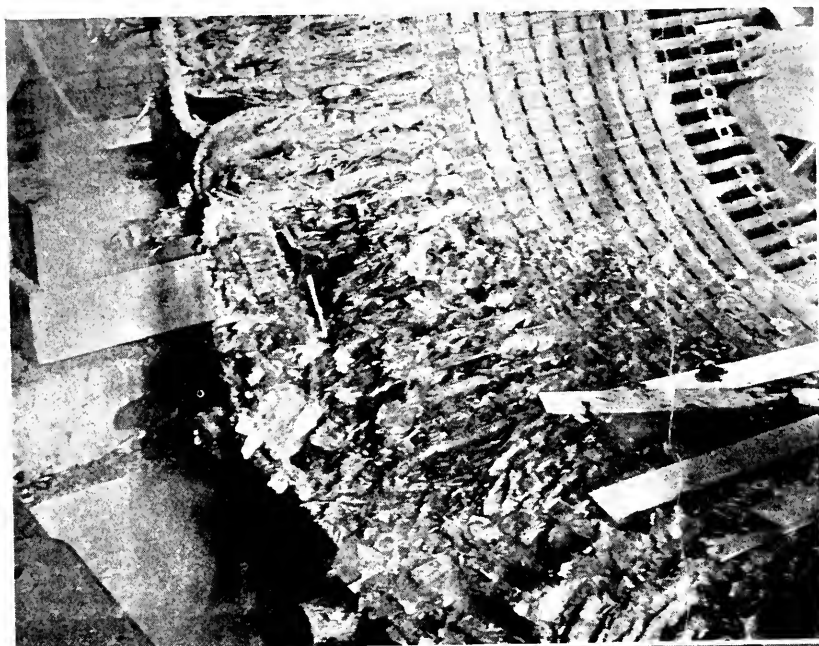
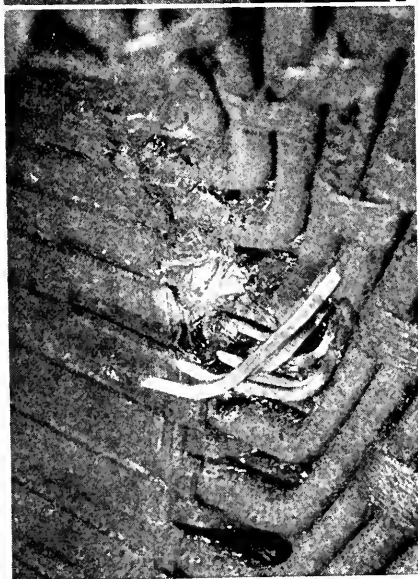
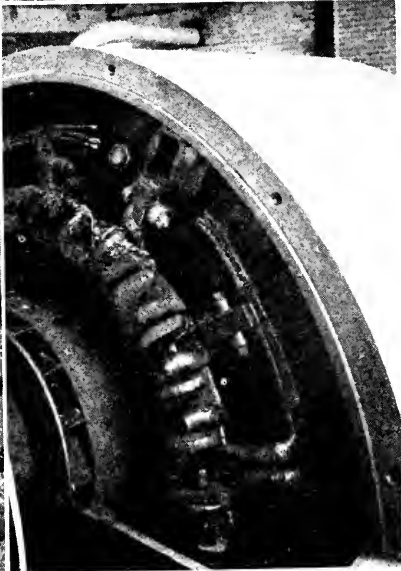
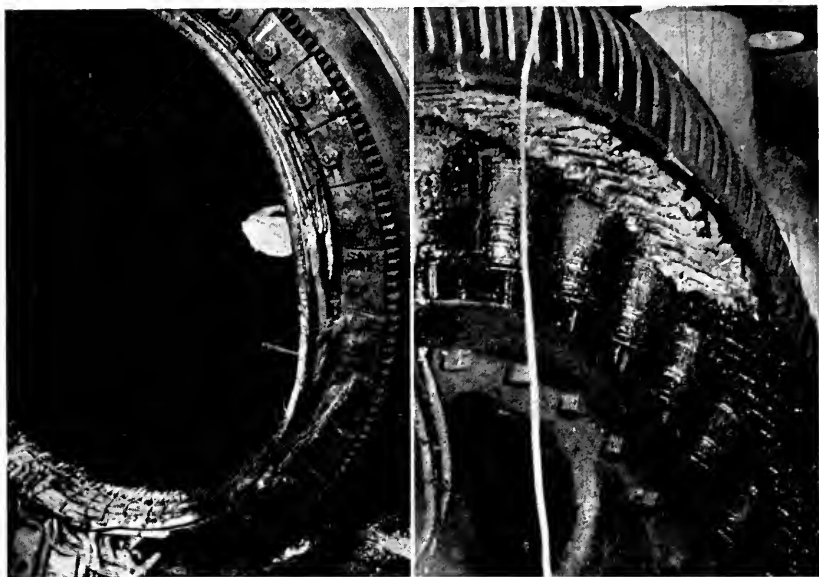
Top, Page 2—Stator burnout on starting. The machine is a 2500 kva AC generator, part of a frequency-changer set, at a county utility. Bottom, Page 2—Two failures of turbo-generators because of lightning. The picture at the left shows a 3,000 kw machine at an oil refinery and that at the right a 750 kw generator at a municipal utility. Above—Left—A high frequency 1125 kw motor-driven alternator used at a boiler factory. Half of the coils were damaged when insulation failed on end turns. Right—Short circuiting of turns in one coil brought damage to about 60 other coils of a 168 kw generator driven by a steam engine at a manufacturing plant.

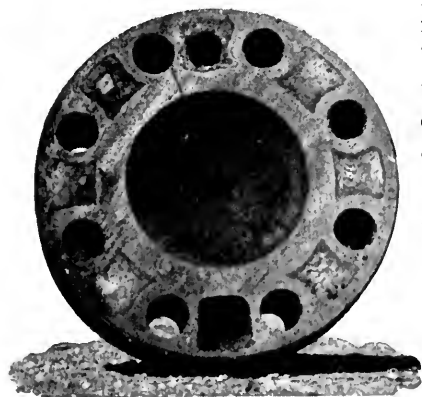
Obviously, one major advantage of the closed cooling system lies in the practically complete freedom of scale and mud accumulation in the water jackets. This results in much longer life of cylinder heads and liners. There is, however, another advantage that has been frequently overlooked, namely, the fact that with the dual-flow type of cooling system it is almost impossible to cause an abrupt lowering of the temperature of the inlet water to the cylinder jackets. Such changes of inlet water temperature are rather common where the open type of cooling system is used. They cause sudden shrinkage and distortion of cylinder liners, an unduly large number of piston seizures, and crank bearing troubles.

Figure 1—Diesel cylinder-head completely choked with scale. The faulty water condition in connection with an open cooling system caused repeated failure of the cylinder-heads on this engine.

Hence, a very much lower insurance rate, about 40 per cent less, is available for Diesel engines having closed type cooling systems. This point may well be considered when new Diesel installations are planned. The saving in insurance in one or two years often equals the difference in cost between an open and a closed cooling system.

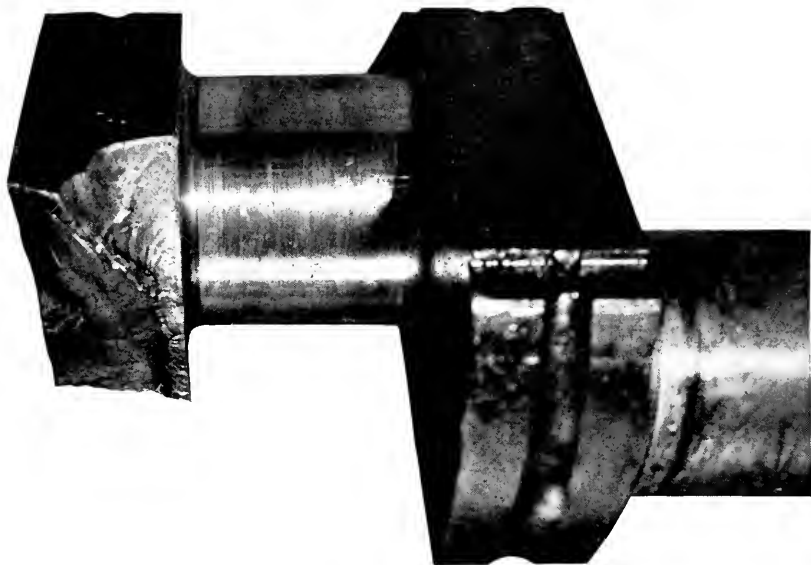
Figure 2—Crank distortion caused by bearing misalignment resulted in the breaking of this crankshaft. The fatigue cracks started in the fillet on the journal side of the crankweb.

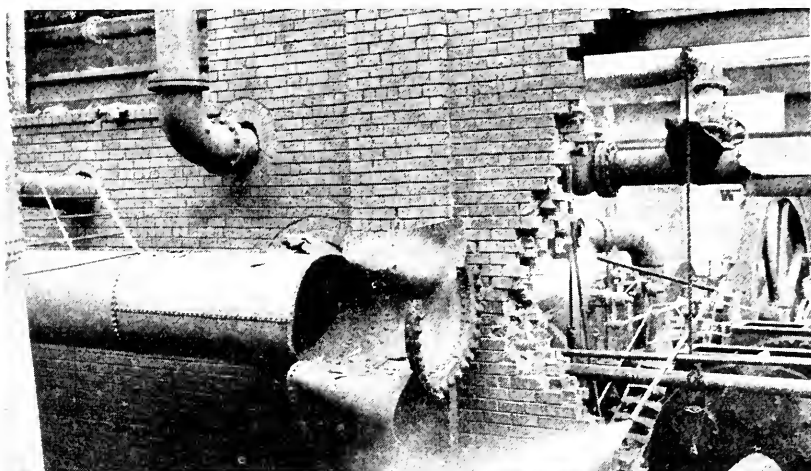
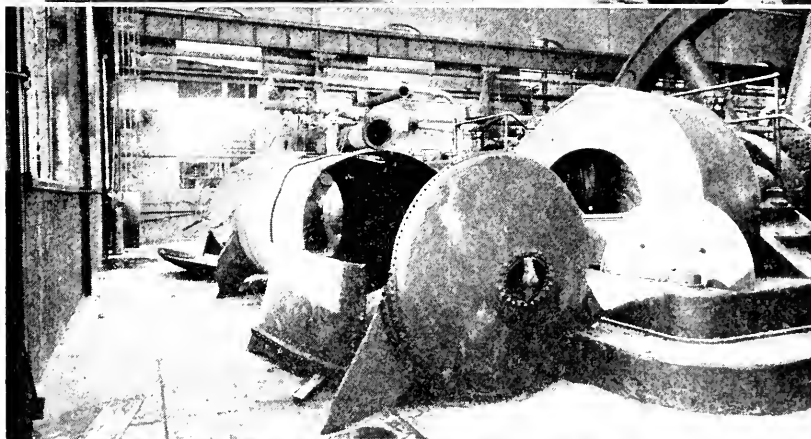
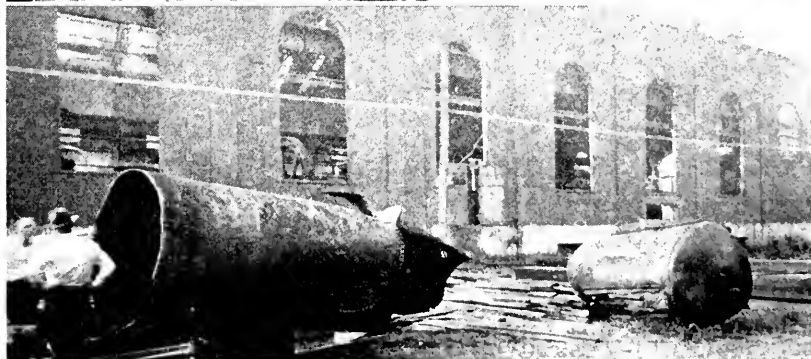
There are many vessels that contain a mixture of a flammable substance and air which may operate indefinitely with no trouble whatsoever. On the other hand, there have been some violent explosions of such vessels and in many of them the source of ignition has been a mystery.

Results of a combustion explosion in an air line and two large air receivers.

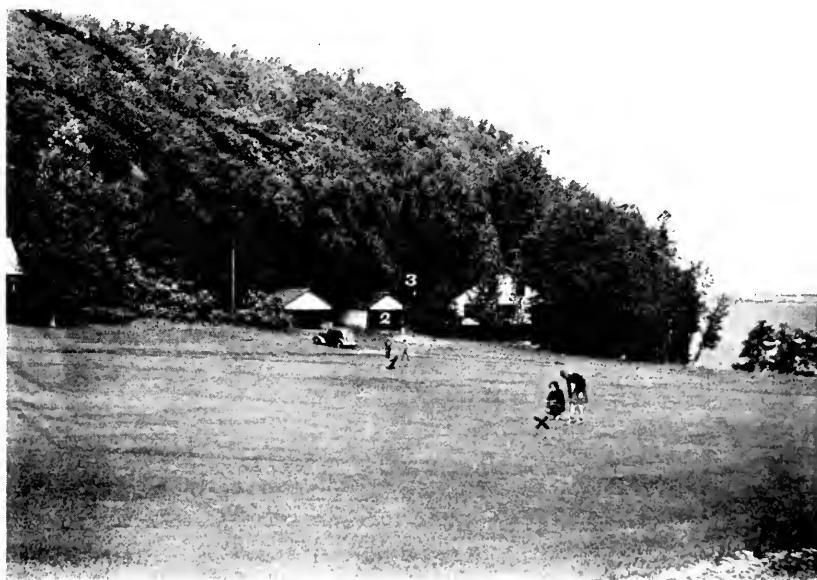
This pleasant spot on the shore of Lake Champlain witnessed the deaths of two men and a young girl one evening last summer. A hot water tank exploded in a small building at the location marked "3," struck the two men who were about 15 feet away, caromed into the garage "2," struck the girl at "1" and finally came to rest at "X" after traveling 750 feet. The accident illustrates the tremendous force inherent in hot water under pressure and above the atmospheric boiling point. In some way the building housing the tank had caught fire. The heat from this was believed to have brought about the explosion as it rapidly raised the pressure in the tank to a point which it could not withstand.

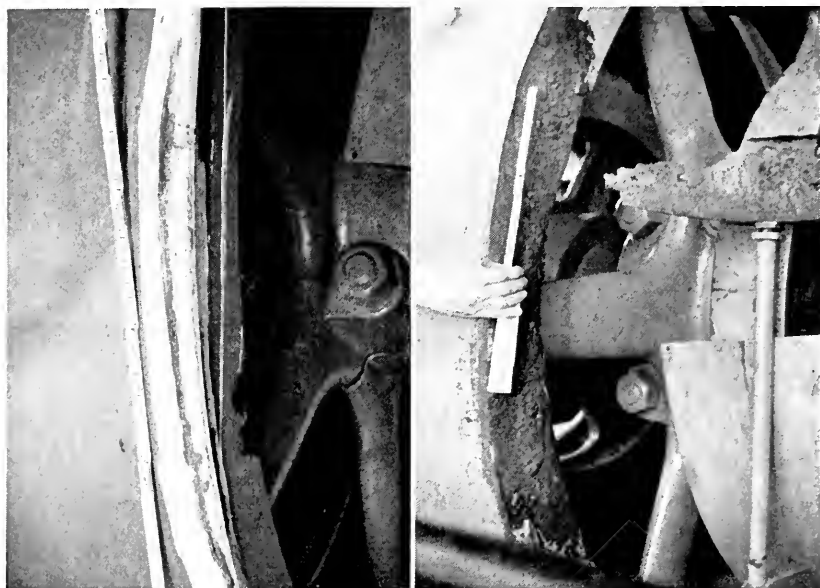
The illustrations show a casting defect in a 40-year-old flywheel. The engine on which this wheel was used had not been in operation for two years as it was kept as a stand-by for emergency service. It was given a test run each week.

The presence of the circumferential crack was suspected, and a whitewash test applied with the results shown in the photographs. By means of a few well-directed hammer blows large slabs of cast iron came off the wheel rim. Apparently, the defect was attributable to faulty casting practice at the time the wheel was poured.

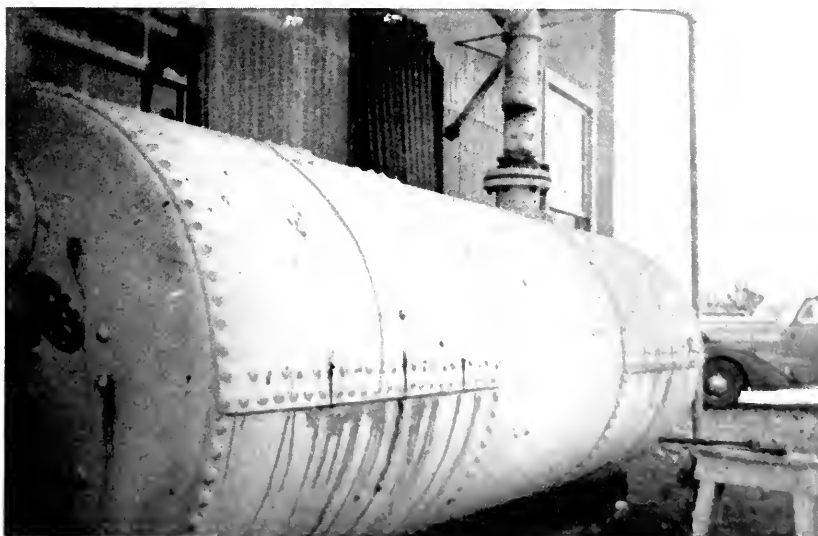
AN explosion of a large air tank was undoubtedly prevented when longitudinal cracks were discovered recently by cutting slots in one of the seams. As this tank was of lap riveted construction the inspector suspected a crack when he found leakage, although slight, along the caulking edge of a seam that showed signs of repeated caulking. On his recommendation, the seam was slotted at several points and leakage through these slots with the vessel under hydrostatic pressure showed definitely that a crack had developed in the plate forming the outside lap of the seam. As is usual with this type of crack, it started from the hidden side of the plate and could not be seen. The slots, made at right angles to the direction of the probable cracks, are shown in the accompanying photograph of the tank.

Possible explosion of this air tank was averted when hidden cracks were found by slotting the seams.

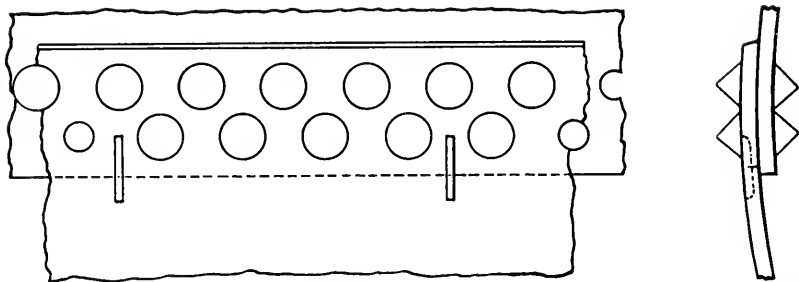
Drawing of a lap-riveted joint showing method of testing the outside plate for hidden cracks.

seams of lap-riveted boilers. Although it has not been used generally for unfired pressure vessels of similar riveted construction, there are cases, as in this one, where it is applicable and effective. Previous articles in THE LOCOMOTIVE have given accounts of explosions resulting from lap seam cracks and have also described the procedure for making the investigation. Briefly, the method consists of chiseling or milling a series of slots (about $1\frac{1}{2}$ " long and $\frac{1}{4}$ " wide) two-thirds or more through the plate and spaced about 1' apart along the line of rivets. The drawing on this page illustrates the relation of the slots to the seam. Such slots will not appreciably weaken the strength of the joint but will reveal whether a lap-seam crack exists, either by leakage during a hydrostatic test or by the crack being visible in the bottom of the slot.

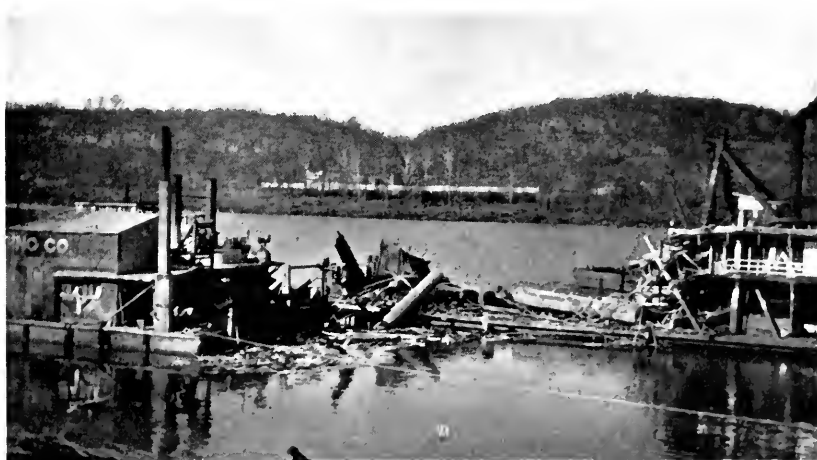
The power plant for the steamboat consisted of three marine-type fire-tube boilers, lap-seam construction, with maximum approved pressure of 240 lb per sq in. According to the reports, two of the boilers exploded while the pressure was only 150 lb. The boat had been tied to the dock for washing out the boilers and steam was being raised again when the accident occurred.

The exact cause of the explosion was not stated. According to the news accounts, new shell sheets had been installed on the boilers within three years—some in 1937 and the remainder in 1939.

View of the wreckage following a boiler explosion in an Ohio river steamboat.

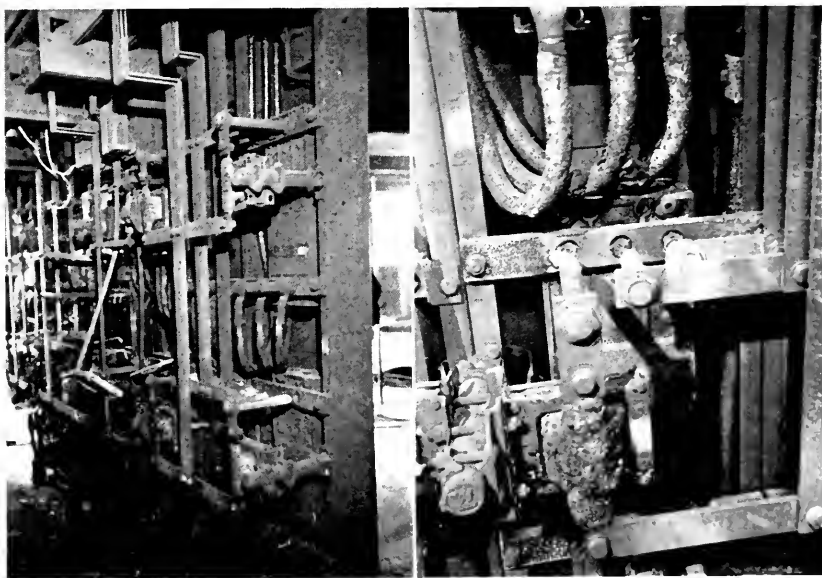
Examination of the electrical equipment after the accident showed that there had been arcing across the studs of circuit breakers on four of the seven panels. The remainder of the damage appeared to have been caused by the ensuing fire and intense heat from the short circuits. One of the two pictures on this page shows some of the burned insulation and damage to the back of the switchboard, while the other is a close-up view of one section showing the studs burned through at one

Left—Back of a seven-panel switchboard badly damaged by phase to phase short circuit and by ensuing fire.

Right—The connecting studs burned through at one circuit breaker, and damage to a current transformer and to cables is clearly shown in this close-up view of one section of the same switchboard.

Constructed of sheet steel $\frac{1}{8}$ " thick, the switchboard was 7'8" high and 10'8" long. Air circuit breakers and meters with their transformers were mounted on each of the seven panels. In addition there were copper buses, cables, copper strap conductors and control wiring—all attached to the back of the board. As all the control wiring, circuit breaker casings and supports, meters, and instruments transformers were damaged by the short circuits and the ensuing fire, it was necessary to ship the board to the manufacturer's shop for rebuilding.

Although a careful investigation was made after the accident the actual cause of the short circuit has not been determined. As repairs required over two months' time a temporary bus was installed to which the plant feeder lines were connected, so that the owner was thereby able to maintain normal production.

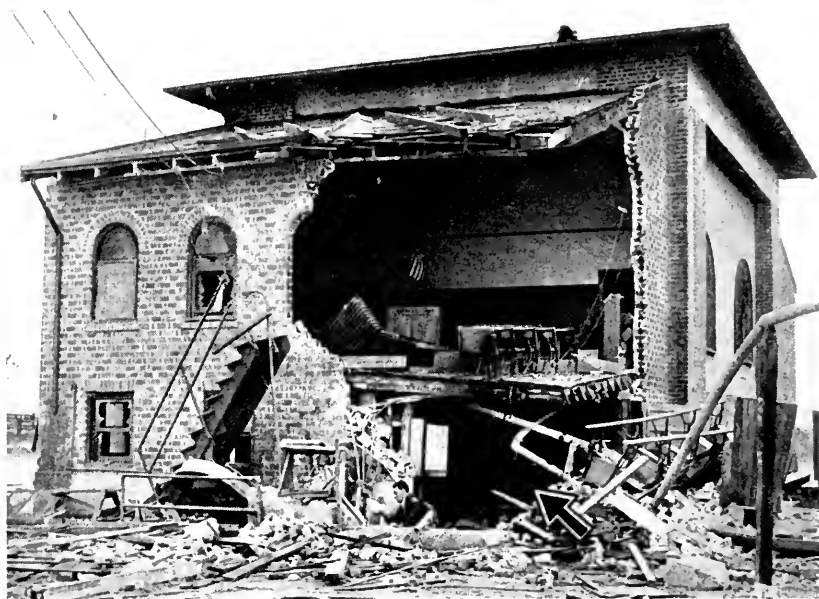
an employe who had been in the second building a few minutes before, narrowly missed being hit. Had the accident happened later in the day, many students would have been exposed to serious injury. The severity of the explosion can be judged from the wreckage of the school as shown in the accompanying photograph. A local newspaper estimated the damage as \$10,000.

The damage to this school was caused by an explosion of a hot water tank.

The tank, 3' in diameter by 6' long, was constructed with $\frac{3}{8}$ " saucer heads welded to the shell, without any skirt or flange, and with the longitudinal lap seam of the $\frac{1}{4}$ " shell tack-riveted and fillet-welded. Both the tank and the cast iron hot water supply boiler to which it was connected normally operated under a pressure of 55 lb per sq in. A thermostat, set for a maximum temperature of 160°F, and a pressure relief valve were provided to control the temperature and guard against over-pressure.

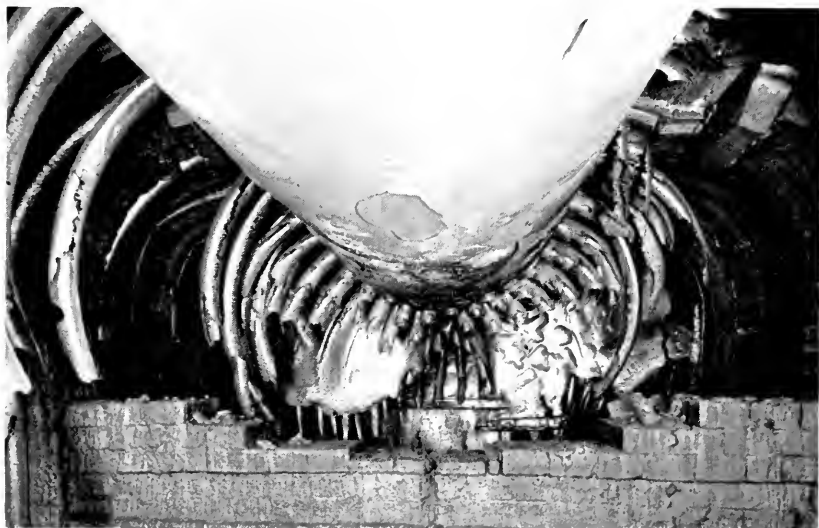
Damage to this water tube boiler was reported to have been caused by overheating when the feedwater was shut off and the automatically controlled stoker continued in operation. Installed about 7 months previously at a cost of \$12,000, the boiler was so badly burned that replacement was necessary.

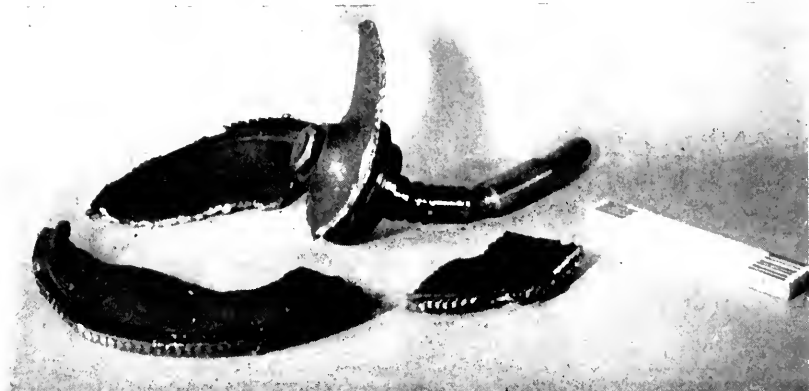
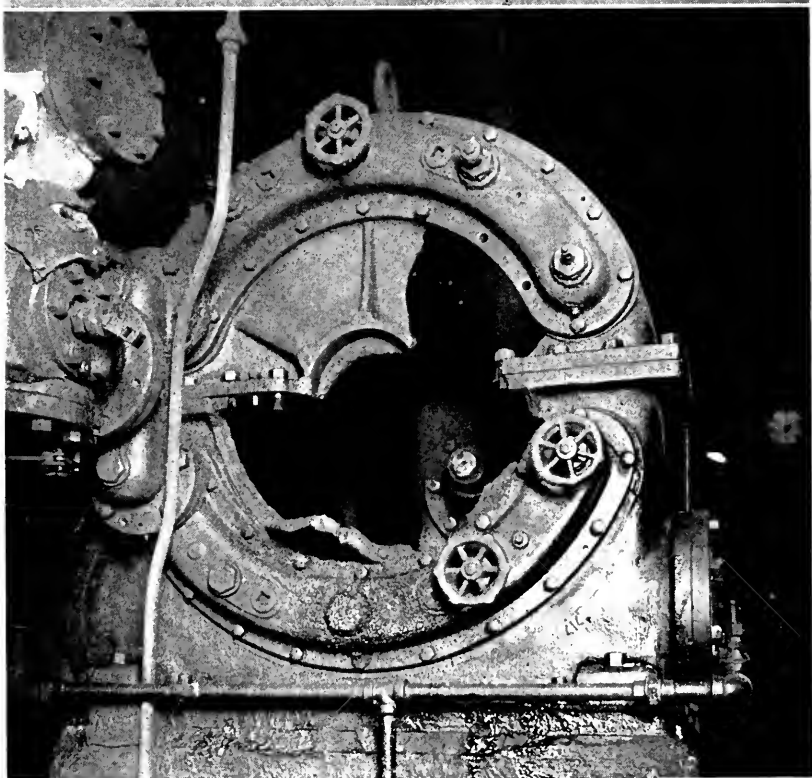
Top—Two men were injured when the rotor—pictured above—of a small steam-turbine burst from excessive speed.

Bottom—Explosion of this steam-turbine draft-fan unit was attributed to overspeed after the load was lost.

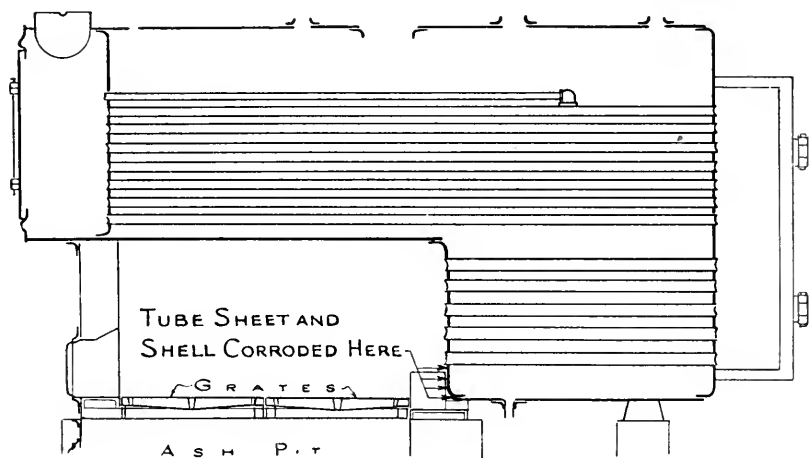
Figure 3—Drawing of an economic-type boiler indicating areas concealed by grates or brickwork where external corrosion is likely to occur.

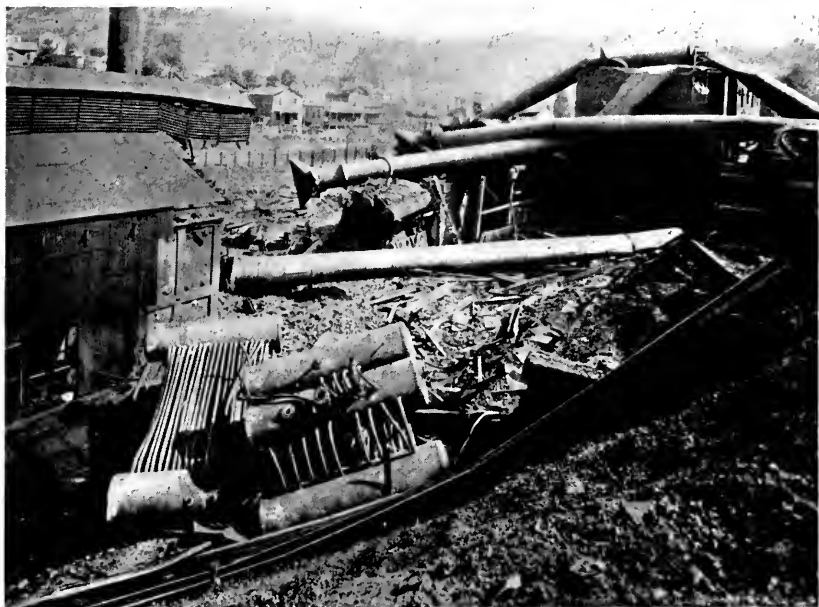
Figure 4—Wreckage at a steel mill following an explosion of a water tube boiler. Caused by external corrosion of one head of the lower drum which had been concealed in brickwork, the explosion killed two people and injured five others. Property loss was about \$75,000.

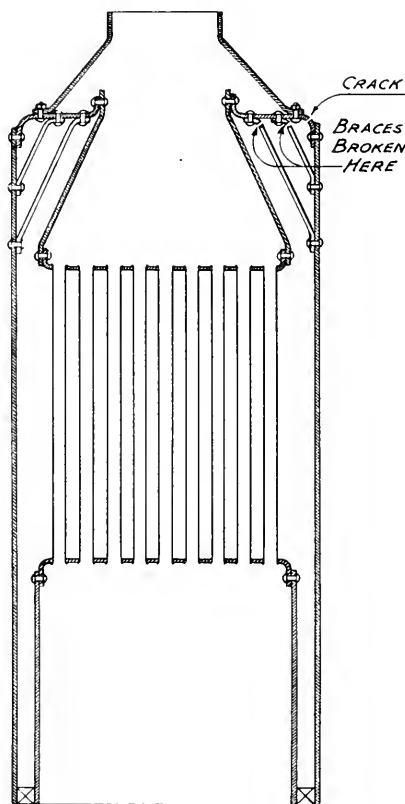
Figure 5—Three men were badly scalded when the top head of a small vertical tubular boiler, similar to the one drawn here, tore open at the flange along the line of a previous crack.

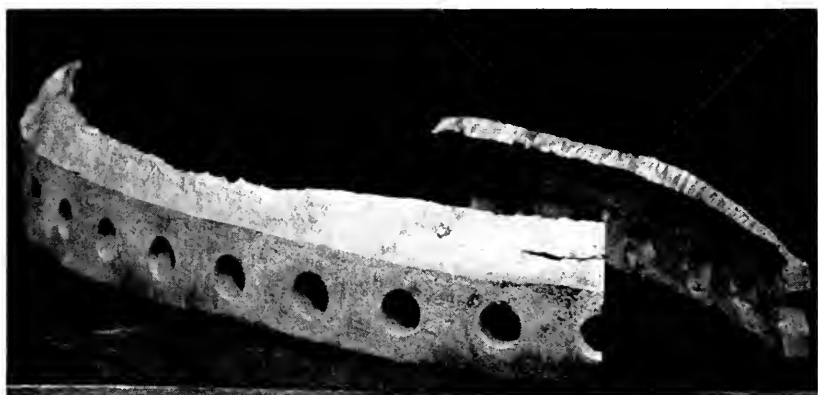
Figure 6—Parts of the lower drum of a water tube boiler showing the manner external corrosion wastes away the metal and weakens the head.

examination of hidden parts and such repairs should be planned with that thought in mind. Before the boiler surfaces are re-covered, following an examination, a valuable protection can be given them by applying a suitable coating of moisture-absorbing material next to the surfaces, beneath the usual insulation of masonry or magnesia blocks.

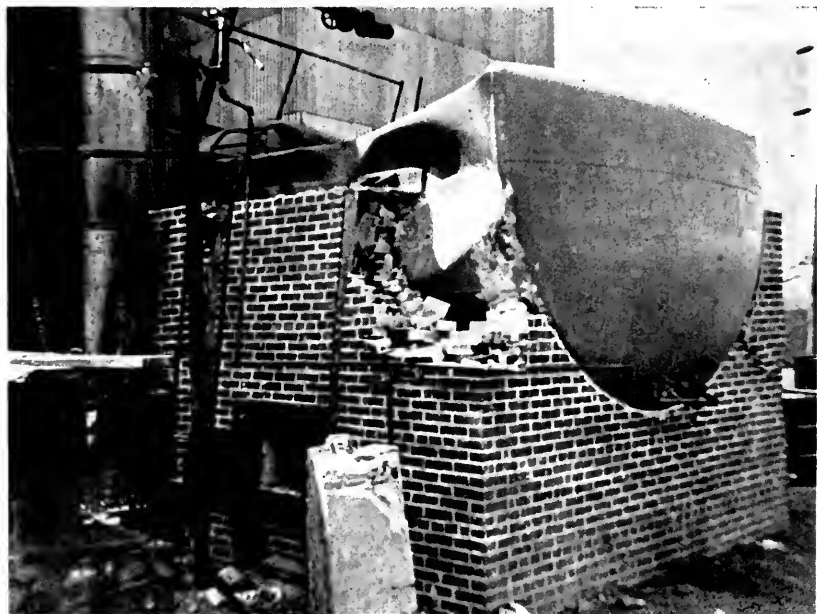
Constructed with welded seams, the vessel was 10' in diameter by 12' long and made of tank steel $\frac{1}{4}$ " thick in the upper half and $\frac{3}{8}$ " thick in the lower half. According to accepted engineering standards, the structure was adequate for a maximum safe vacuum of only 6".

View of a large tank after it had collapsed while being given a vacuum test.

accepted standards of construction. Many states and cities have laws governing the construction of several classes of pressure vessels, and the purchaser should determine whether or not the vessel he requires will come within such laws. If it does, he should specify that the vessel be constructed in accordance with those requirements. Otherwise, in order to assure proper construction and workmanship, it is recommended that the vessel be built in accordance with the A.S.M.E. Code.

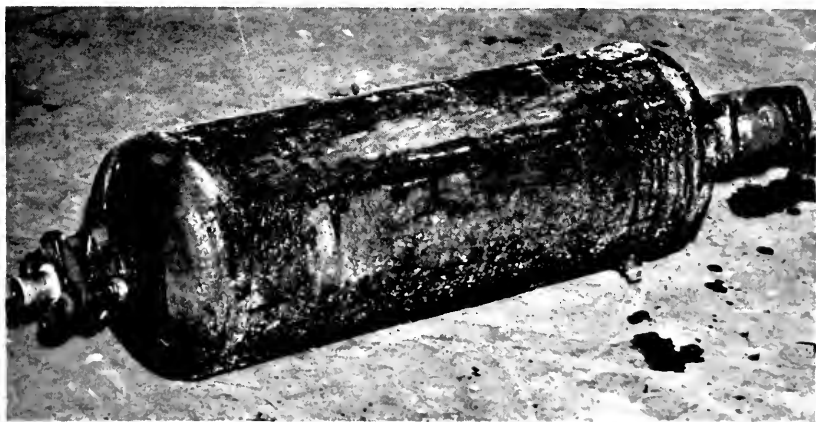
Figure 1—Five men were injured (three of them fatally) by the rupture of this ammonia receiver along a welded seam. Overpressure from expansion of the ammonia when an acetylene torch was used to cut a connected pipe was the probable cause of the failure.

to have been pumped out of the receiver before the work was started. One of the men was cutting a connected pipe line with an acetylene torch while the others were unbolting the receiver supports when the vessel suddenly burst along a welded longitudinal seam as shown in Figure 1.

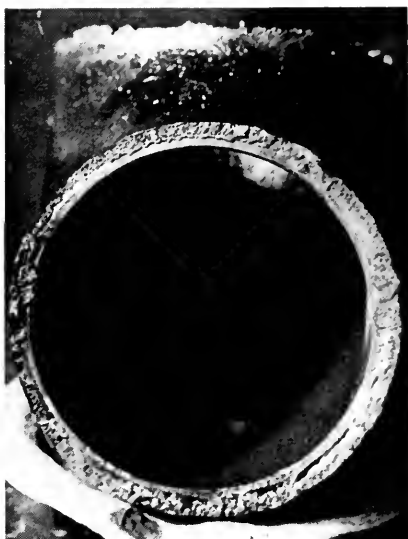
Thrown out of line by a worn outboard bearing, the crankshaft of a vertical ammonia compressor broke in the web adjacent to the fly-wheel. Resultant damage to the compressor consisted of bent connecting rods, broken piston and bearings and a hole in the crank case. The compressor supplied refrigeration for a dairy products plant and con-

On investigating the cause of this accident, it was found that a centrifugal pump, mounted on the wall behind the compressor, had been leaking badly and probably had thrown water into the oil well of the outboard bearing. Without proper lubrication the bearing wore rapidly and allowed the shaft to drop about one-sixteenth of an inch. Subjected to excessive stresses because of this condition, the shaft broke at a point where, it is believed, a small crack had existed previously.

tained two cylinders each 6" in diameter. It was belt-driven by a 20 hp motor. Rather than make repairs, which would have cost nearly \$700 and taken considerable time, the owners decided to install a new compressor.

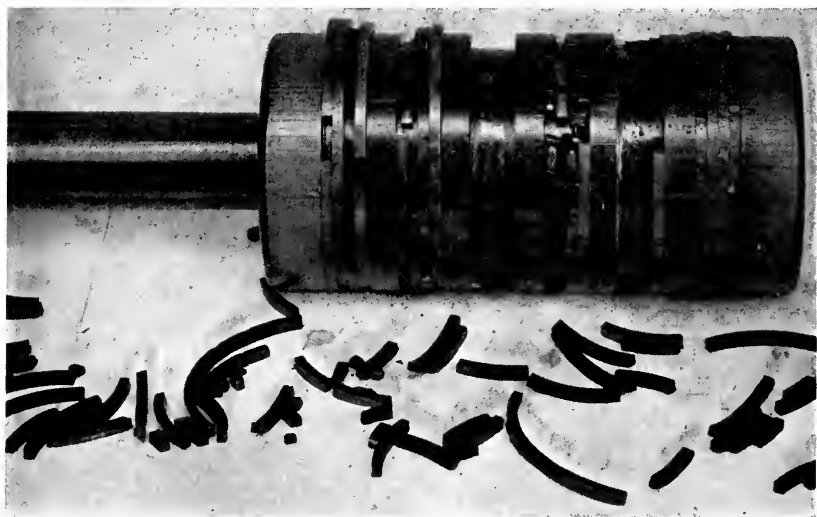
Another refrigerating compressor accident involved a single cylinder carbon-dioxide compressor in a hotel. Jamming against a small piece of a valve spring which had worked its way between the piston and cylinder, the piston rings broke and scored the piston and cylinder surfaces. The cylinder was scored so deeply that a new cylinder was necessary. Because replacement was less costly and more satisfactory than attempting to recondition the old parts, a new piston and rings were installed. Figure 5 shows the damaged piston and broken rings.

Figure 5—Carbon-dioxide compressor piston and rings damaged by a piece of valve spring which worked its way between the piston and cylinder wall.
