The Locomotive

THE HARTFORD STEAM BOILER
INSPECTION AND INSURANCE CO.

INDEX
to
VOL. 42 - 43

INDEX TO VOL. 42—1938-1939

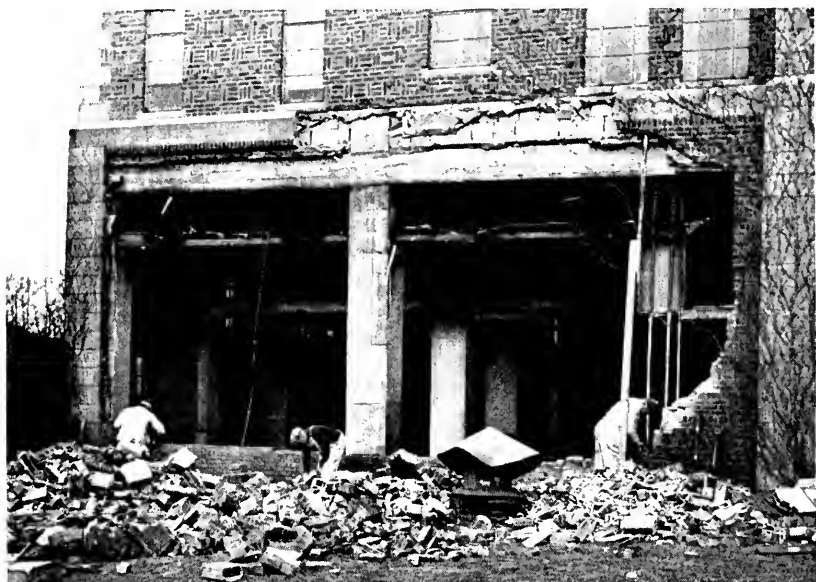
Figure 1—Top—Section of a brick wall in a large apartment house demolished by an explosion in a cast iron steam heating boiler.

Examination of the broken parts of the rear section revealed that the cast stays which supported the flat surfaces had been broken previously as there was a thin hard scale on the broken ends of the stays. Because of the weakened condition of this part of the section, the explosion may have been caused by steam and water pressure even though that pressure was comparatively low. It is also possible that the accident resulted from an explosion of accumulated fuel gases in the firebox and in the gas passages of the boiler. However, neither from the facts that were obtained nor by careful consideration of the nature and extent of the damage, could it be determined definitely whether internal pressure or ignition of accumulated fuel gases caused the explosion.

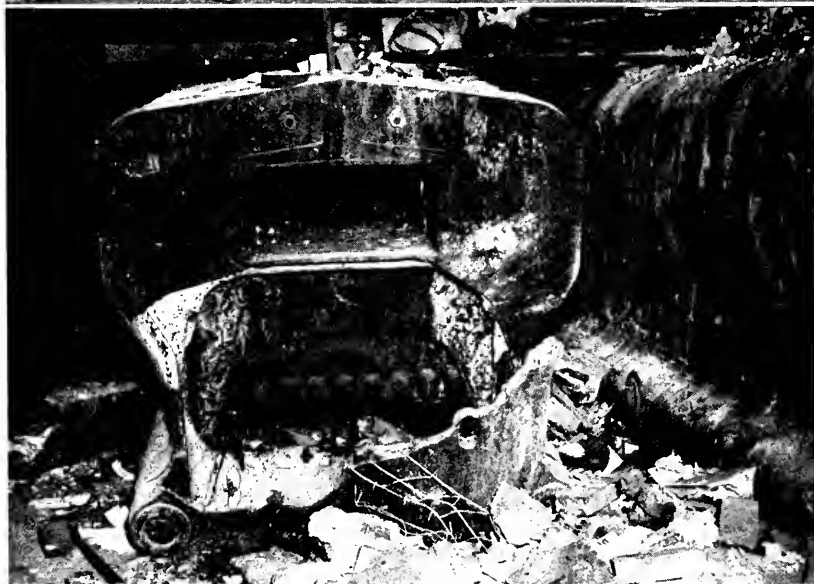
Figure 2—Bottom—Front view of the boiler in which occurred the explosion that resulted in the damage shown in the top photograph.

iron steam heating boiler shown in Figure 2. About three hundred tenants were in the building at the time of the accident but fortunately no one was injured. Local papers carried the story of the blast as front page news and although an estimate of the property damage was not given it undoubtedly amounted to several thousand dollars.

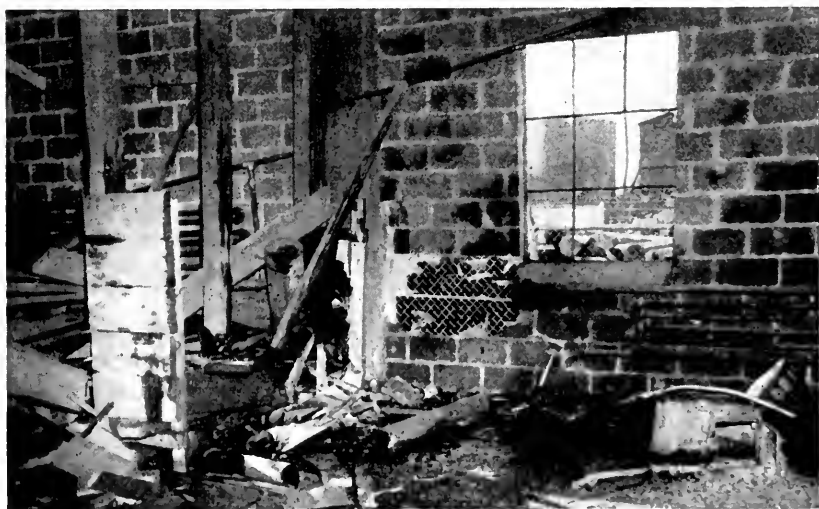
Evidence of the terrific force of the concussion, of which some indication may be seen in Figure 3, was the fact that the outer shell was broken into many small pieces while the remainder of the boiler and its base were hurled in different directions several feet away. In addition, a large area of the cement-block wall adjacent to the boiler was blown out, several holes were made in the roof by small pieces of cast iron, doors were broken and windows shattered both in the garage and in another building a considerable distance away.

Figure 3—After an explosion of a cast iron hot water heating boiler in a garage. Originally located adjacent to the hole in the rear wall, the base of the boiler was hurled several feet to the right.

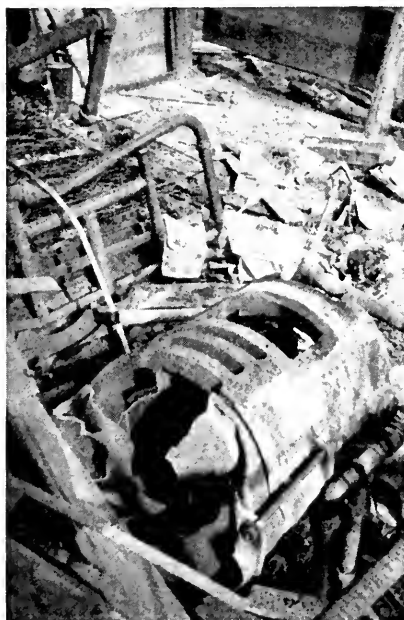
April of a four-section cast iron steam heating boiler in a Michigan greenhouse. Pieces of the boiler were found over a radius of 80'. Excessive steam pressure was believed to have been the cause of the explosion. Whether or not there was a safety valve on the boiler was not determined but none was found afterward. As indicated by Figure 6, the boiler room was completely wrecked.

Figure 6—Some of the wreckage caused in a greenhouse boiler-room by the explosion of a round cast iron sectional steam heating boiler.

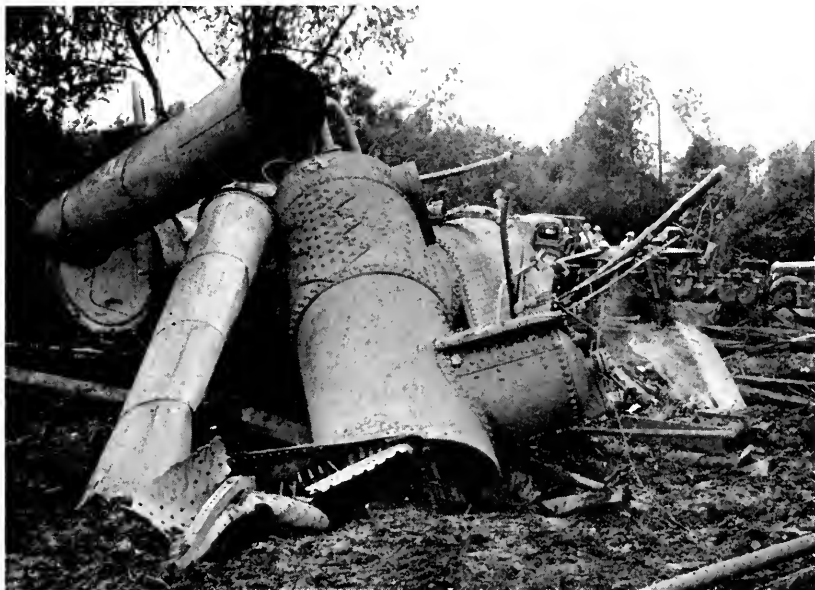
An explosion of a locomotive type boiler, one of a battery of four, caused this wreckage. Located a few miles from New Orleans, La., these boilers furnished power for oil-well drilling operations. In addition to extensive damage to the boilers, piping and other equipment used for the operation of this drilling rig, a fireman was killed and his helper injured.

As can be seen in the picture, the failure occurred in the firebox section of the boiler. Although no reason for the accident was given in the news account, it is probable that the cause was low water, or scale and sediment, which resulted in over-heating of either the crown sheet or side sheets. Investigations of other similar oil-well drilling boiler explosions have borne out this assumption as in a large number of such cases, inferior feedwater or inadequate attention to the maintenance of a safe water level have caused overheating and the subsequent explosion.

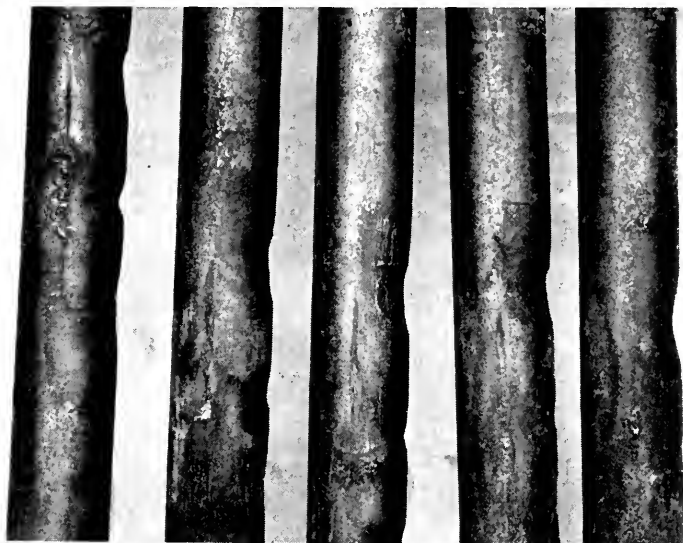
While, in this case, erosion by steam from the operation of the soot blower was believed to have been the reason for the excessive wearing away of the tubes, it is possible that corrosion was a contributing factor. Occasionally, leakage of steam into a blower when it is not in use, causes an intermittent discharge of steam and water against the tubes or other boiler parts, either because the steam shut-off valve is defective or has not been closed tightly. This moisture, combining with the waste products of combustion, produces corrosive acid. Then when the boiler is placed in operation, metal in those parts of the boilers that have been corroded by the acid will wear away more rapidly than the uncorroded metal.

Top—Tubes in a water tube boiler eroded by steam from a soot blower. Previously, shields had been welded to these tubes to stop the erosion but they proved ineffective.

If the steam valve for a soot blower does not close properly it should be repaired, and each time the blower has been used the operator should be sure that the steam valve has been closed completely. Warping or the wear and tear of service may sometimes prevent telescopic blowers from being retracted. With this condition, should leakage occur, water and steam may strike the tubes, drums or headers, causing corrosion of those parts.

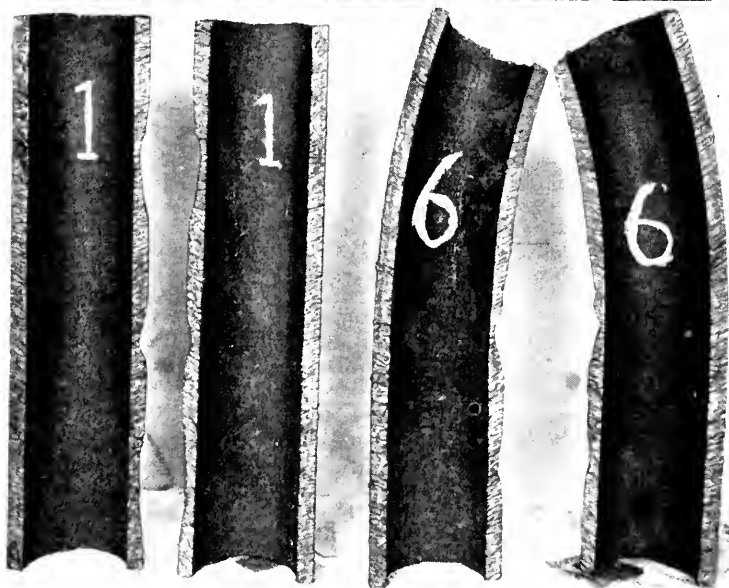
Bottom—Sections of two of the tubes in the same boiler showing the extent of the erosion. The wall thickness was reduced 60% in tube “1” at one point while tube “6” was reduced 66% at one point.

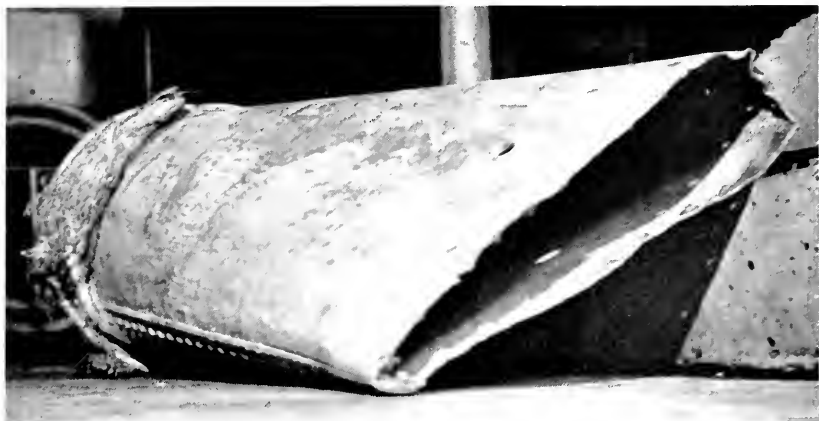
Figure 1—Over-pressure caused explosion of this hot water tank in a laundry. The property loss was over \$5,800.

Figure 1 shows a picture of a new hot water tank after it had exploded from over-pressure. This failure occurred in a cleaning plant and resulted in damage amounting to more than \$5,800.

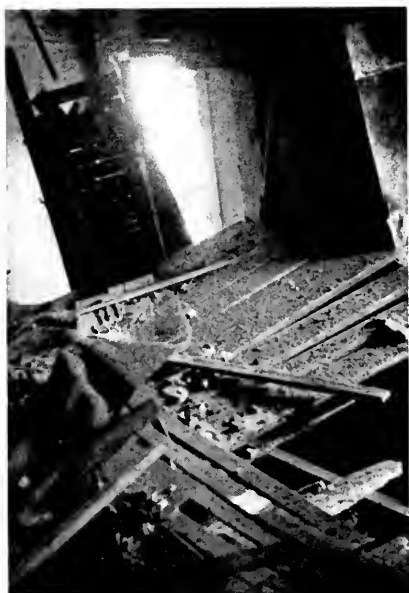
Figure 2—Part of the damage to the first floor of a residence from an explosion of a hot water tank.

pletely, is shown in Figure 2. Plaster was knocked down, flooring torn apart and furniture upset and broken. Brick foundation walls and the sills were jarred out of place and the outside walls were blown apart at one corner. In fact, the damages were so extensive, it was reported that the house might have to be dismantled and rebuilt.

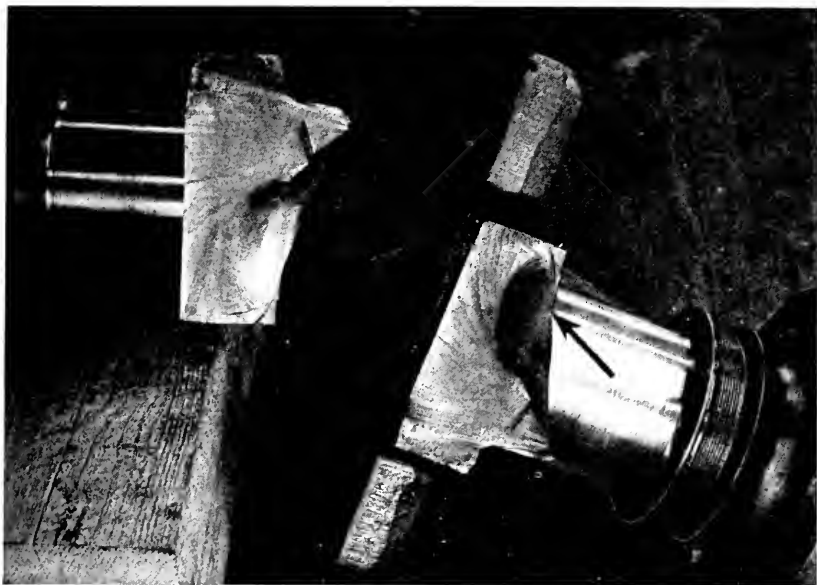
Broken crankshaft on an 180 hp Diesel engine which had been operated only 1000 hours. The failure lines in the surfaces of the break show that it started with a small crack on the main-bearing side of the web (see arrow) and also clearly indicate the progress of the crack through the web. Evidently caused by high local stress produced by misalignment, this failure illustrates the value of timely and thorough inspections of Diesel engines. Many similar failures have been prevented by such inspections.

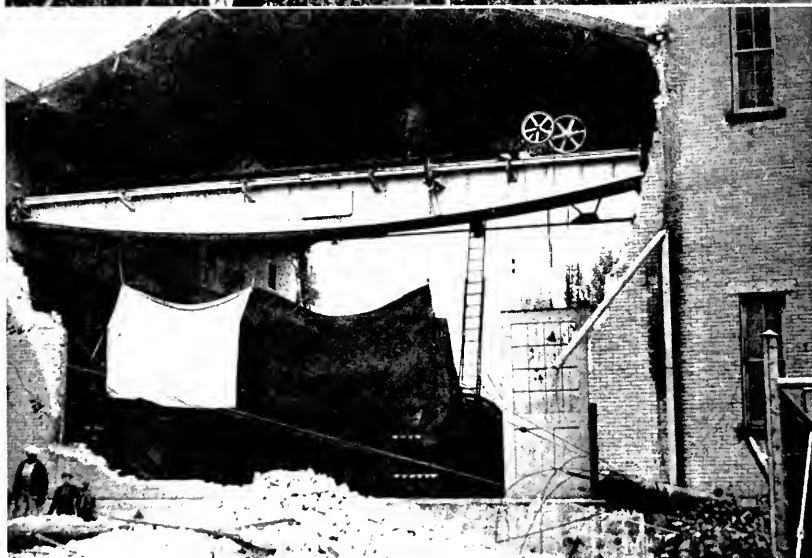
Two views of a utility sub-station after an explosion, caused by a direct stroke of lightning, blew out the end-walls.

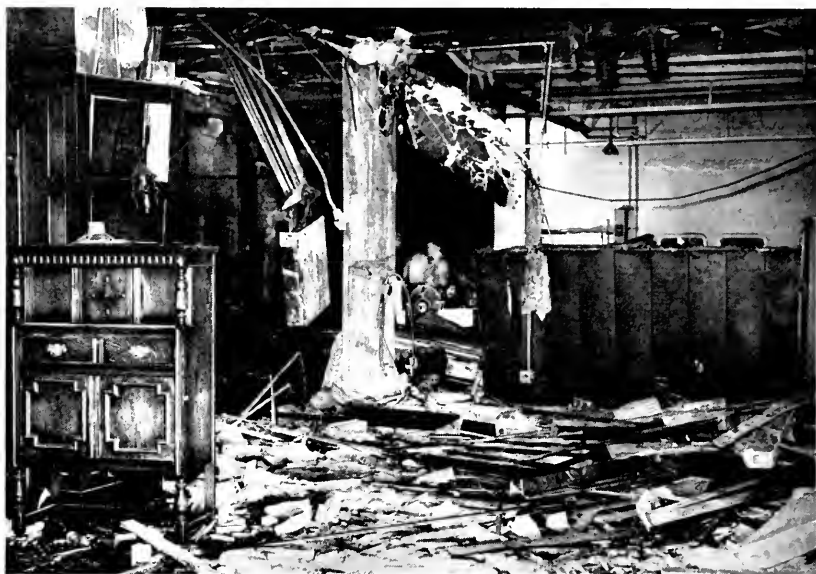
These ruins in a hotel grill-room resulted from an explosion of gas which had been generated in an oil-insulated transformer.

in oil-insulated transformers. One of these is overloading. As the amount of heat to be absorbed by the cooling medium varies approximately with the square of the current, an overload, particularly for a long period, is likely to result in volatilization of the oil. Similarly, oil may be vaporized from overheating of the transformer because of insufficient oil. Loose terminal connections or accumulation of dirt or other matter at these connections may cause arcing and provide the source of heat for generating oil vapors. In an endeavor to prevent explosions from lightning surges as well as to avoid breakdowns of transformer windings and other electrical equipment, it is advisable that adequate lightning arrestor protection be afforded and that the arrestors be kept clean and properly grounded. In many installations in which transformers are located within buildings or confined places and there is danger of a large amount of damage from explosion and fire, other than to the transformers themselves, a non-flammable fluid may be used for insulating and cooling medium.

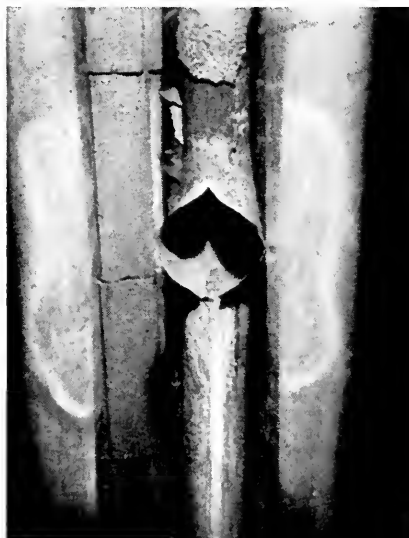
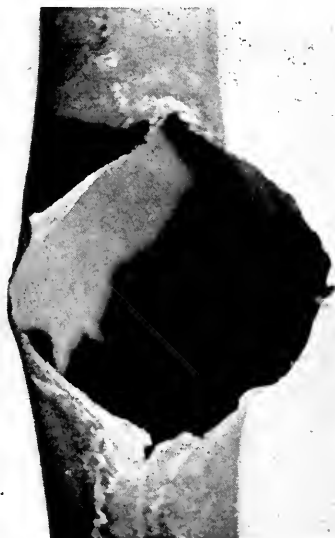
Two views of a ruptured tube for a water tube boiler reported to have been operated at a higher rating than that for which it was designed. Steam pocketed in the tubes, causing one of them to overheat and rupture. Because of the resultant loss of water and the high furnace temperature, 100 additional tubes were distorted and had to be replaced.

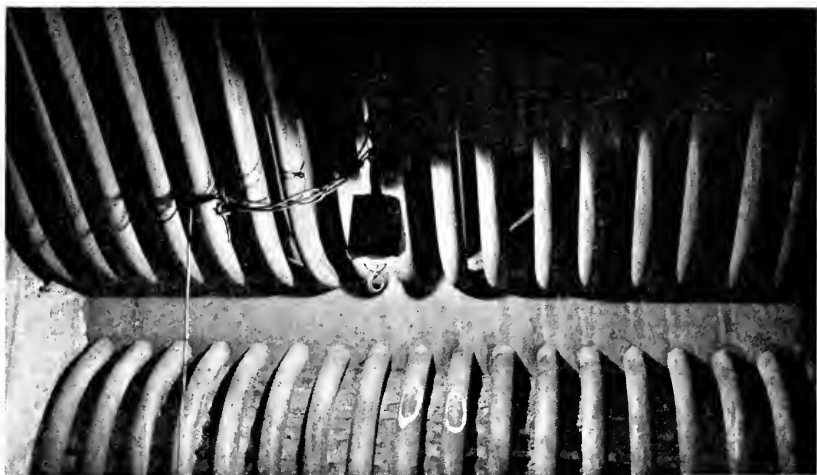
Scale resulted in overheating and bulging of a number of water-wall tubes in this boiler. Change in the feedwater supply without proper adjustment of the feedwater treatment caused the scale accumulation. Two of the damaged tubes are marked. Cost of repairs was not large but several hours of production were lost before steam could be supplied by spare boilers.

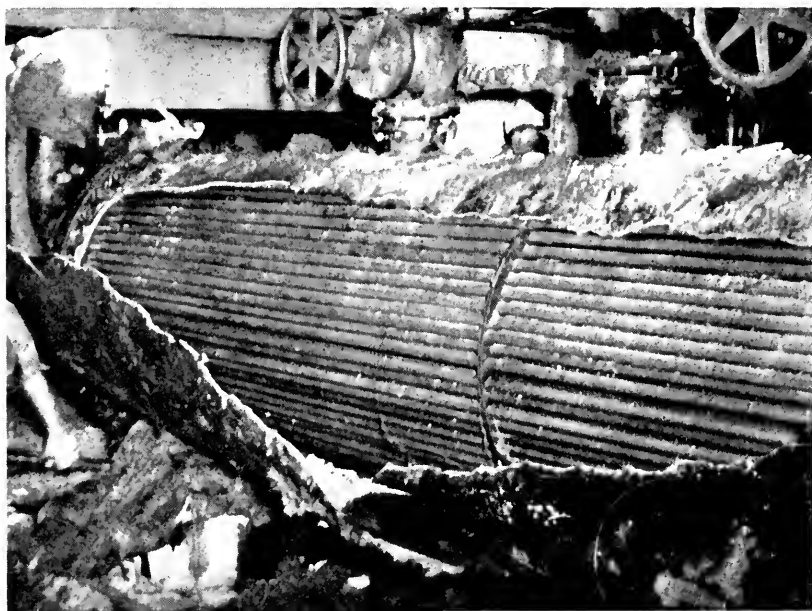
When this brine cooler exploded violently last August four men were seriously injured, one of them being burned so severely by ammonia that he died three days later. Estimated at more than \$40,000, damage to the building and contents was caused principally by escaping water and ammonia.

The brine cooler was 43" in diameter by 16' long. It contained ammonia in the shell and brine in the tubes. Apparently a pressure greater than normal caused the explosion although the reason for the excessive pressure is not known as the piping arrangements, location and condition of valves, method of operation and the events preceding the accident were not obtained.

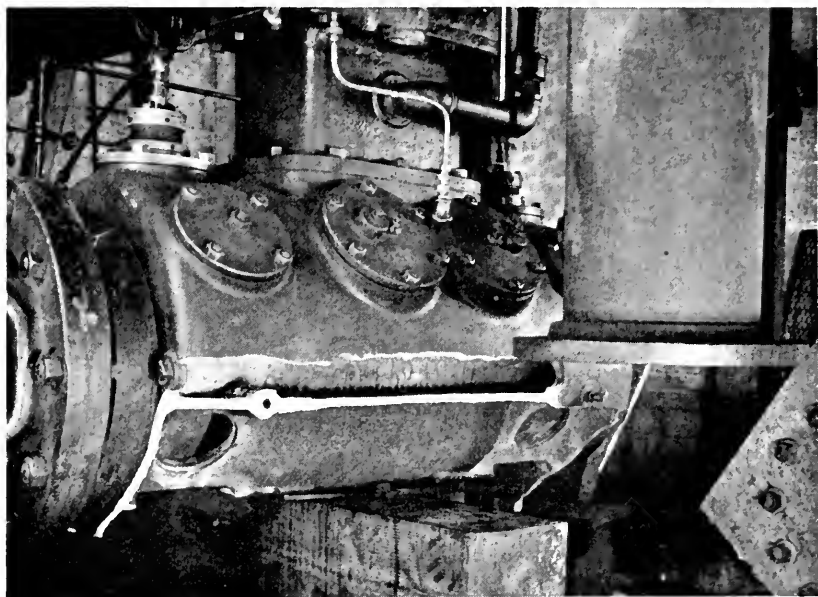
Figure 1 shows a high pressure cylinder of a two-stage motor-driven machine which was damaged by an explosion. The lower half of the cylinder and discharge piping near the compressor were blown off, and the water jacket broken on both sides of the cylinder. In an attempt to analyze the cause, the thought was expressed that the stop valve in the discharge piping had been closed by vibration, and as there was no safety valve between the compressor and the stop valve, over-pressure caused the accident. However, it is possible that overheating caused a combustion explosion or, at least, was a contributing factor. As shown in the picture, a large amount of scale had accumulated on the inside surface of the water jacket. Unfortunately, the engineer was struck by flying parts and fatally injured.

Figure 1—High pressure cylinder on a two-stage motor-driven air compressor damaged by an explosion. Excessive air pressure or a combustion explosion may have been the cause. The operating engineer was killed.

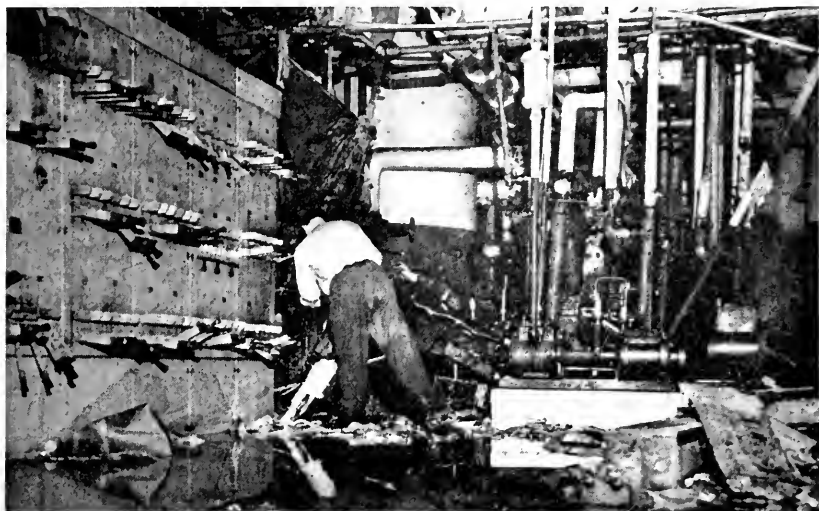
Steam for both power and heating was obtained from a battery of water tube boilers, and engine-generator sets furnished electric power. The exhaust from the engines was discharged to the feedwater heater through a 20" line to which other steam piping was connected for supplying heat to a separate building. In order to maintain an even pressure for the heating system as well as limit the pressure in the heater, a control valve was installed in one of two pipe lines which ran from the heater to the atmosphere. In the other line there was a stop valve which was opened only slightly. When the pressure exceeded 2 lb, the control valve was intended to relieve the excess steam to the atmosphere. A by-pass line, having a stop valve and an atmospheric relief valve, was connected around the section of piping containing the control valve but during normal operation this stop valve was closed and the relief valve loaded down. Since the heater itself did not have a safety valve, there was no way of preventing excess pressure if the control valve failed.

Some of the damage caused by an explosion of an open-type cast iron feedwater heater. Originally the heater was installed near the place where the man is standing and parts of it can be seen to the man's right and over his head. The explosion caused the death of 3 men and property damage of approximately \$4,000.

Because of the low pressure at which open-type feedwater heaters are operated, owners and engineers may not think of them as a possible source of serious accidents. But occasionally these vessels are so installed that no safeguard against excess pressure is afforded. Through oversight valves may be shut off or may be closed by vibration, with the heater in service. On any installation having a stop valve between the heater and the atmospheric relief valve, the stop valve should either be removed or locked in a fully open position. It is also important that relief valves be examined and tested regularly in order to be sure that they will function properly when required.

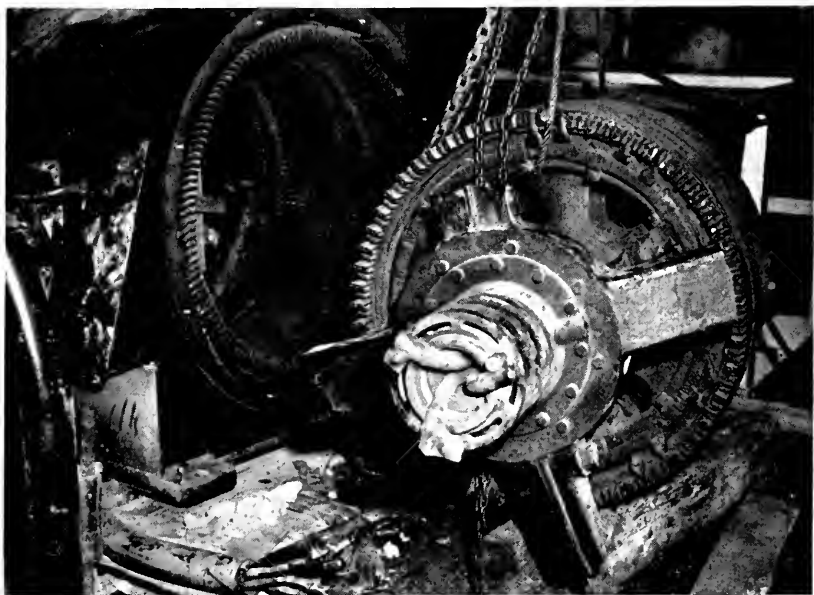
From the findings obtained by an examination of the broken fan parts and from an investigation of operating conditions at the time of the failure, there were conclusive indications that the accident had been caused by internal erosion of the fan, together with high stack temperatures. Many of the rivet heads had been eroded extensively and the cross-section area of some of the angle-irons at the joints attaching the shrouding to the fan blades likewise had been so reduced by erosion that less than 20% of the original area remained. Normally the average stack temperature was about 550°F. but the boiler room charts indicated that these temperatures had been considerably higher prior to the failure. Further evidence of abnormally hot stack gases was obtained

Figure 2—Connected through a coupling to the draft fan shown in Figure 1, this 450 hp wound-rotor induction motor was wrecked by the severe vibration which resulted from the disruption of the fan.

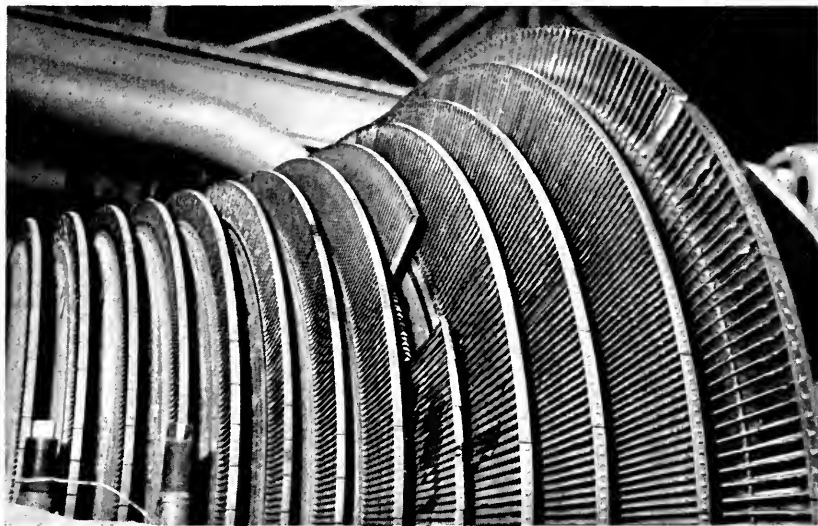
A FEW months ago a 23,000 kw steam turbine in a Texas utility plant was damaged when a section, about 12" long and containing 18 blades, broke from the rim of the disc of the nineteenth stage wheel. Having a rated speed of 1800 rpm, the turbine contained twenty-three stages and was operating at a pressure of about 185 lb at the time of the accident. Figure 1, which is a view of the top-half of thirteen of the lower pressure stages, shows where the break occurred. Although the broken parts, in striking the diaphragms and blading in the remaining stages, nicked and bent some of the nozzles and blades, the defects were not sufficiently serious to require replacement of these parts. Some additional damage, however, was sustained by the turbine through the diaphragm packings becoming badly worn by the whipping action of the shaft.

Figure 1—Part of the upper half of a 23,000 kw steam turbine showing damage to the nineteenth stage wheel when a 12" section of the disc broke near the rim. The cause was attributed to a progressive crack.

This accident is a good illustration of the importance of careful observation of a turbine's vibration. When an appreciable increase is noted, the unit should be shut down immediately. In this case, through discovery of the damaged condenser tubes and the subsequent investigation, it is quite likely that a much more costly accident was avoided, for if the turbine had been operated for an appreciable time with the broken wheel, the continual vibration created by the unbalanced rotor might have caused further damage to the unit.

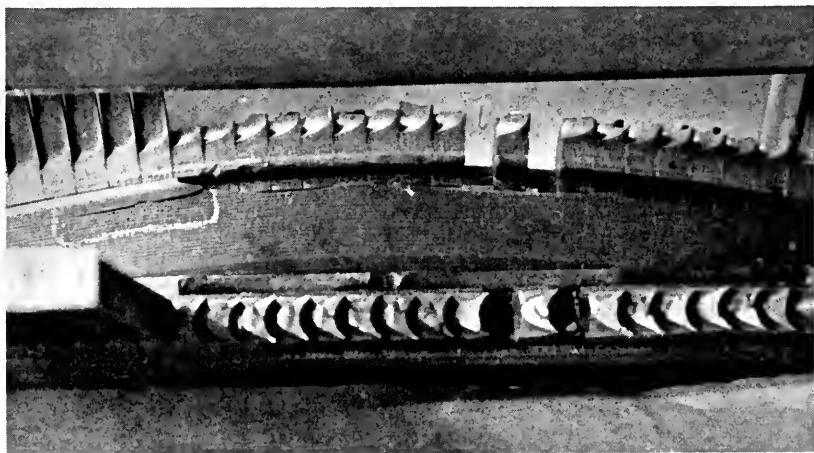
The original point of failure occurred at the rim of the wheel in the shoulder of the groove in which the blades were fastened. Figure 2, which was taken with the aid of a mirror, gives both a top and side view of the fracture. The appearance of the broken metal indicated that part of the crack had existed for some time. Just what caused the crack originally could not be determined but as a burr was found on the dove-tail of one of the broken blades, the thought was expressed that when this blade was installed the tight fit produced sufficient wedging action to start a small crack on the inside of the shoulder. Then, progressing gradually along the rim of the wheel and through the shoulder, the crack finally so weakened the disc that it broke from centrifugal force.

Figure 2—Taken with the aid of a mirror, this picture gives a close-up view of both the top and one side of the broken section in the turbine rotor shown in Figure 1.

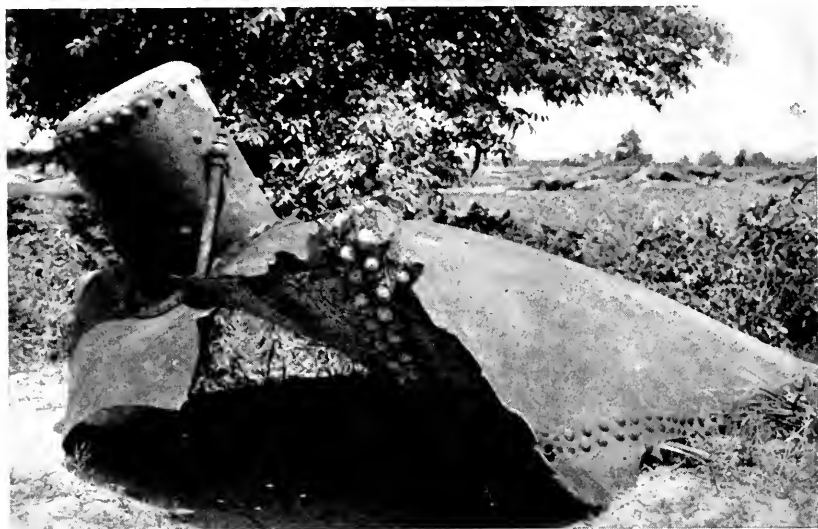
Figure 1—A crack in a longitudinal lap-seam caused the explosion of this boiler. Three men were killed and twelve others injured, eight of them seriously.

been set at 140 lb. From an examination of the wreckage the cause was definitely established as a crack in a longitudinal lap-seam, the crack extending for a distance of several feet along the hidden surface of the outside plate. Figure 1 shows a part of the boiler 400' from its original setting. The sheet in the left foreground is the one in which the initial failure occurred.

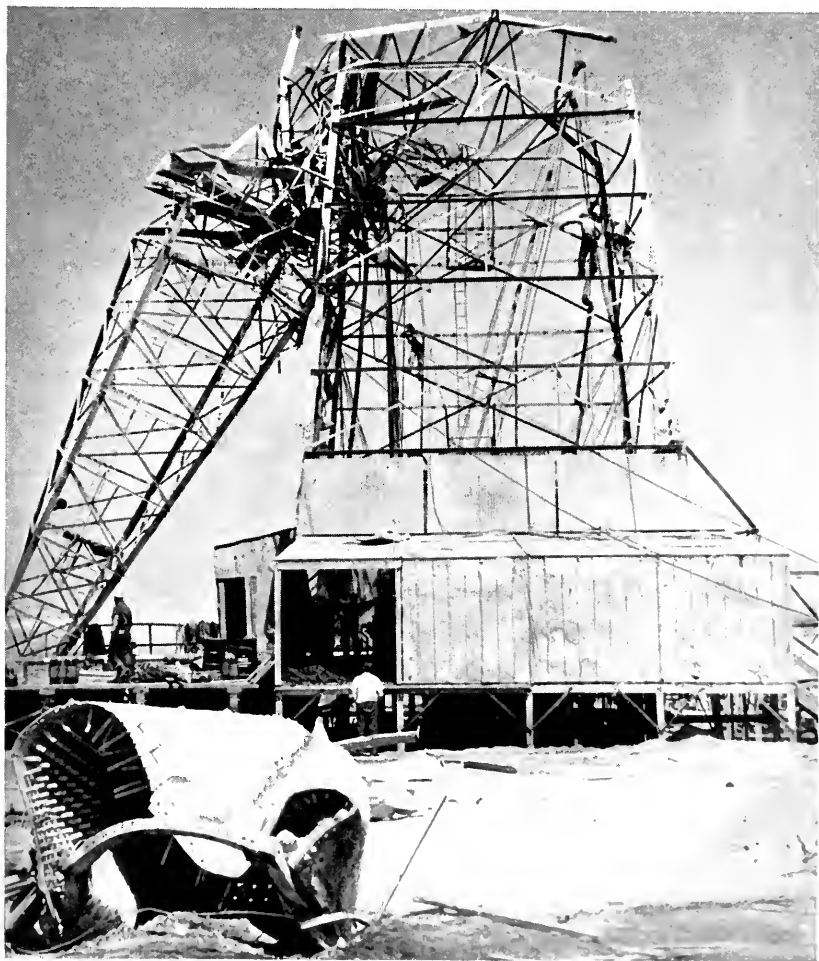
Figure 2—Derrick in an oil field wrecked by an explosion of an oil-well drilling boiler which was located a quarter of a mile away. The boiler's fire box that crashed into the derrick is shown in the foreground.

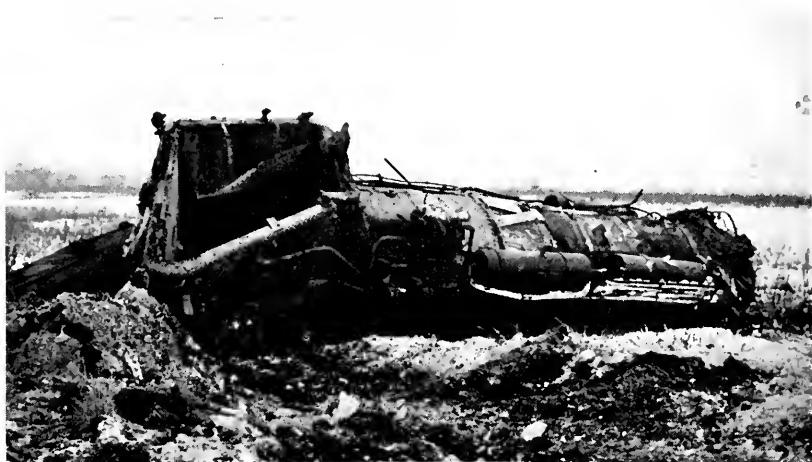
Figure 3—Weighing more than 40 tons, this track locomotive boiler was hurled 500' when low water caused failure of the crown sheet.

yards at Denver. A news account of this latter explosion stated that the boiler and cab were lifted from the undercarriage, hurled 60' in the air and thrown upside down on an empty railway express car over 200' away. It was reported also that at least twenty-two persons were injured, some of them seriously. In the four freight train explosions, eight trainmen were killed and two injured. News reports on most of these accidents indicated that they involved failure of the crown sheets because of low water. Figure 3, showing one of the freight train locomotives, was taken after the heavy boiler had been torn from the running gear and hurled 500' by the force of the explosion. As shown in the picture the failure occurred in the fire box.

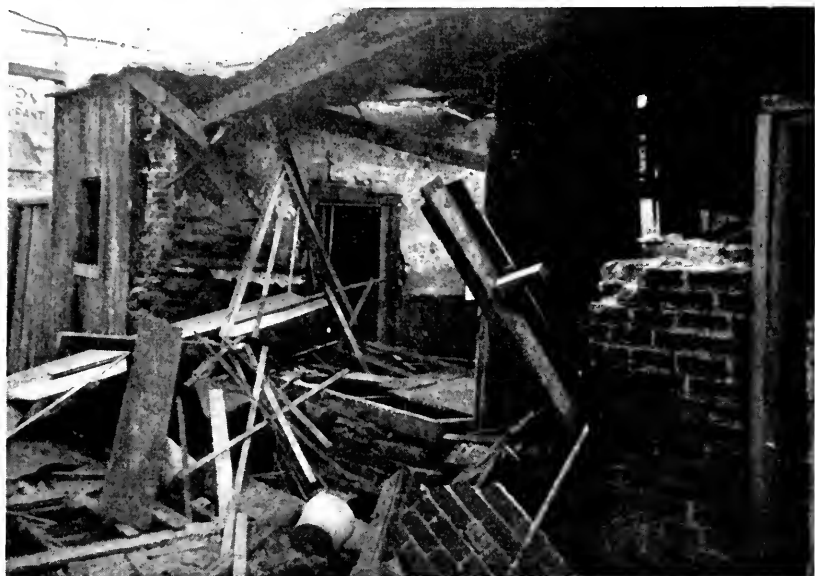
Figure 4—Part of the damage to a laundry building caused by an explosion of a small vertical flueless boiler.

the roof of the laundry building, sailed over an alley and an adjacent two-story building, and landed in a yard a half block away. Part of the wreckage is shown in Figure 4.

Although the boiler was not insured, an investigation was made by an inspector who was in the vicinity when the accident occurred. He found that the entire cone in the top of the furnace had collapsed and that the initial failure took place along the longitudinal lap-seam in the cone, this seam having been weakened by a crack about 2' long. In addition, he found that a crack had extended around the entire circumference of the cone head-seam and that the furnace sheet had cracked for a short distance at the edge of the mud ring opposite the fire door. In several places the furnace sheet and the cone had been pitted and corroded half way through the metal. Even with all these defects, however, at no point in the boiler had they made themselves evident through leakage.

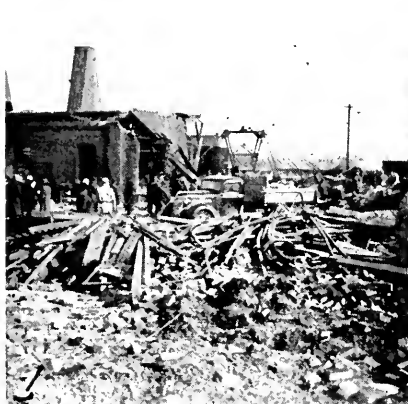
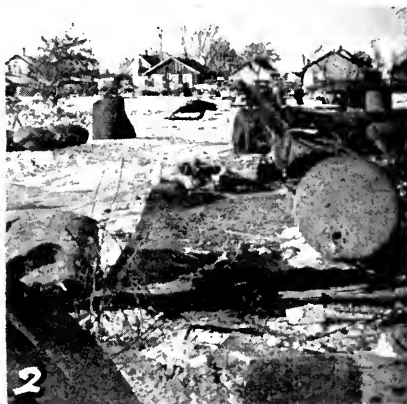
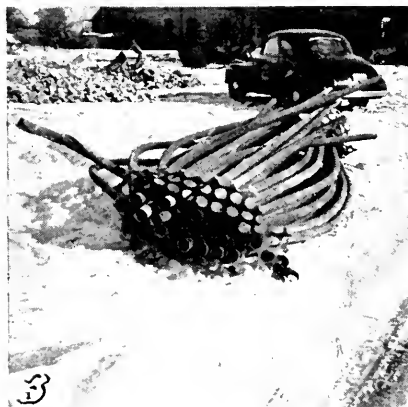
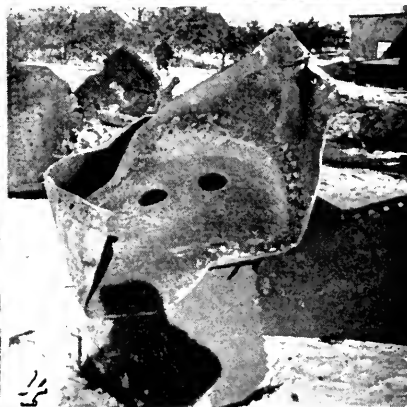
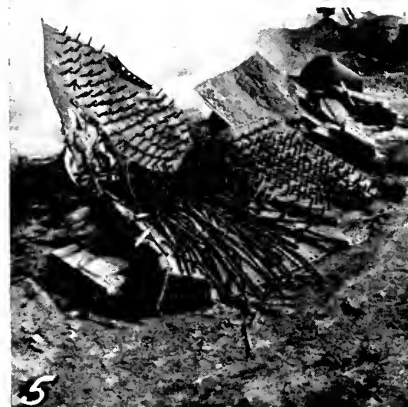
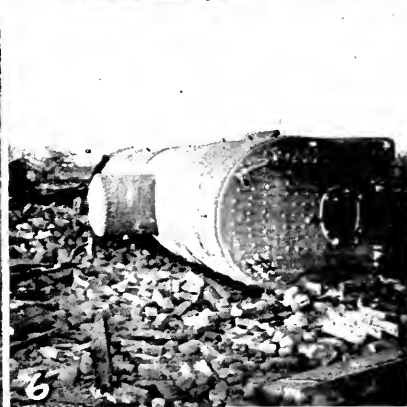
A Boiler Explosion Caused this Wreckage

LAST February an explosion of a stationary locomotive-type boiler at a roundhouse in Minnesota killed three railroad employes and injured a fourth seriously. All four men were in a boiler house adjacent to one end of the roundhouse building when the accident occurred. An eight-stall section of the roundhouse and the boiler house, both of brick and wooden frame construction, were demolished. The pictures on the opposite page, taken at the scene of the disaster, indicate graphically some of the havoc which resulted from this explosion.

The photograph in Figure 1, giving a general view of the wreckage, was made as a search of the debris for the missing workmen was being started. Of the several parts of the disrupted boiler and stack shown in Figure 2, the flat sheet in the center is the manhole course in which the initial point of failure is believed to have occurred. The tubes, steam dome and the wrapper sheet are shown in Figures 3, 4 and 5, respectively. All these and other parts of the boiler were scattered over a wide area. Figure 6 shows another boiler of the same size and type, which was also in operation, where it was thrown by the concussion, 60' from its setting. Several automobiles in the roundhouse were damaged, a wooden coal bin was wrecked, and various other pieces of equipment such as a feed-water heater, an air receiver, two feed pumps, piping and wiring were destroyed. In addition, stained glass windows were broken in two churches, as also were a number of windows in residences, all several blocks away.

Although a complete investigation was made in an attempt to determine the exact sequence of events which brought about the explosion, the definite cause remains largely a mystery. The boiler had been shut down a few days previously for cleaning, inspection and repairs, and apparently it had not been fired again until about two and one-half hours before it blew up. Information could not be obtained from the operators who may have known what happened, as unfortunately they were killed, but from an examination of the shattered parts of the boiler, the conclusion was reached that over pressure was the probable cause.

Approved pressure for the boiler was 110 lb and the safety valve was stated to have been set at about 100 lb. However, when the safety valve was tested after the accident, it did not open until a pressure of 250 lb had been reached. Moreover, the main-steam stop-valve for the boiler was reported as having been closed, indicating that there had been no outlet for the steam as it was generated. In this type of boiler a common cause of explosions is overheating and failure of the crown

sheet from low water, but in this case no evidence was revealed by the investigation to support an opinion that the accident was brought about by a low-water condition, nor was there any evidence to indicate that the boiler contained any weakness which might have led to its failure.

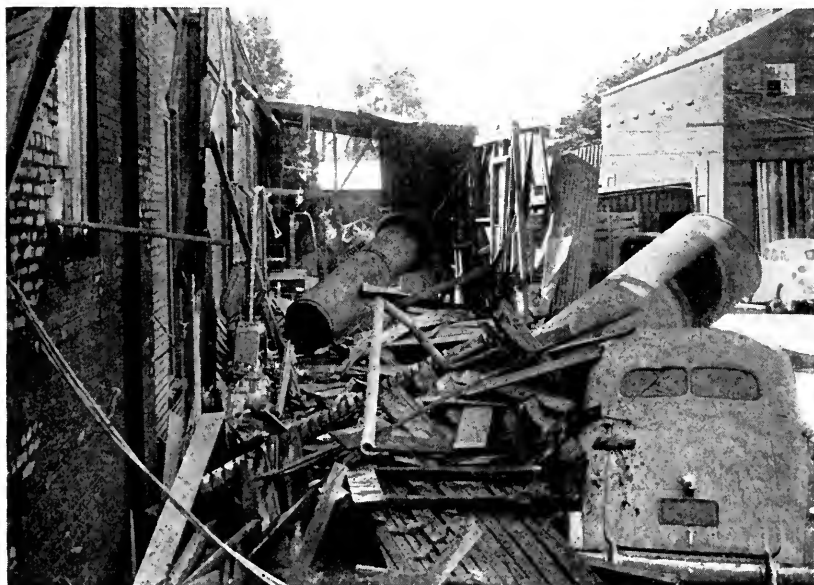
Damage at a creamery and cold storage plant caused by a boiler explosion as a result of low water which, in turn, was attributed to failure of automatic controls. The furnace in the boiler overheated, collapsed and ruptured. Property loss was nearly \$5,900.

The boiler in which this disaster occurred was of the Scotch-marine type, 78" in diameter, with its safety valve set at 92 lb. At the time of the accident gas fuel was being used although the boiler was equipped to burn either gas or oil fuel. Operation was entirely automatic, as controls were provided for regulating the feed-water supply, the damper and the burner. Furthermore, it was reported that the boiler was checked about once an hour when the plant was in operation.

In this case the cause of the explosion was definitely determined, for as a result of low water the furnace had overheated, collapsed and ruptured. The exact cause of failure in the automatic controls was not established as all fittings, attachments and other equipment connected to the boiler, except the safety valve, were so badly damaged that any conclusions reached, even after a careful examination had been made of these parts, would not have been reliable. Actually lack of proper testing and servicing of the controls might more appropriately have been stated as the real cause.

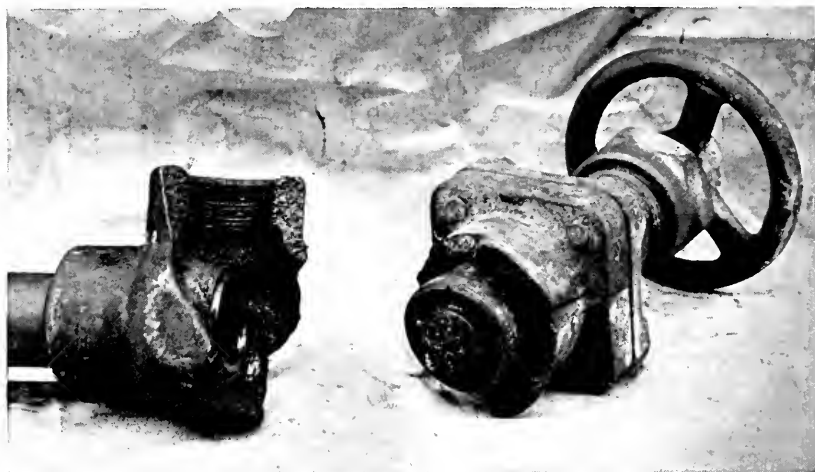
Figure 2—View of the broken by-pass valve which led to the violent explosion described on Page 203.

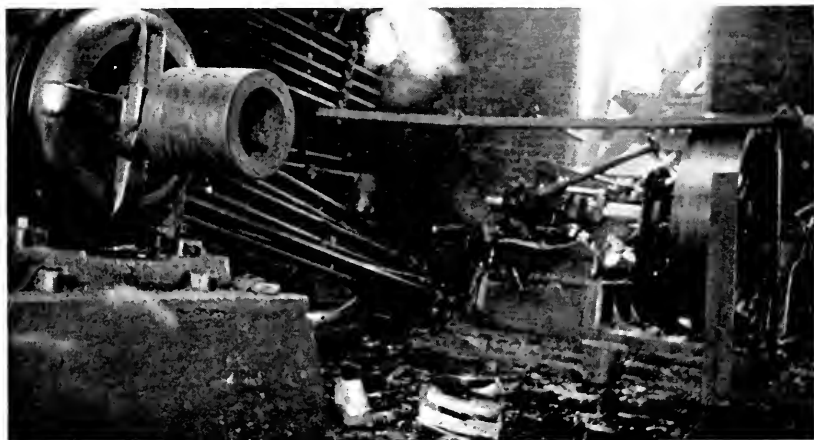
The following account of an explosion shows the danger in running a motor-driven compressor with the stop valve closed in the discharge line and also shows the value of an overpressure-actuated cut-out for the driving motor. According to the statement of the operator who barely escaped being killed, the explosion was accompanied by a blinding flash of fire. It was found that he had started the compressor with the discharge-line stop valve closed and had operated the machine in that manner for nearly four hours. As a result, the ammonia gas temperature increased greatly and the compressor overheated. What actually happened then isn't known but the conjecture is that a piston seized and caused a shock which broke the crankcase. The hot oil vapor or

Figure 4—Only the bottom of the crankcase, the shaft and the wheel remained after this vertical twin-cylinder belt-driven ammonia compressor exploded. The cause was attributed to a combustion explosion in the crankcase. \$7,500 was the estimated damage.

ammonia gas thus released mixed with the air and was ignited almost instantly as evidenced by the sudden flash of fire.

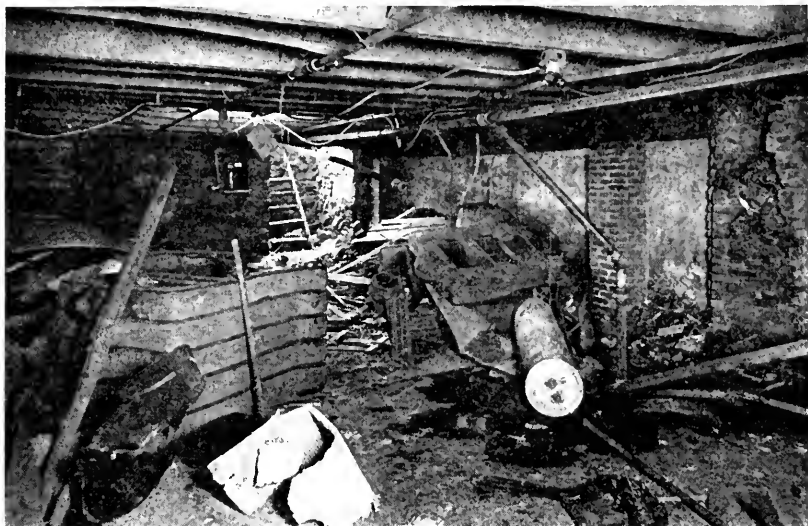
Figure 1 (Top)—An explosion of a cast iron sectional heating boiler caused this damage. A new boiler, it had been placed in service for the first time only a short while previously.

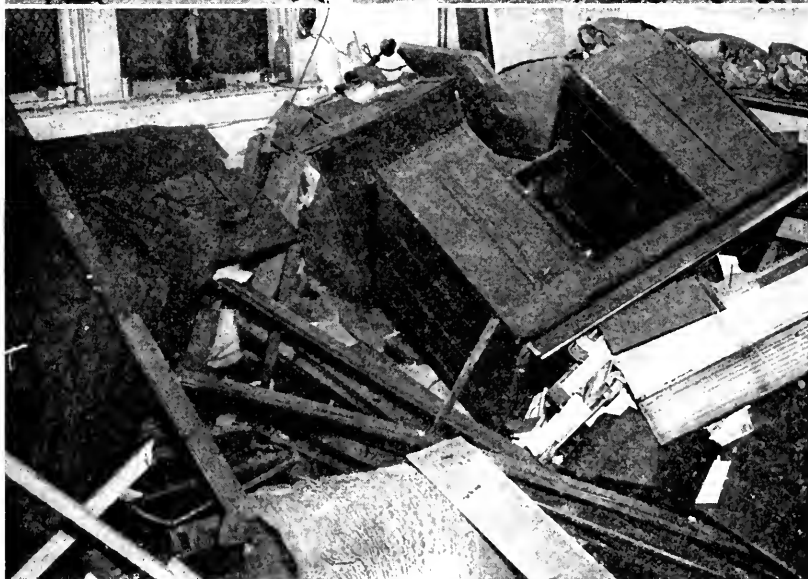
Figure 2 (Bottom)—View in a hotel office showing havoc caused by an explosion of a small hot water supply boiler. The damage was estimated at \$2,000.

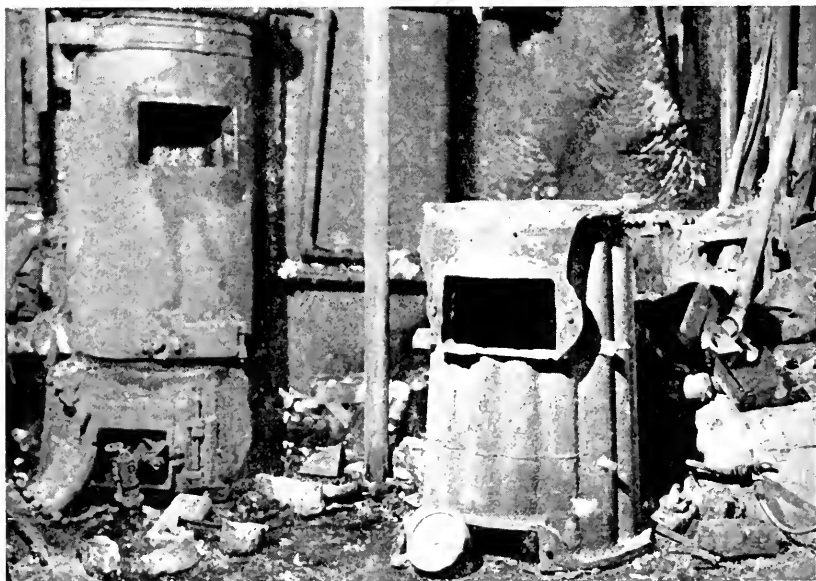
Figure 4—Through an operating mistake, a small hot water supply boiler was changed to a steam boiler. As its water relief valve did not afford suitable protection, the boiler exploded from overpressure.

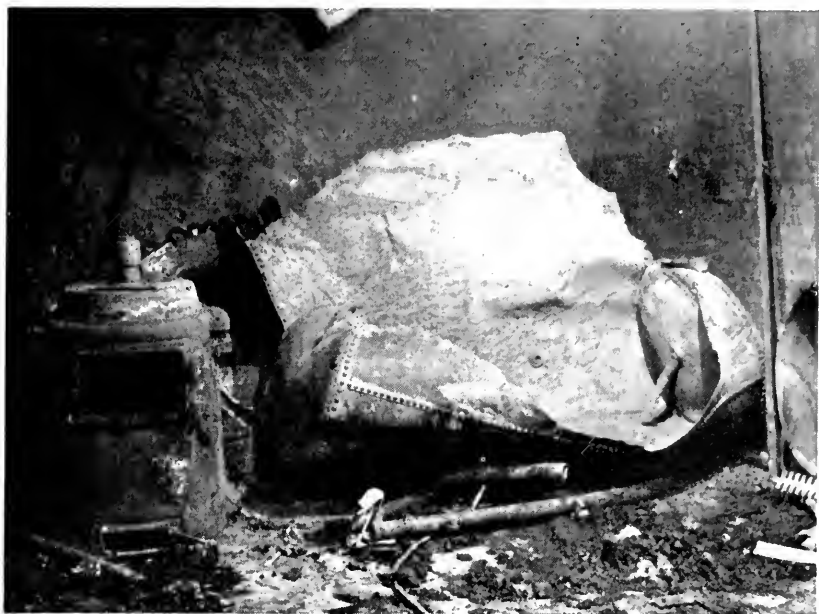
In three cases involving failure of hot water supply equipment the hot water storage tanks were the weakest points in the supply systems rather than the boilers or coil heaters in which the water was heated. One explosion occurred in a nurses' home in Tennessee, another in a residence in Connecticut and the third in a store and apartment building in Illinois. Damage to the buildings was extensive as the total for the three explosions, according to the reports, was approximately \$10,000. The news accounts for the first two of these accidents stated that the blasts resulted from the safety valves having been stuck. Although an inspector made an investigation of the Illinois accident, piping, valves and fittings were so badly twisted and broken that he found it impossible to reach a definite conclusion as to the cause. The exploded tank, which was 2-ft. in diameter by 5-ft. long and constructed of galvanized steel, is shown in Figure 5.

Figure 5—The damage resulting from the explosion of this hot water tank was estimated at \$4,000. The cause was not determined.

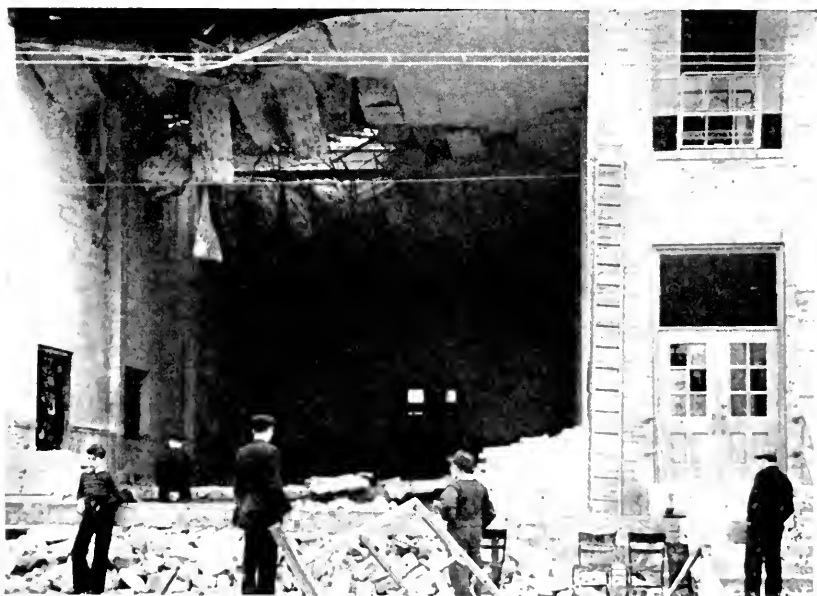
Part of the damage to an Ohio school from an explosion of a welded steel hot water heating boiler is shown in Figure 1. Although positive proof was lacking, the nature and extent of the damage indicated that overpressure was the probable cause. The boiler was stoker-fired and automatically controlled. The theory generally accepted for the explosion was that the water circulation in the system had been greatly reduced or stopped entirely and that a water temperature control for the stoker had failed, resulting in the pressure increasing until the boiler burst. If the water relief valve functioned at all, it must have been of inadequate discharging capacity to relieve the pressure at the high temperature which undoubtedly had been reached when the boiler exploded, as at that temperature a large amount of water would have

Figure 1—An explosion of a steel hot water heating boiler was responsible for the damage to this Ohio school. Excessive pressure was believed to have been the cause.
