The Locomotive

THE HARTFORD STEAM BOILER
INSPECTION AND INSURANCE CO.

INDEX
to
VOL. 42 - 43

INDEX TO VOL. 42—1938-1939

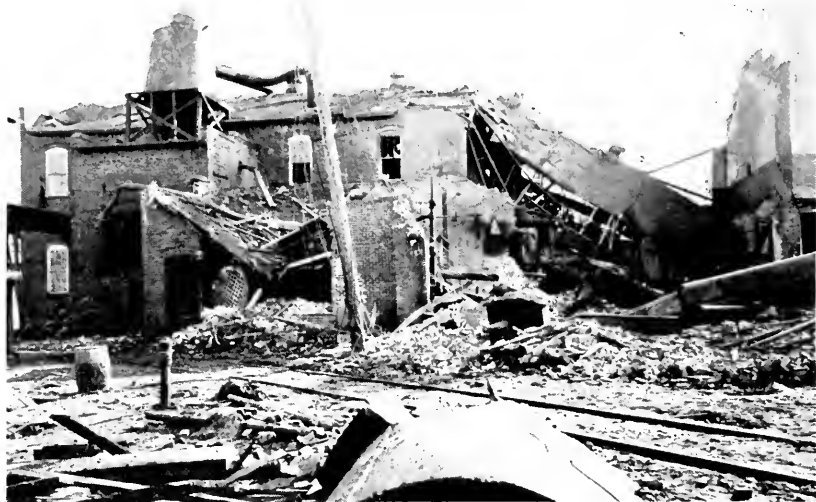
Figure 2—View of a North Carolina manufacturing plant wrecked by an explosion of a horizontal tubular boiler. Overheating from an accumulation of scale and sediment caused the accident.

Six persons were killed and nine injured in a North Carolina plant by an explosion of a horizontal tubular boiler that had been overheated as a result of a heavy deposit of foreign material. A large part of the property damage, which all together amounted to approximately \$45,000, is shown in Figure 2. The overheating was brought about by an increase in the sediment and scale-forming content of the feedwater. Although the operators had followed a practice of opening the boiler for cleaning every week, this cleaning had consisted only of removing the lower manhole plate and of washing the loose scale and sediment to the rear of the boiler with a hose, the operators expecting that this foreign matter would be carried away through the blow-off piping when the boiler was blown down. However, because of the unexpectedly heavy accumulation of this foreign matter, this method of cleaning proved insufficient and the fire sheets overheated.

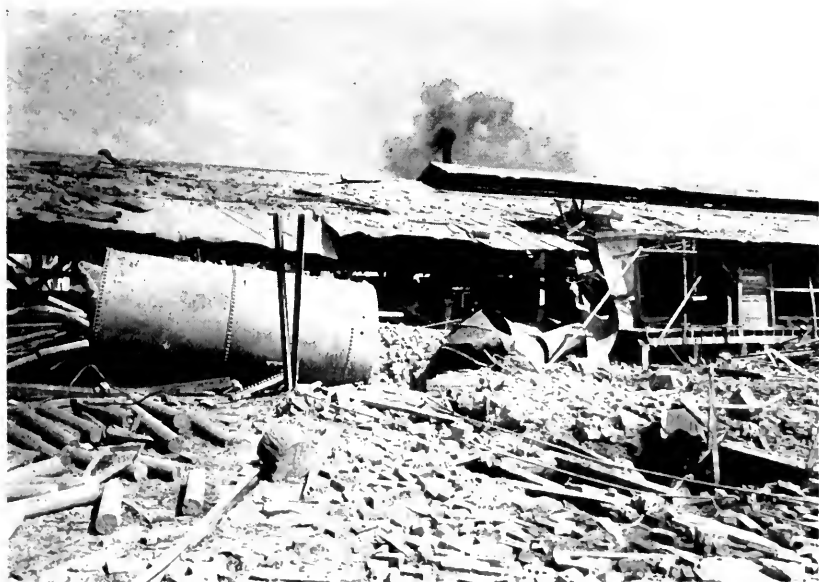
Figure 3—Georgia sawmill extensively damaged by an explosion of a horizontal tubular boiler. The feedwater contained tannic acid which resulted in rapid internal corrosion.

Figure 3 is an illustration of damage from a boiler explosion caused by internal corrosion. Two persons were injured and property damage amounted to \$6,500. Feedwater for the boiler, a horizontal tubular, was obtained from a log pond, and as this water contained a considerable proportion of tannic acid, it was the reason attributed for the very rapid and extensive internal corrosion which caused the accident.

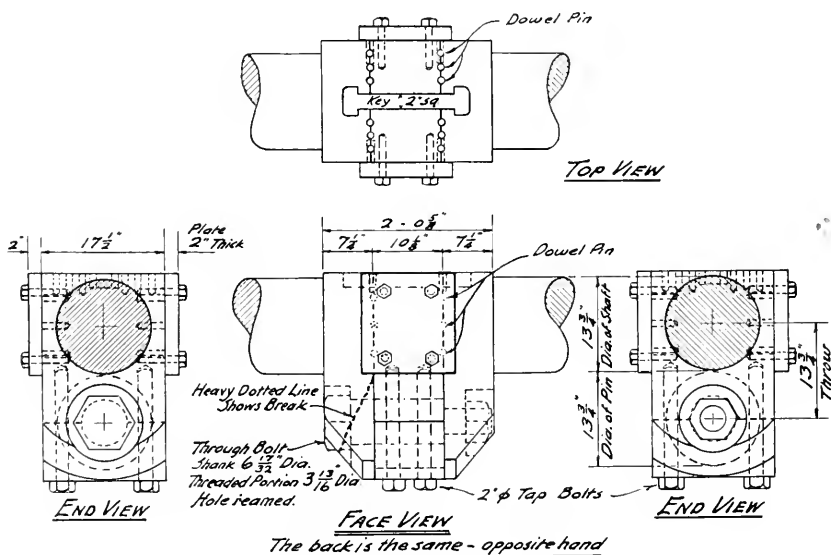
Operated at a speed of 240 rpm, the engine had a one-piece shaft 22-ft. long and 13 $\frac{3}{4}$ -in. in diameter. Each web was 7 $\frac{1}{4}$ -in. thick and 17 $\frac{1}{2}$ -in. wide, except at the crankpin ends where the webs were chamfered. The pins, which were hollow, were 13 $\frac{3}{4}$ -in. in diameter and 10 $\frac{1}{8}$ -in. long between the webs.

Sketches showing method used in making a temporary repair to a large shaft for a 3,000 hp Diesel engine.

with the sixth cylinder cut out. A temporary repair was accomplished by removing the connecting rod, blocking the piston in such a position that the exhaust and scavenging ports were closed, and installing between the webs a solid steel block with a cap, both machined to fit around the pin and both securely held in place, thus firmly connecting the two ends of the shaft together. As shown in the accompanying sketches, this block and cap were fastened to the shaft by a steel link at the top, a through bolt at the bottom, and two steel plates bolted to the block, one on the front and the other on the back. Four 2-in. tap-bolts fastened the cap to the block.
